March 14, 2019
SL11157-1

Parcel 9, North Ocean
Avenue
APN: 064-481-009
Cayucos Area
San Luis Obispo
County, California

COASTAL BLUFF EVALUATION

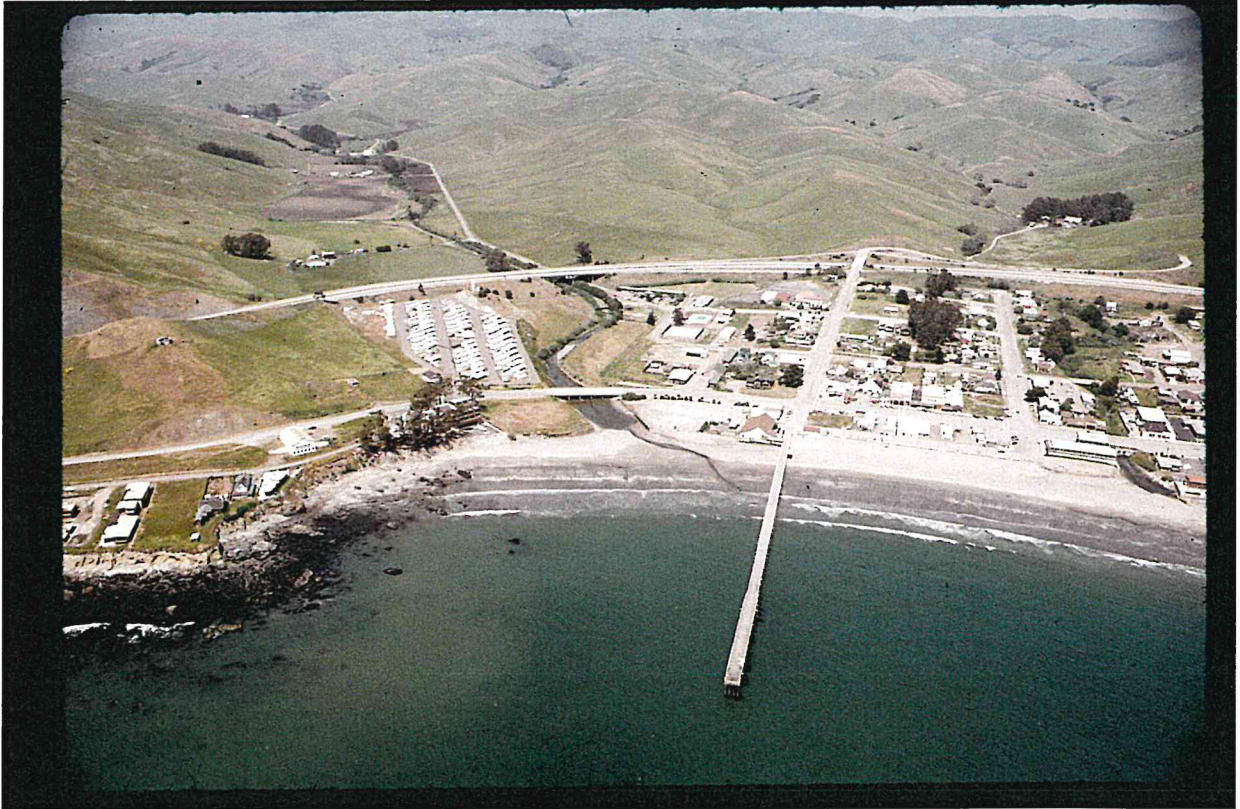
Figure 3: Aerial Photograph – 1972 (Kenneth & Gabrielle Adelman)

Artificial fill was mapped throughout the majority of the Site. A maximum of 12 feet of fill was encountered within Borings B-2 and B-3. Based on historical photographs, it appears that fill was placed on the site between the 1953 and 1972 photographs, possibly during the grading of the mobile home park across North Ocean Avenue. The fill encountered within the borings and observed along the bluff face consisted of light gray sand with gravel and boulders of serpentinite.

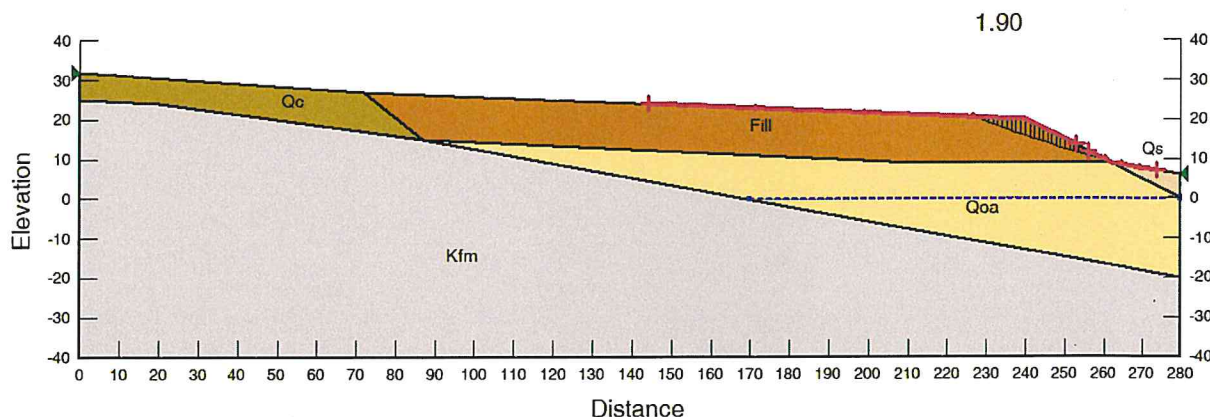
Figure 5: Section A-A (static)

The potential slip surfaces for static and psuedo-static conditions (based on a factor of safety of 1.5 for static and 1.1 for pseudo-static) are presented on Figure 5 and 6. The respective factor of safety values are presented in Table 3.

The horizontal distance from the top of bluff to the potential slip surface for both static and psuedo-static conditions is less than the required 10-foot buffer distance. Therefore, a 10-foot buffer from the top of bluff (in addition to the 100-year bluff erosion rate) appears to be the most conservative setback for new development on the subject property.

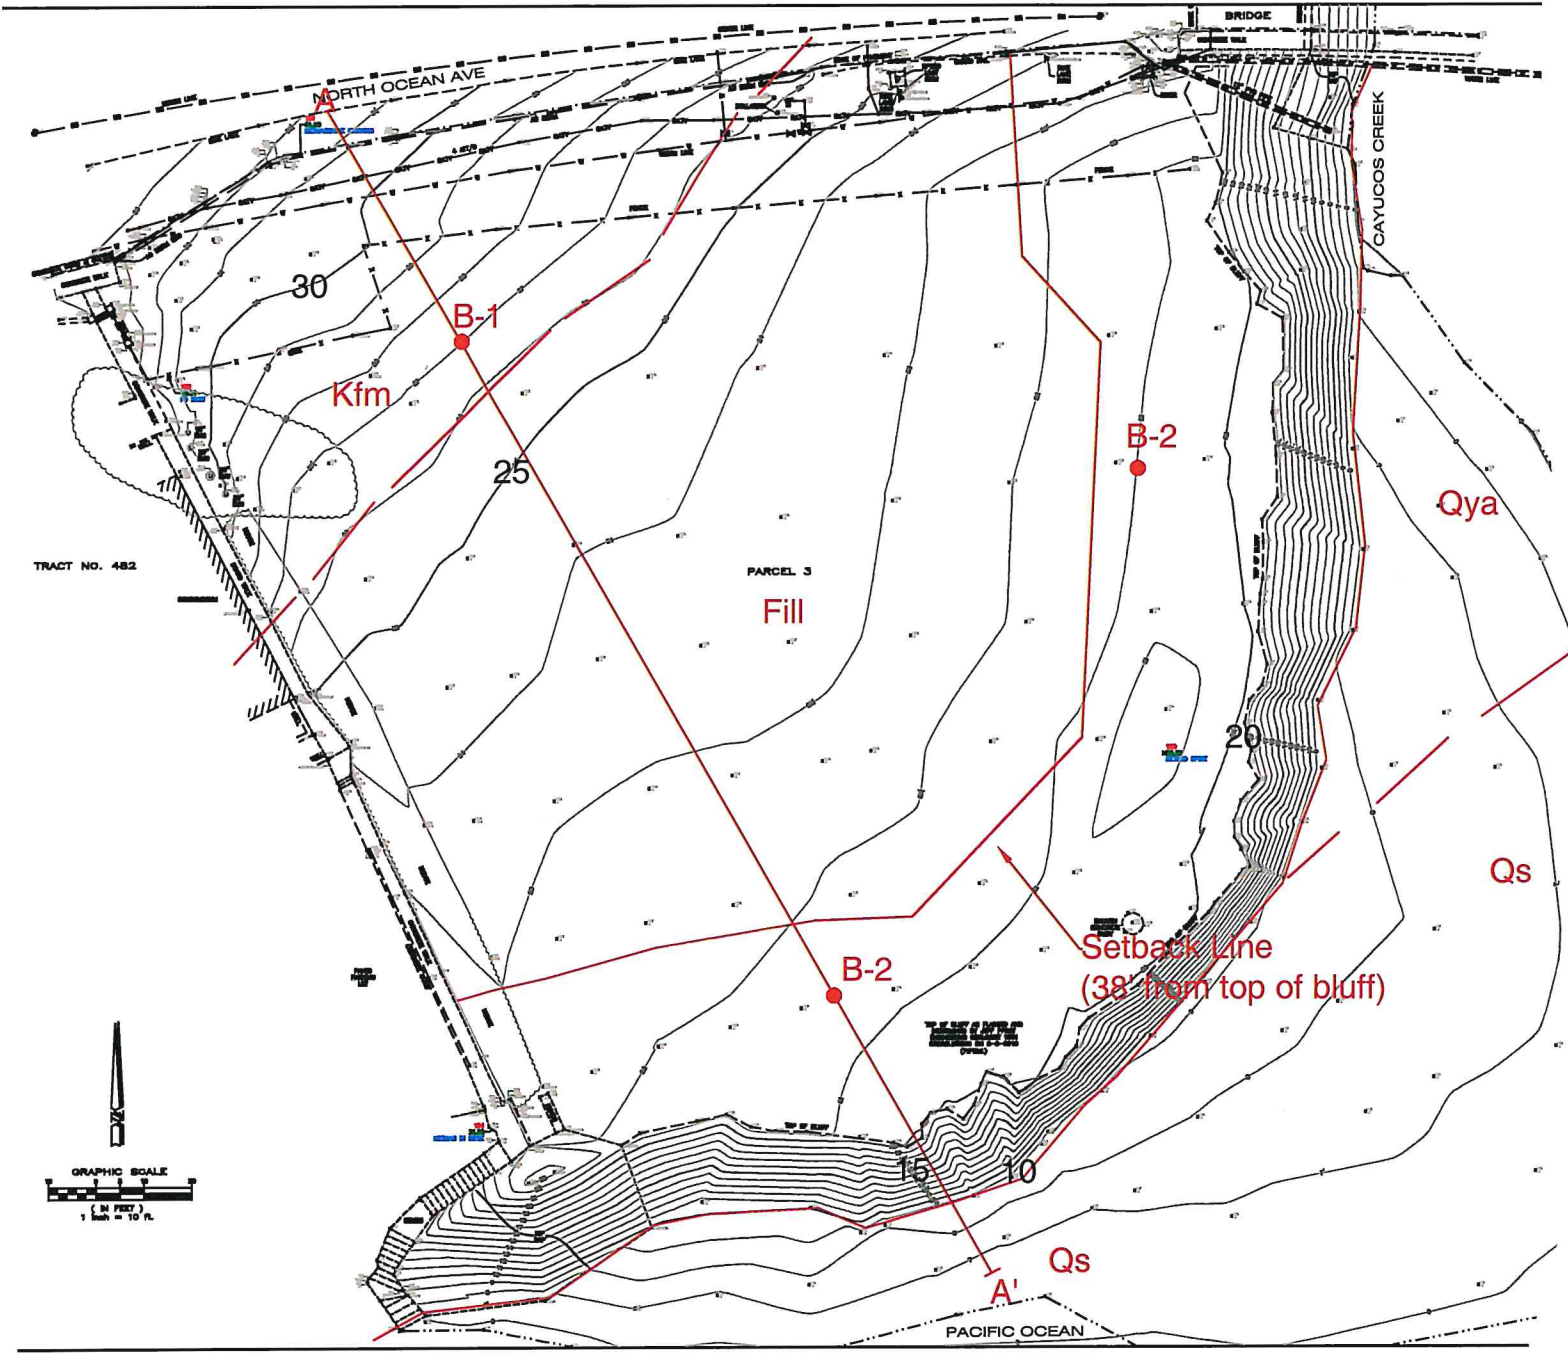
According to Johnsson (2003), total development setbacks should include an additional buffer, generally 10 feet, that serves to allow for uncertainty in aspects of the analysis, allows for future increase in bluff retreat due to sea level rise, and assures that at the end of the design life of the structure that the foundation is not being undermined. An additional setback to the 100-year retreat rate would be the greater of either a 10-foot buffer or a slope stability analysis that shows instability greater than 10 feet. The numerical slope stability analysis (as described in Section 9.1) shows that the bluff maintains a factor of safety of 1.5 or greater and that the greater of the two additional setbacks is the 10-foot buffer. A total setback for the house is 38 feet, which is the addition of the 100-year retreat rate (28 feet) plus the 10-foot buffer. This 38-foot total setback line is depicted on Plate 1, Site Engineering Geology Map.

1. The retreat rate analysis (28-feet in 100 years) and addition of the 10-foot buffer has calculated a construction setback line at the property of 38 feet. It is recommended that the setback line as depicted on Plate 1A, Site Engineering Geologic Map, be incorporated into the design.

2. The setback line as depicted on Plate 1A is recommended to be established in the field as a series of stakes prior to initiation of construction. This setback line would be the measured distance from the top of bluff as determined from the date of this report. It is understood that erosion of the bluff may occur between the period of publication of this report and construction of the building but the retreat rate analysis has considered the long-term erosion rate of the property and episodic erosion events are anticipated and are calculated within the erosion safety factors.
