PHASE I ENVIRONMENTAL SITE ASSESSMENT 4.13 ACRE PARKING LOT NORTHEAST CORNER OF WEST 190TH STREET AND CRENSHAW PLACE TORRANCE, CALIFORNIA

December 26, 2007

073-91953

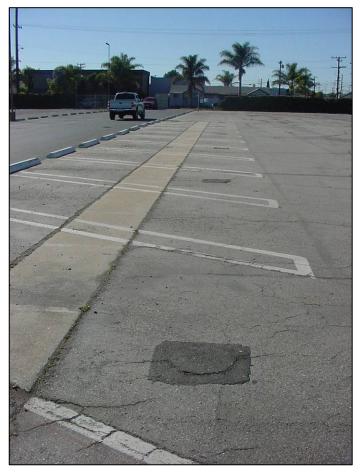
A row of circular asphalt patches was observed just north of the access road from the eastern boundary to approximately halfway to the western boundary. Adjacent to the south along these patches was a concrete strip that appeared to be present by the 1990 aerial photograph and extended from the eastern boundary to halfway to the western boundary. The origin of the patches and concrete strip is unknown.

Photograph 14: View of concrete strip and patches.
