6000 Condor Dr. Arborist Report

Prepared for HPA inc.
c/o Tammi Bailey
18831 Bardeen Ave. Suite 100
Irvine, CA 92612

Prepared by James Komen
BCMA WE-9909B
RCA #555

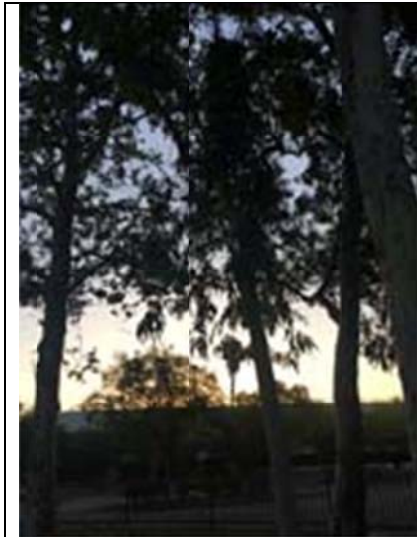
Tree 4

This tree has been partially suppressed by competition. It has good health and good form. I recommend pruning off the deadwood.

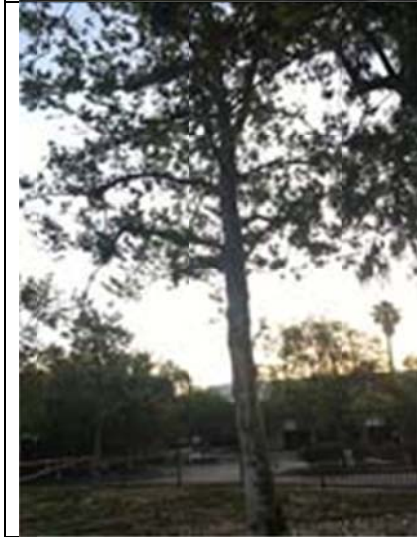
Tree 5

This tree has minor anthracnose. It has good health and good form. No treatment is recommended.

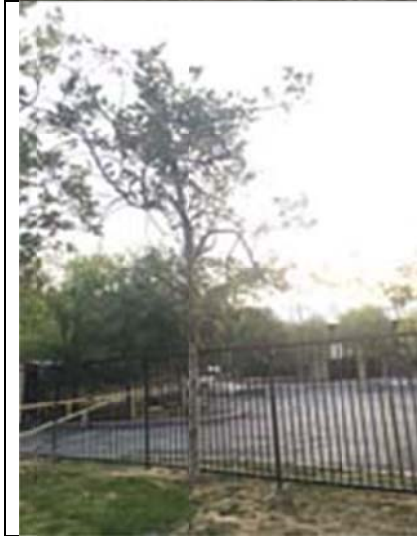
Tree 6

This tree has anthracnose and minor tip dieback. It has good health and excellent form. I recommend pruning off the deadwood and supplying supplemental irrigation.

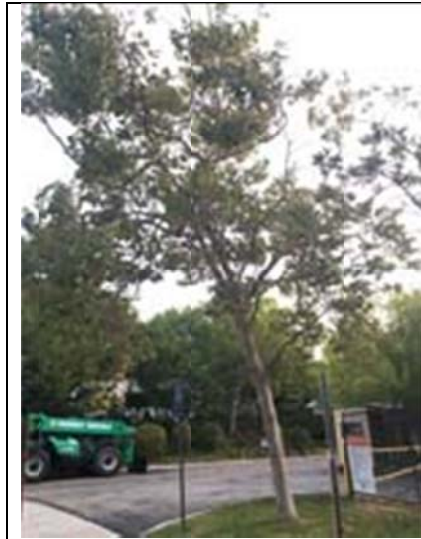
Tree 7

This tree has minor anthracnose. It has good health and good form. No treatment is recommended.

The proposed asphalt resurfacing will encroach within the critical root zone of this tree. All project activity within the drip line of this tree should be directly supervised by a Certified Arborist. This tree is intended to be retained in place throughout the project even though some of its roots may be impacted.

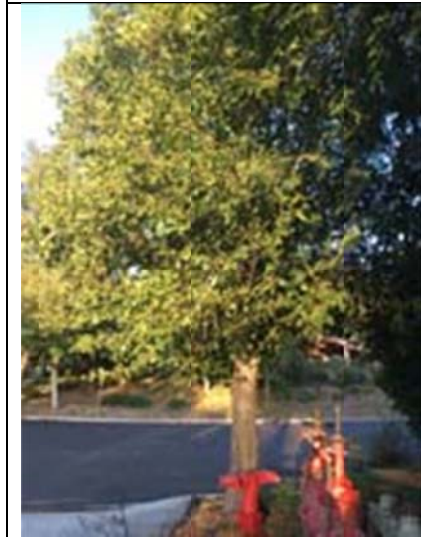
Tree 8

This tree has a sunburned trunk, but it is still vigorous. It has good health and good form. I recommend prune driveway clearance.

The proposed asphalt resurfacing will encroach within the critical root zone of this tree. All project activity within the drip line of this tree should be directly supervised by a Certified Arborist. This tree is intended to be retained in place throughout the project even though some of its roots may be impacted.

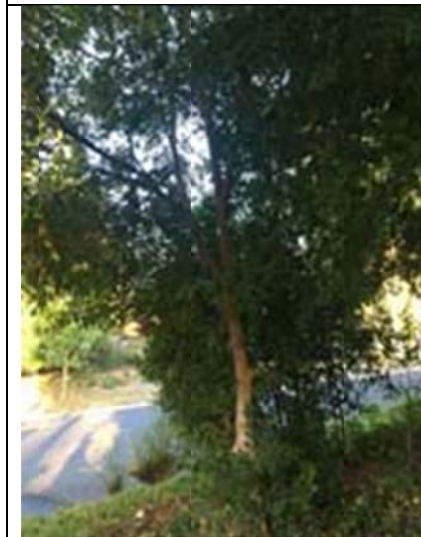
Tree 9

This tree has suppressed by competition. It has good health and good form. No treatment is recommended.

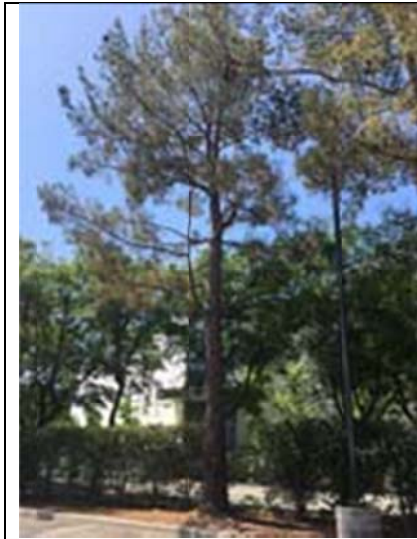
This tree has drought stress, deadwood. It has average health and good form. I recommend pruning off the deadwood and supplying supplemental irrigation.

The proposed parking lot demolition will encroach within the critical root zone of this tree. All project activity within the drip line of this tree should be directly supervised by a Certified Arborist. This tree is intended to be retained in place throughout the project even though some of its roots may be impacted.

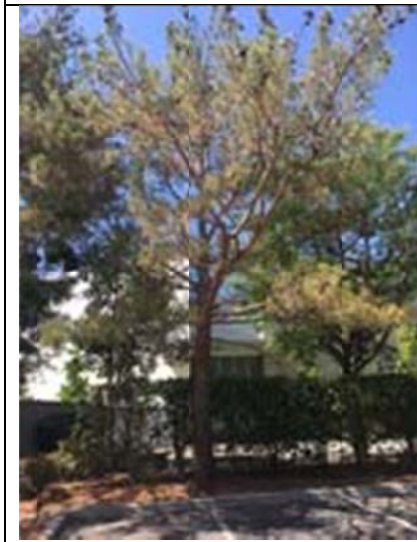
Tree 109

This tree has symptoms of drought stress, and there is deadwood in its canopy. It has average health and good form. I recommend pruning off the deadwood and supplying supplemental irrigation.

The proposed parking lot demolition will encroach within the critical root zone of this tree. All project activity within the drip line of this tree should be directly supervised by a Certified Arborist. This tree is intended to be retained in place throughout the project even though some of its roots may be impacted.

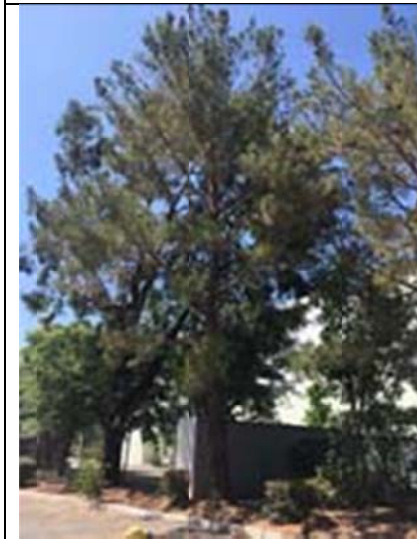
Tree 110

This tree has symptoms of heat and drought stress. It has average health and excellent form. I recommend supplying supplemental irrigation.

The proposed asphalt resurfacing will encroach within the critical root zone of this tree. All project activity within the drip line of this tree should be directly supervised by a Certified Arborist. This tree is intended to be retained in place throughout the project even though some of its roots may be impacted.

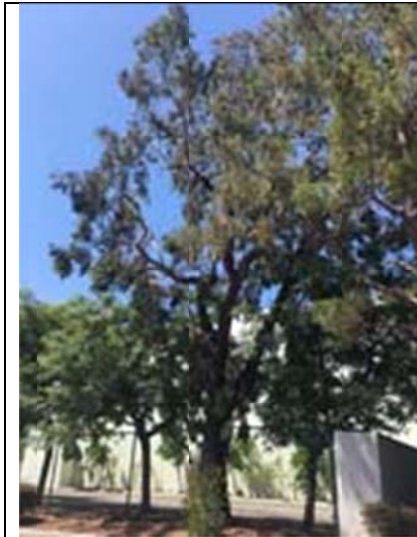
Tree 111

This tree has symptoms of heat and drought stress. It has good health and good form. I recommend supplying supplemental irrigation.

The proposed asphalt resurfacing will encroach within the critical root zone of this tree. All project activity within the drip line of this tree should be directly supervised by a Certified Arborist. This tree is intended to be retained in place throughout the project even though some of its roots may be impacted.

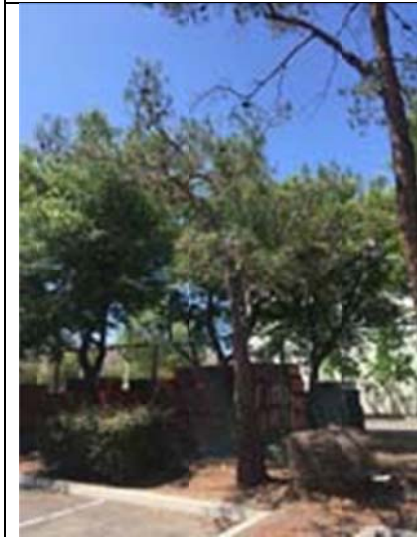
This tree is missing its mid-canopy. It has symptoms of heat stress. I observed pine borer activity in its trunk. It has poor health and average form. I recommend supplying supplemental irrigation.

The proposed asphalt resurfacing will encroach within the critical root zone of this tree. All project activity within the drip line of this tree should be directly supervised by a Certified Arborist. This tree is intended to be retained in place throughout the project even though some of its roots may be impacted.

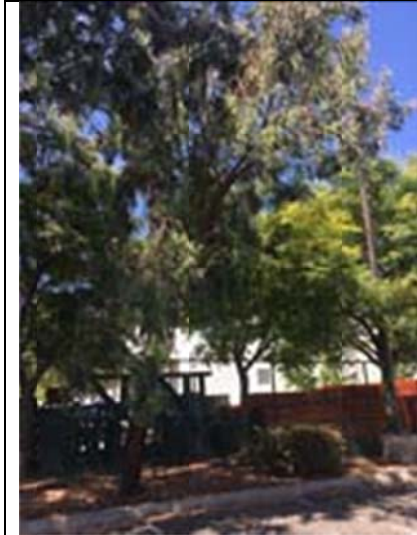
Tree 114

This tree has symptoms of heat and drought stress. It has average health and good form. I recommend supplying supplemental irrigation.

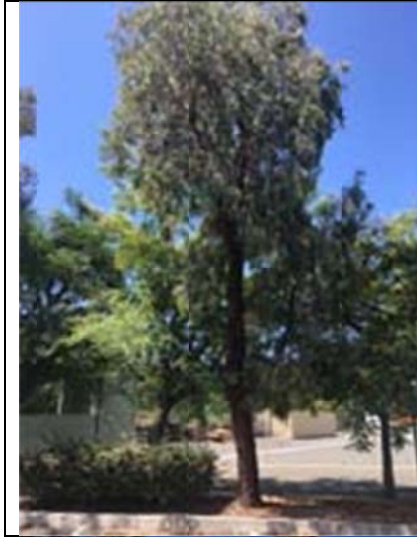
This tree has co-dominant trunks. I observed sap exudation from its trunk, which could potentially indicate a concealed defect below the bark. This tree has good health and average form.

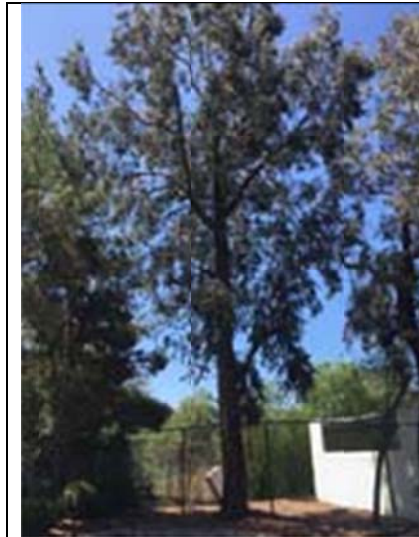
This tree has symptoms of drought stress, and there is deadwood in its canopy. I also observed sap exudation from its trunk, which could potentially indicate a concealed defect below its bark. This tree has good health and good form.

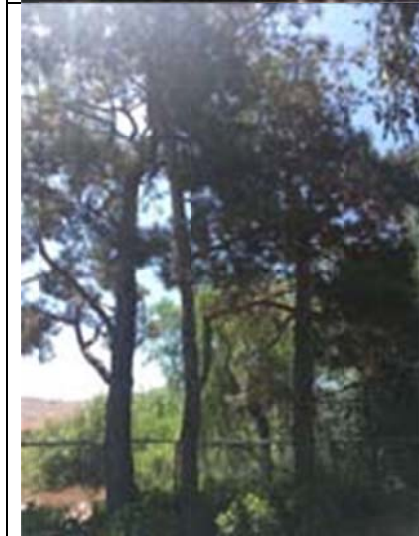
Tree 120

This tree has drought stress, partial suppression. It has good health and good form. I recommend supplying supplemental irrigation.
