December 9, 2019  
File: 2875.001REVrpt.doc

Lyons Hillside Vineyards  
8280 Wild Horse Valley Road  
Napa, California 94558

Re: Geotechnical Investigation – Vineyard Development (Updated)  
Lyons Hillside Vineyards  
8220 Wild Horse Valley Road (APN 033-190-004)  
Napa, California

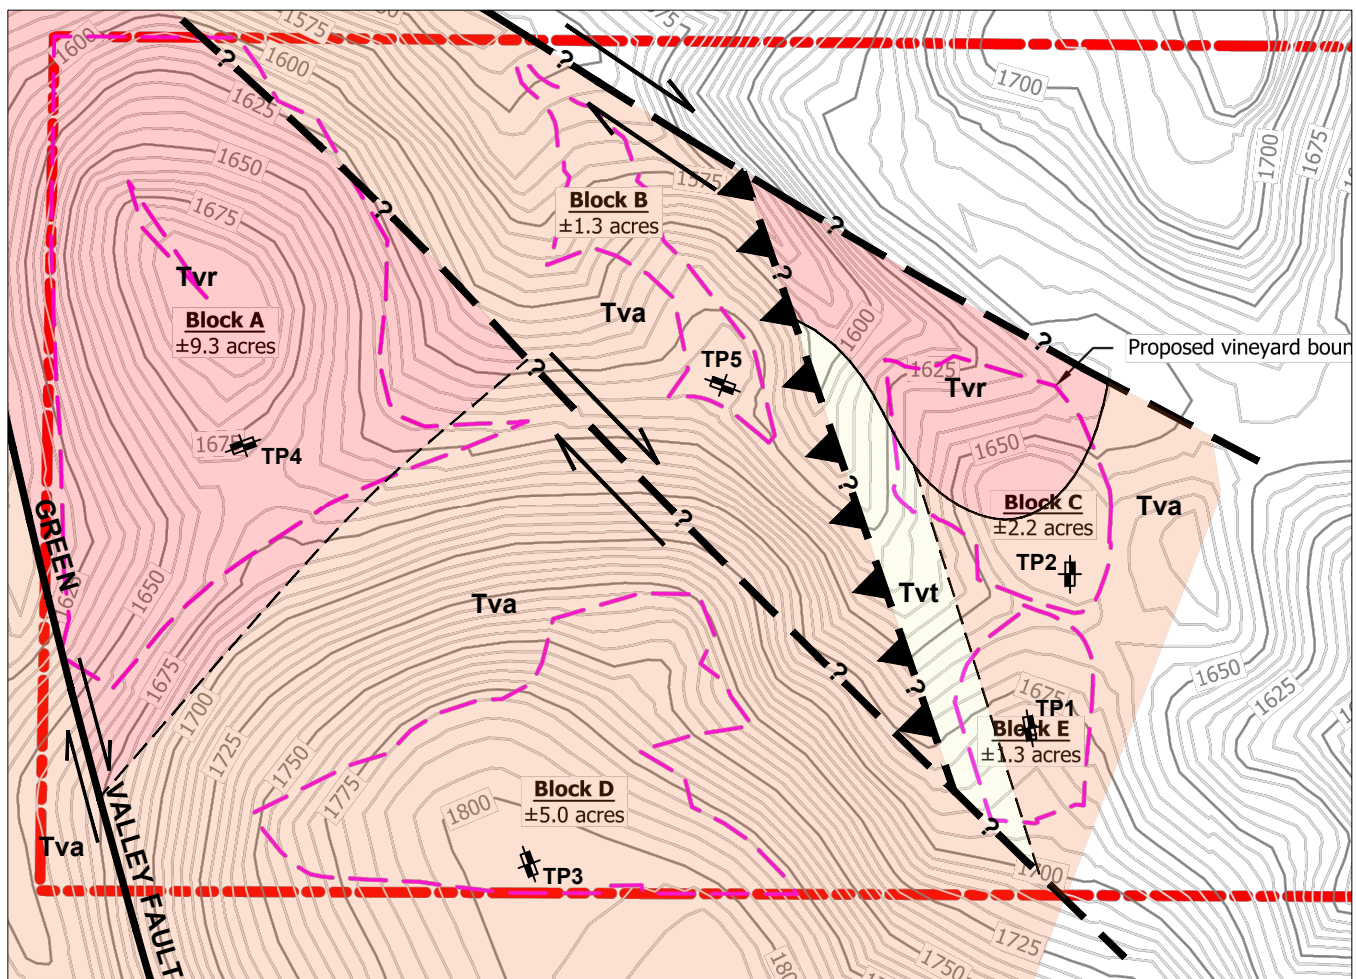
2  
FIGURE

During our reconnaissance, we observed an approximate 20- to 30-foot wide zone of gouged rock and confirmed the regionally-mapped location of what is apparently the primary trace of the Green Valley Fault, passing through the southwest corner of the parcel. We observed exposures of brecciated andesite in the creekbanks just north of Blocks B and C, and also noted apparently unconformable contacts between tuff and andesite bedrock in the ravine separating Blocks B and C, which we suspect are fault-related. Our geologic map of the vineyard is shown on Figure 2.

During our site reconnaissance, we observed an approximately 20- to 30-foot wide zone of gouged, sheared volcanic bedrock in the north-trending creek channel west of Blocks A and D, which is indicative of historic fault activity. Local topography is defined by narrow ridges and intervening valleys which generally mirror the northerly trend of the confirmed fault trace. Observations of gouged/brecciated bedrock in test pits and during field mapping, as well as interpretation of site geomorphology, indicates additional branch or secondary faults may cross the site as shown on Figure 2.

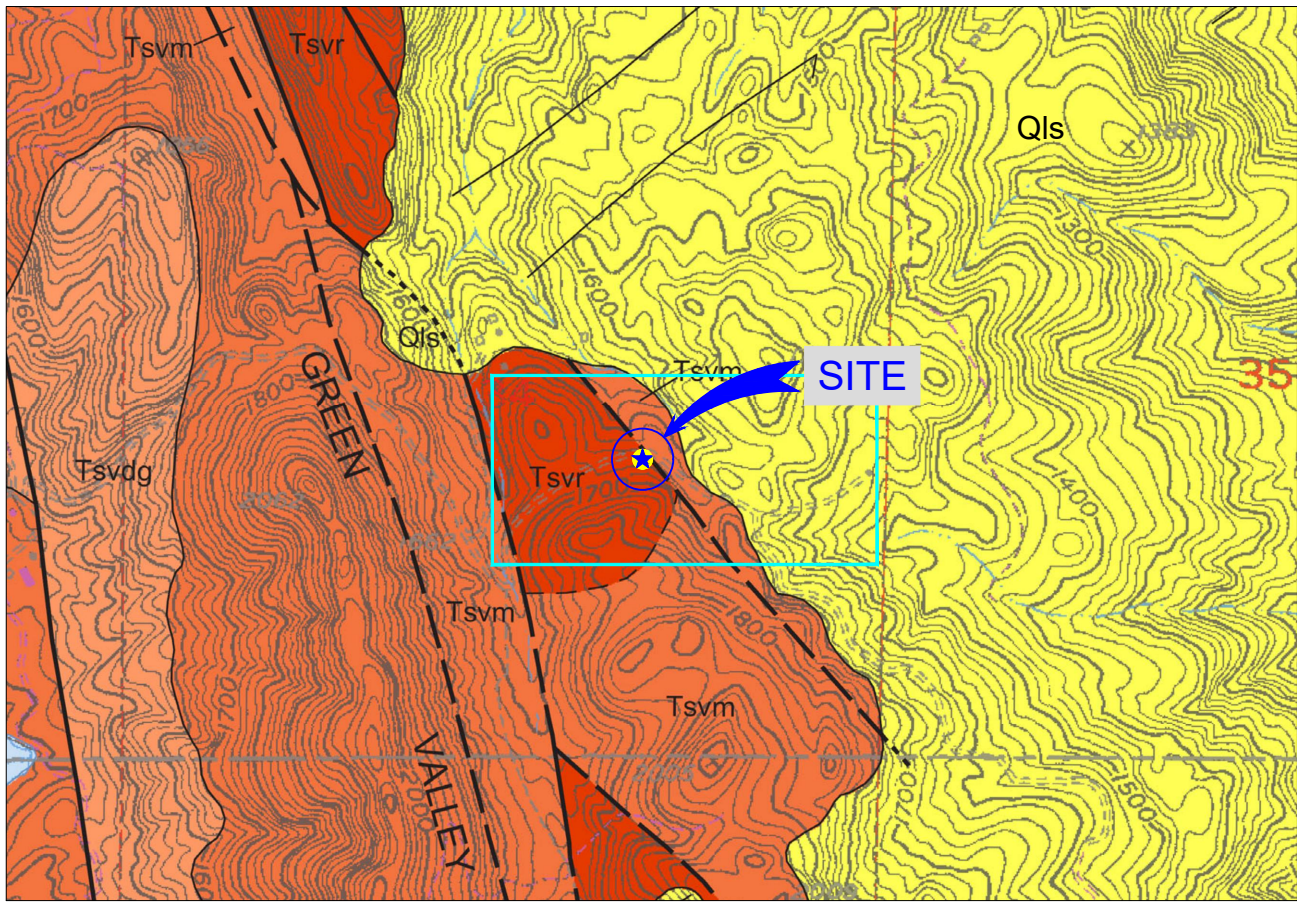
**3**  
FIGURE

As shown on Figure 3, regional geologic mapping<sup>1</sup> indicates the site is underlain by Dacite of Mt. George (map symbol Tsvdg), which is characterized as flows, domes, and shallow intrusions of gray to tan porphyritic dacite which is strongly flow banded. The site is shown as lying just east of the Green Valley Fault zone. Mapping shows the north-northwest trending fault just passing through the southwestern corner of the parcel.

Regional geologic mapping (as shown on Figure 3) indicates that the northeastern part of the site (generally including portions of Blocks B and C) are underlain by the debris fields of massive landslides which extend from the crest of the ridge down to the bottom of Wooden Valley, some 2-miles northeast of the site. During our site reconnaissance, we noted that topography could be related either to faulting or to massive landsliding. We note that onsite areas mapped regionally as being underlain by slide debris exposed variably-weathered bedrock at or near the surface, and as such the mapped slide (if it exists) is likely a very large bedrock block slide.

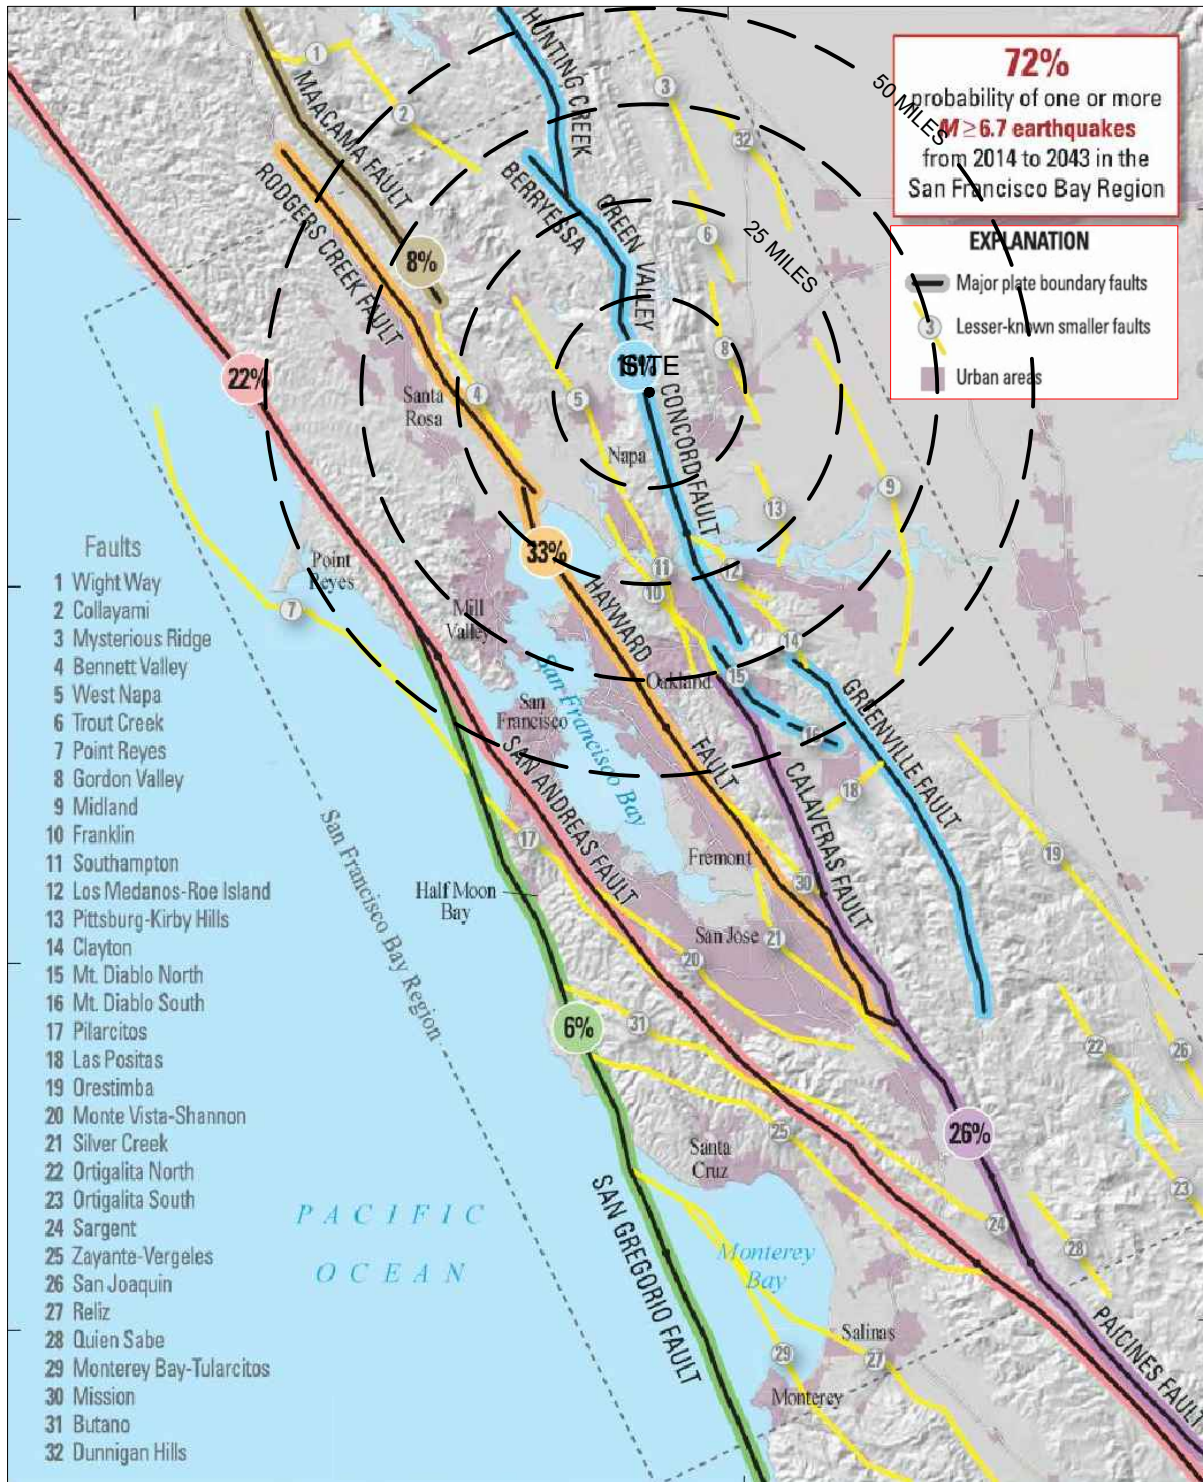
**4**

The site will likely experience seismic ground shaking similar to other areas in the seismically active San Francisco Bay Area. Earthquakes along several active faults in the region, as shown on Figure 4, could cause moderate to strong ground shaking at the site. Estimates of peak ground accelerations are based on either deterministic or probabilistic methods.

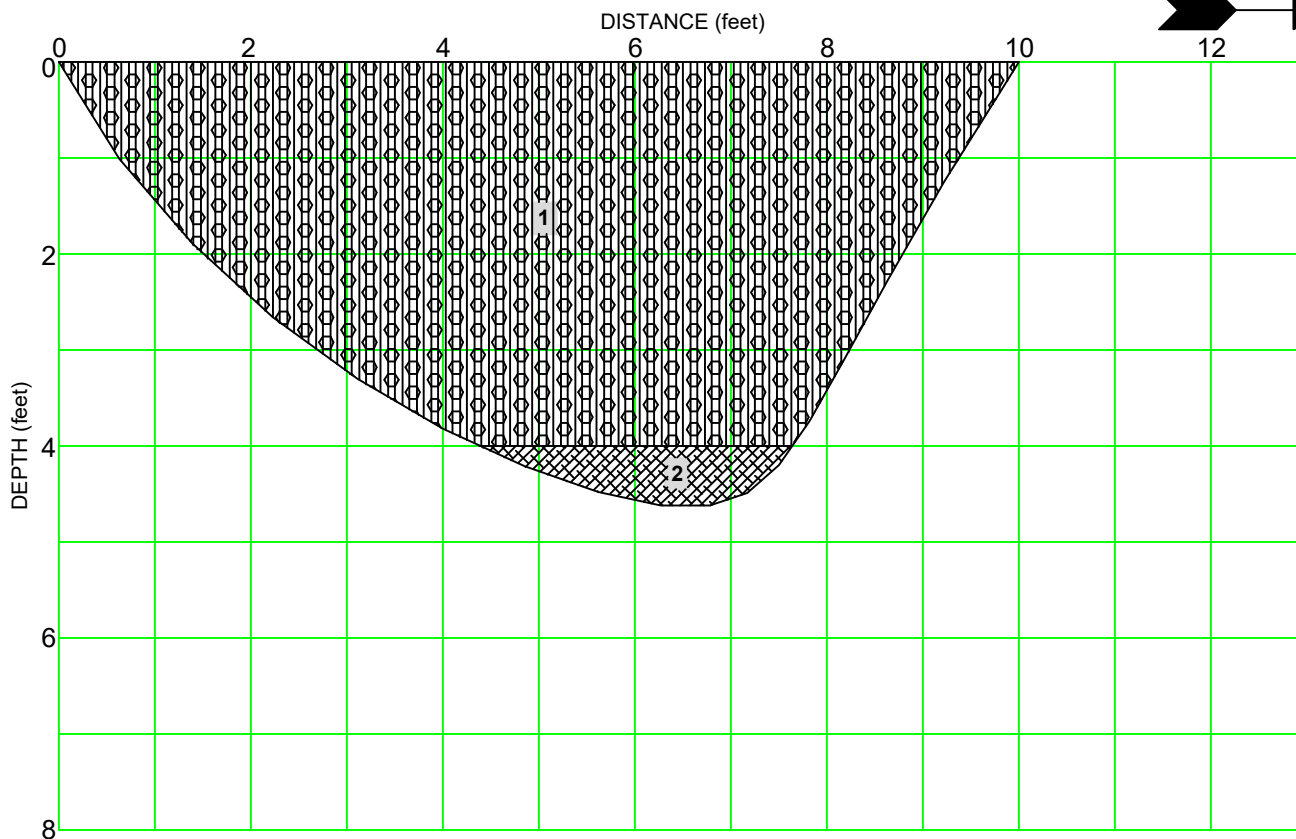
## TEST PIT 1

| Layer | Description |
|---|--|
| 1 | SILTY GRAVEL (GM-GP)<br>Medium red-brown, moist, medium-dense, ~75% angular volcanic cobbles to 24-inches embedded in low-plasticity silty matrix. [RESIDUAL SOIL] |
| 2 | ANDESITE LAVA FLOW<br>Dark gray groundmass with ~20% each euhedral quartz and plagioclase, rare potassium feldspar. Low hardness, weak, highly weathered, extensively gouged/brecciated [SONOMA VOLCANICS]<br><br>Very difficult excavation/near-refusal noted at 55". |

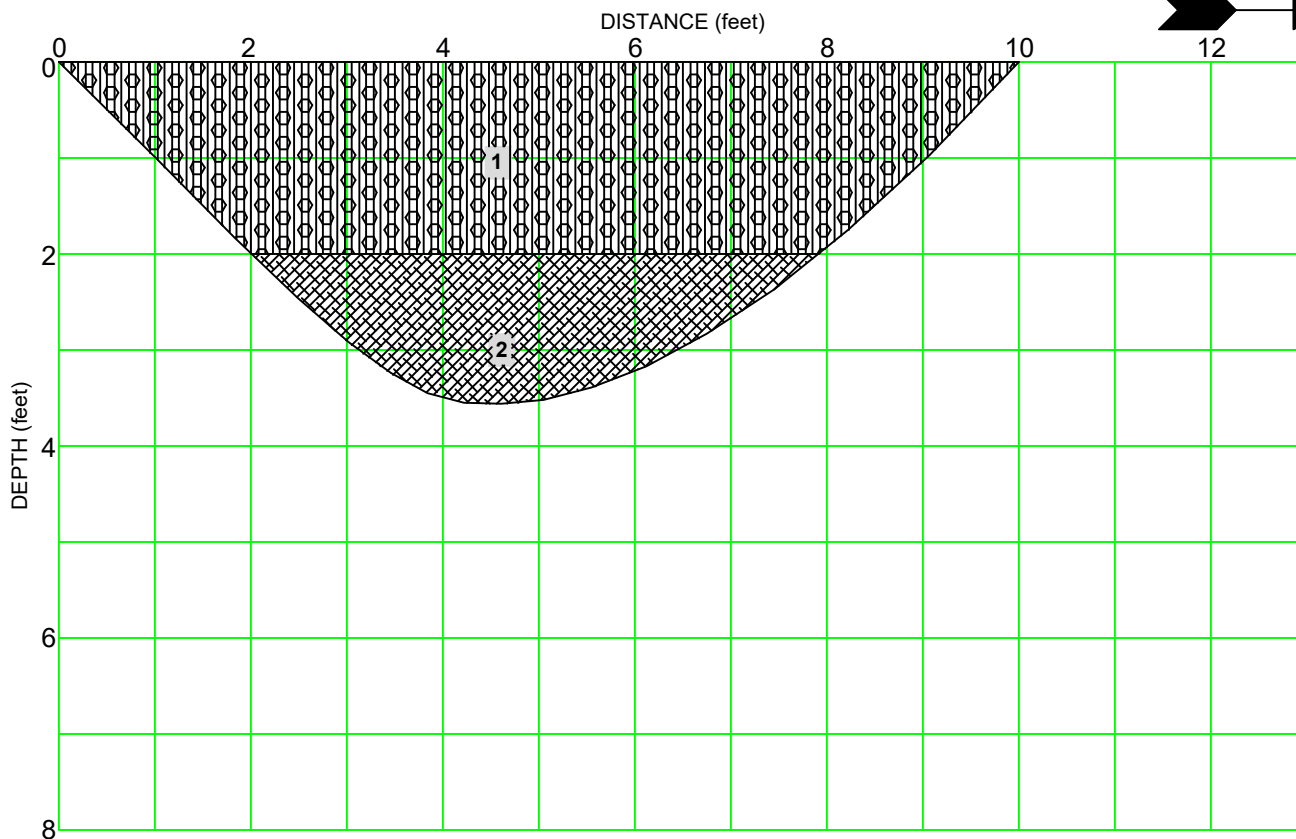
## TEST PIT 2

| Layer | Description |
|---|---|
| 1 | SILTY GRAVEL (GM-GP)<br>Medium red-brown, moist, medium-dense, ~75% angular volcanic cobbles to 24-inches embedded in high-plasticity silty matrix. [RESIDUAL SOIL] |
| 2 | ASH-LAPILLI TUFF<br>Light gray, completely weathered (as very stiff clay), grades moderately weathered, friable at 36". [SONOMA VOLCANICS]<br><br>Moderately difficult excavation noted at 42". |

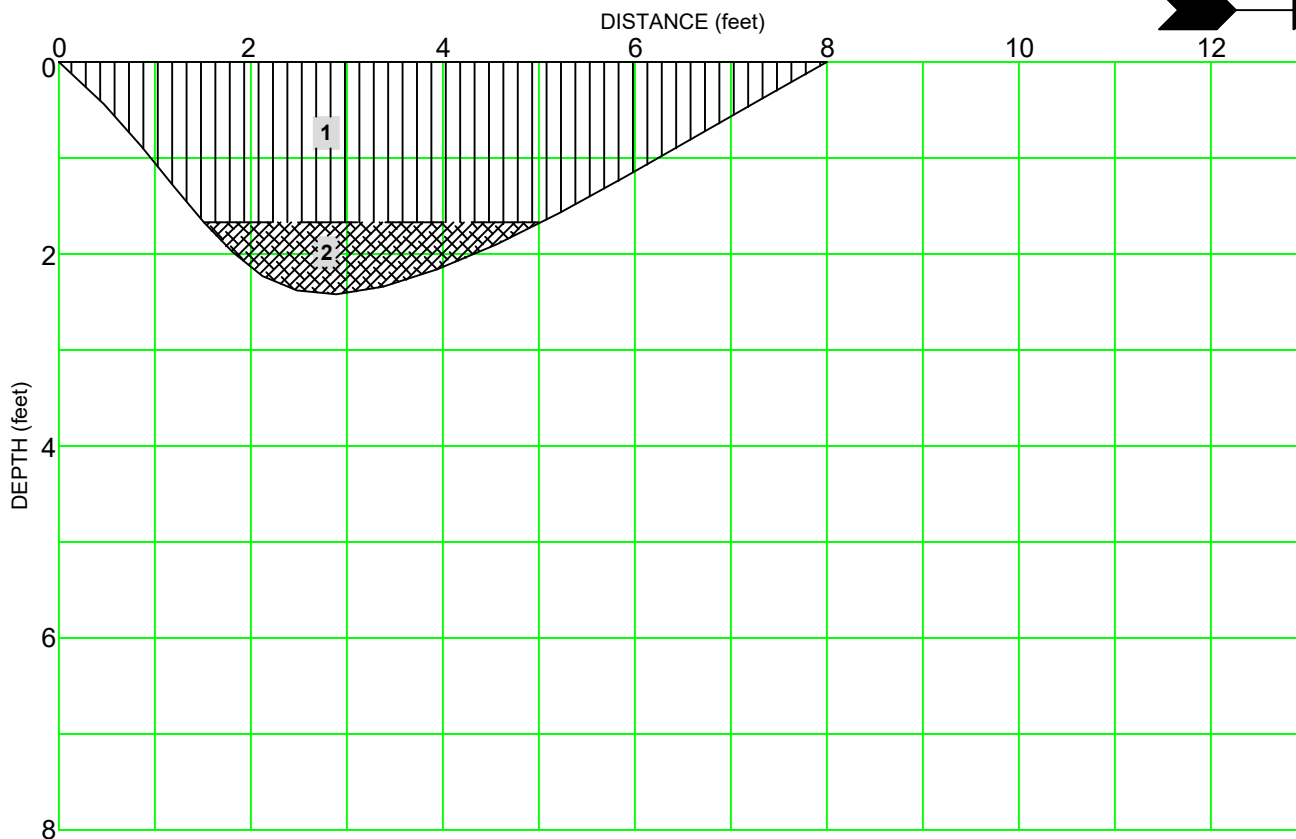
## TEST PIT 3

| Layer | Description |
|---|---|
| 1 | SANDY SILT (ML)<br>Medium red-brown, moist, medium-stiff, low-plasticity, with +/-25% fine sand, +/-15% angular andesite fragments.<br>[RESIDUAL SOIL] |
| 2 | ANDESITE LAVA FLOW<br>Dark gray groundmass with ~20% each euhedral quartz and plagioclase, rare potassium feldspar. Moderately weathered, moderately fractured, very hard.<br>[SONOMA VOLCANICS]<br><br>Equipment refusal noted at 29". |

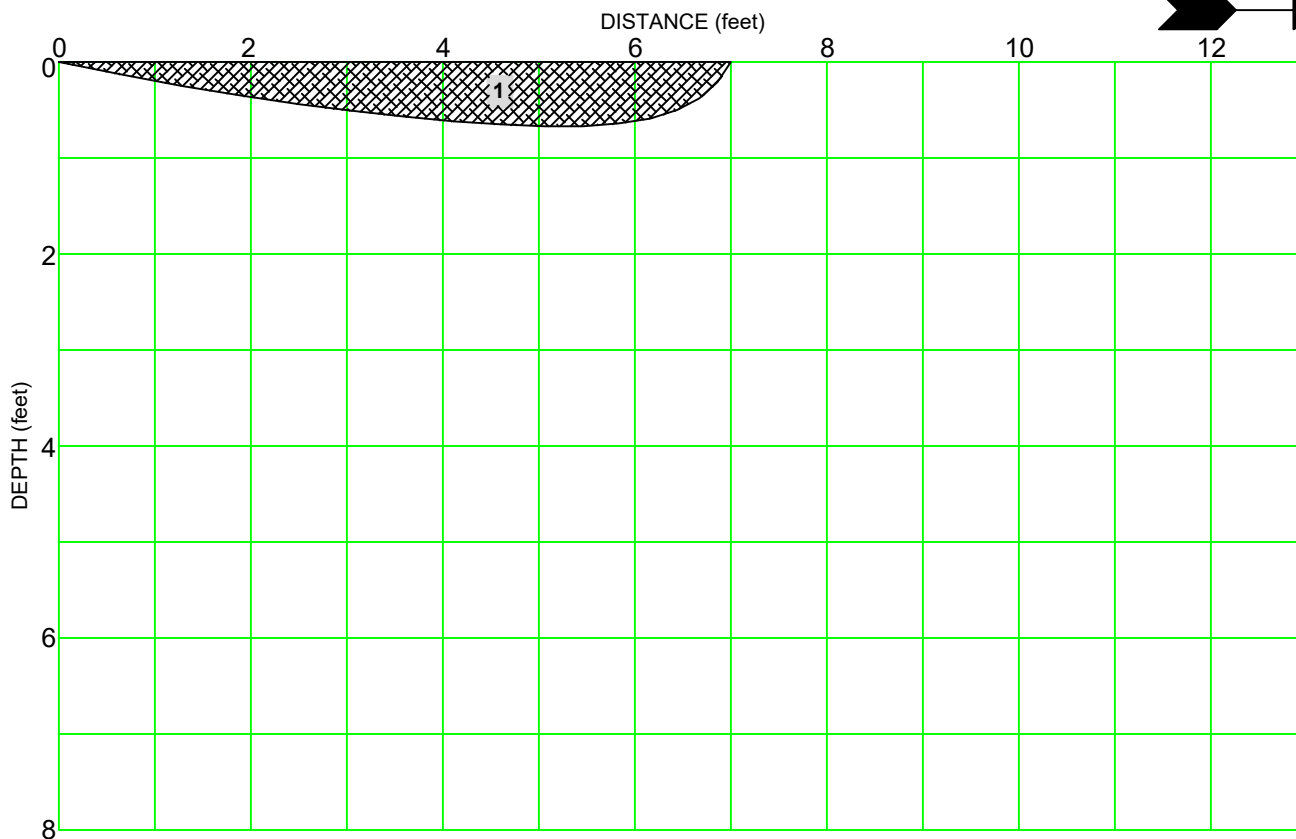
## TEST PIT 4

| Layer | Description |
|---|---|
| 1 | <p>RHYOLITE LAVA FLOW<br/> Dark red-brown, aphanitic, very hard, very strong, slightly weathered to fresh. [SONOMA VOLCANICS]</p> <p>Equipment refusal noted at 9".</p> |

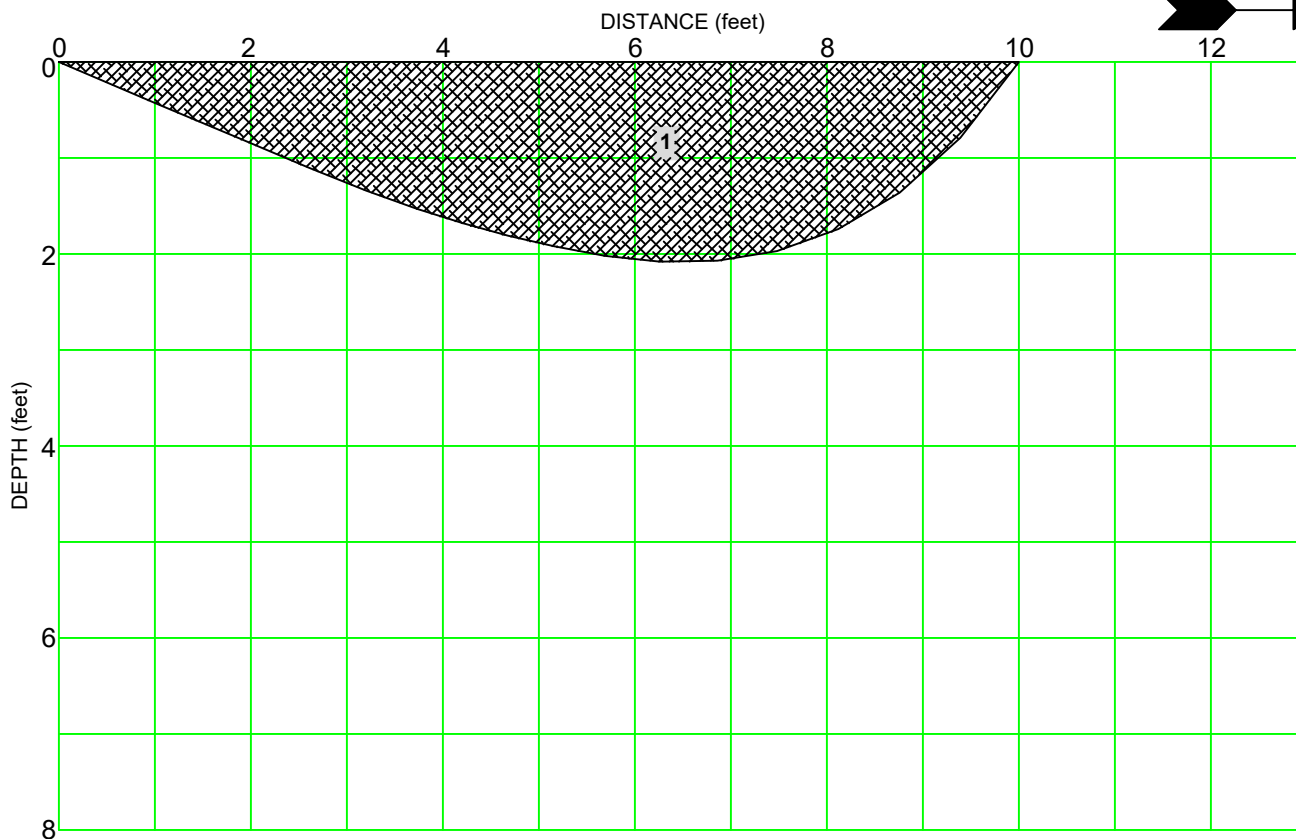
## TEST PIT 5

| Layer | Description |
|---|--|
| 1 | ANDESITE LAVA FLOW<br>Dark gray groundmass with ~20% each euhedral quartz and plagioclase, rare potassium feldspar. Slightly weathered, very hard, very strong, closely to moderately fractured [SONOMA VOLCANICS] |
