# SITE REMEDIATION REPORT VACANT PROPERTY LOCATED AT THE NORTHWEST CORNER OF MILLIKEN AVENUE AND JERSEY BOULEVARD (AKA 8595 Milliken Avenue, Tract Number 11891) RANCHO CUCAMONGA, CALIFORNIA 91730

#### SCS ENGINEERS

July 31, 2020 File No. 01219262.00 Tasks 1 and 2 This Site Remediation Report dated July 31, 2020 for the Vacant Property located at the northwest corner of Milliken Avenue and Jersey Boulevard in Rancho Cucamonga, California, was prepared and reviewed by the following:

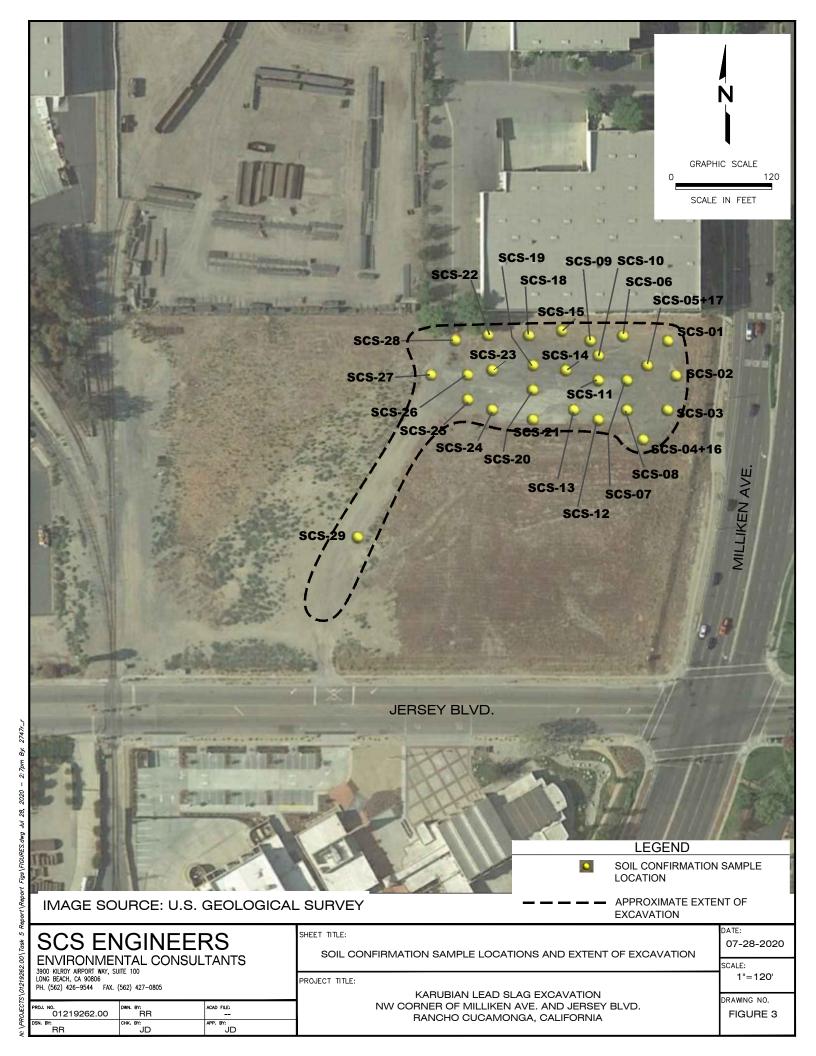
Confirmation samples were collected in an approximate 40-foot grid across the excavation area, as depicted on Figure 3. Confirmation soil samples were collected in 4-ounce glass jars. Immediately after sample collection, the glass jars were sealed and a solvent-free label noting date and time of collection, sample number, and project number was affixed to each sample. Samples were then

- Slag and heavy metal-impacted soil in the "area of concern" identified by Earth Systems Southwest (Report of Phase II Investigation, dated August 7, 2015, Figure 2) has been remediated, as shown throughout this report and on Figure 3 of this report. During excavation of the area of concern in May and June of 2020, additional slag material was visually observed extending beyond the anticipated boundary of the slag area. The presence of additional slag material was confirmed through the use of an XRF meter (x-ray fluorescence), which measures lead concentrations in the field. Using both visual and XRF information, the excavation of impacted slag and soil continued to the east, north, northwest and southwest, until there was no visual indication of slag material and the readings from the XRF were below 50 parts per million.

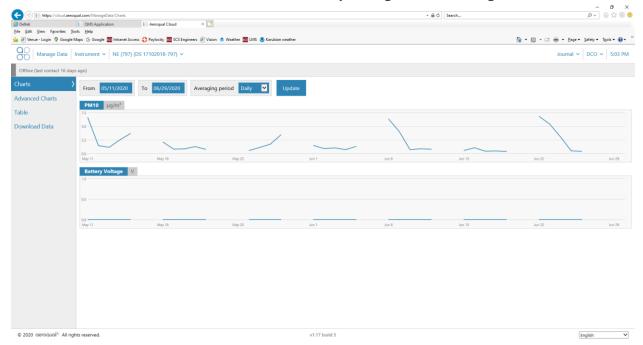
Chart 1 - Downwind Dust Sentry Average PM10 Readings

The two dust sentries were operated continuously during excavation activities. Charts 1 and 2 present the data collected. Chart 1 shows that the daily PM10 average did not exceed 7.5 micrograms per cubic meter ( $\mu g/m^3$ ). Chart 2 shows that the PM10 daily average did not exceed 4  $\mu g/m^3$ , average wind speed did not exceed 7.5 miles per hour, and the average wind direction was from the southwest, typically between 200 and 300 compass degrees.

- Review of the data from the dust monitoring equipment at the Site reveals that based on a daily average (Charts 1 and 2), PM10 dust levels entering or leaving the Site did not exceed 25 ug/m³. Work was shut down once for ½-day based on wind speeds in excess of 20 miles per hour. Therefore, the excavation work is considered to be in compliance with SCAQMD Rules 403 and 1466 (although Rule 1466 was determined by the SCAQMD to not be applicable to the excavation activities at the subject property).

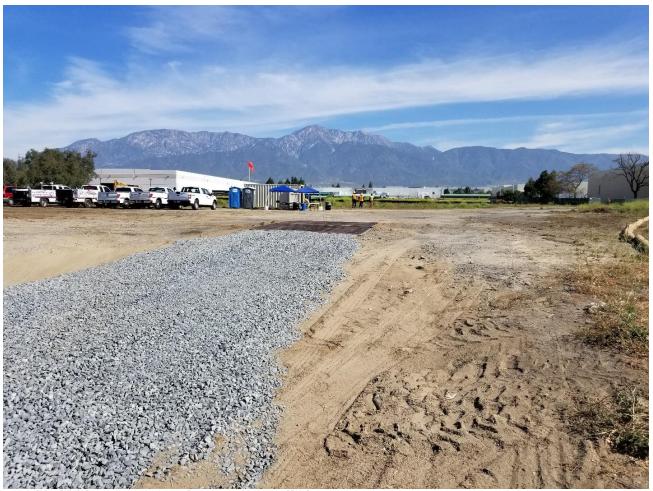
May 11, 2020, looking North from entrance off of Jersey Boulevard

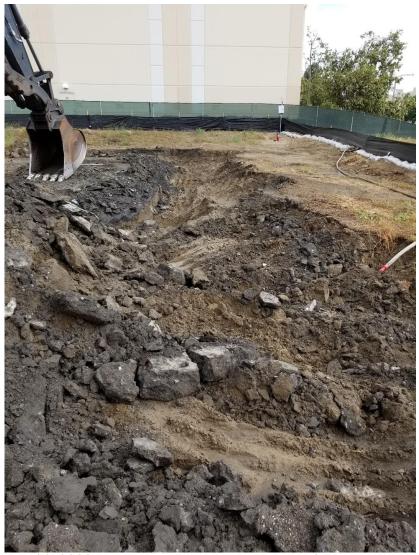
May 11, 2020 looking North along eastern edge of excavation

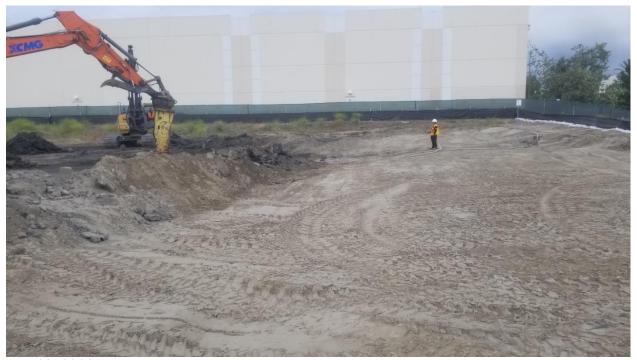
May 18, 2020 – looking North as excavation progresses westward

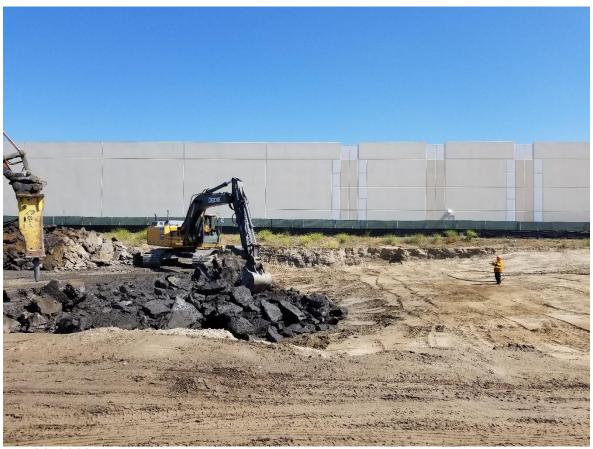
May 26, 2020 – looking North at excavation progress

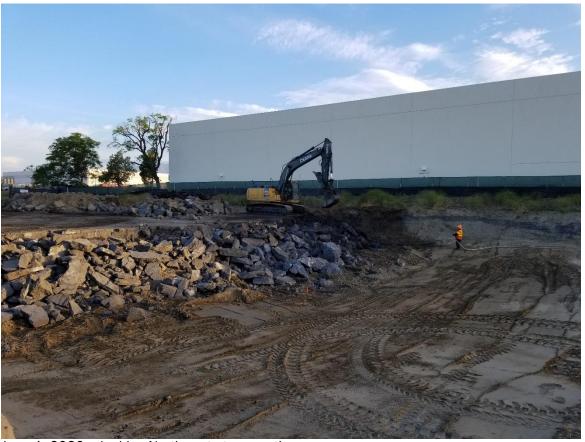
June 1, 2020 - looking Northwest at excavation progress

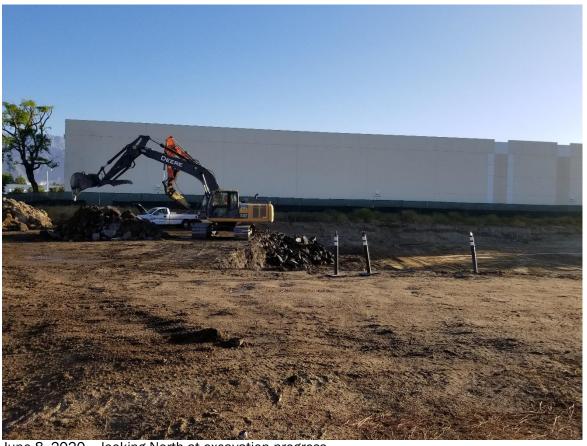
June 8, 2020 - looking North at excavation progress

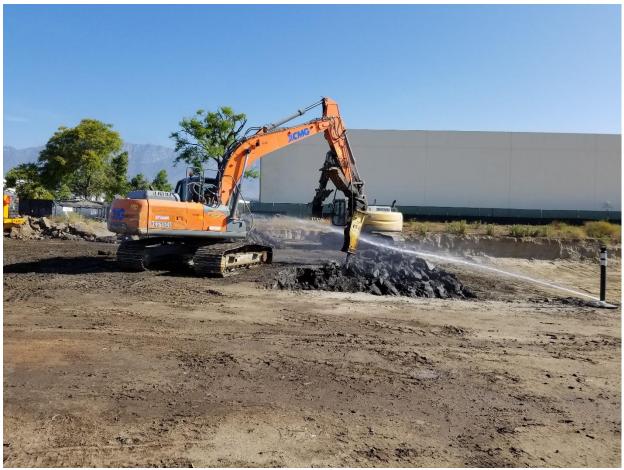
June 15, 2020 - looking North at excavation progress

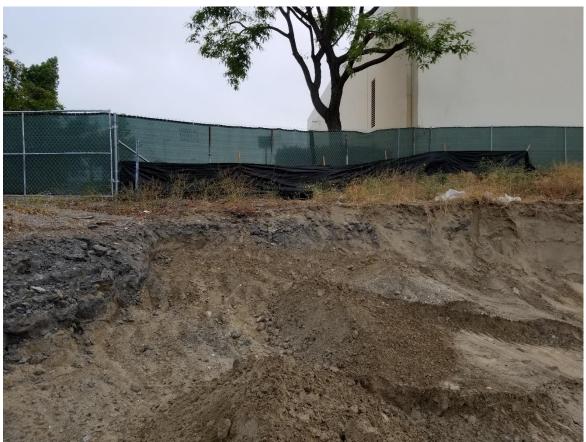
June 22, 2020 – looking North at excavation progress

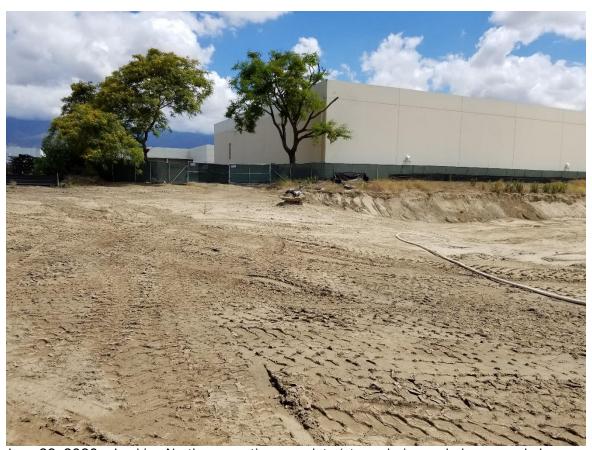
June 29, 2020 - Looking North, excavation complete (storm drain manhole exposed above grade)
