**GEOTECHNICAL REPLY TO PEER REVIEW,  
PRELIMINARY CITY STORM DRAIN OUTFALL  
SLOPE RETREAT ASSESSMENT,  
& GEOTECHNICAL REPORT UPDATE STUDY**  
Proposed Glenview Terrace Residential Subdivision  
2880 San Bruno Avenue  
San Bruno, California

February 7, 2020  
GEO Project No. 91-04747-A  
2172.01.00

**RE: GEOTECHNICAL REPLY TO PEER REVIEW,  
PRELIMINARY CITY STORM DRAIN OUTFALL  
SLOPE RETREAT ASSESSMENT,  
& GEOTECHNICAL REPORT UPDATE STUDY**  
Proposed Glenview Terrace Residential Subdivision  
2880 San Bruno Avenue  
San Bruno, California  
GEO #91-04747-A (2172)

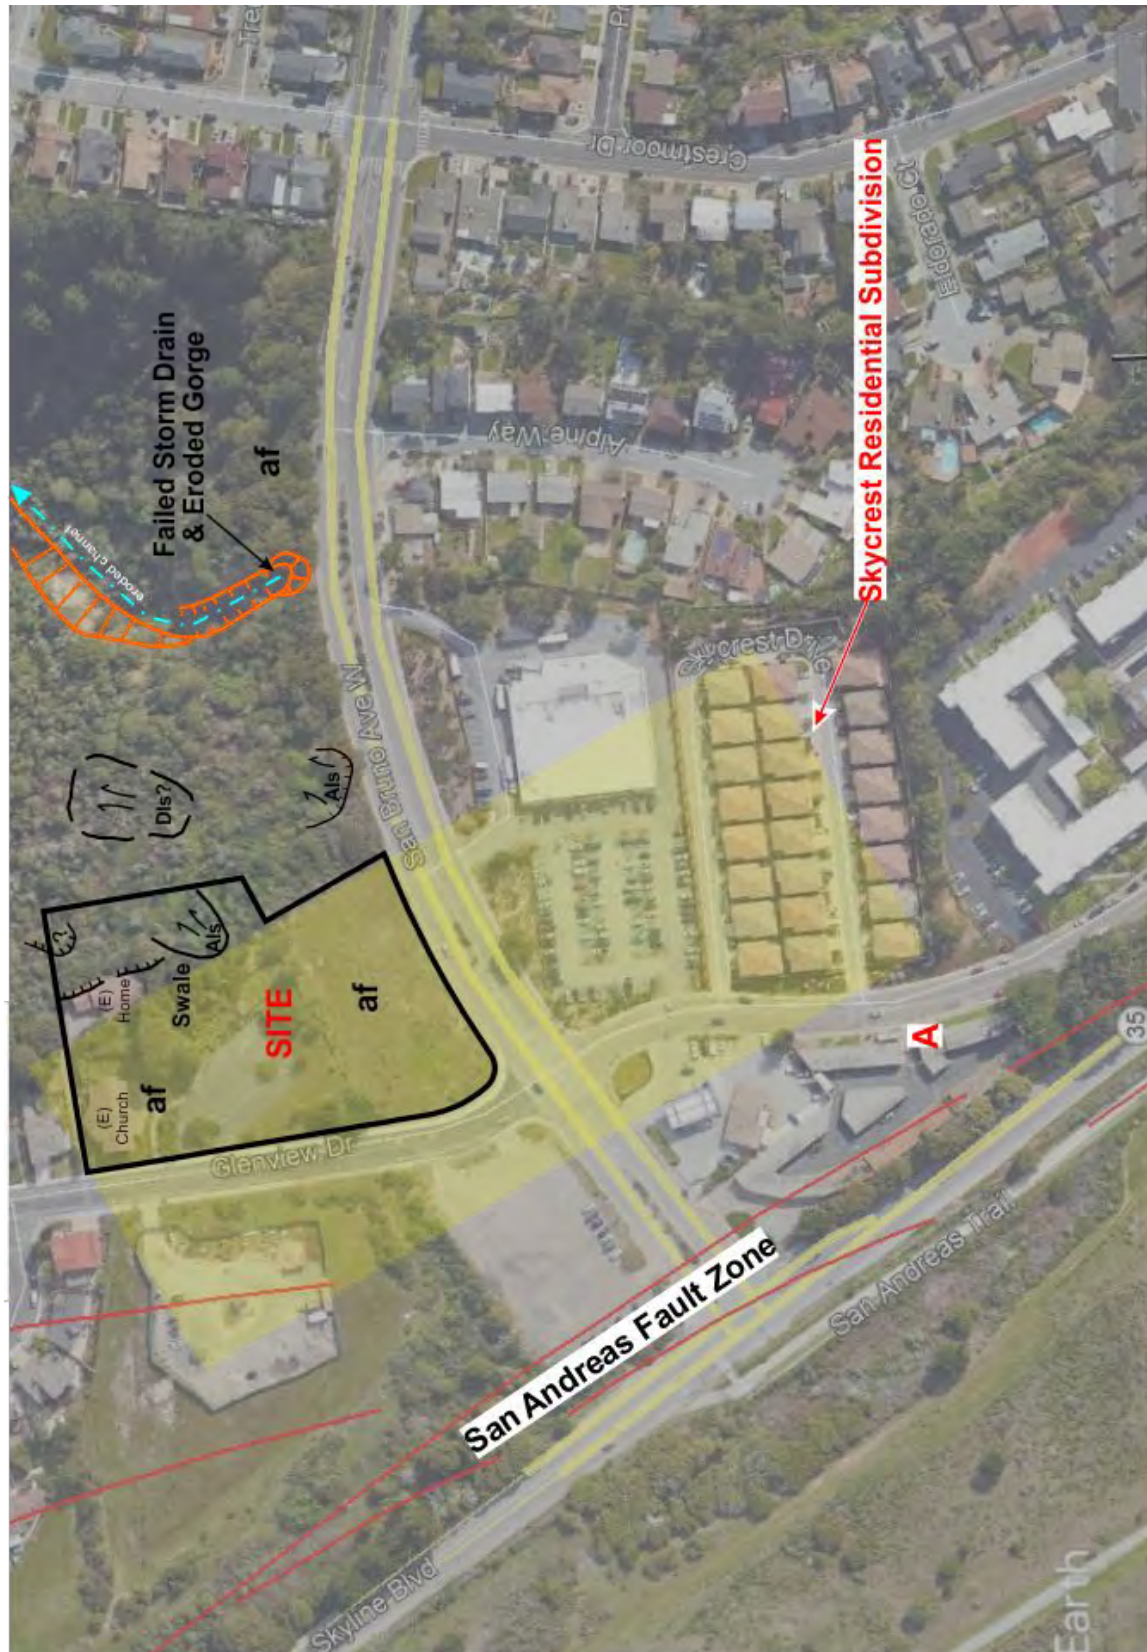
Figure 1. Vertical aerial view of N30°W projection of fault trench shadow projected across Site (yellow shade data from: BAGG, 2003; Romig Engineers, 2008; Google Earth, 2014). Fault rupture hazard clearance was approved by the City of San Bruno in the late 1980's for development for the Arco Self Storage facility office building (A). (af - Artificial Fill) (Fill distribution and landslides after Cotton, Shires, & Associates, Inc., March 2008).

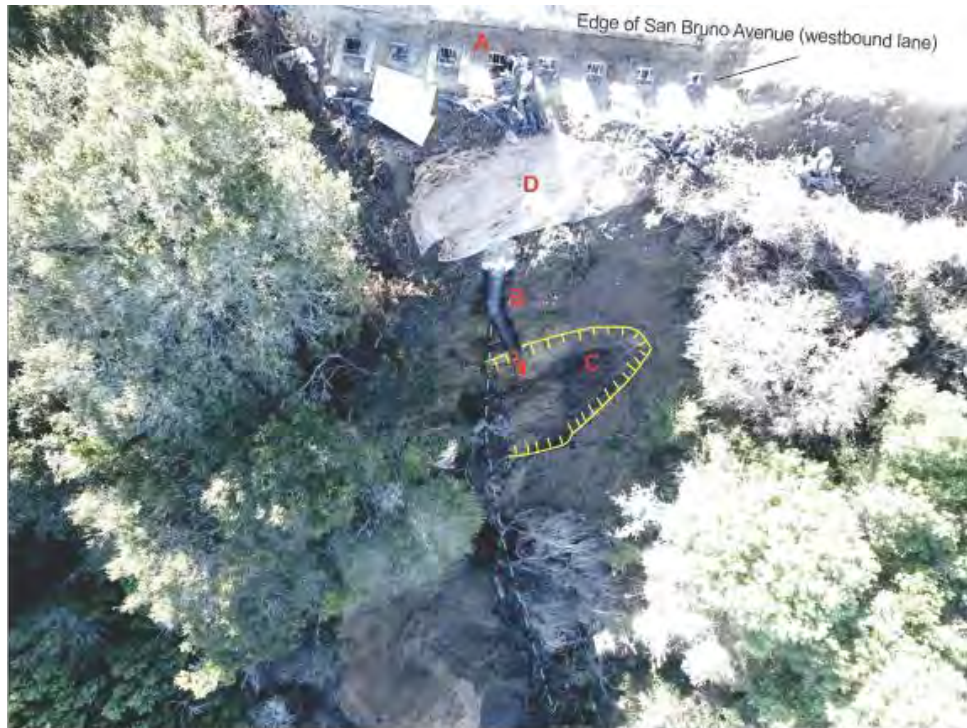
- Installation of approximately 20 feet of approximately 24-inch diameter HDPE pipe connected to the pre-existing CMP, and placed against the steep gully headwall escarpment to discharge onto the lower section of headwall. Considerable erosion has occurred since installation of the new outfall pipe with a point of discharge approximately 20 feet below the new headwall. The position and orientation of the pipe outfall forces concentrated discharge against the curved transition from gully escarpment to west flank. In our opinion, the as-built condition of the stormwater discharge facility presents a low potential for adverse impact to site slope stability, but it is likely to induce rapid westerly undercutting of the west flank of the gully and consequent upslope and westerly headwall recession.

- Installation of a row of approximately 3-foot diameter concrete pier-reinforced double I-beam shear pins (AKA, stitch piers) spaced approximately 5 feet apart and extending at least 50 feet below the ground surface and spanning the existing gully headway several feet as a measure to mitigate future headwall recession. Tiebacks were prescribed in the geotechnical report but evidence of their presence was not observed.

Photo 1. Aerial image of storm drain outfall, including stitch piers (A), and new HDPE outfall pipe (B), at least 20 feet above the established drainage course (blue dot-dash line). Yellow hachured line denotes gully erosion from runoff since pipe was installed (C). Temporary erosion netting at top of slope (D).

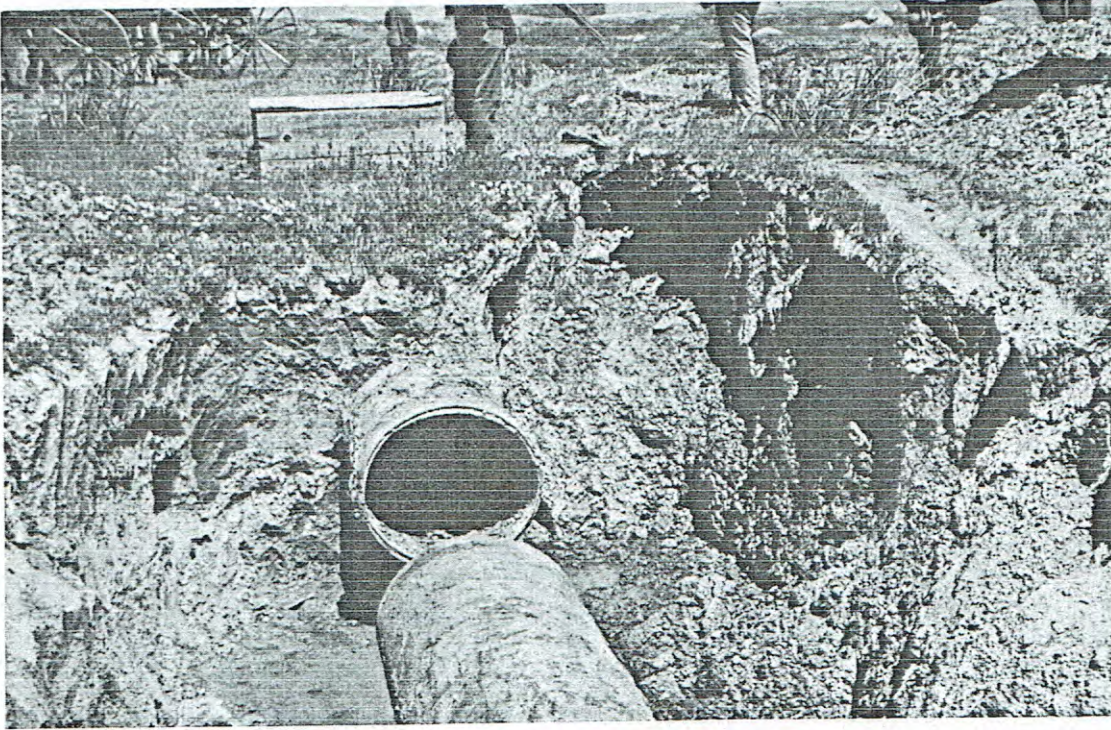
It is a 2-foot pipe made of iron 1 inch thick. The fault broke it at an upward bend. An elbow at the bend was crushed by the compression and thrown down, while the two remaining ends were brought about 22 inches nearer together. At the same time they were faulted past each other a distance of 20 inches.

A. Rupture of 30-inch water-pipe by fault. Northwest of San Andreas Lake. A. C. L.

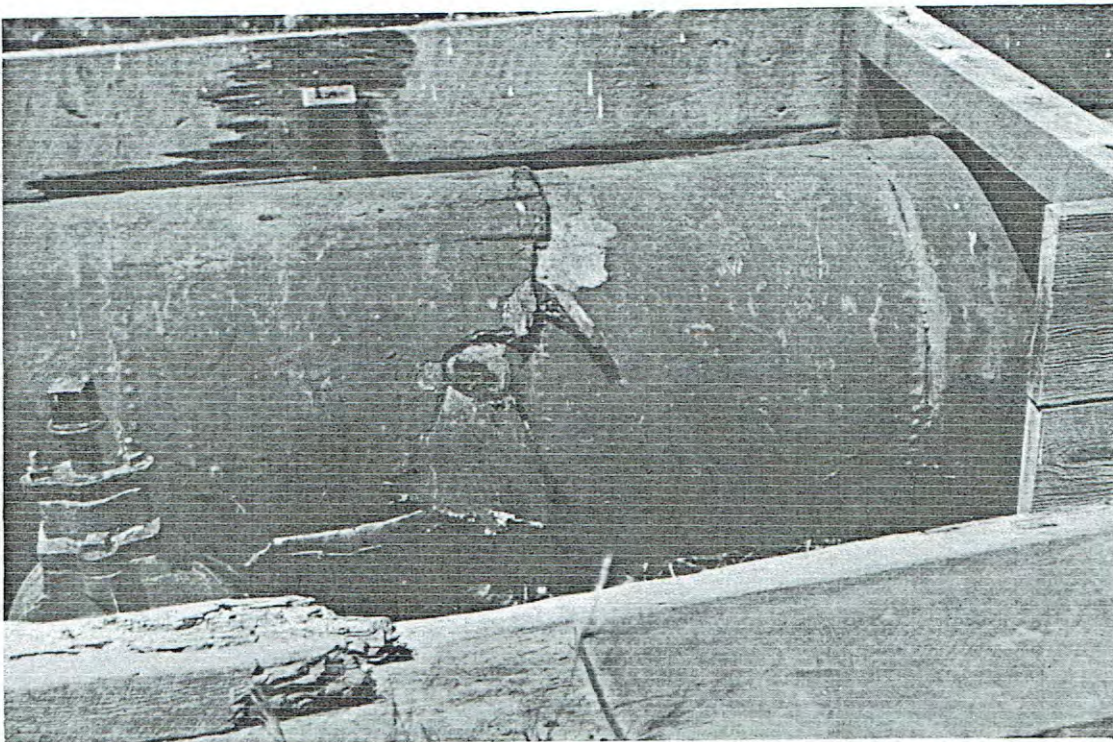
B. Thrust of 30-inch water-pipe by fault, northwest of San Andreas Lake. Amount of telescoping is 58 inches. A. C. L.
