#### **EVALUATION OF ROADWAY ALIGNMENT**

September 11, 2020 SL10982-3

Project name:
Old Creek Road
APNs: 046-031-033 &
046-131-043
Cayucos area, San
Luis Obispo County,
California

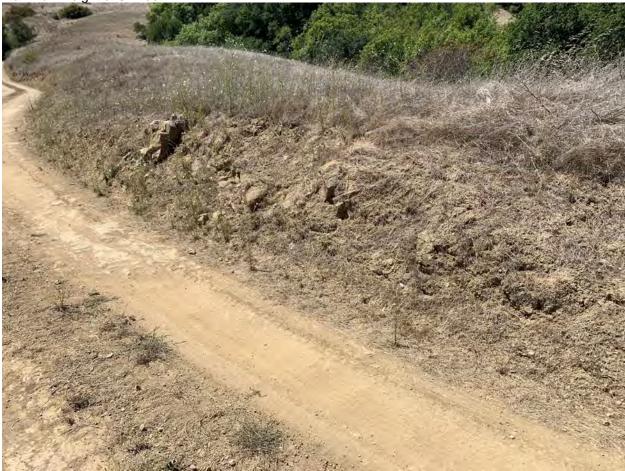
Figure 3: Photograph of existing cut slope at Station 17+00

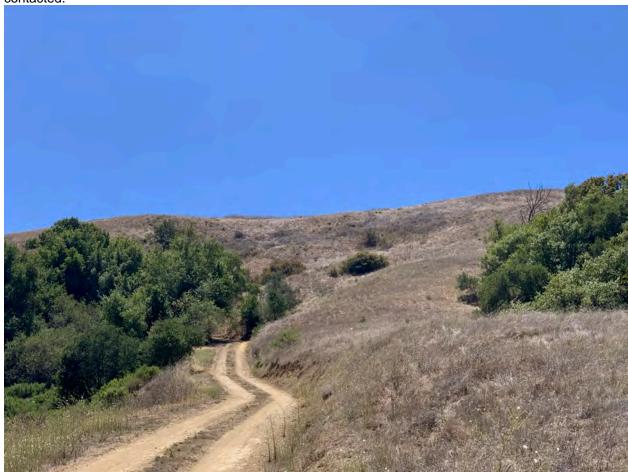
The County of San Luis Obispo Land Use View depicts a landslide extending through the roadway at the existing drainage channel at Station 22+00. Multiple trenches were excavated along the roadway alignment at the site and shallow rock was observed. A landslide was mapped above the roadway however it is assumed the landslide is surficial in nature and doesn't extend to the roadway below. However, the engineering geologist should observe the temporary excavation for the retaining wall to verify the onsite conditions. Additional recommendations may be made at the time of construction. In addition, if conditions vary from those described in this report, the engineering geologist should be contacted.

Figure 4: Photograph of mapped landslide above Station 22+00

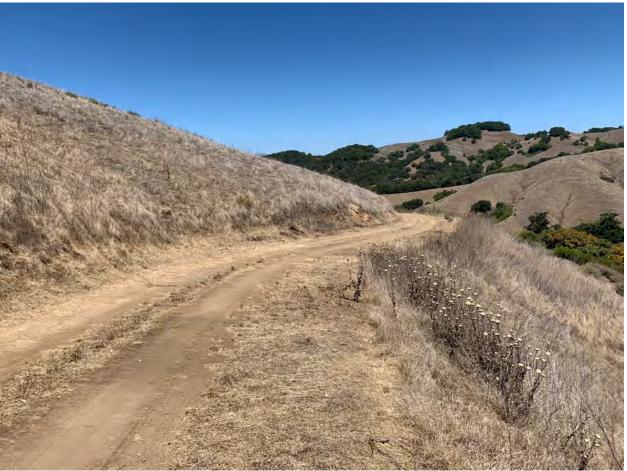
Figure 5: Photograph of roadway at Station 26+00

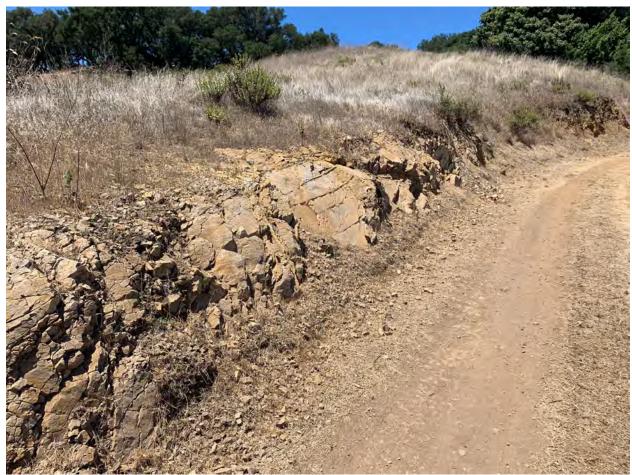
The roadway alignment continues at the switchback at Station 28+00 and continues northwest along the existing roadway alignment to the final switchback at Station 43+80. Existing cut slopes upslope of the existing roadway expose Monterey Formation shale that are near vertical to 1:1 (horizontal: vertical) in steepness and 5 to 6 feet high. Bedding within the Monterey Formation along this section is dipping 20 to 45 degrees to the south. The fill slopes along the west side of the roadway alignment from Station 28+00 to 36+75 and along the east side of the roadway alignment from Station 36+75 to 43+80, consist of 2 to 3 feet of undocumented fill that maintains established vegetation at an approximate gradient of 1:1 (horizontal: vertical) and appears stable provided that drainage is diverted away from the slope face. A landslide was mapped on the east side (downslope) of the roadway alignment at Station 37+00.

Figure 6: Photograph of cut slopes at Station 37+00

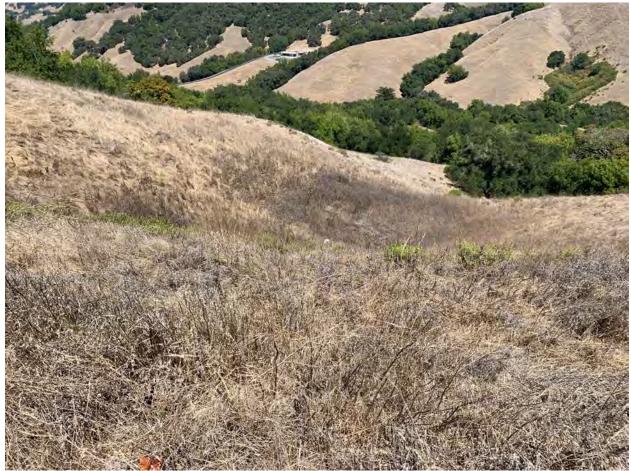
Figure 7: Photograph of landslide below Station 37+00

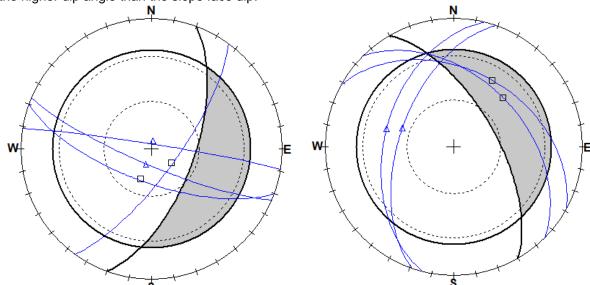
For data set 1, all the attitudes do not meet conditions 1 through 4. Therefore, there is a low potential for planar failures. For data set 2, the conditions are met depicting planar failure. This is observed as the existing cut slopes have eroded back to the bedding dip angle of 45 degrees. As the proposed cut slope is 2:1 (horizontal: vertical), the potential for planar failure will be low due to the higher dip angle than the slope face dip.

Figure 8: Stereonet (blue arcs depict bedding; bold black arc depicts slope)

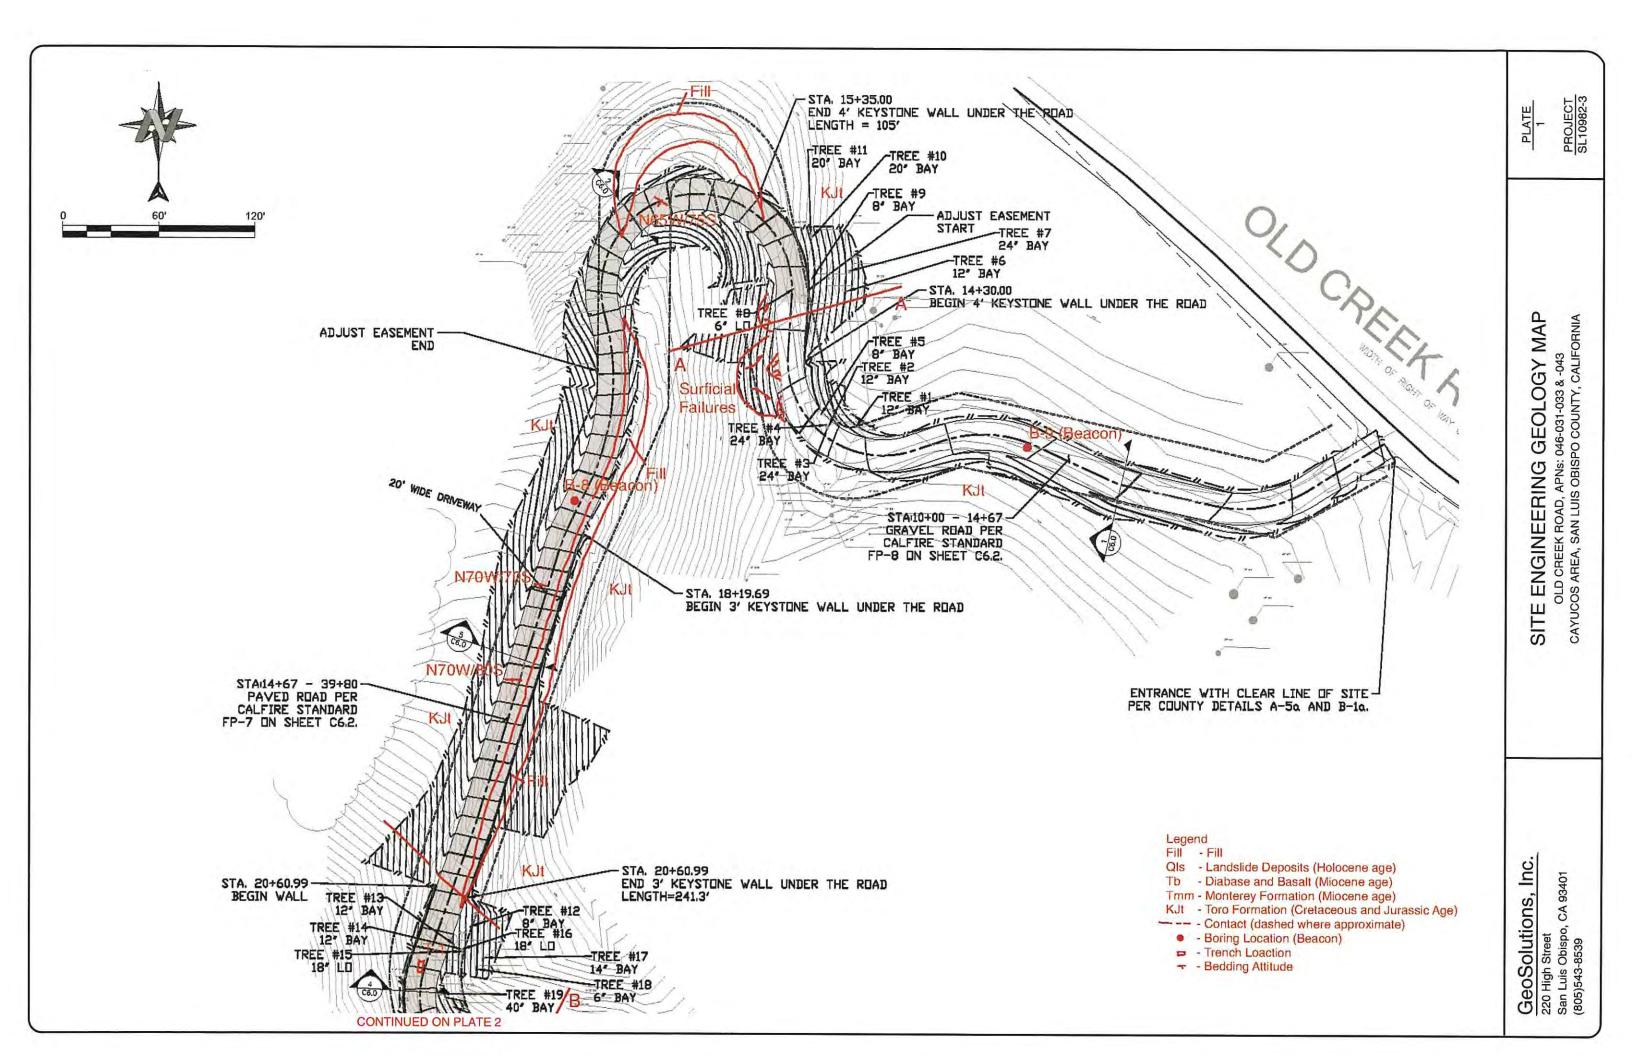
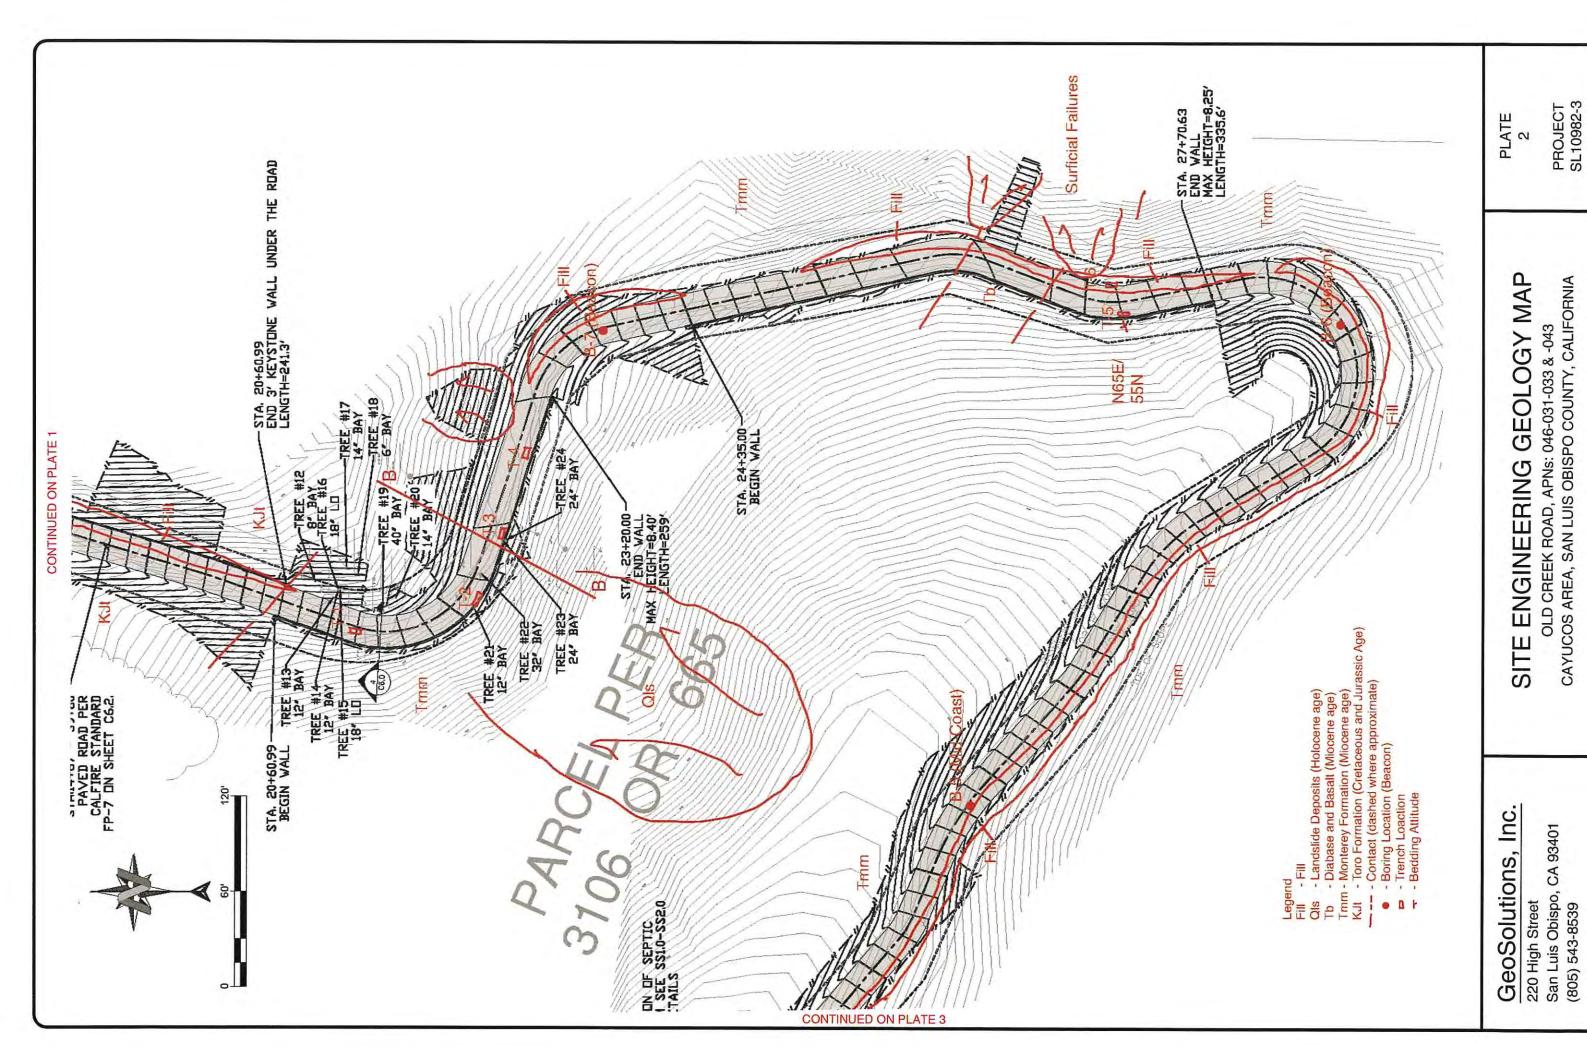
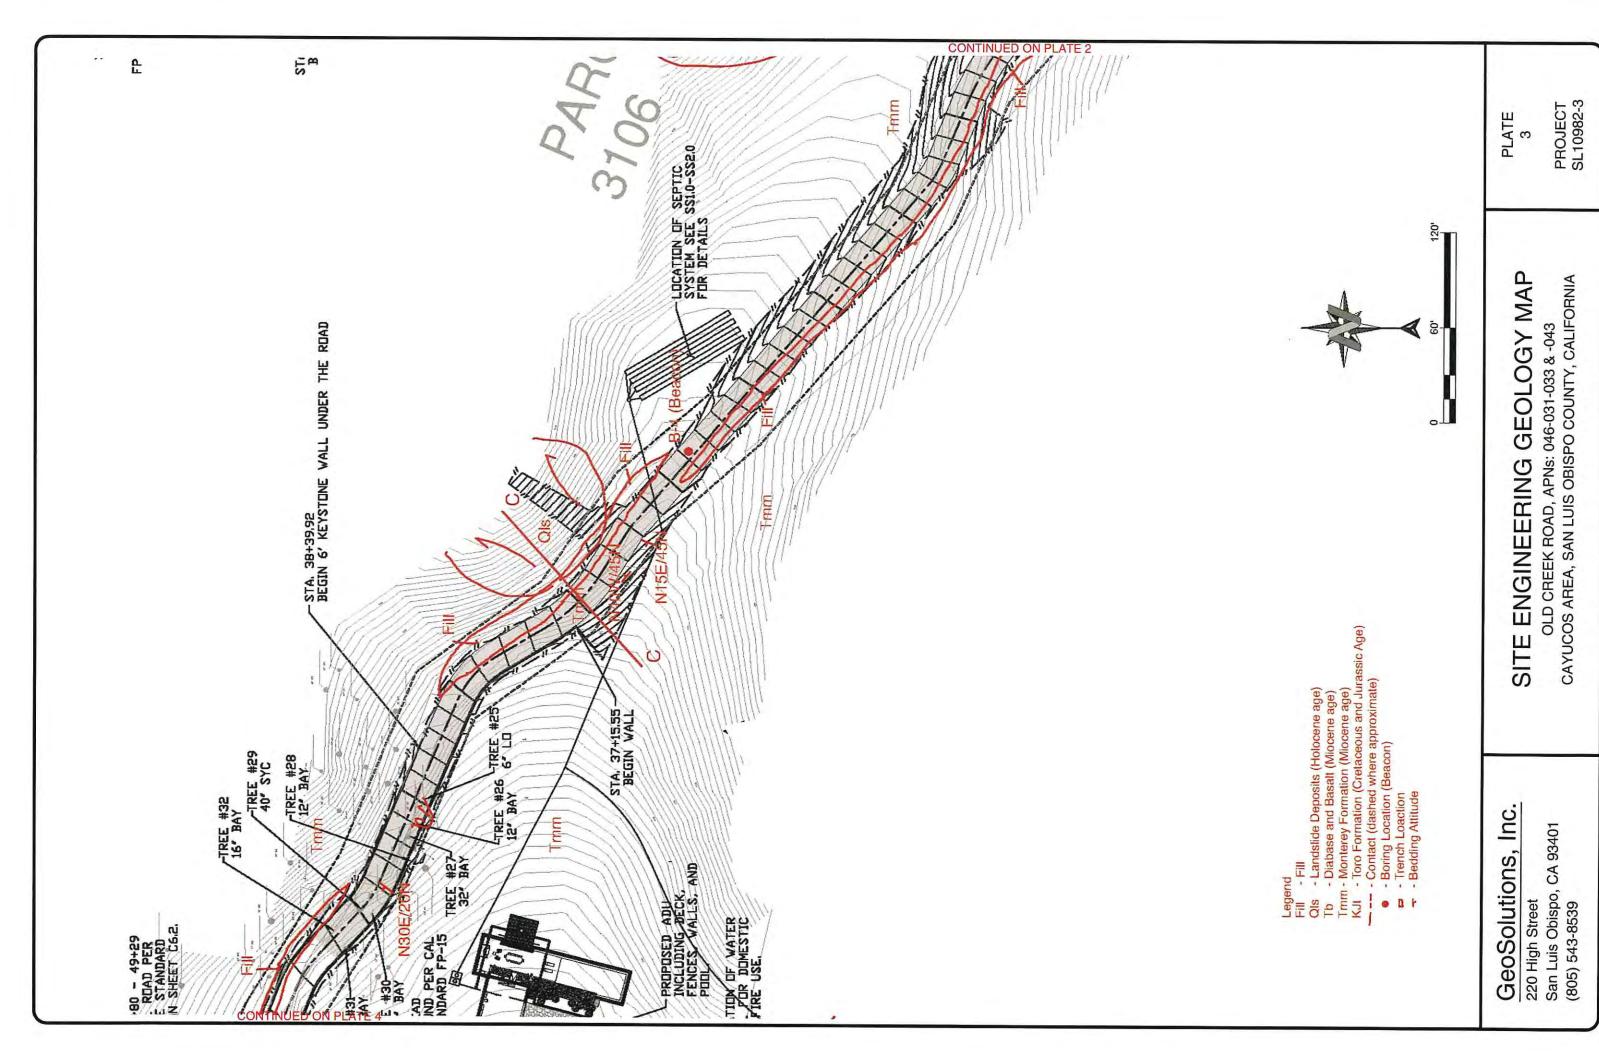
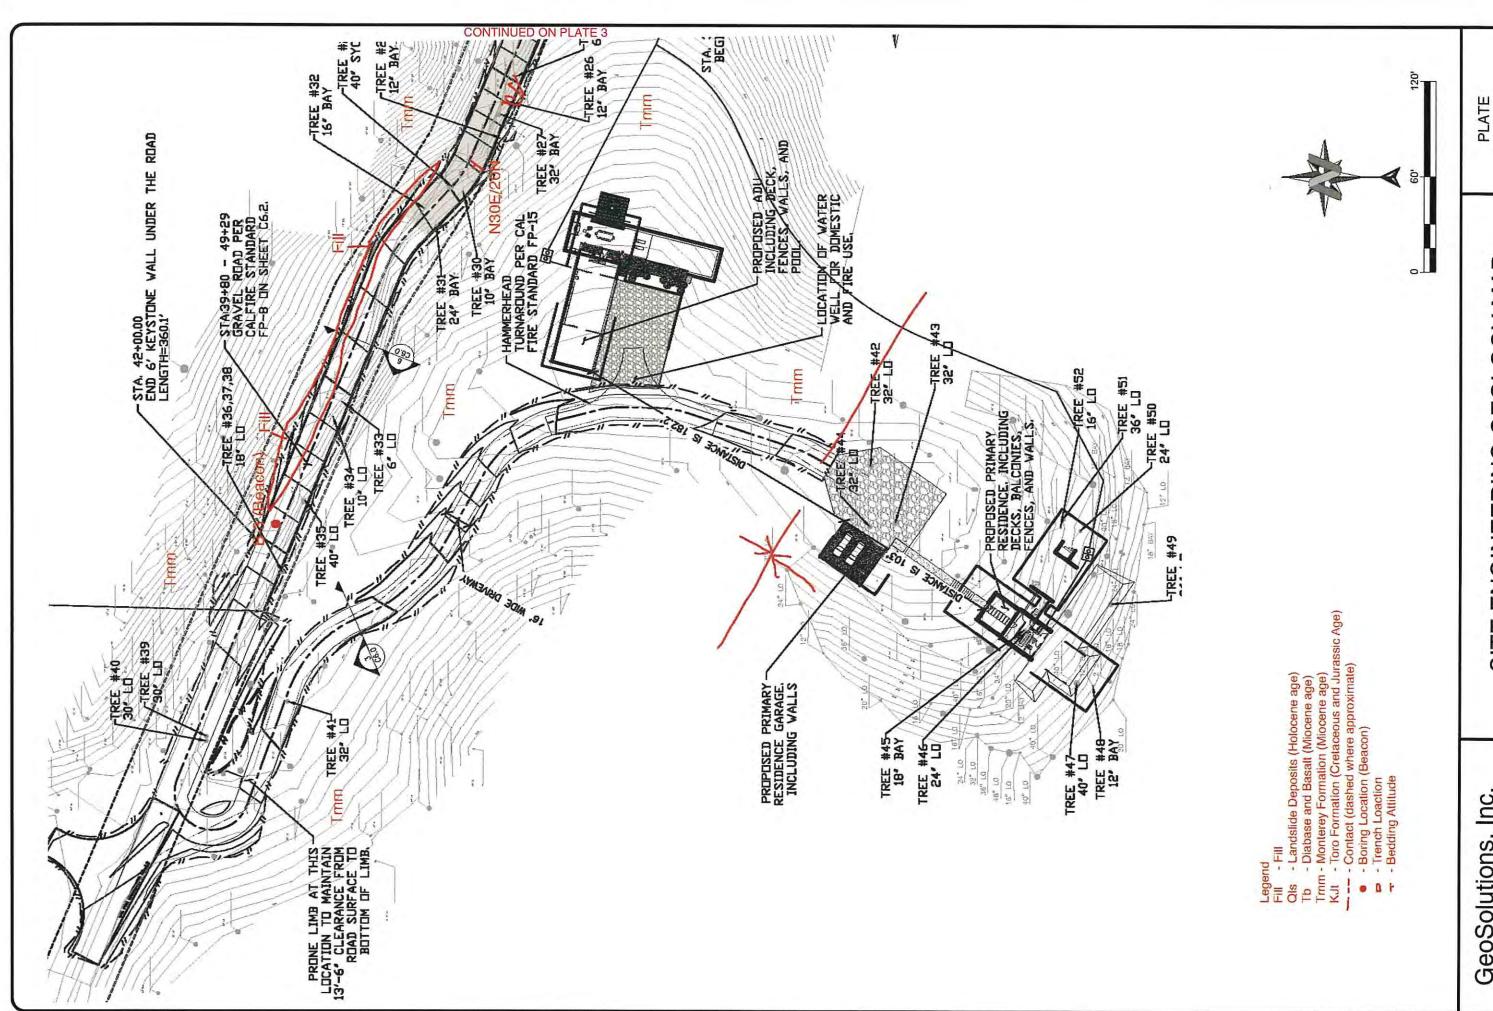
SITE ENGINEERING GEOLOGY MAP OLD CREEK ROAD, APNs: 046-031-033 & -043 CAYUCOS AREA, SAN LUIS OBISPO COUNTY, CALIFORNIA

Plate 1 depicts the location of cut and fill slopes as well as the location of existing failures along this section of roadway. Construction of this section of roadway can be achieved with conventional grading, although localized sections of resistant mudstone should be anticipated.

Plate 1 and 2 depicts the location of cut and fill slopes, retaining walls and failure areas along this section of roadway. Construction of this section of roadway can be achieved with conventional grading, although localized sections of resistant formational material should be anticipated.

Plate 2, 3 and 4 depicts the location of cut and fill slopes, retaining walls and failure area along this section of roadway. Construction of this section of roadway can be achieved with conventional grading, although localized sections of resistant formational material should be anticipated.
