Arborist Report

1655 Berryessa Road Project

October 29, 2018

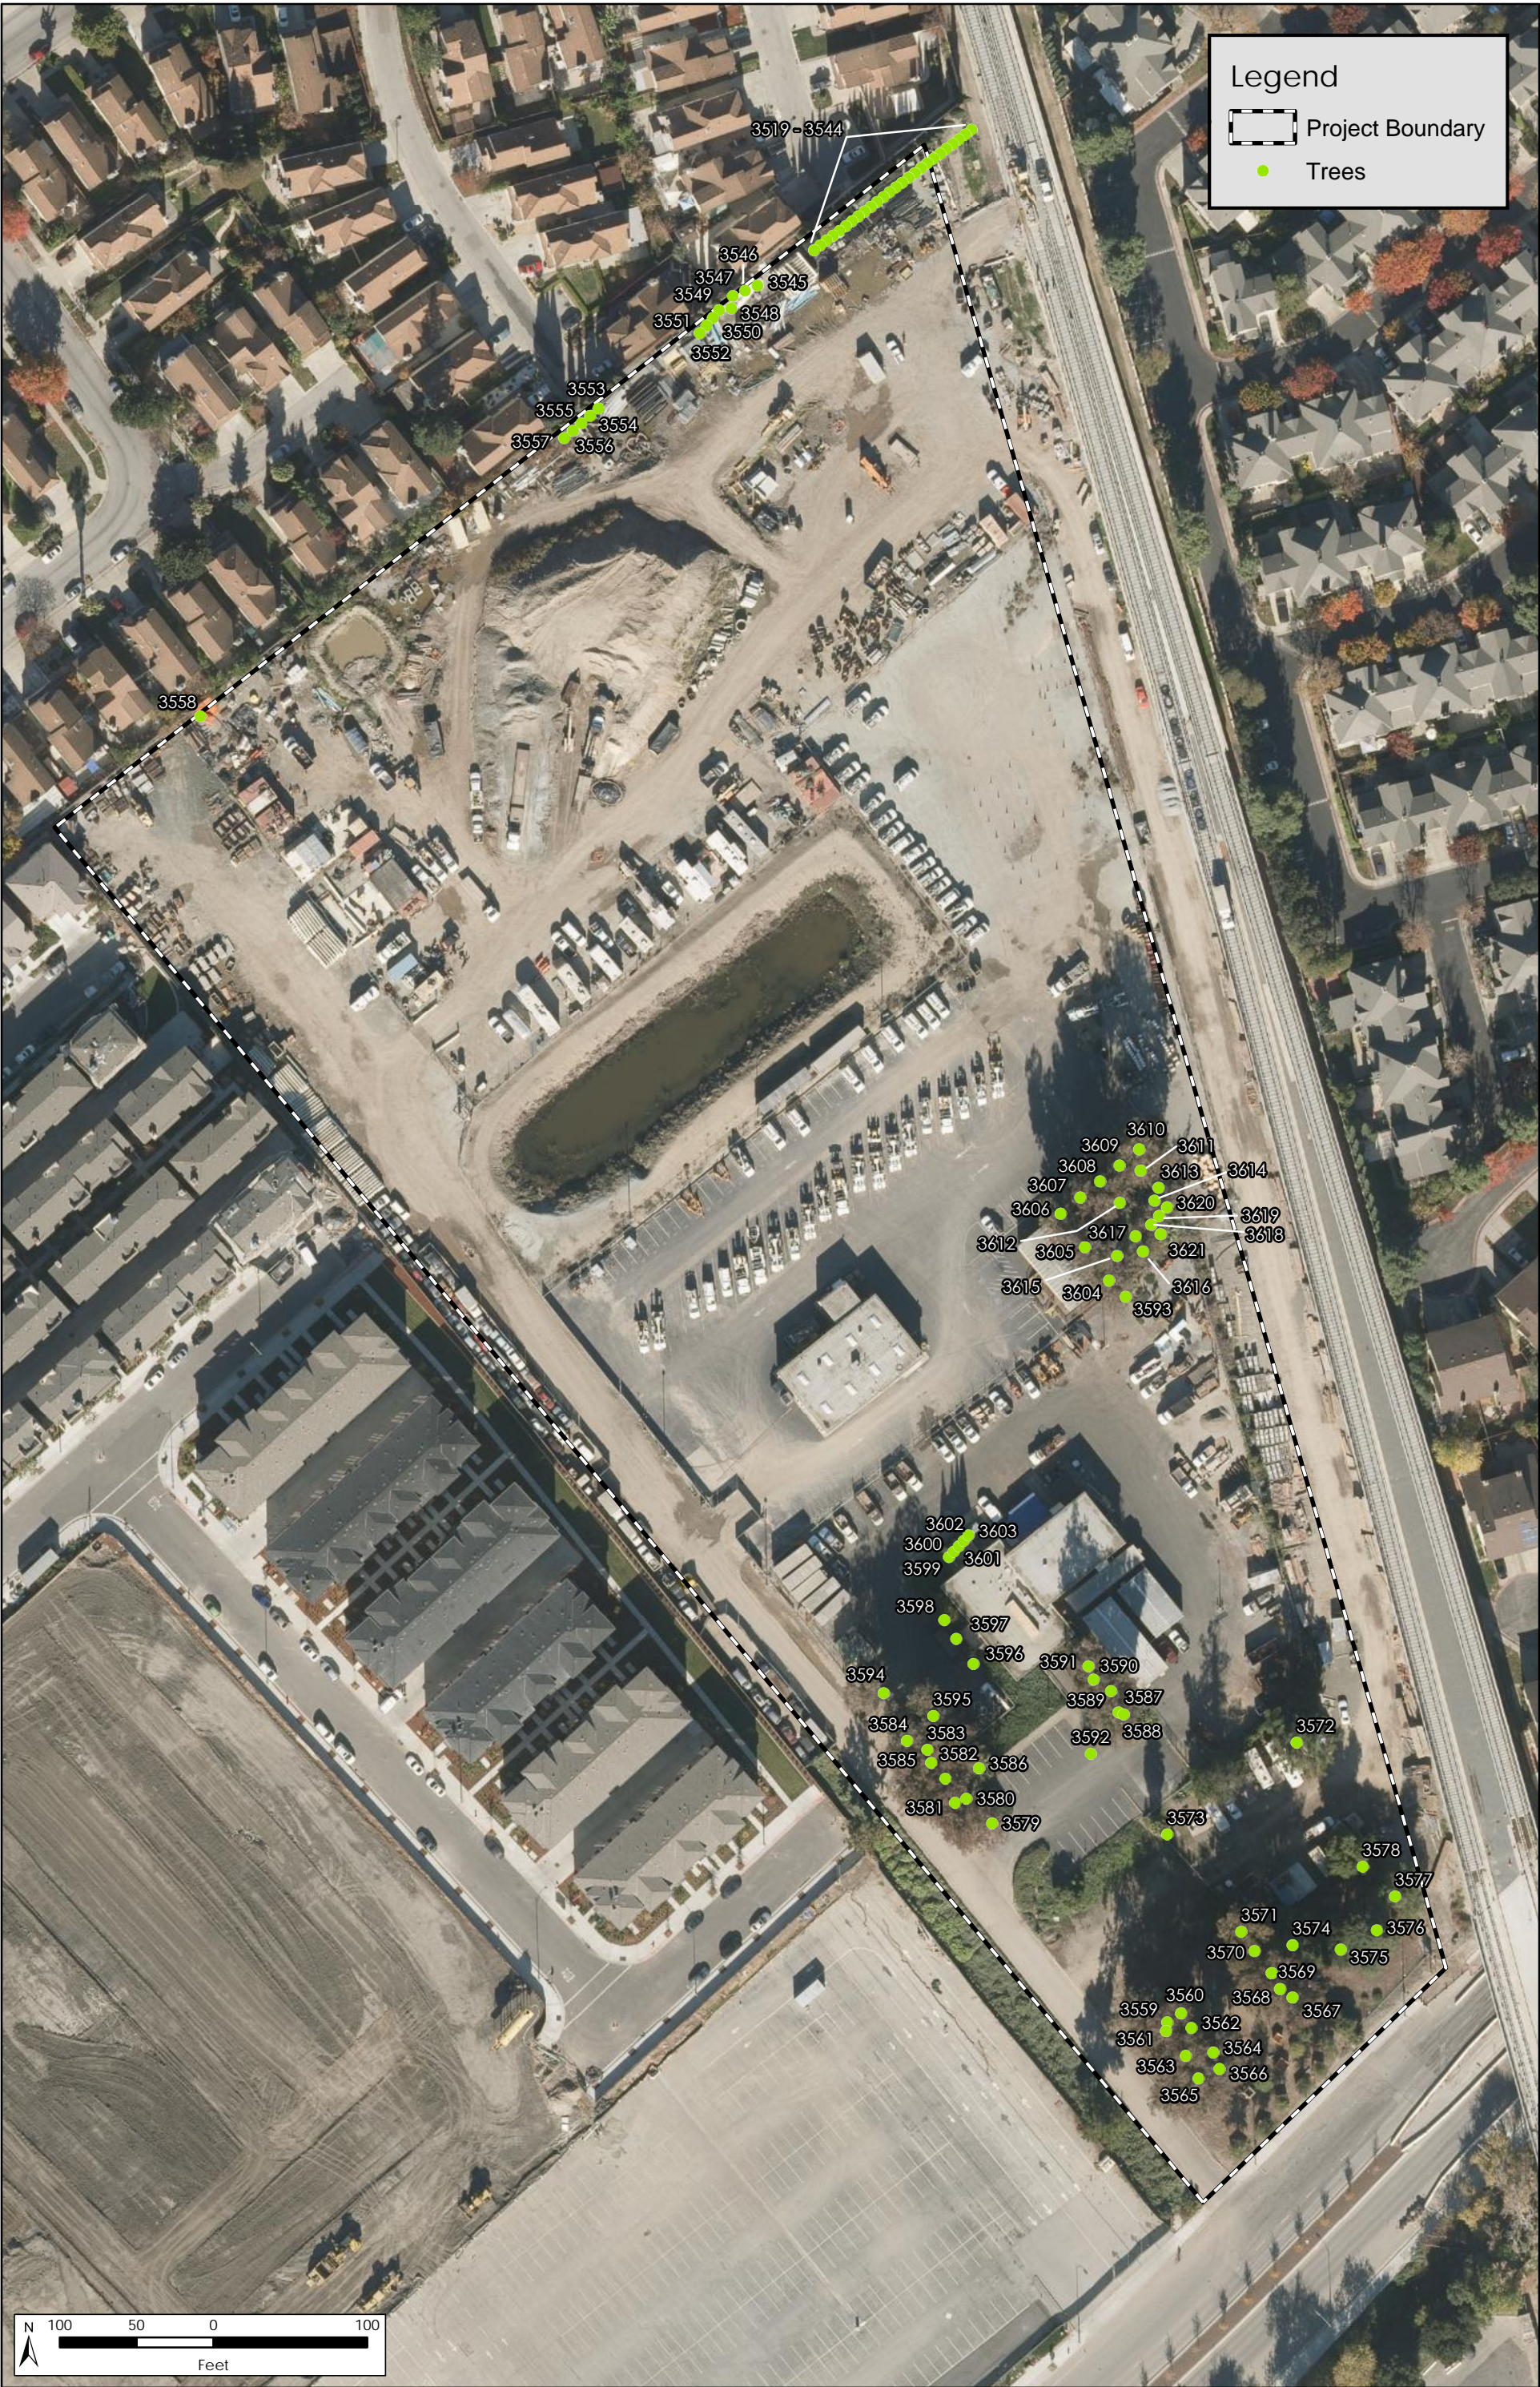
We identified 103 trees on the site (Figure 1). Descriptions of each tree including DBH, tree health and structural scores, and whether or not each tree is ordinance-sized are provided in Appendix C. Table 3 provides a summary of the 103 trees that were assessed, which represent 10 species. Of the 103 trees located on the site, 47 (46%) met the City's criteria for ordinance-size trees (see Section 3.4 below). The most common species on the site were Italian cypress (44%) and red ironbark (41%).

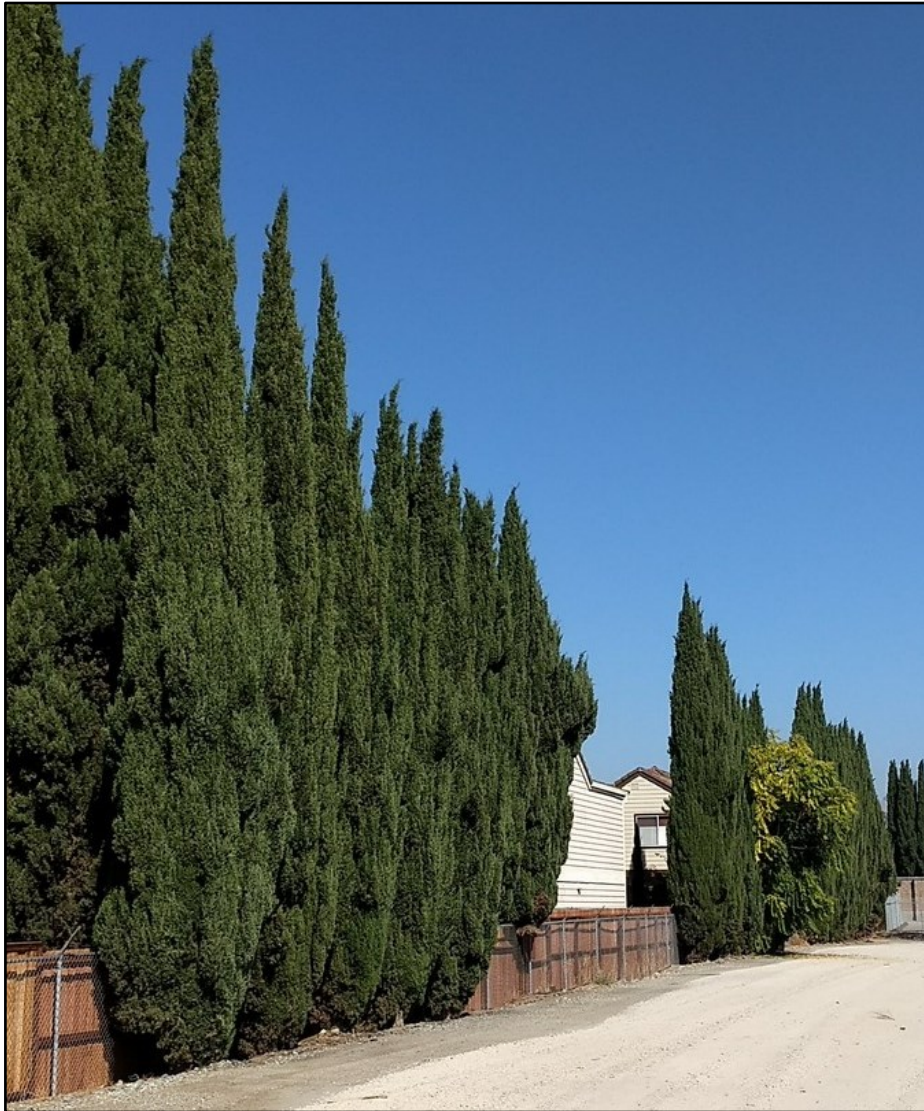
Photo 1. Row of Italian cypress (*Cupressus sempervirens*) along the northern site boundary. Tree #3557 is in the foreground.

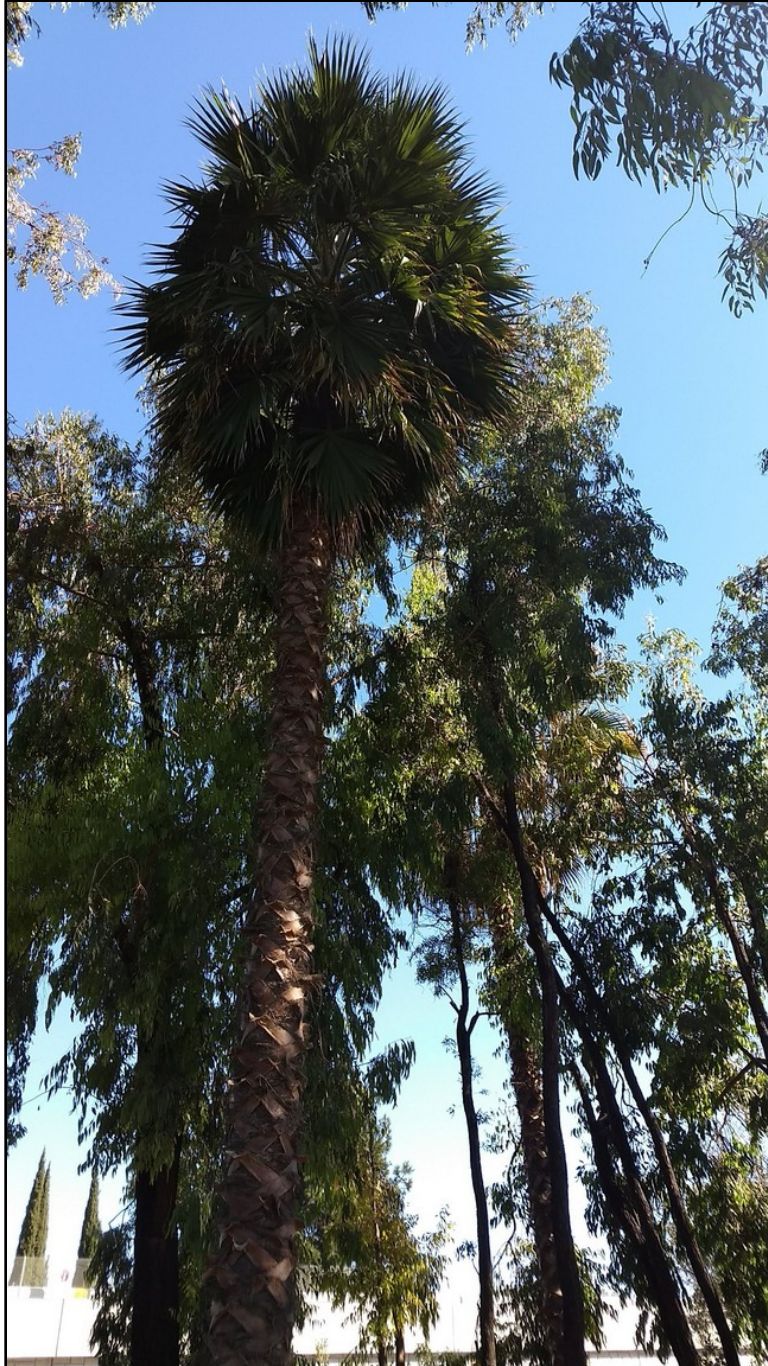
Photo 2. Tree #3221, Mexican fan palm (*Washingtonia robusta*), in a stand of red ironbark (*Eucalyptus sideroxylon*).

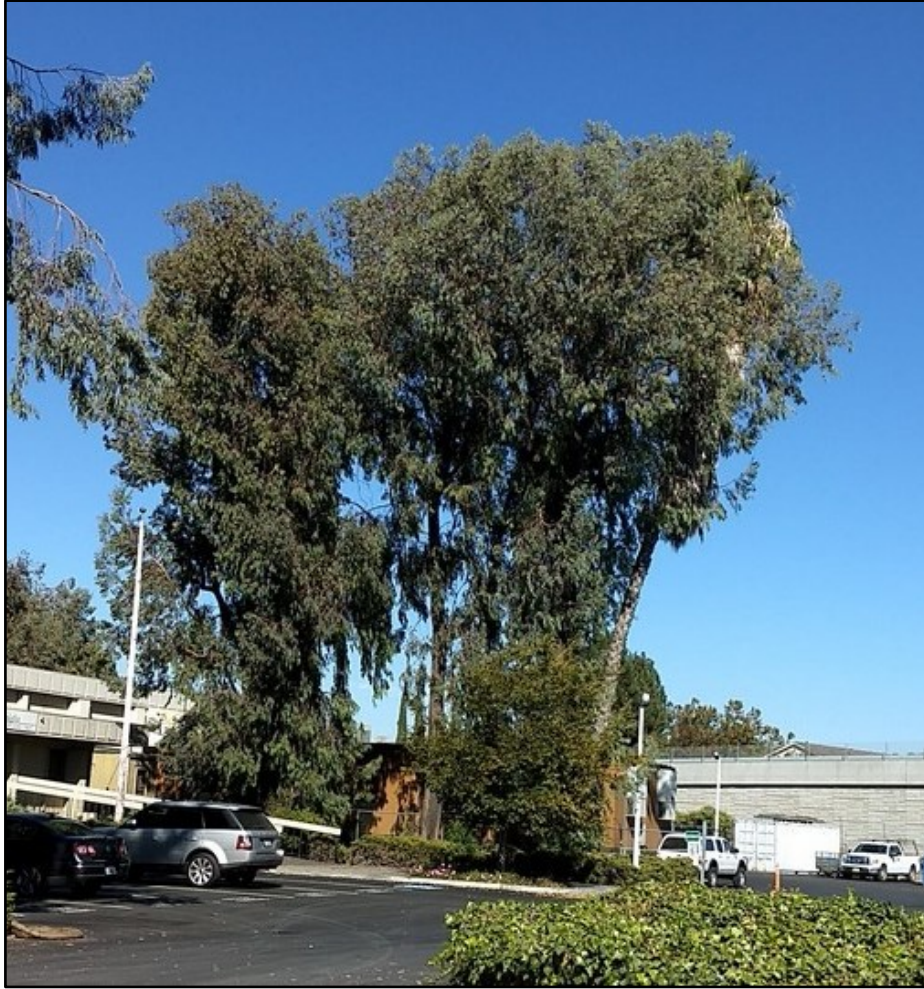
Photo 3. A stand of red ironbarks with an individual Mexican fan palm at right and Chinese hackberry (*Celtis sinensis*) in foreground (trees #3588–3592).
