Project No. S1350-05-05
May 15, 2018

Subject: LIMITED GEOTECHNICAL INVESTIGATION
PIG POND DAM / BEAR HIDE LAKE DAM
PACHECO STATE PARK
MERCED COUNTY, CALIFORNIA

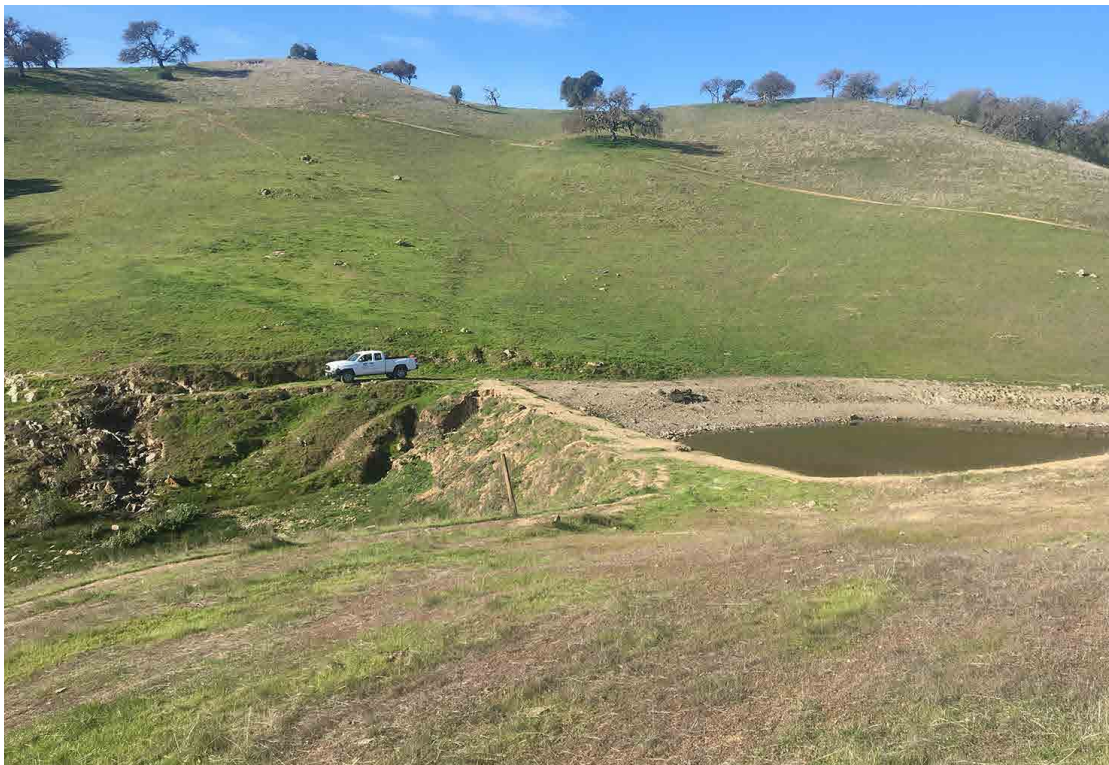
The existing Pig Pond Dam is on the order of 15 feet high, about 100 feet long, and impounds a pond approximately one-half acre in surface area (Photo 1). The dam is constructed of undocumented earthen fill with embankment side slopes of approximately 1:1 (horizontal: vertical) on the dry side and 2:1 on the water side and a crest on the order of 8 feet (south end) to 15 feet (north end) wide. The dam crest exists at an approximate elevation of 1,400 feet above mean sea level (MSL). The dry side dam embankment slope is predominantly exposed soil with sparse, low weeds and brush while the water side dam embankment slope is exposed soil. The land side embankment and crest show significant erosion (near-breach) from storm activity that occurred in 2017 (Photo 2). The land side of the dam has abundant animal-burrows throughout the dam (Photos 3 and 4).

Photo No. 1 Pig Pond Dam looking west

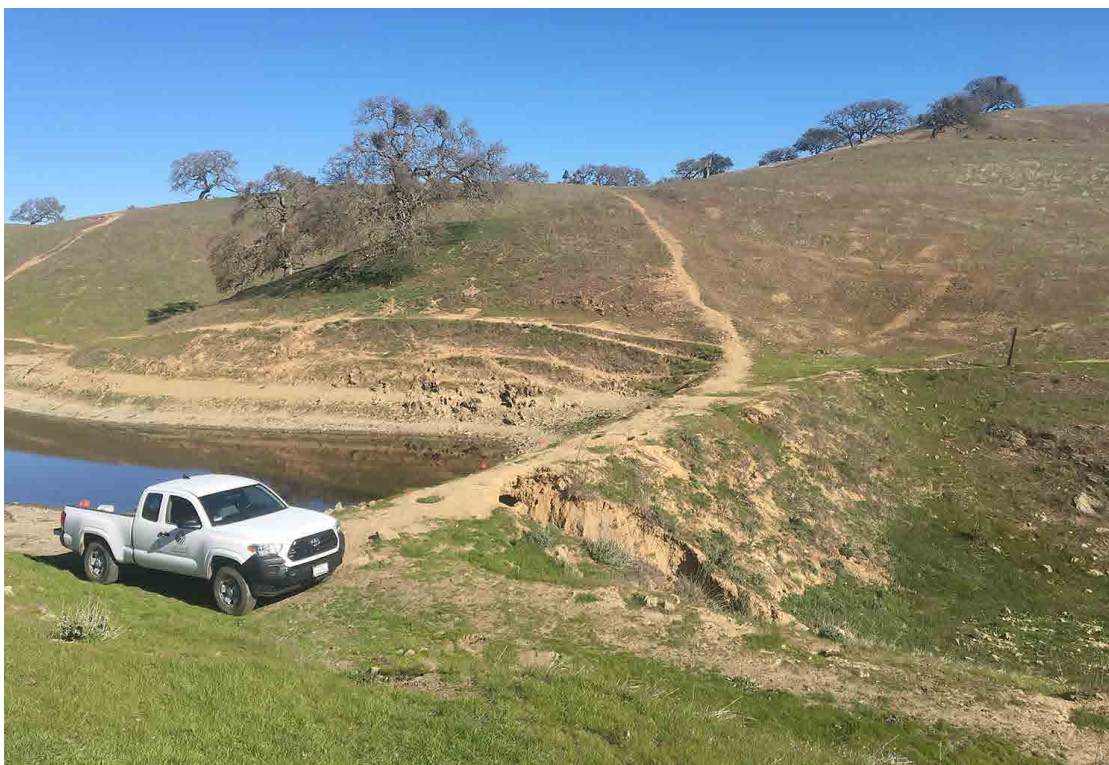
Photo No. 2 Pig Pond Dam looking east showing dam breach erosion in the foreground

- **Alternative 1 - Dam Breach Erosion Repair** – The dam breach erosion at each dam may be repaired at the location of the dam breach by excavating into the dam embankment to remove loose and disturbed embankment material. The excavation should be stepped into the embankment to allow for keyed and benched placement of engineered fill to restore the dam embankment to its original configuration. The material excavated from the breached area may be replaced as engineered fill. Additional fill material required to restore the original dam configuration may be mined from the pond side of the dam or from a local borrow area. Prior to placing engineered fill, a keyway at least 5 feet wide, 2 feet deep and extending 5 feet longer than the repair area should be excavated at the base of the embankment slope to key the replacement fill into the foundational material (weathered bedrock). The replacement engineered fill should then be placed in lifts no thicker than 8 inches (loose thickness), moisture conditioned to approximately 2% over optimum moisture and compacted to 95% relative compaction per ASTM D1557 Test Procedure.

- **Alternative 2 - Dam Replacement** – Due to the degree of animal burrowing in Pig Pond Dam and the depth of the dam breach erosion in Bear Hide Lake Dam, the existing dam sections may be removed and replaced using the existing embankment materials (and possibly excavated materials from the pond or excavated from a local borrow area) as engineered fill. The engineered fill should be moisture conditioned approximately 2% over optimum moisture and placed in lifts no thicker than 8 inches (loose thickness) and compacted to 95% relative compaction per ASTM D1557 Test Procedure to restore the dam to its original configuration. This will serve to reduce the permeability of the dam embankments, mitigate existing animal disturbance/burrows in the dams, and improve the structural section of the dam (reduce the possibility of future erosion of the dam sections and disturbance due to animal activities). This option would provide new, stronger embankment sections but would be more costly than Option 1.

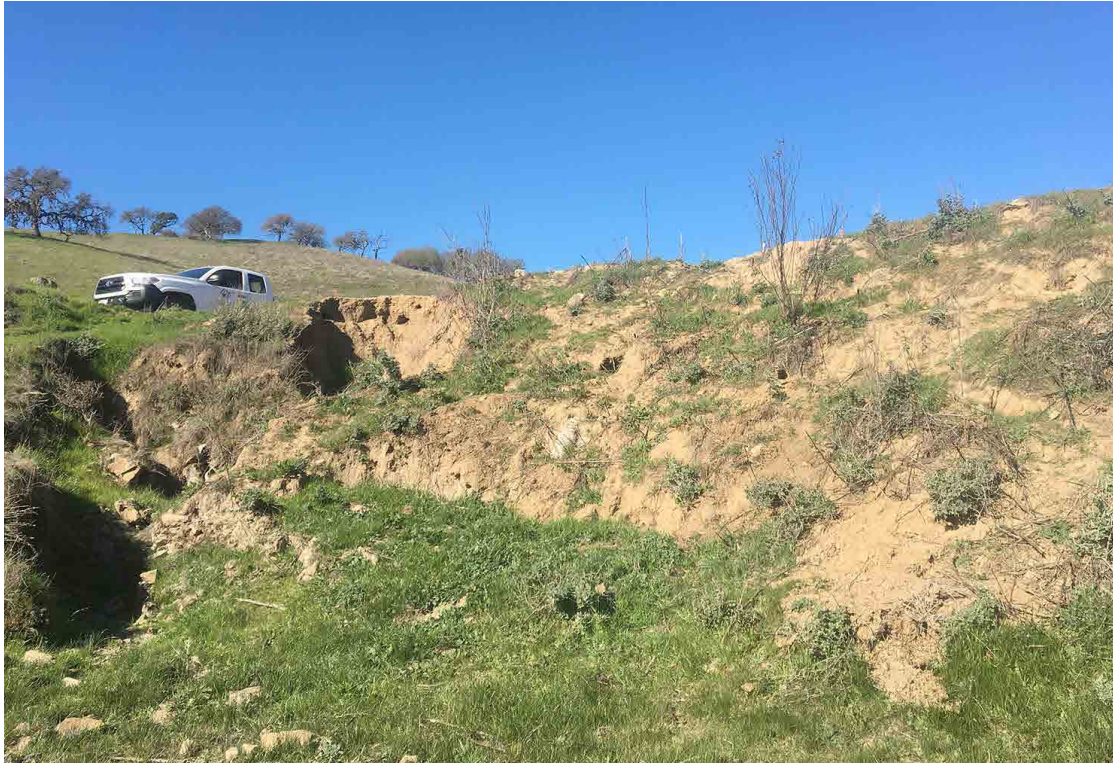
- It is apparent that burrowing animals are present in Pig Pond Dam and may also be present in Bear Hide Lake Dam. Based on our observations it is apparent that animal burrows contributed to the damage at Pig Pond Dam. We recommend repairing any existing burrows and implementing an animal-burrow control program to mitigate potential damage from future burrowing. Burrow repair is typically performed by grouting in or otherwise filling existing burrows. If grading/earthwork is proposed for the project, such activity will remove animal burrows within the extent of earthwork. Burrows extending beyond earthwork limits should be grouted or filled. Animal burrow control can be improved by providing dam slope conditions that discourage burrowing animals (embankment facing materials or similar), removing burrowing animals once they are noted in the dam (via poisoning/trapping, etc.), or other methods.

Photo No. 3 Pig Pond Dam looking north showing animal burrows in the dry side of the dam

- Rodent/burrowing animal control measures should be implemented to reduce the impacts of burrows to the dams. Ongoing regular dam slope maintenance activities should include repairing animal burrows or erosion areas.

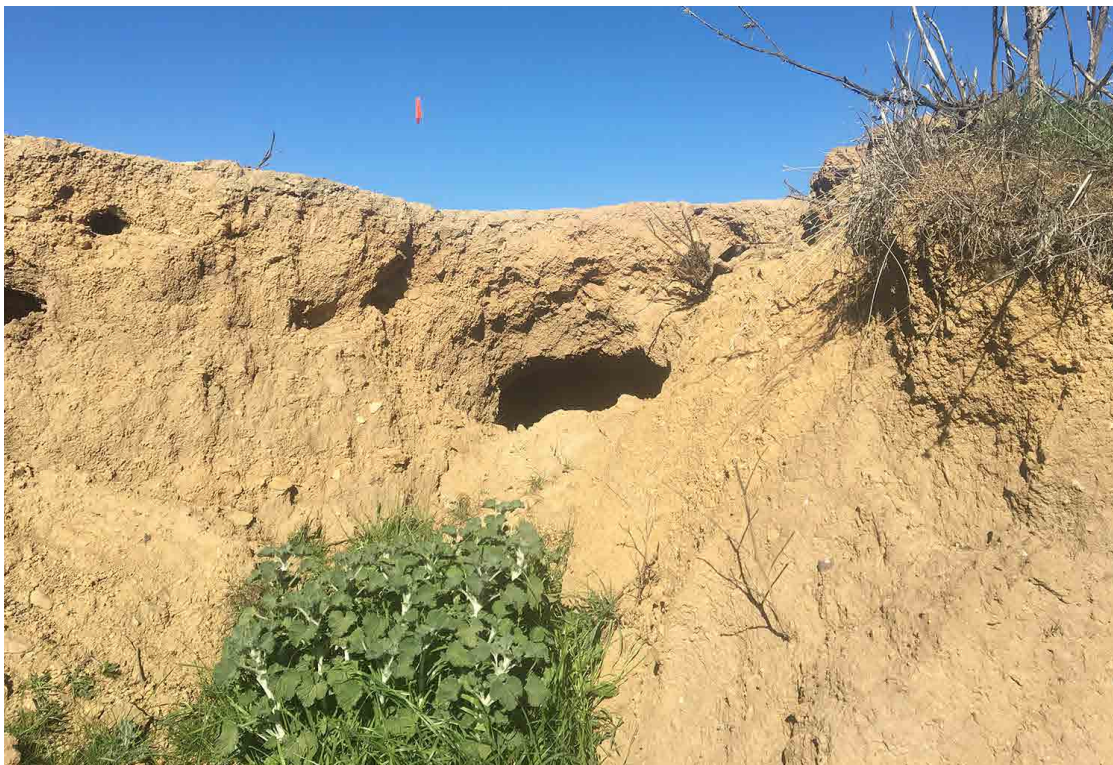
Photo No. 4 Animal burrows in the dry side of the dam

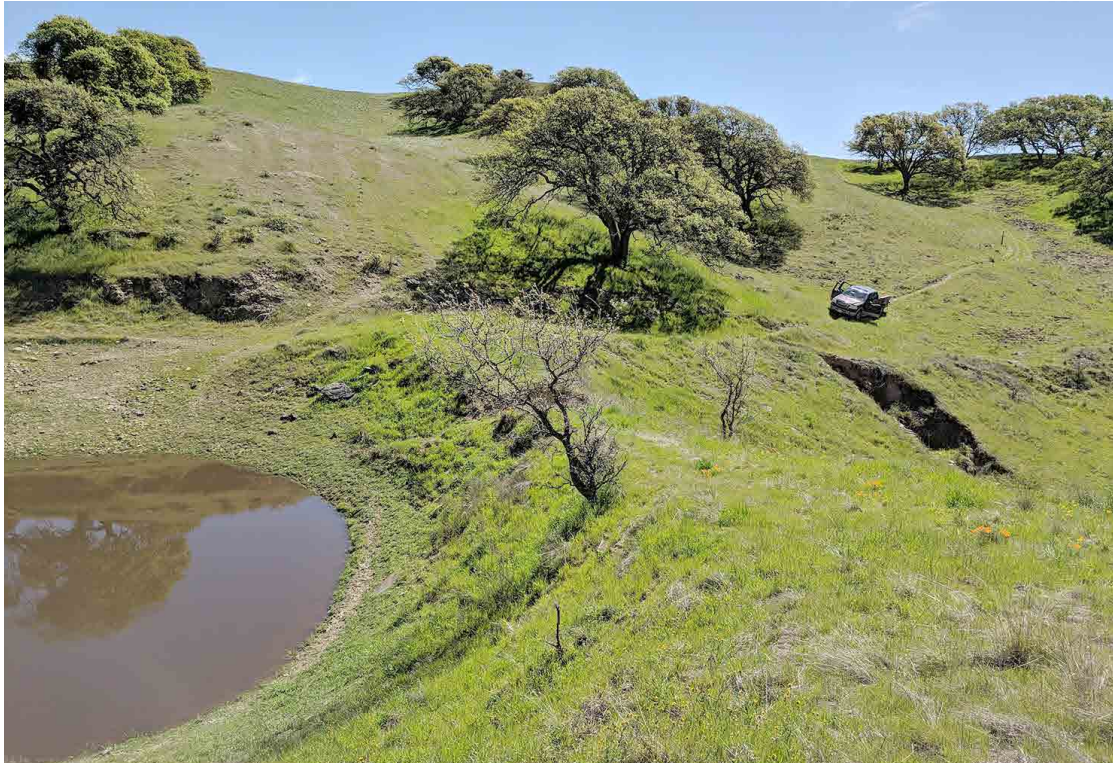
The existing Bear Hide Lake Dam is on the order of 16 feet high, about 120 feet long, and impounds a pond approximately one-half acre in surface area (Photos 5 and 6). The dam is constructed of undocumented earthen fill with embankment side slopes of approximately 3:1 on the dry side and on the water side with a crest on the order of 10 feet wide. The dam crest exists at an approximate elevation of 1,293 feet MSL. The dry side and water side dam embankment slopes are predominantly vegetated with grasses. The water side of the dam and crest show surficial disturbance from cattle trails (Photo 7). The crest and dry side of the dam show significant erosion (near-breach) from storm damage that occurred in 2017 (Photo 8).

Photo No. 5 Bear Hide Lake Dam looking east

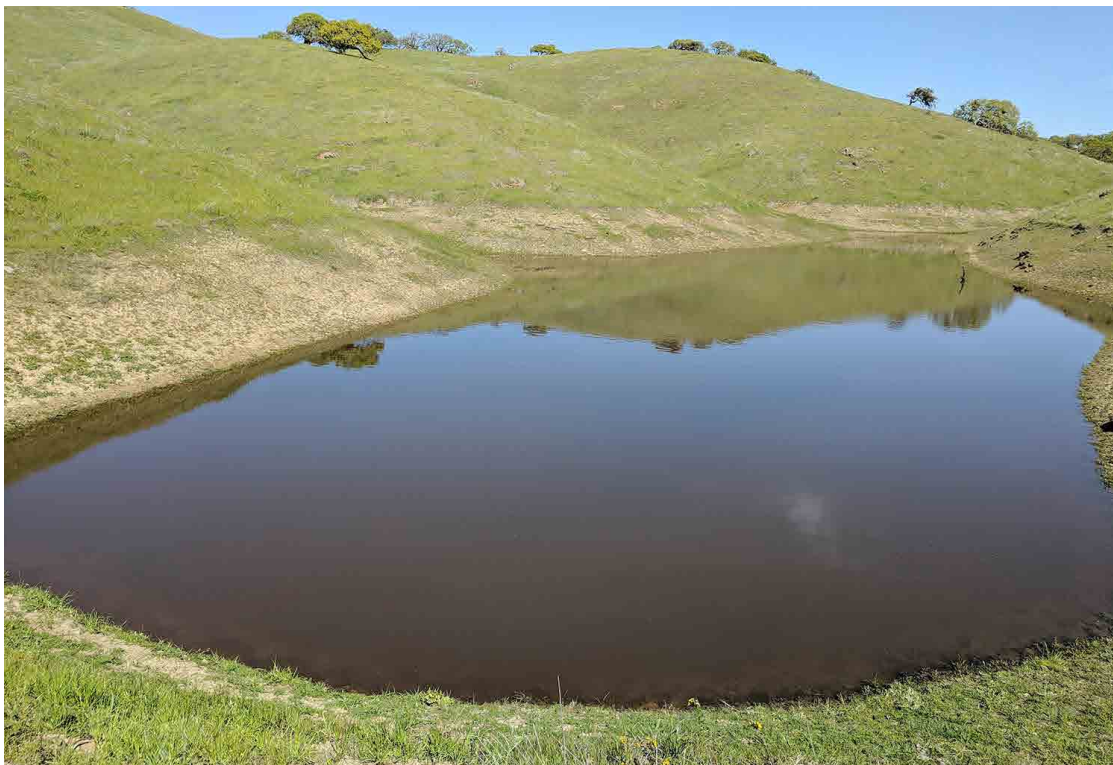
Photo No. 6 Bear Hide Lake looking north

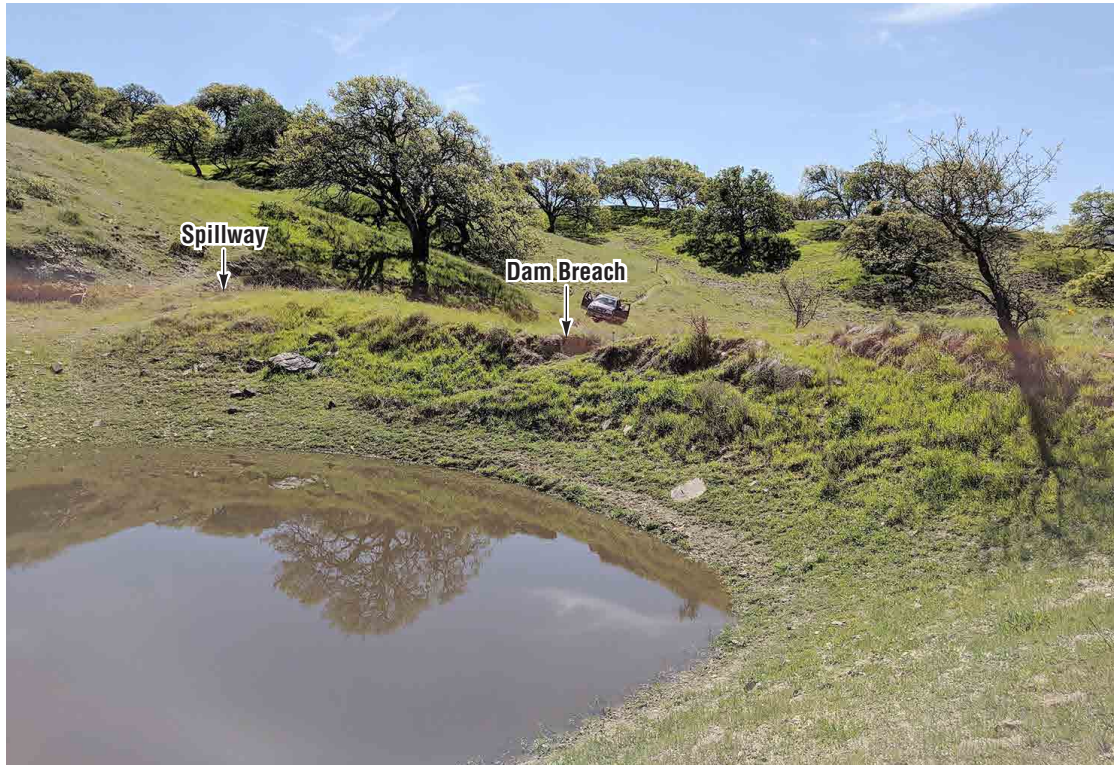
Photo No. 7 Bear Hide Lake Dam showing dam breach and spillway

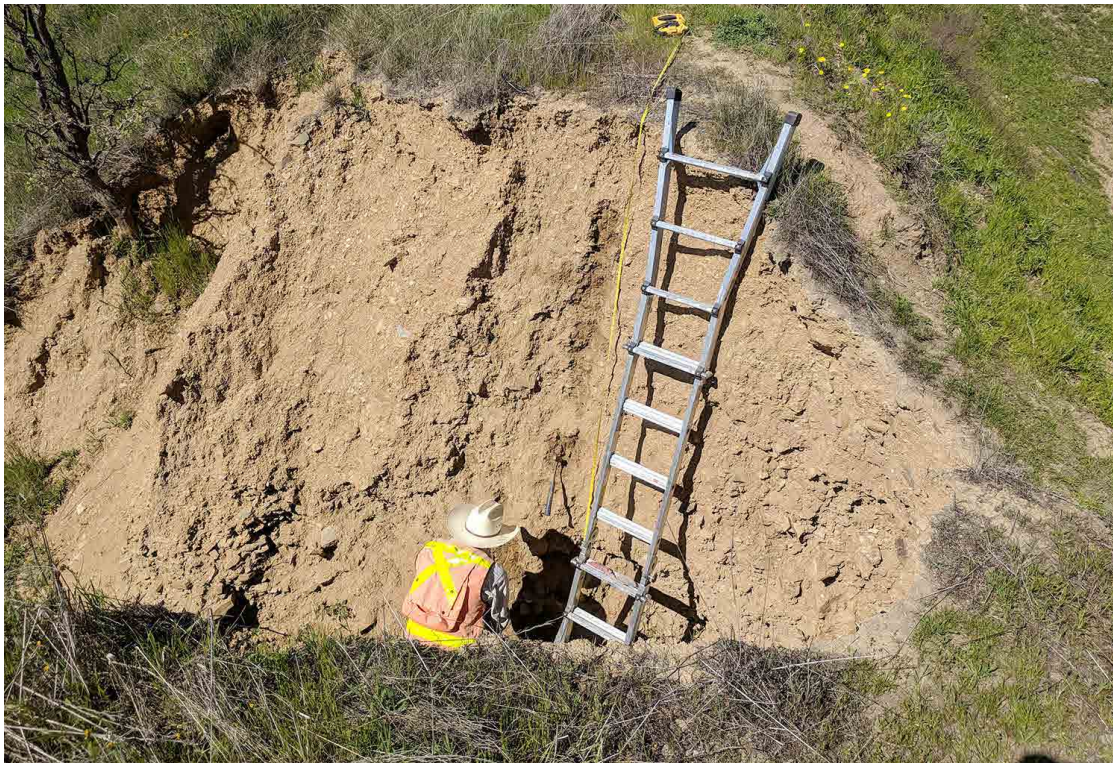
Photo No. 8 Bear Hide Lake Dam showing dam breach erosion
