# HISTORIC SIGNIFICANCE EVALUATION FOR THE BELTRAMO RANCH PROJECT CITY OF MOORPARK, VENTURA COUNTY, CALIFORNIA

# Prepared for: CITY OF MOORPARK

February 2022

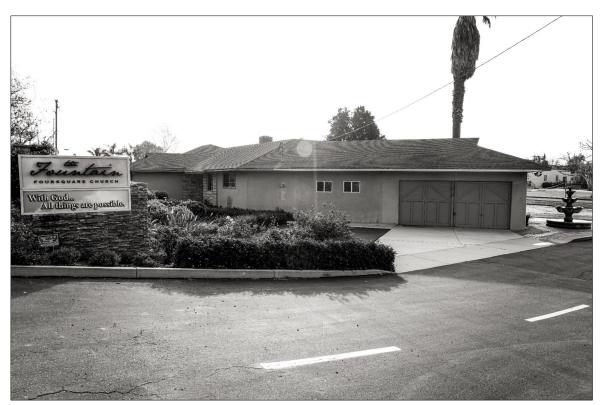
Photo 1: 11930 3/4 View of North Elevation. View East-Southeast

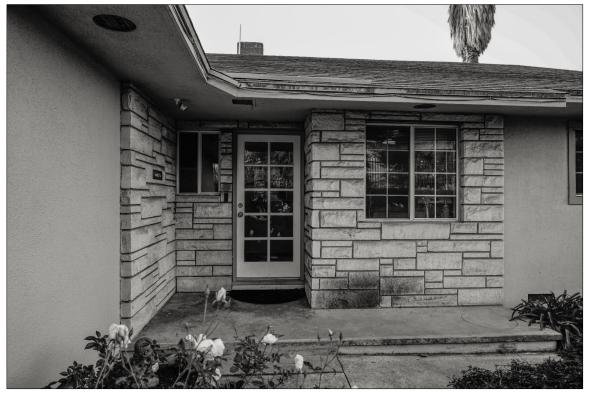
Photo 2: Formalized Entrance. View South

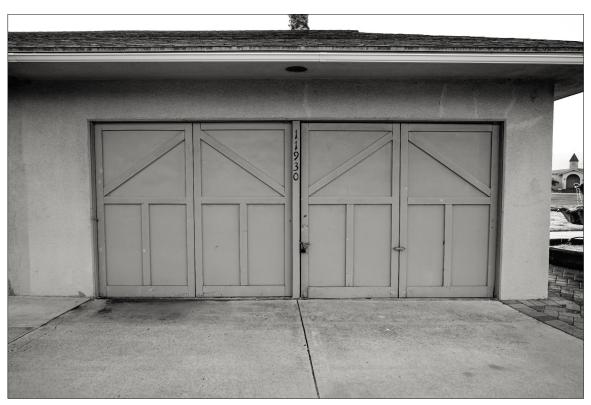
A portion of the living space and the attached two-car garage jut at an angle to the main building and open to a property corner-oriented driveway for access. The original garage doors have been replaced with what appear to be built-on-site wood replacements, possibly in the same style or pattern of the originals. The center 4" x 4" post and the surrounding jambs appear to be original to the house as evidenced by the higher quality of the underlying wood, and the numerous layers of built-up paint, which the doors lack.

Photo 3: Replacement Garage Doors in Original Framing. View South-Southeast

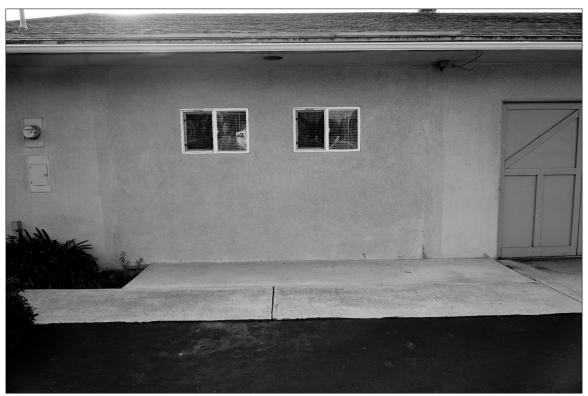
Photo 4: Area of Possible Remodel Adjacent to Garage Doors. View South-Southeast

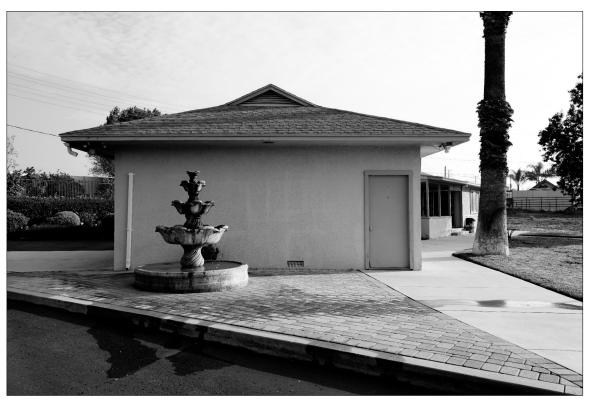
Photo 5: West Elevation, with Replacement Door, Jams, and Casing. View East-Northeast

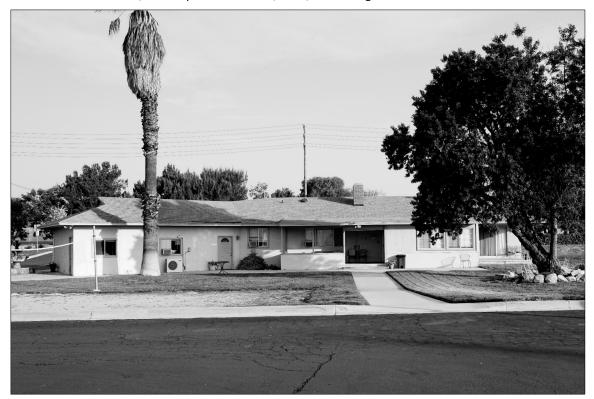
Photo 6: South Elevation. Note Partially Enclosed Patio Porch, Numerous AC Units. View North

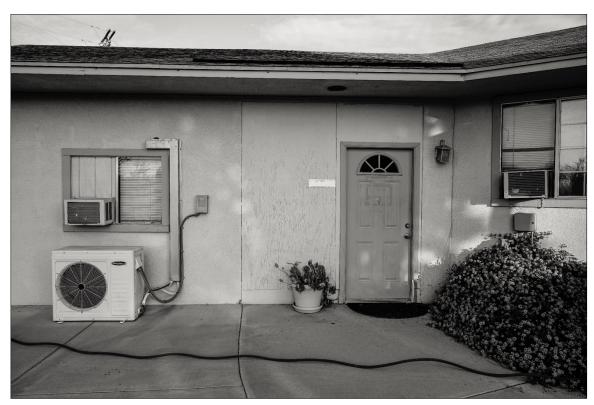
Photo 7: Low-cost Incompatible Infilling of Prior Aperture Between Main House (R) and Garage (L). View North

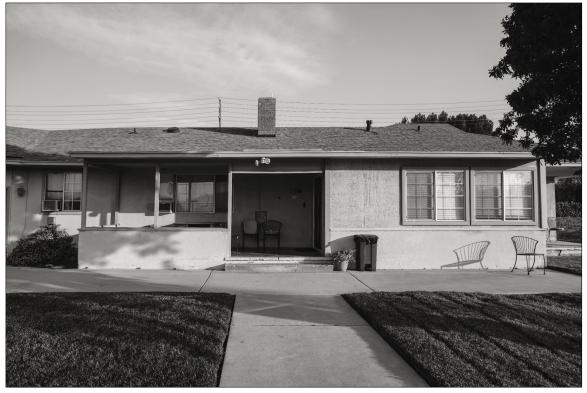
Photo 8: Partially Enclosed Patio Porch with Modified Entryway. View North

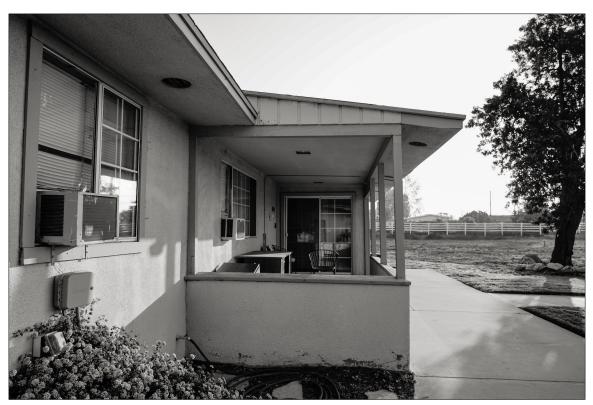
Photo 9: Rear Patio Porch with Original Finishes. Note Vertical Drop-Lap Siding below Shed Roof, and Original Framing. Note Replacement Vinyl Windows and Doors and 1"x4" Casement. Note Round Soffit Vents. View East

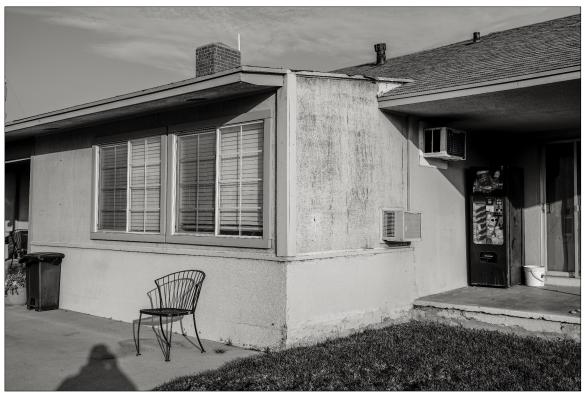
Photo 10: Enclosed Patio Porch. Note Loss of Fabric, Feeling, and Condition Noted in Photo 9. Note use of 2"x4" Studs, instead of Appropriate 1"x4" Common Board for Casing View Northwest

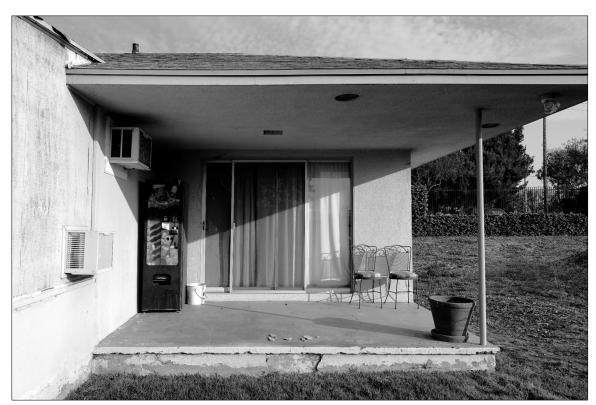
Photo 11: Patio at Southeast Corner of House with Original Aluminum Sliding Doors and Casework. Note Rough-Sawn No Bead Plywood Siding Enclosing Patio Porch and Loss of Fabric Noted in Photo 9. View North

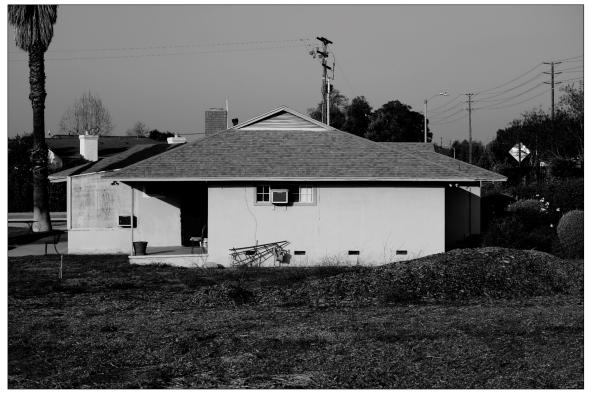
Photo 12: East Elevation. Note Enclosure of Patio Porch no longer Mimics Feeling of Southeast Patio. View West

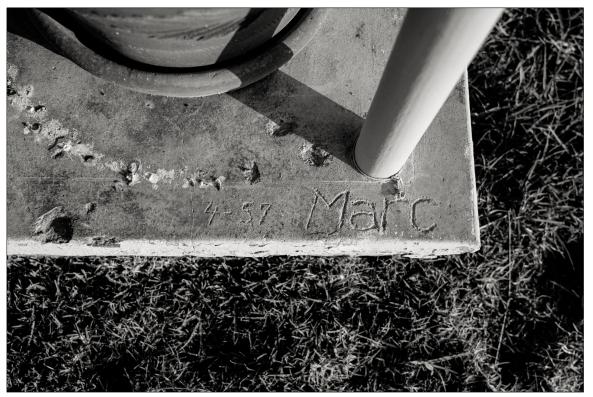
Photo 13: Date Stamp in Slab of Southeast Patio

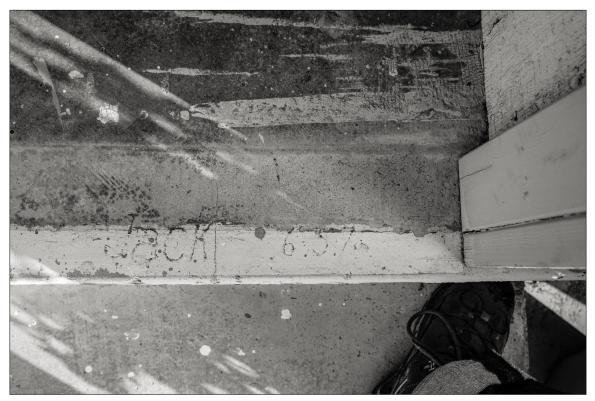
Photo 14: Date Stamp in Rear Patio Porch Slab. Note Removed Stem Wall Ghost Print in Modified Entryway

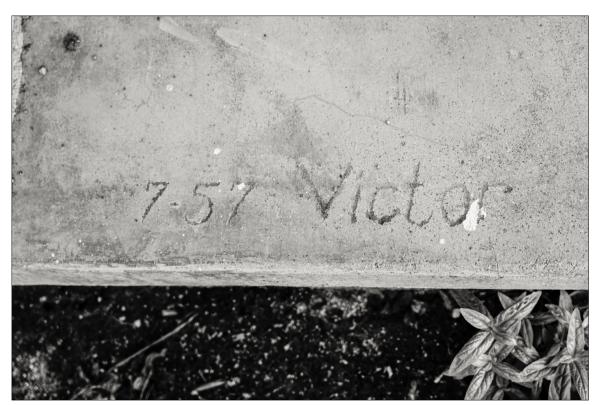
Photo 15: Date Stamp in Front Porch Slab

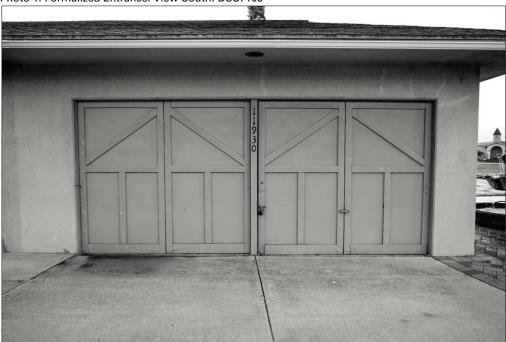
A portion of the living space and the attached two-car garage jut at an angle to the main building and open to a property corner-oriented driveway for access. The original garage doors have been replaced with what appear to be built-on-site wood replacements, possibly in the same style or pattern of the originals. The center 4" x 4" post and the surrounding jambs appear to be original to the house as evidenced by the higher quality of the underlying wood, and the numerous layers of built-up paint, which the doors lack.

Photo 2: Replacement Garage Doors in Original Framing. View South-Southeast. DSC7110

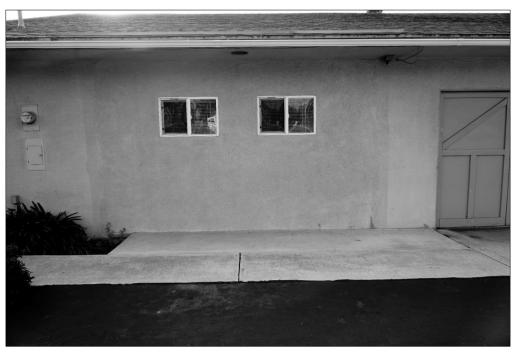
Photo 3: Area of Possible Remodel Adjacent to Garage Doors. View South-Southeast. DSC7151

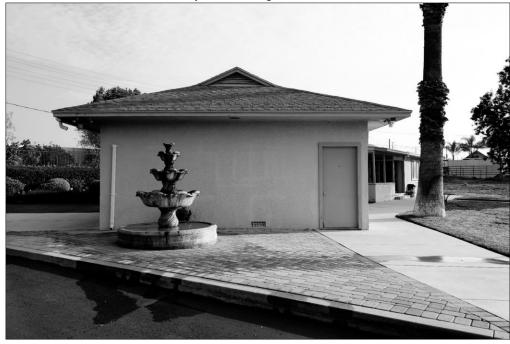
Photo 4: West Elevation, with Replacement Door, Jams, and Casing. View East-Northeast. DSC7149

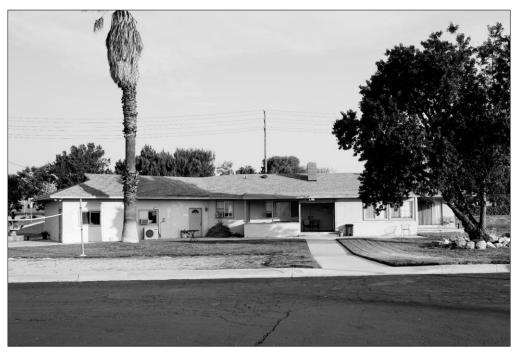
Photo 5: South Elevation. Note Partially Enclosed Patio Porch, Numerous AC Units. View North. DSC7139

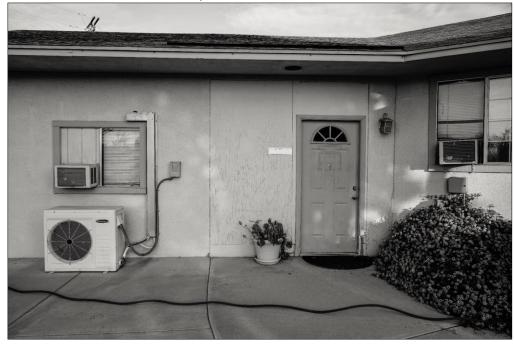
Photo 6: Low-cost Incompatible Infilling of Prior Aperture Between Main House (R) and Garage (L). View North. DSC7120

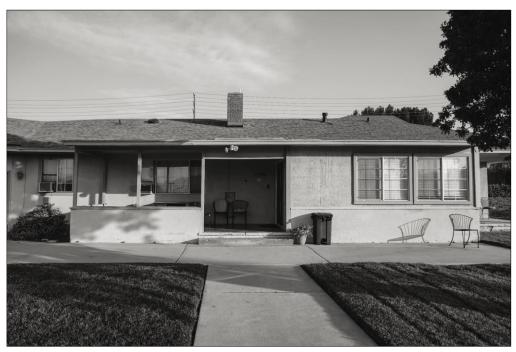
Photo 7: Partially Enclosed Patio Porch with Modified Entryway. View North. DSC7123

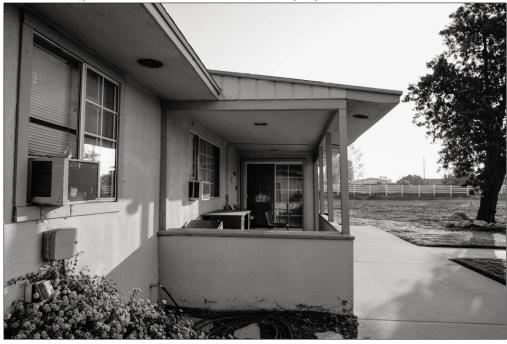
Photo 8: Rear Patio Porch with Original Finishes. Note Vertical Drop-Lap Siding below Shed Roof, and Original Framing. Note Replacement Vinyl Windows and Doors and 1"x4" Casement. Note Round Soffit Vents. View East. DSC7121

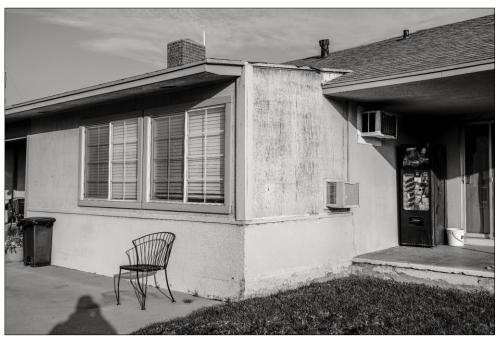
Photo 9: Enclosed Patio Porch. Note Loss of Fabric, Feeling, and Condition Noted in Photo 9. Note use of 2"x4" Studs, instead of Appropriate 1"x4" Common Board for Casing View Northwest. DSC7130

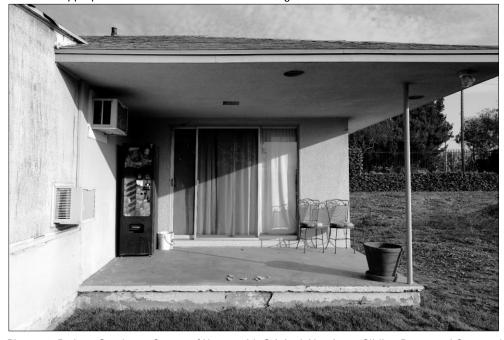
Photo 10: Patio at Southeast Corner of House with Original Aluminum Sliding Doors and Casework. Note Rough-Sawn No Bead Plywood Siding Enclosing Patio Porch and Loss of Fabric Noted in Photo 9. View North. DSC7142

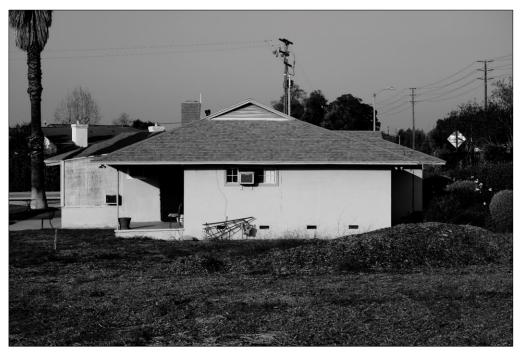
Photo 11: East Elevation. Note Enclosure of Patio Porch no longer Mimics Feeling of Southeast Patio. View West. DSC7138

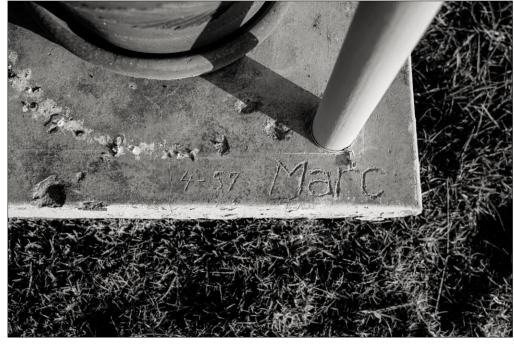
Photo 12: Date Stamp in Slab of Southeast Patio. DSC7132

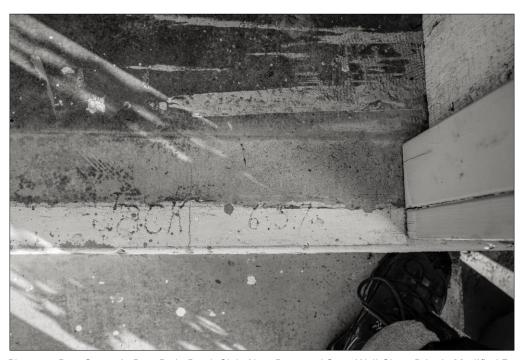
Photo 13: Date Stamp in Rear Patio Porch Slab. Note Removed Stem Wall Ghost Print in Modified Entryway. DSC7125

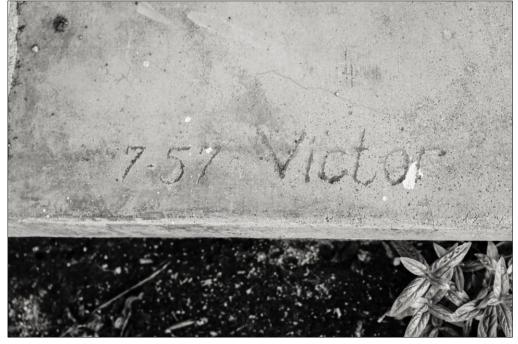
Photo 14: Date Stamp in Front Porch Slab. DSC7104

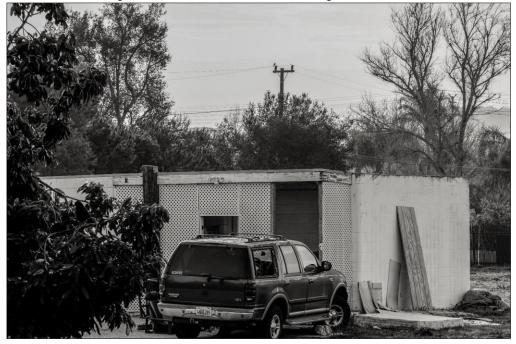
Photo 2: 3/4 View Noting Wood Lattice Enclosure of Office Porch and Entrance View Southeast. DSC7169

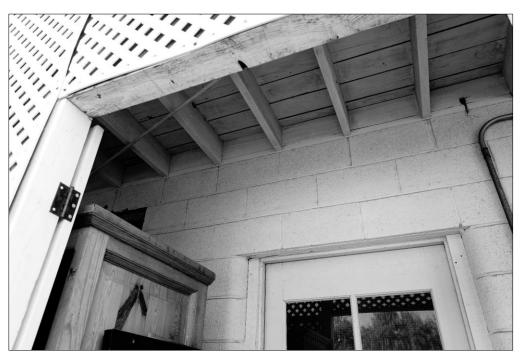
Photo 7: Detail View of Office Entrance. Note Rafters and Board Sheathing. DSC7196

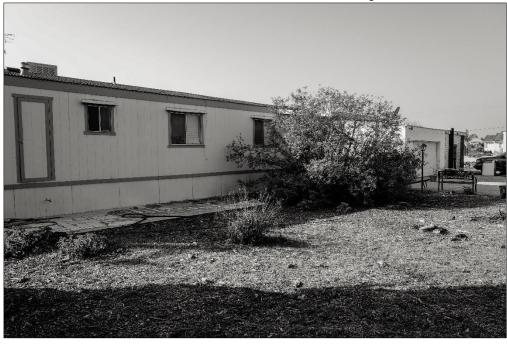
Photo 8: Oblique View of Mobile Home on Original Concrete Slab, and Garage, Illustrating Relative Setting. View West-Southwest. DSC7200
