Tree Report

Tree Inventory
Panorama Mall
8401 Van Nuys Blvd.
Panorama City, CA 91402

TREE INVENTORY INDEX
Panorama Mall

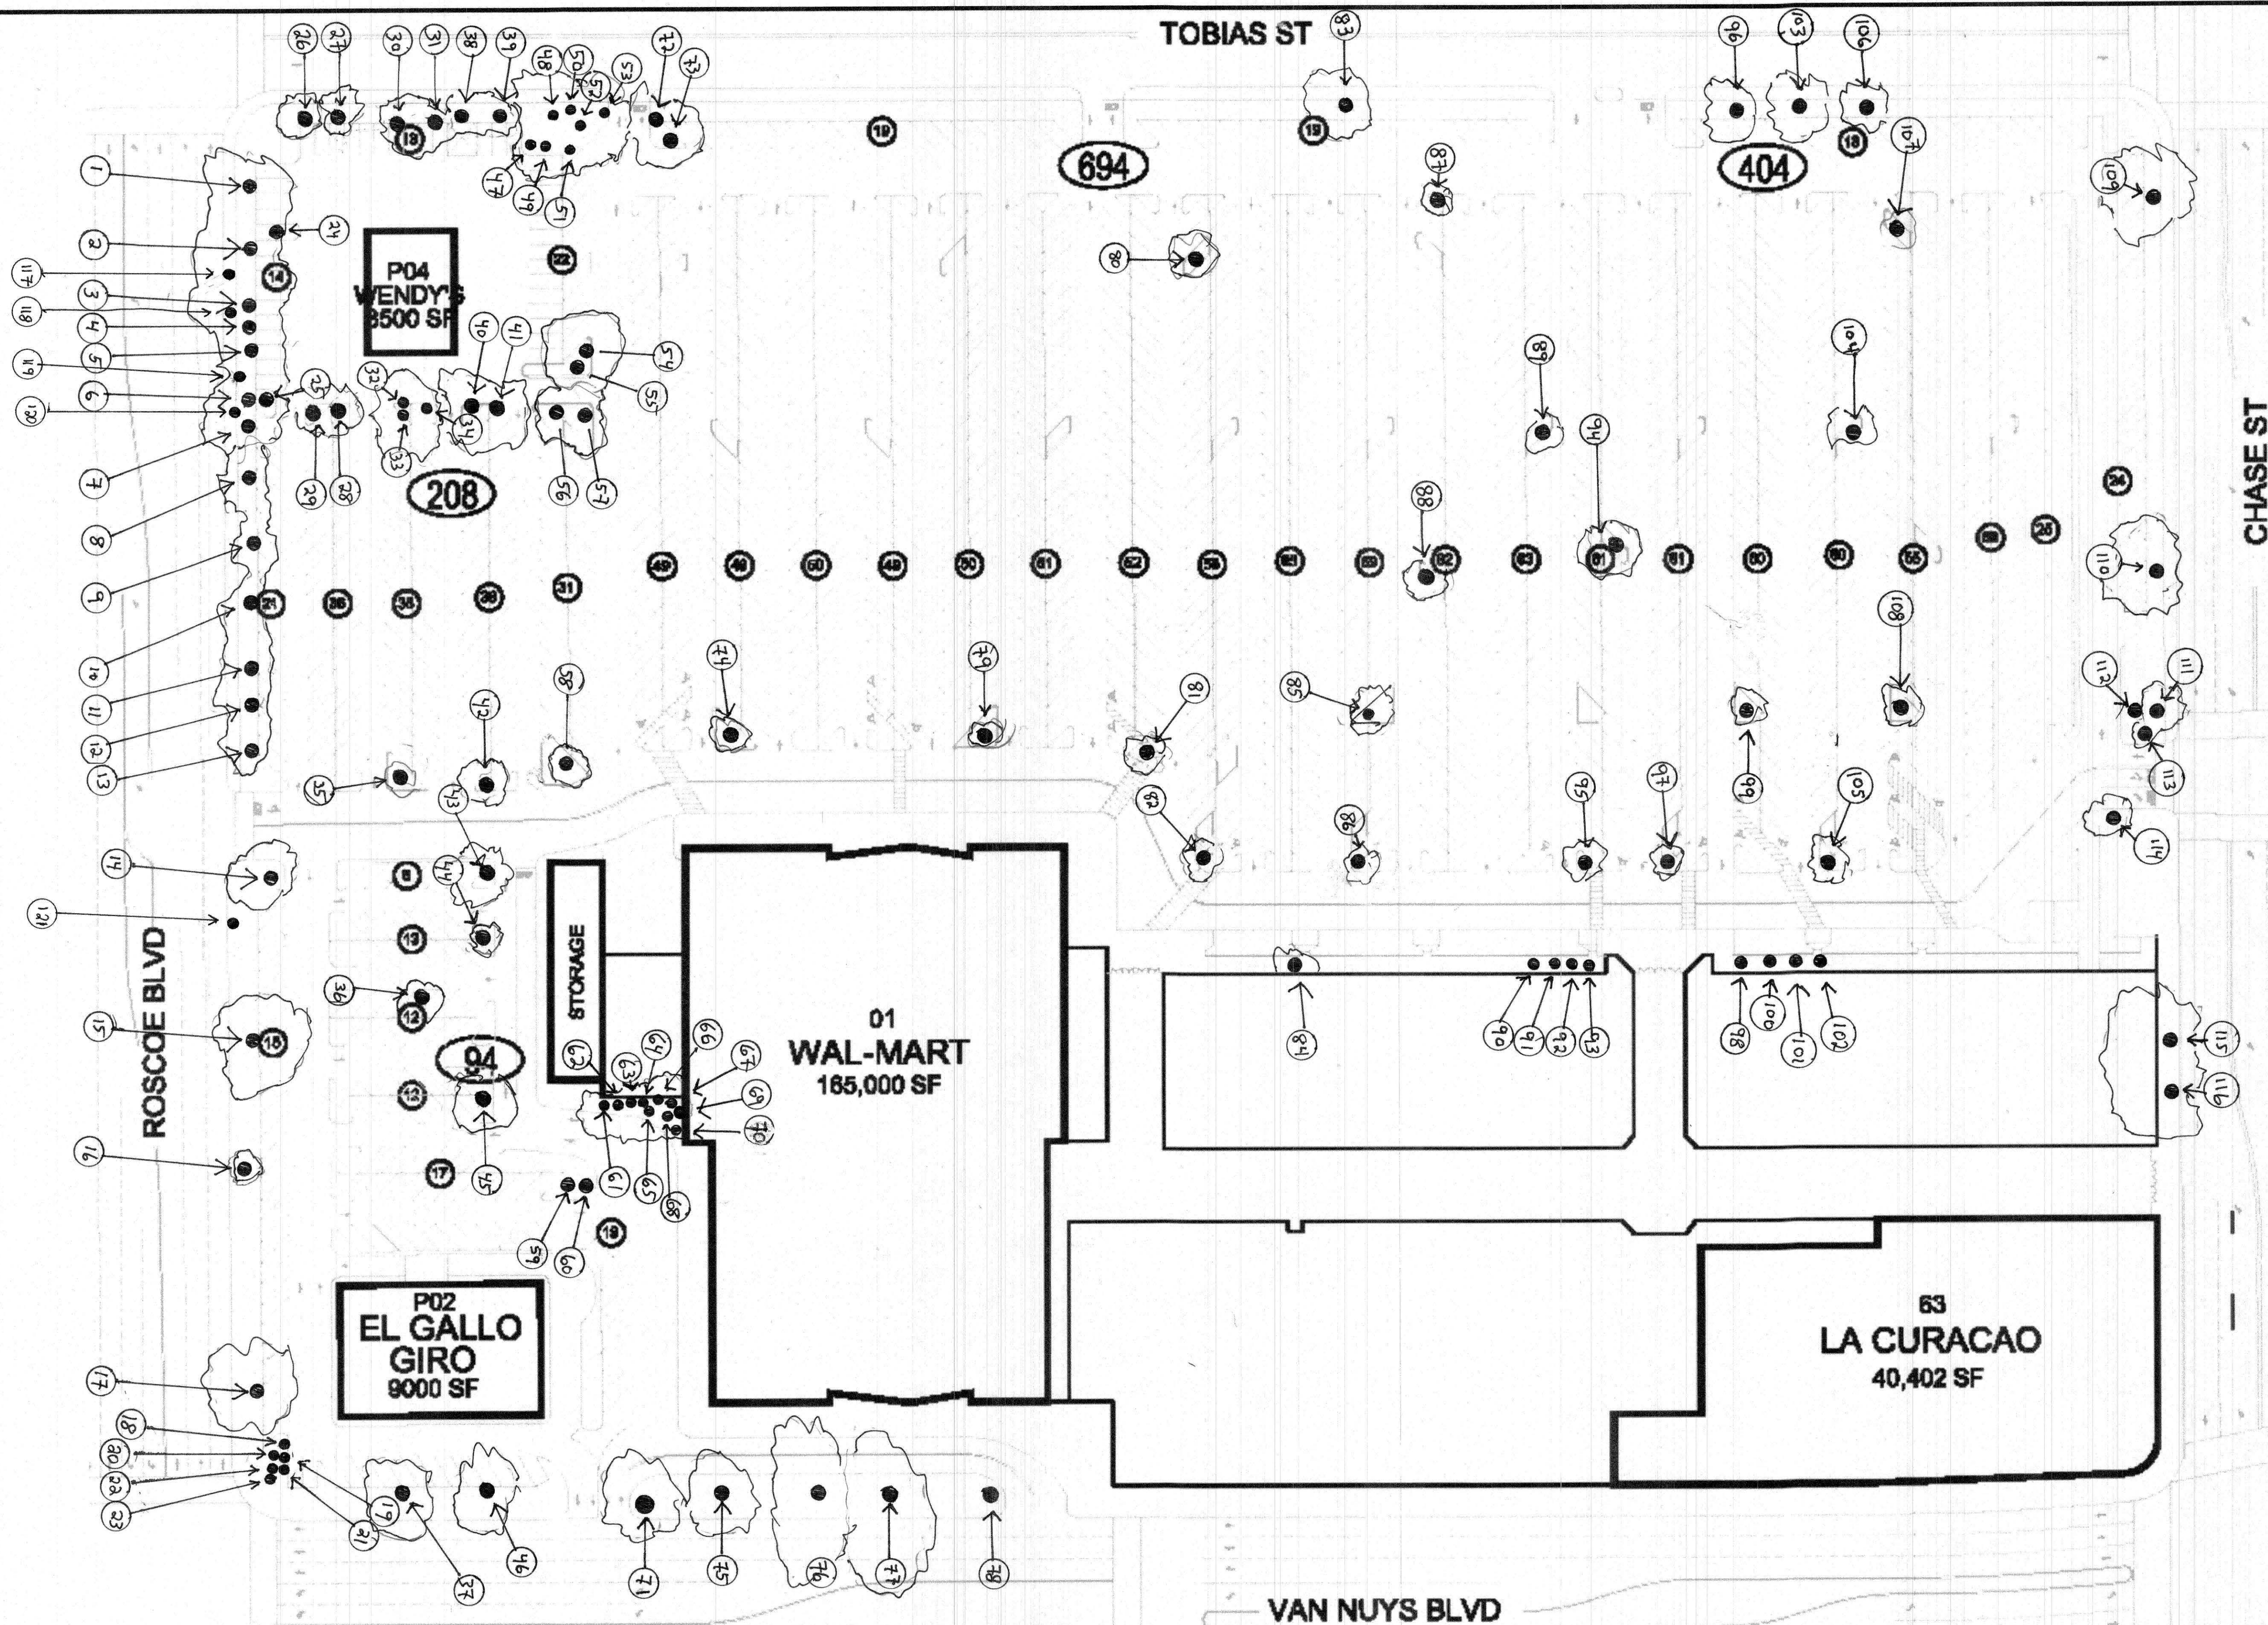
TREE SITE MAP

This inventory consists of 3 components – the text report you are now reading, the Index of Trees where each tree is describes as detailed above and a modified Site Plan showing the location of each of the 116 numbered trees with an approximation of their existing canopy.
