4057 N HAYVENHURST AVENUE, ENCINO

Protected Tree Report

Permits #21010-30000-02481, 21010-30000-02484, and 21010-30000-03246

September 2021

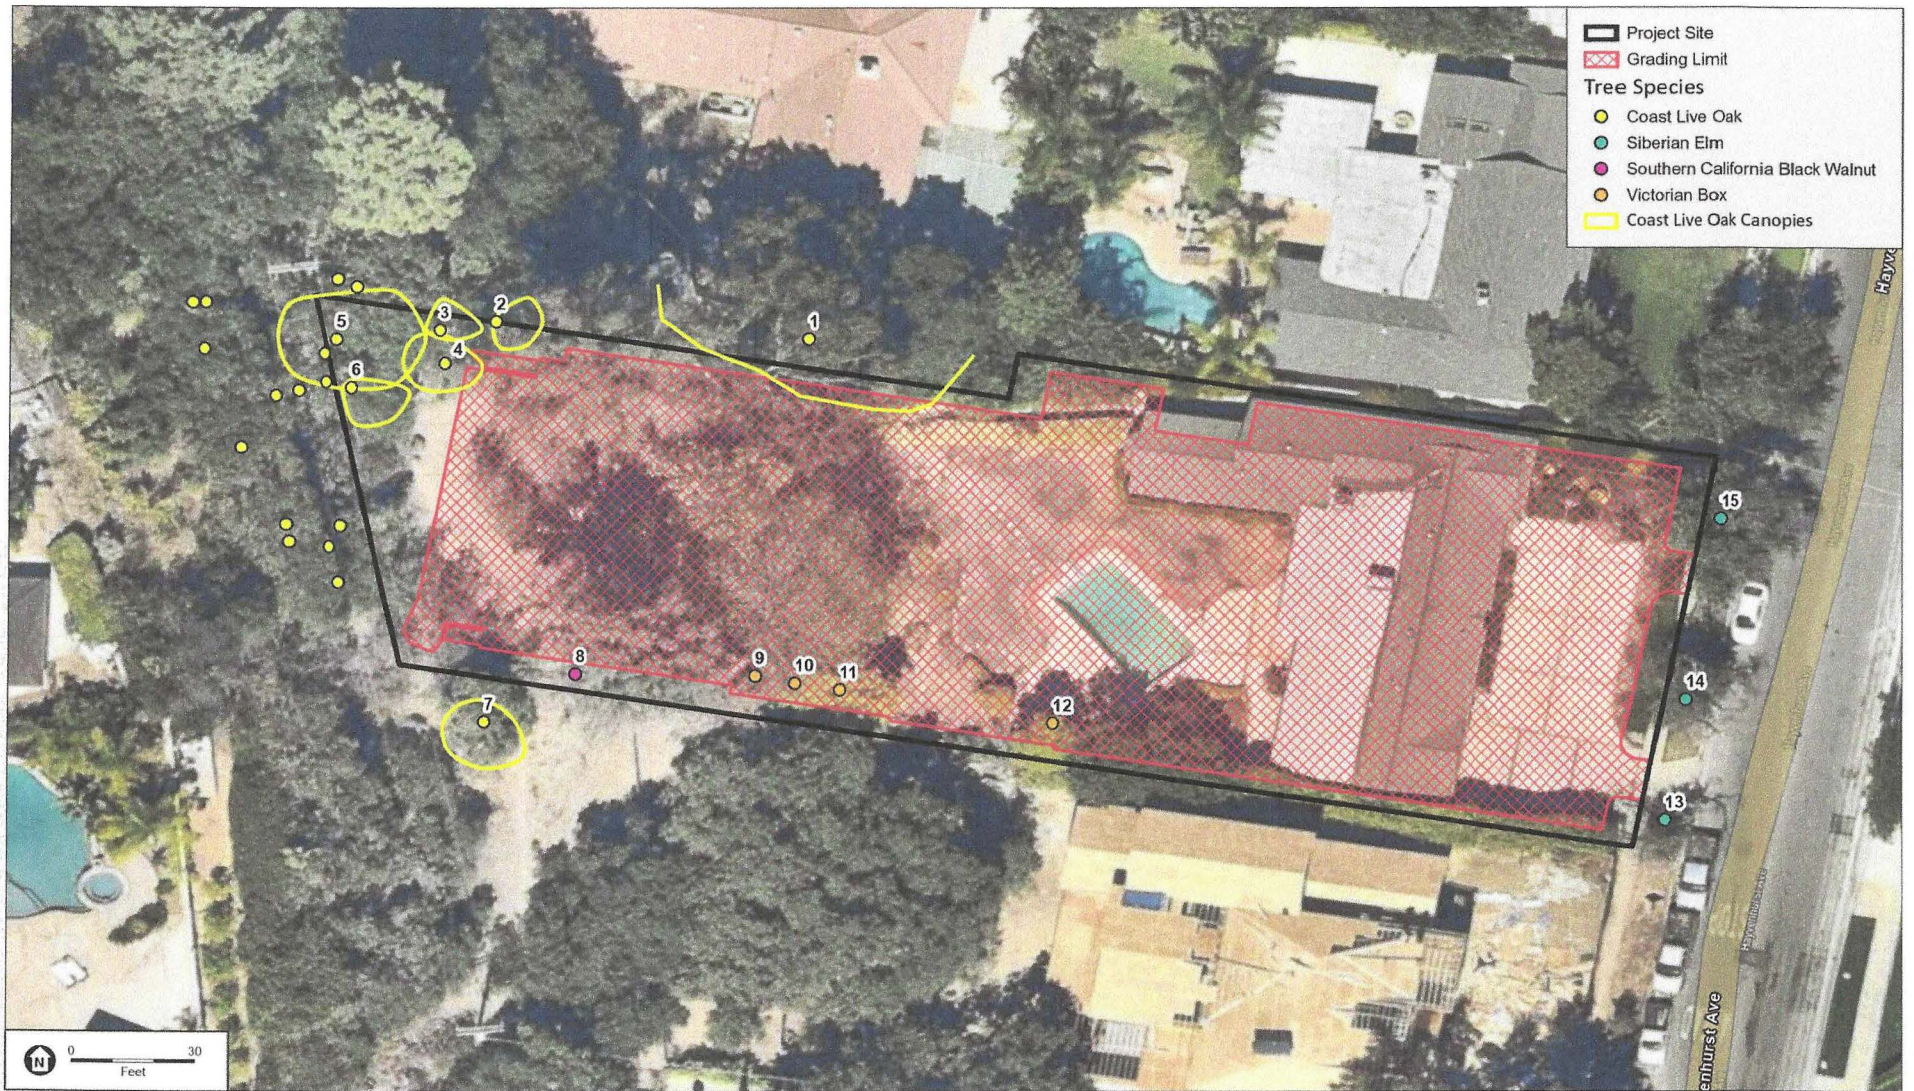
Figure 4
 Tree Plot Plan

No protected tree species will be removed as a result of the project design. One off-site coast live oak (Figure 4 – Tree #1) on the adjacent property to the north will be encroached upon as a result of the installation of retaining wall #2 along the northwest boundary of the property. The tree is located behind a fence on a neighboring property and the DBH was estimated at 30 inches. A small retaining wall installed by the neighbor has likely severed the tree's northern anchoring roots (See Attachment A, *Site Photographs 8, 9, & 10*). The tree's southern anchoring roots would remain within areas proposed for a lawn and a rose garden. Installation of a proposed retaining wall is proposed in the protected zone of this oak, however a large landscape area south of this wall will be retained beyond the southern extent of the dripline radius to provide ample root space. Retaining wall #2 is anticipated to encroach approximately 3% of the protected zone. Excavation with hand tools (or air excavation tools) within the root zone, monitoring by an arborist during construction, and follow up visits are recommended to reduce risks to this tree during construction. A second coast live oak (Figure 4 – Tree 4; See Attachment A, *Site Photographs 13*) will be encroached as a result of the installation of a small planter within the property. An encroachment of less than 5% is anticipated with the construction of a small planter in the northwest corner of the site.

As depicted in Figure 4 - Tree Plot Plan, no protected trees will be removed as a result of proposed project design or associated construction activities. Two coast live oak trees, one onsite and one offsite, will have their protection zone encroached upon as a result of proposed project activities. No other native (non-oak) trees will be impacted as a result of the proposed project. Avoiding any disturbance to the protected zone of all oak trees is recommended, including

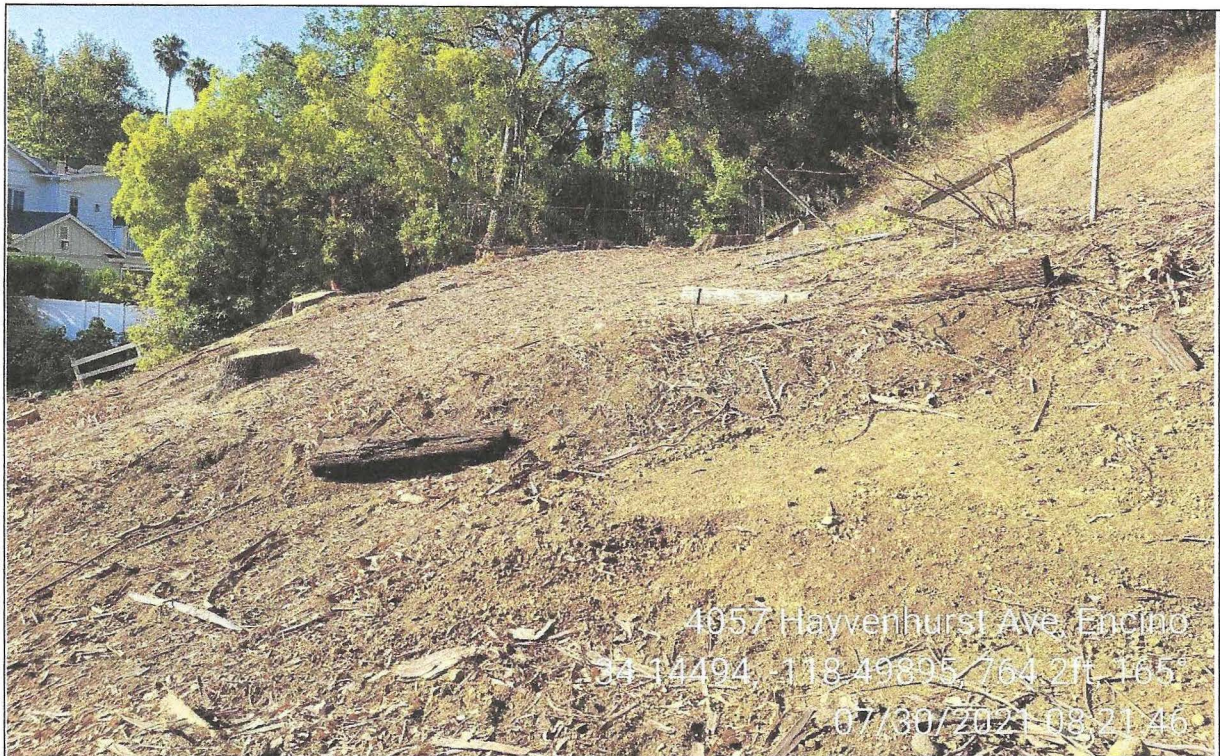
Prior to the site visit, multiple large gum trees (*Eucalyptus* spp.) were removed during site demolition activities. Stumps of those trees were still visible during the site visit (See Attachment A, *Site Photographs 3 and 4*). No trunks of native species were observed to have been removed. Seven additional non-native trees were also observed on the property. Four (4) Victorian box trees (*Pittosporum undulatum*) were observed along the southern boundary. Three (3) Siberian Elm (*Ulmus pumila*) were also observed as street trees along Hayvenhurst Avenue.

Photo 3: View of rear slope and removed gum trees. View from northern property boundary, facing south towards southern boundary.

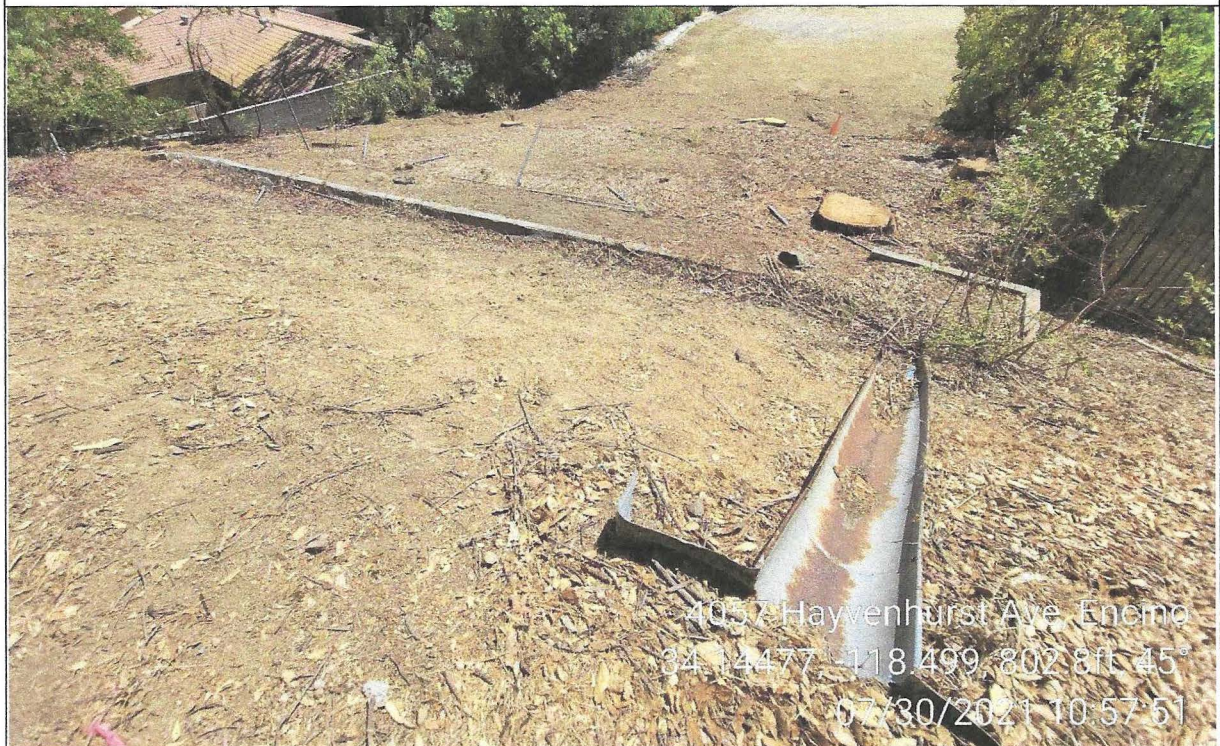
Photo 4: View from southwest corner of property, facing northeast. Photo depicts metal drain and removed gum trees. Southern California black walnut is visible in the right of the photo.

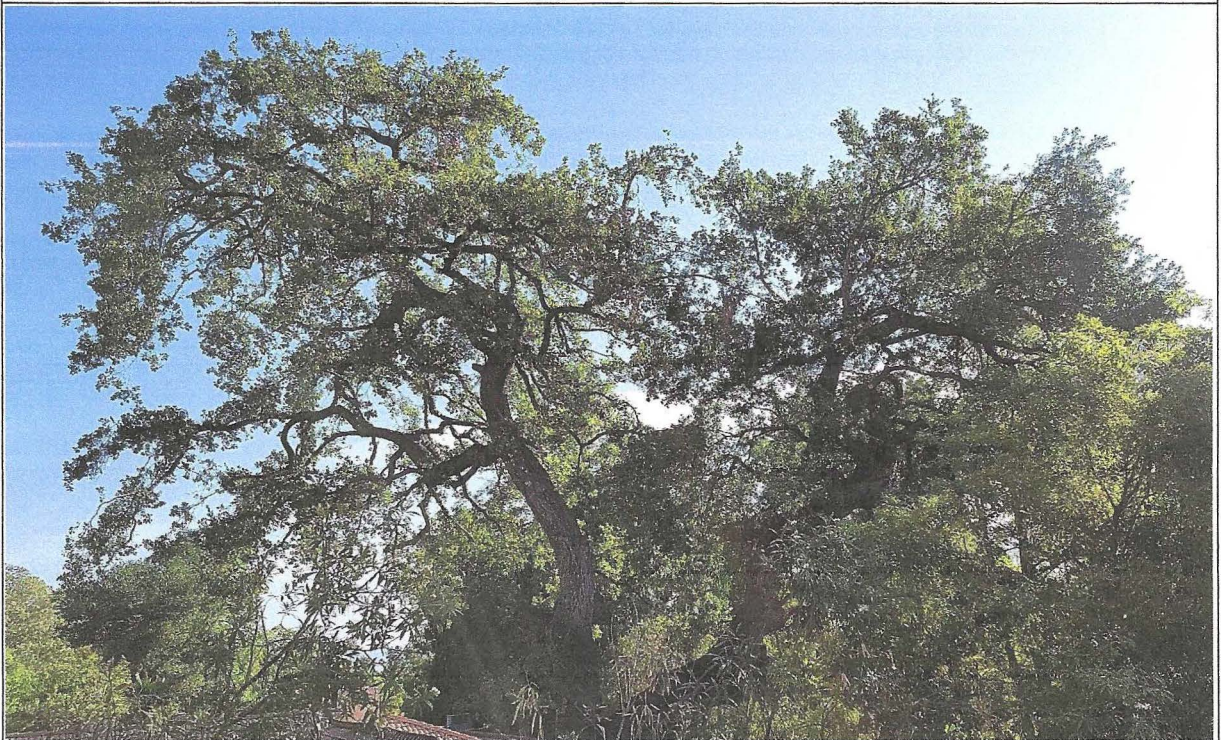
Photo 8: View of Tree #1 – coast live oak, facing north. Photo depicts thinned canopy.

Tree #	Species	DBH (inches)	Height (ft.)	Canopy Measurements (compass direction in feet)								Health	Vigor	Aesthetics	Balance	Protected?	Comments
				N	NW	W	SW	S	SE	E	NE						
1	Coast Live Oak <i>Quercus agrifolia</i>	~30 ¹	40	25	22	18	7	4	8	25	27	B	B	B	B	Yes	Evidence of property line pruning and overall crown reduction. Located on neighboring property. Minor dieback in crown. Northern roots cut for small retaining wall.
2	Coast Live Oak <i>Quercus agrifolia</i>	5.0	14	2	1	1	1	7	9	10	10	A	A	B	B	No	Tree offsite originating from northern neighbor's property, growing through fence. Tree is below 8 inch DBH threshold for protected trees but is recorded for possible mitigation purposes.
3	Coast Live Oak <i>Quercus agrifolia</i>	8.4	19	9	3	4	2	2	4	10	7	B	B	C	B	Yes	Concrete v-ditch compressing root. Possible scale and lichen on underside of branch. Two-horned galls on leaves.
4	Coast Live Oak <i>Quercus agrifolia</i>	8.9	20	8	10	9	9	7	8	9	5	A	A	B	B	Yes	Tree has natural lean but has self-corrected upright. Some exposed roots.

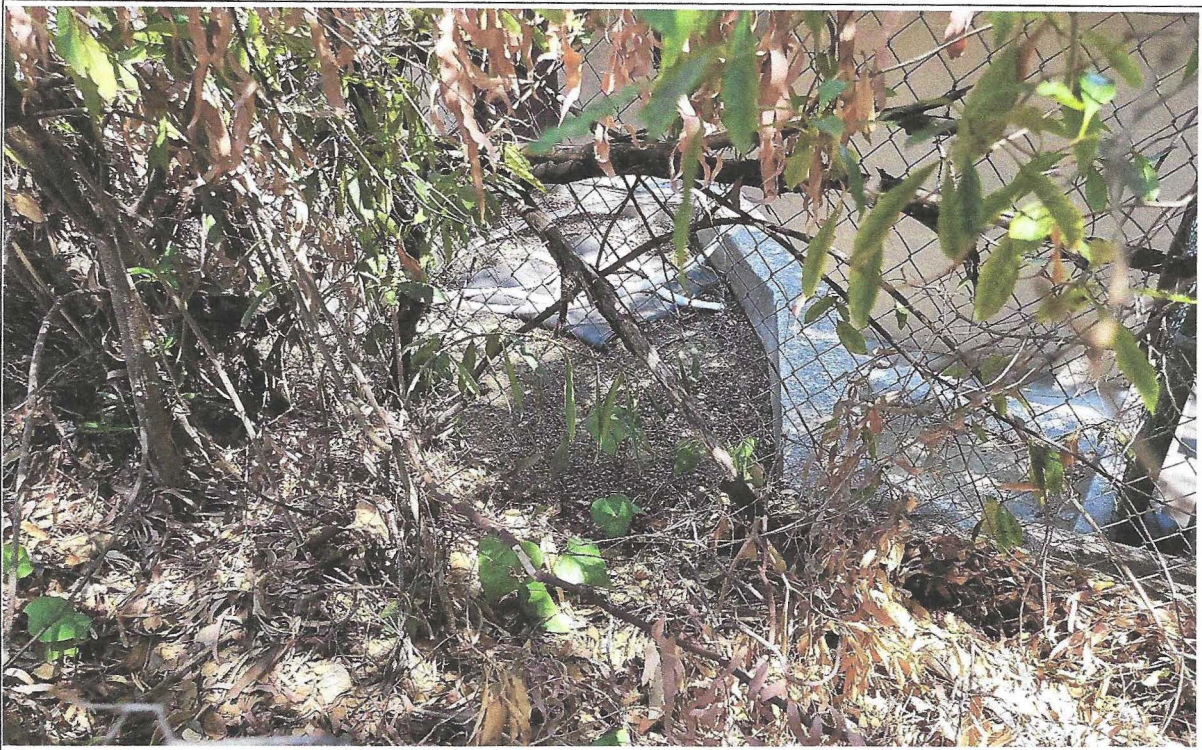
Prior to the site visit, demolition of the previous house occurred on the property and site clearing of old gum trees and vegetation occurred. It was not clear during the site visit whether grade changes or compaction within the root zone of either protected oak tree had occurred. It is assumed that Tree #1 has had multiple grade changes during the demolition phase prior to the site visit. Compaction within this area is also likely.

Photo 9: View of small retaining wall at base of tree #1 – coast live oak, facing north. Photo depicts chain link fence between properties, base of trunk and retaining wall. Tree is located on northern neighbor's property and could not be accessed at time of the survey.

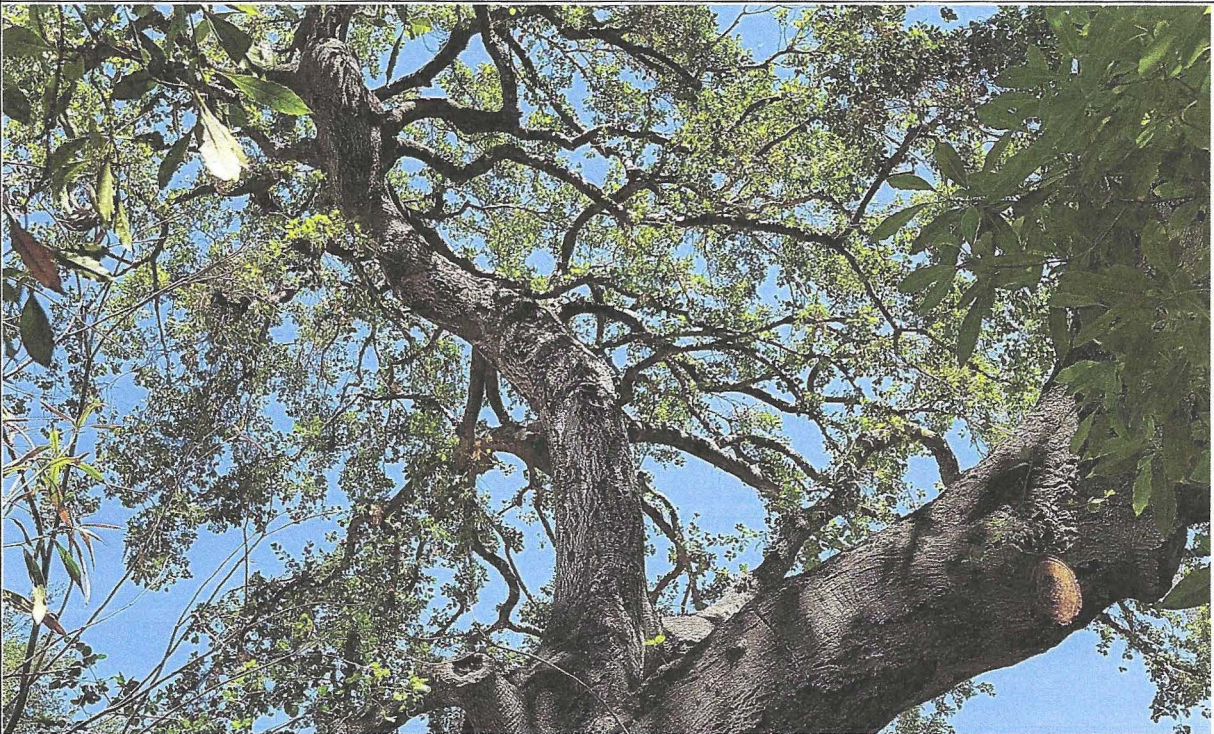
Photo 10: View of thinned canopy of tree #1 – coast live oak, facing south. Removed limbs are visible in the bottom of the photo.

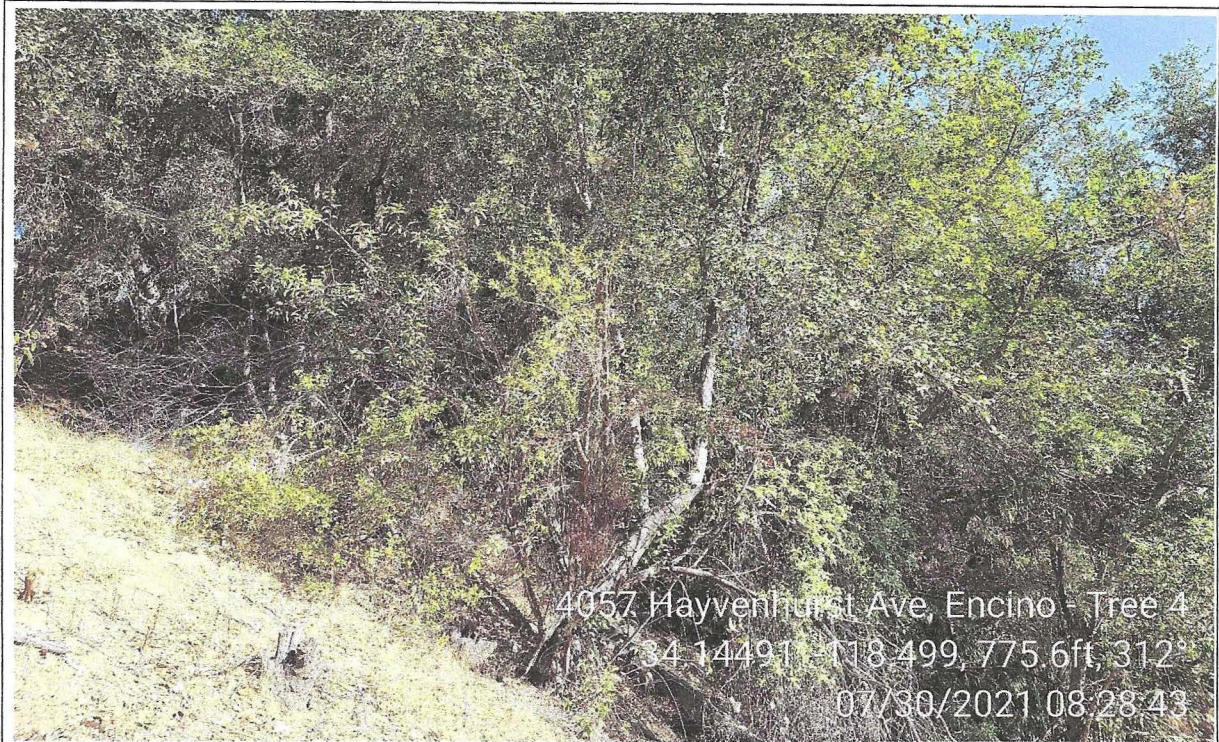
Photo 13: View of tree #4 – coast live oak, facing northwest. Photo depicts self-corrected lean of tree.

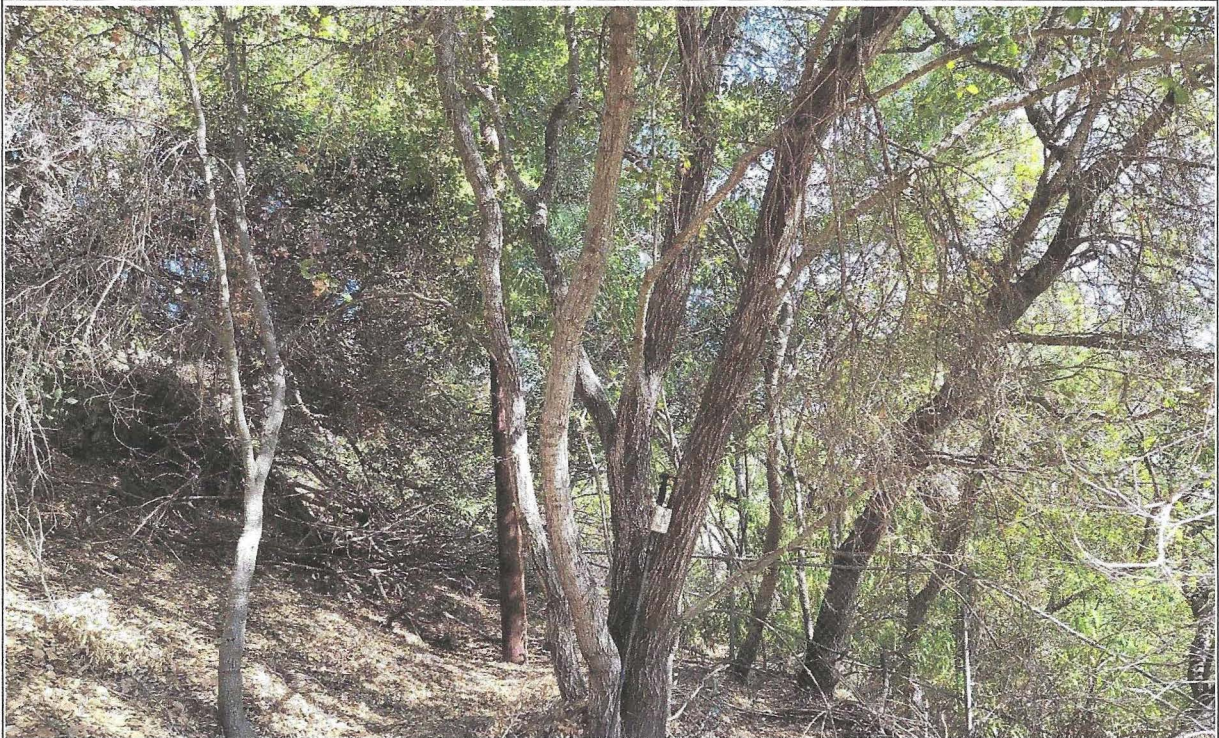
Photo 14: View of tree #5 – coast live oak, facing northwest. Photo depicts multiple trunks of tree. Utility pole is visible in the background.

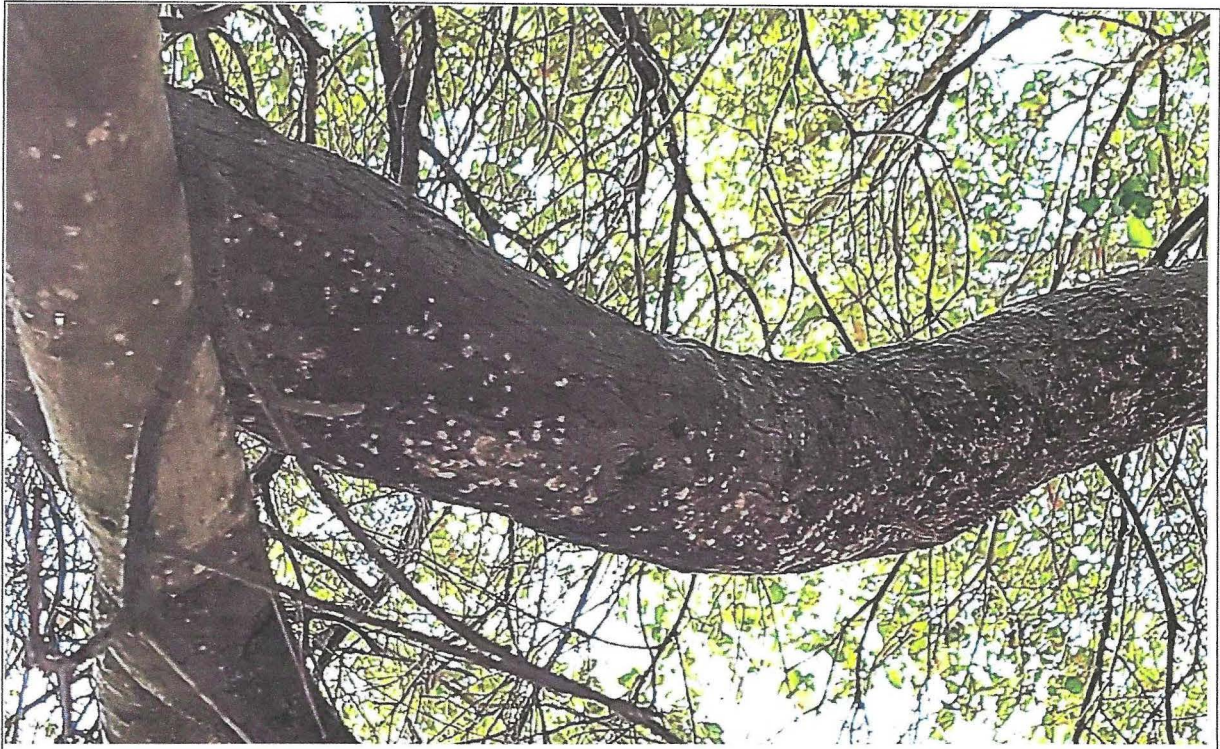
Photo 15: View of tree #5 – coast live oak, facing east. Photo depicts white staining/exudate on underside of trunk.

5	Coast Live Oak <i>Quercus agrifolia</i>	10.5, 8.3, 5.7, 5.7	21	11	14	12	13	12	17	19	18	B	B	B	A	Yes	Multi-trunk, minor dieback in southern trunk. Tree abuts electrical utility line. Large amount of light white staining along underside of trunk. Two-horned galls on leaves.
6	Coast Live Oak <i>Quercus agrifolia</i>	9.1	19	3	2	3	2	10	12	13	3	B	B	B	C	Yes	Minor dieback of lower branches, fissures in trunk, evidence of bark beetle on dead branches. Two-horned galls on leaves.
7	Coast Live Oak <i>Quercus agrifolia</i>	~13 ¹	24	6	7	9	11	12	13	7	5	A	A	B	B	Yes	Evidence of tree climbing spurs used on tree to perform utility line clearance. Minor dieback in crown.
8	Southern California Black Walnut <i>Juglans californica</i>	1	7	2	3	3	2	2	2	3	2	D	D	D	C	No	Basal resprout from long removed walnut tree south of metal McGillivray drain. Basal resprouts spindly and show dieback.
9	Victorian Box <i>Pittosporum undulatum</i>	7	13	5	5	5	5	5	5	5	5	B	A	C	C	No	Heavily topped, former hedge.

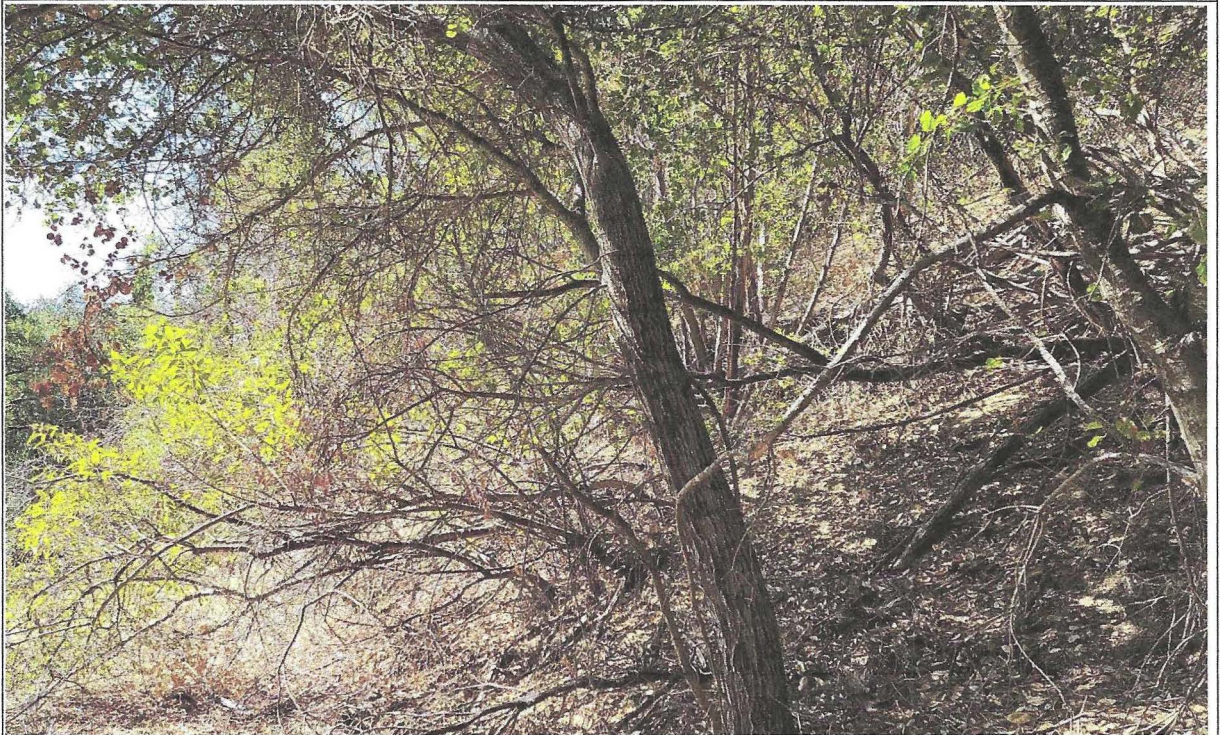
Photo 16: View of tree #6 – coast live oak, facing south. Photo depicts lower branch dieback.

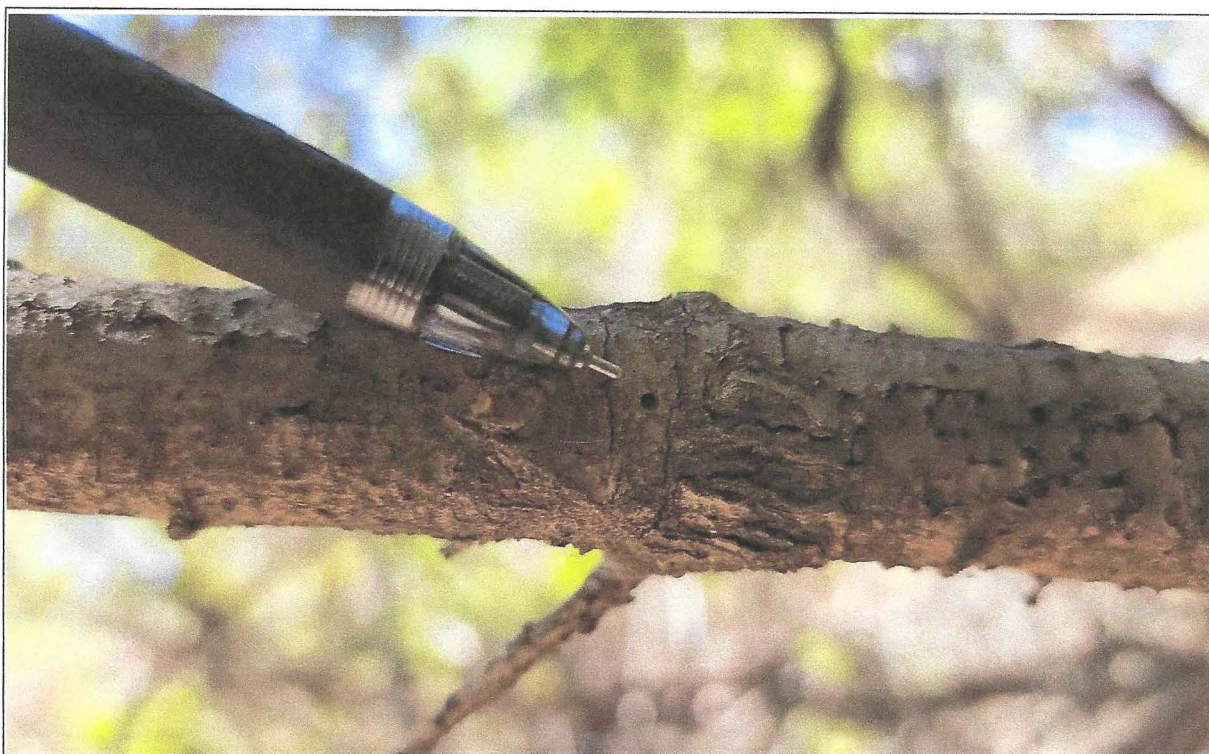
Photo 17: View of tree #6 – coast live oak, facing east. Photo depicts exit hole of unknown species of bark beetle.

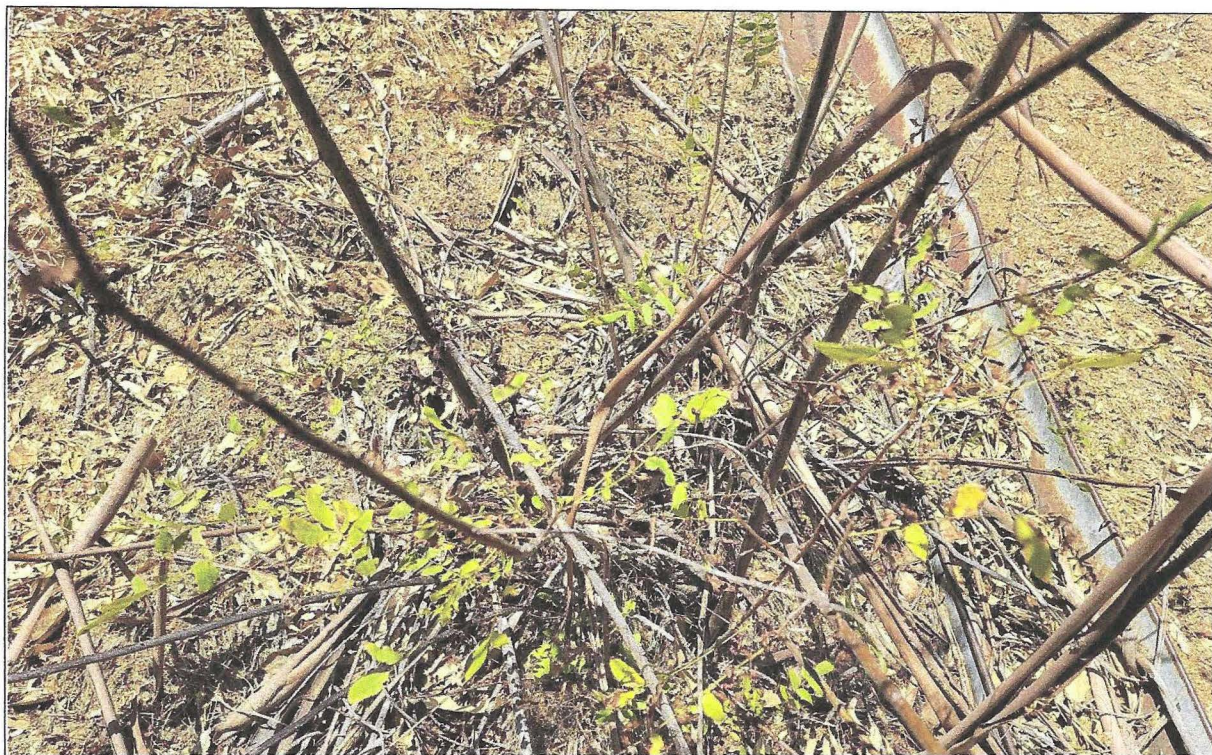
Photo 19: View of tree #8 – southern California black walnut, facing south. Photo depicts basal resprouts and sparse foliage at base.

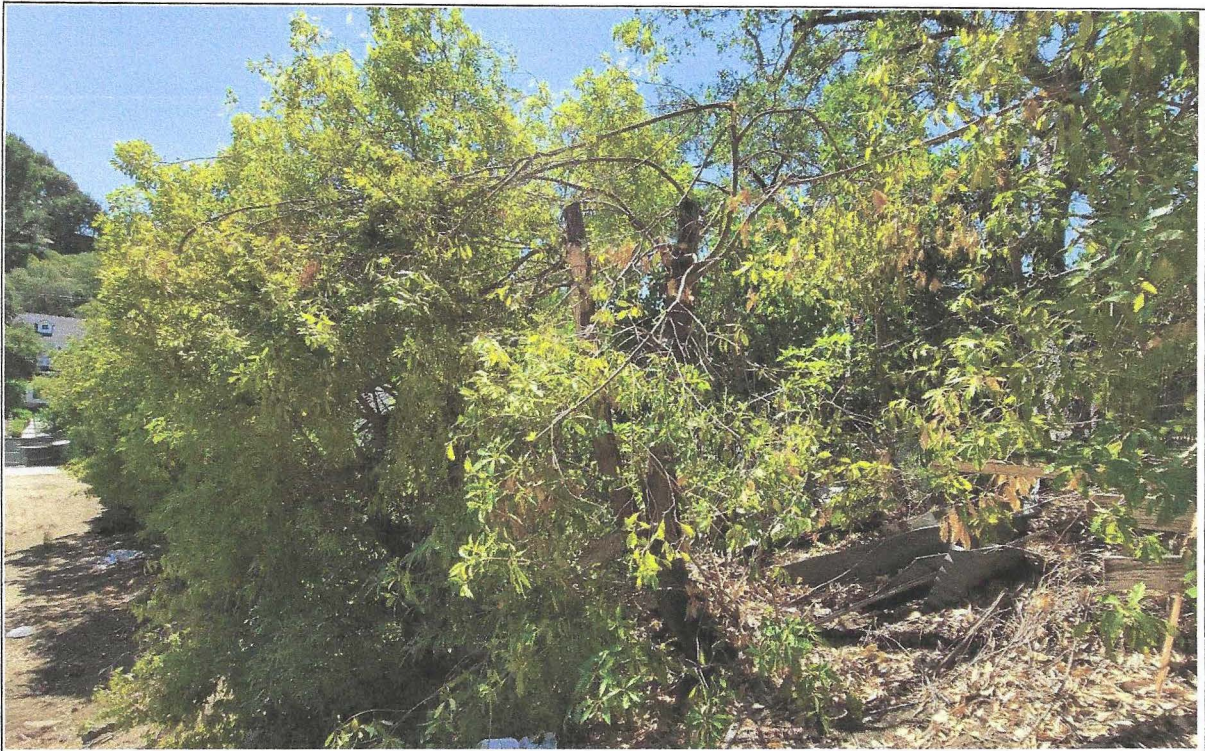
Photo 21: View of tree #10 – Victorian box, facing southeast. Photo depicts a heavily topped and nearly dead tree.

Tree #	Species	DBH (inches)	Height (ft.)	Canopy Measurements (compass direction in feet)								Health	Vigor	Aesthetics	Balance	Protected?	Comments
				N	NW	W	SW	S	SE	E	NE						
10	Victorian Box <i>Pittosporum undulatum</i>	10, 6	8	3	4	3	3	4	4	4	4	D	D	D	D	No	Heavily topped, tree nearly dead, fissure in trunk.
11	Victorian Box <i>Pittosporum undulatum</i>	12, 11	16	6	6	7	8	10	9	5	6	B	A	C	B	No	Fissures in trunk, some dieback in crown, vigorous regrowth.
12	Victorian Box <i>Pittosporum undulatum</i>	10	20	7	7	7	7	7	7	7	7	B	C	C	C	No	Ivy covering trunk, heavily topped and pruned for hedging purposes.
13	Siberian Elm <i>Ulmus pumila</i>	23.5	17	9	10	10	7	8	7	8	7	D	D	D	D	No	Pavement over roots, root girdling, Tree topped and in severe drought stress. Roots upheaving sidewalk. Roots with exfoliating bark, epicormic shooting.
14	Siberian Elm <i>Ulmus pumila</i>	20.7	35	6	6	7	7	3	4	2	4	D	D	D	D	No	Tree has significant crown dieback with exfoliating bark and epicormic shooting. Drought stress likely. Pavement heaving over exposed roots.

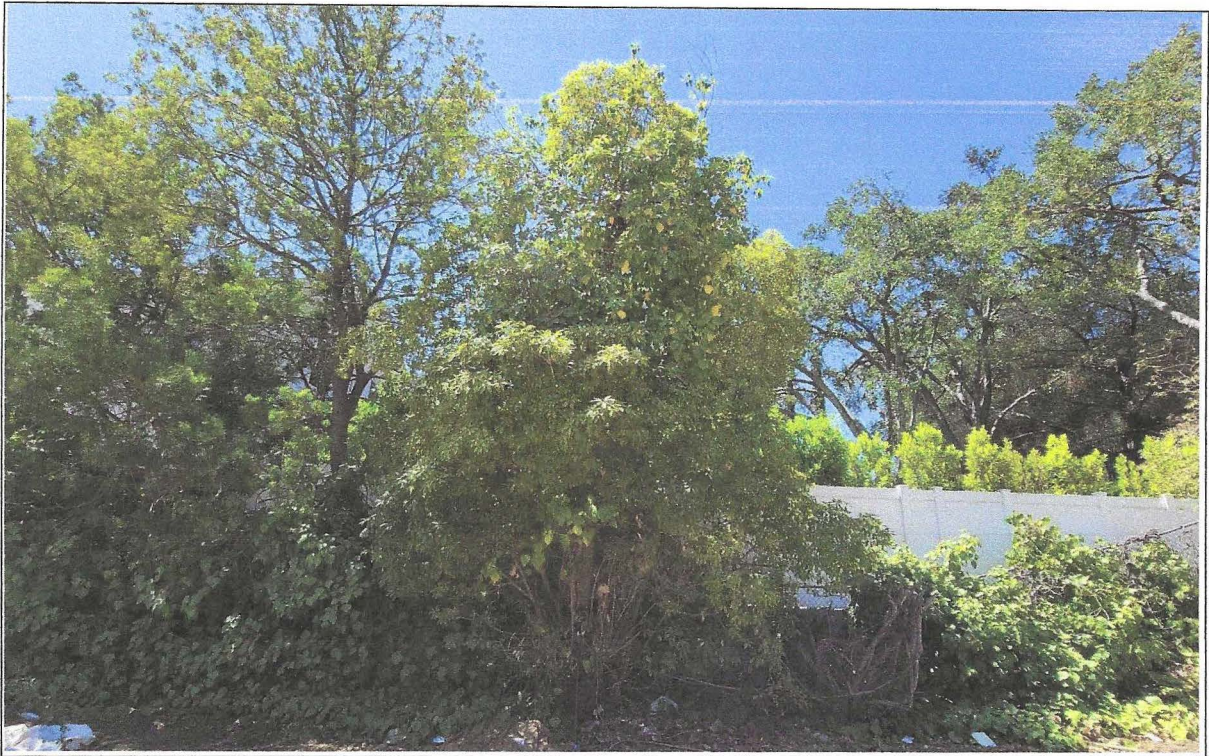
Photo 23: View of tree #12 – Victorian box, facing south. Photo depicts ivy growing within canopy.

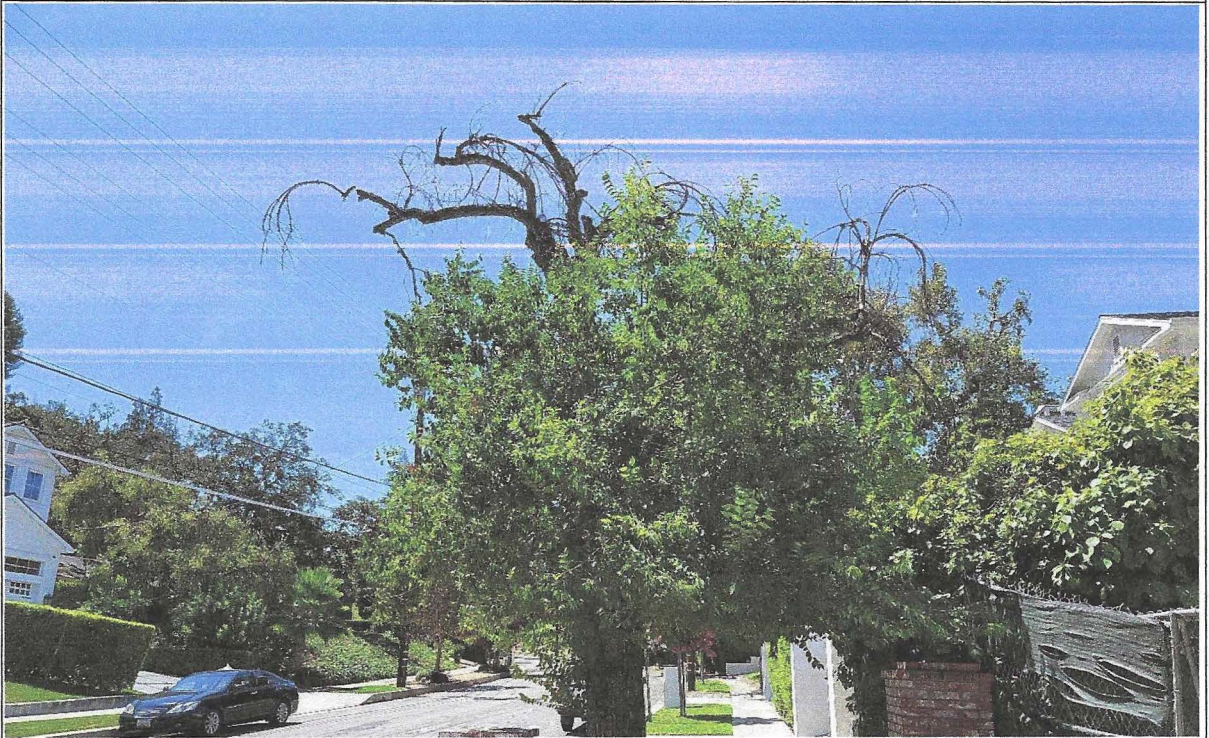
Photo 24: View of tree #13 – Siberian elm, facing south. Photo depicts crown dieback with epicormic shooting.

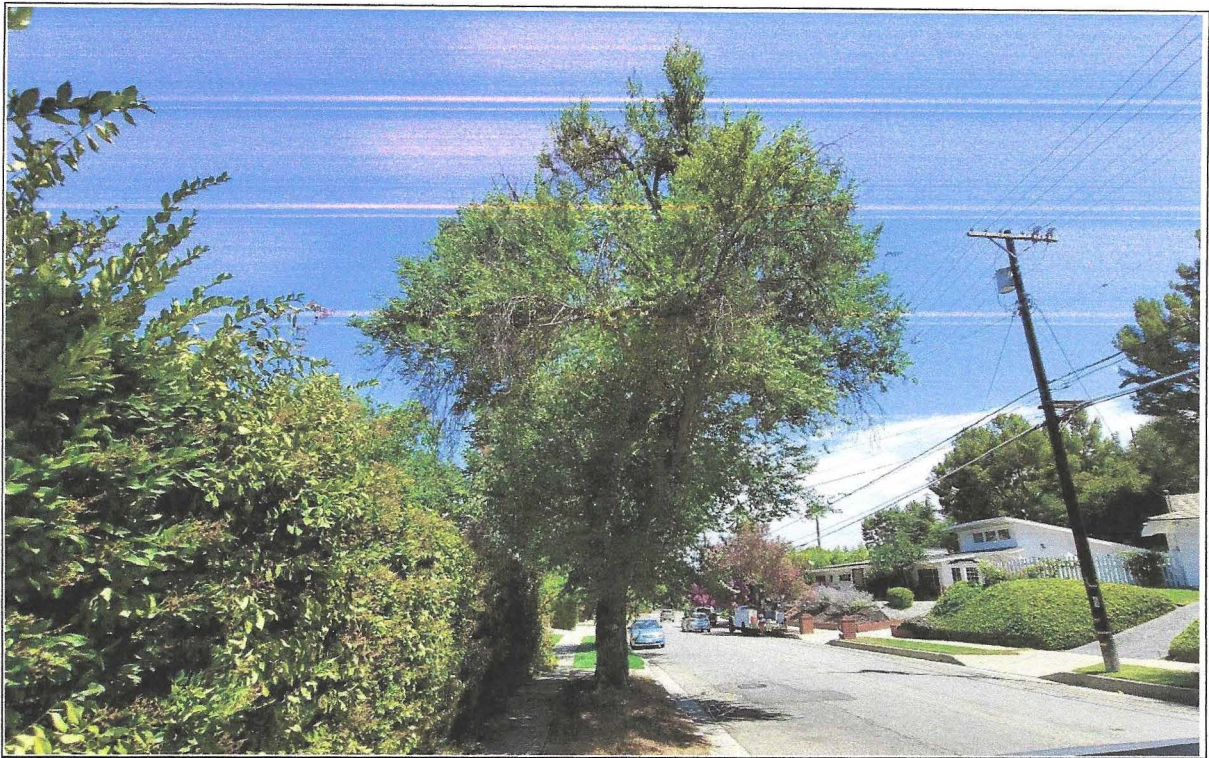
Photo 25: View of tree #14 – Siberian elm, facing south. Photo depicts crown dieback.

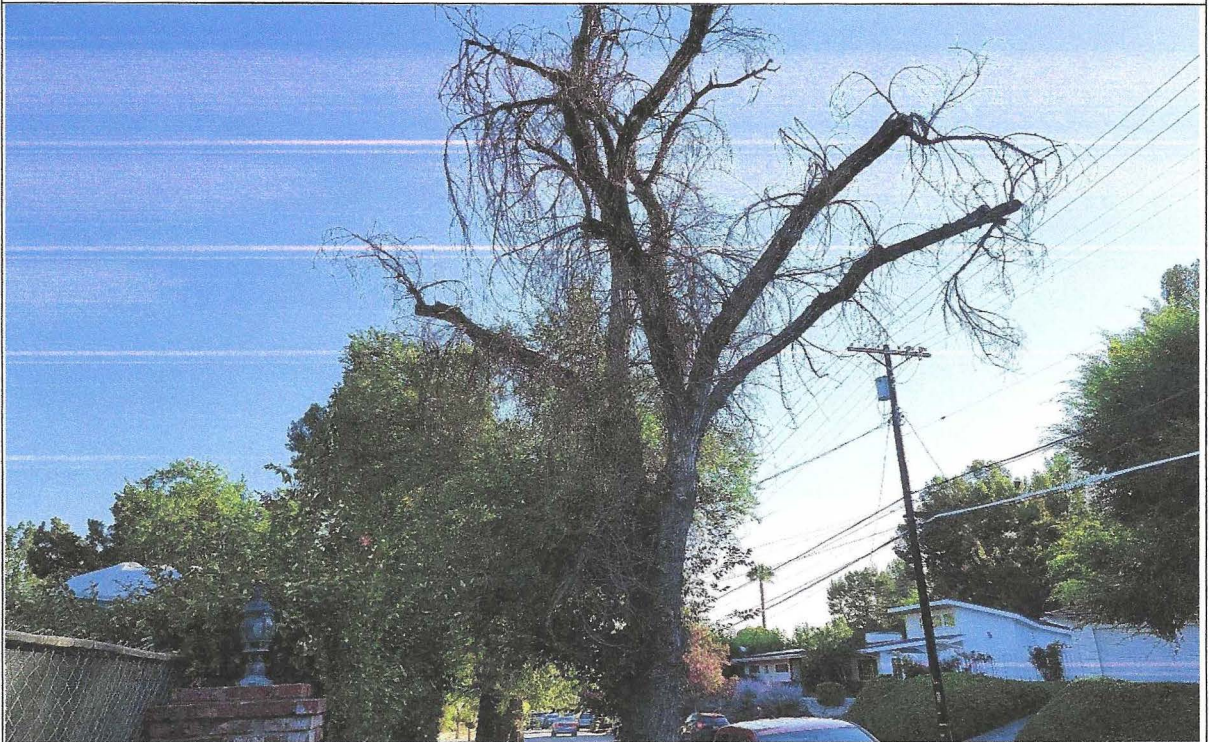
Photo 26: View of tree #15 – Siberian elm, facing south. Photo depicts topped and nearly dead tree, with epicormic shooting.

15	Siberian Elm <i>Ulmus pumila</i>	22.3	30	12	15	16	18	15	16	16	12	C	C	C	C	No	Roots girdled by sidewalk, upheaving pavement. Some dieback in crown and drought stress. Utility line pruning.
Health/Vigor/Aesthetic/Balance (see report for details) A = Very Healthy/Excellent B = Healthy/Good C = Average Health/Fair D = Dying/Poor F = Dead/Very Poor †: Tree is located off-property and trunk and canopy measurements had to be estimated.
