Tree Evaluation Report

For: Proposed Palmyra Cemetery Site

741 Palmyra Street, Orange

Prepared by: **Greg Applegate, RCA #365
Arborgate Consulting, Inc.
1131 Lucinda Way
Tustin, CA 92780
714/ 731-6240**

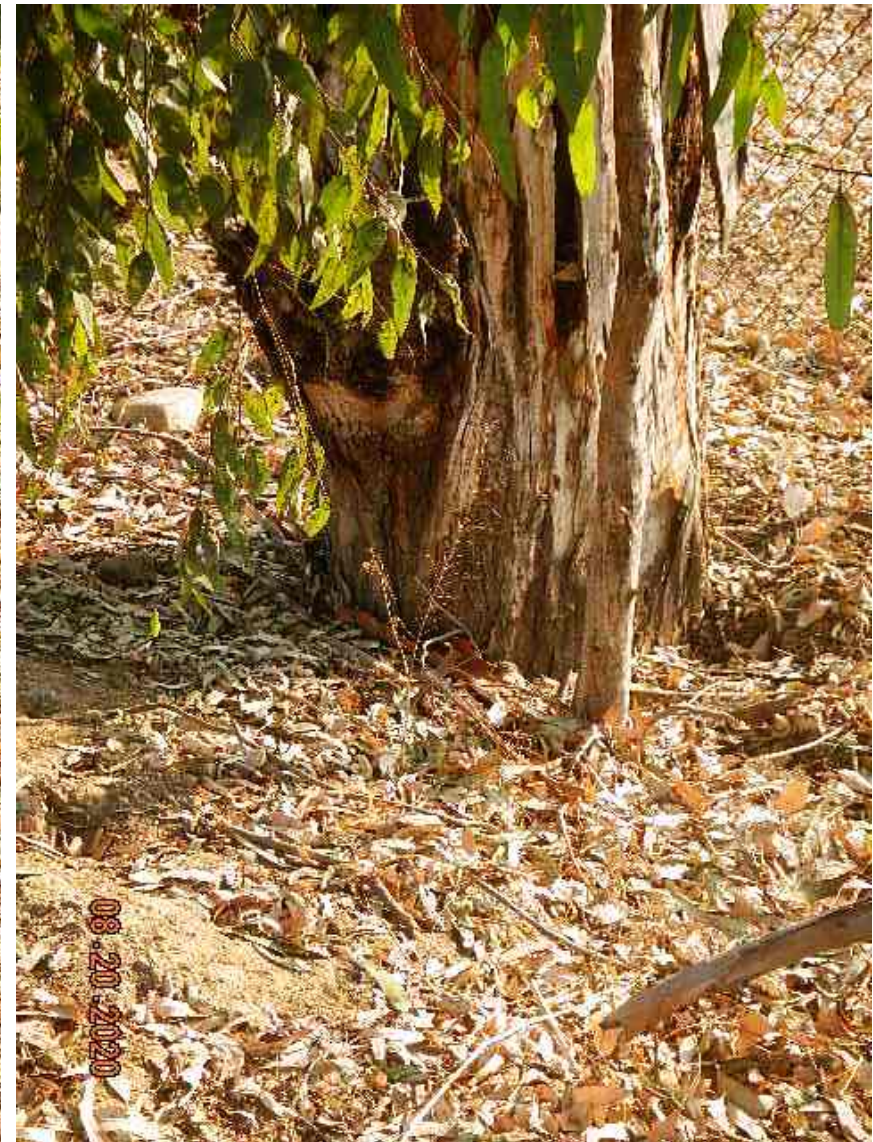
Note split and lack of normal root flare.

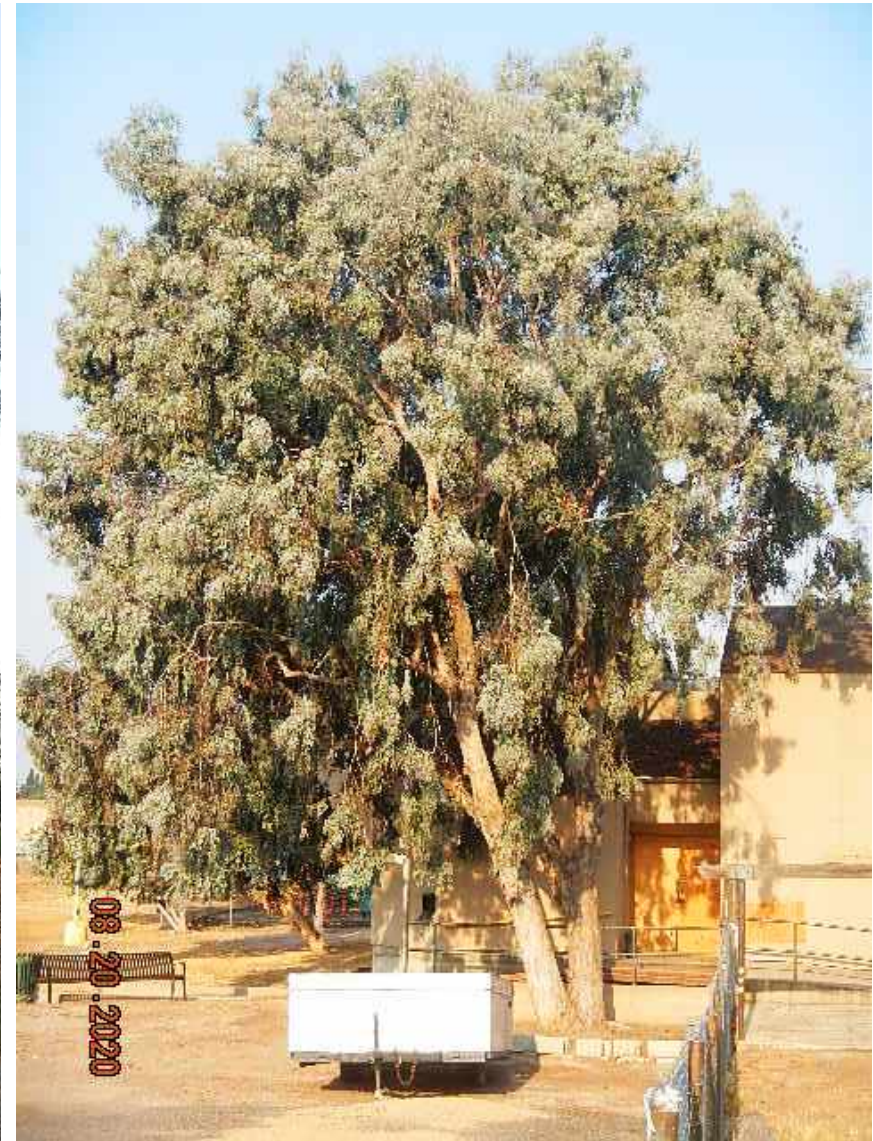
Silver Mt. gum #101

Two Silver Mountain gums are near each other by the recreation building. Both are near the building and may need to be removed if the building is removed. One is healthy and in fair structural condition, but the other is in very poor condition. The lerp psyllids and tortoise beetles have not bothered this species.

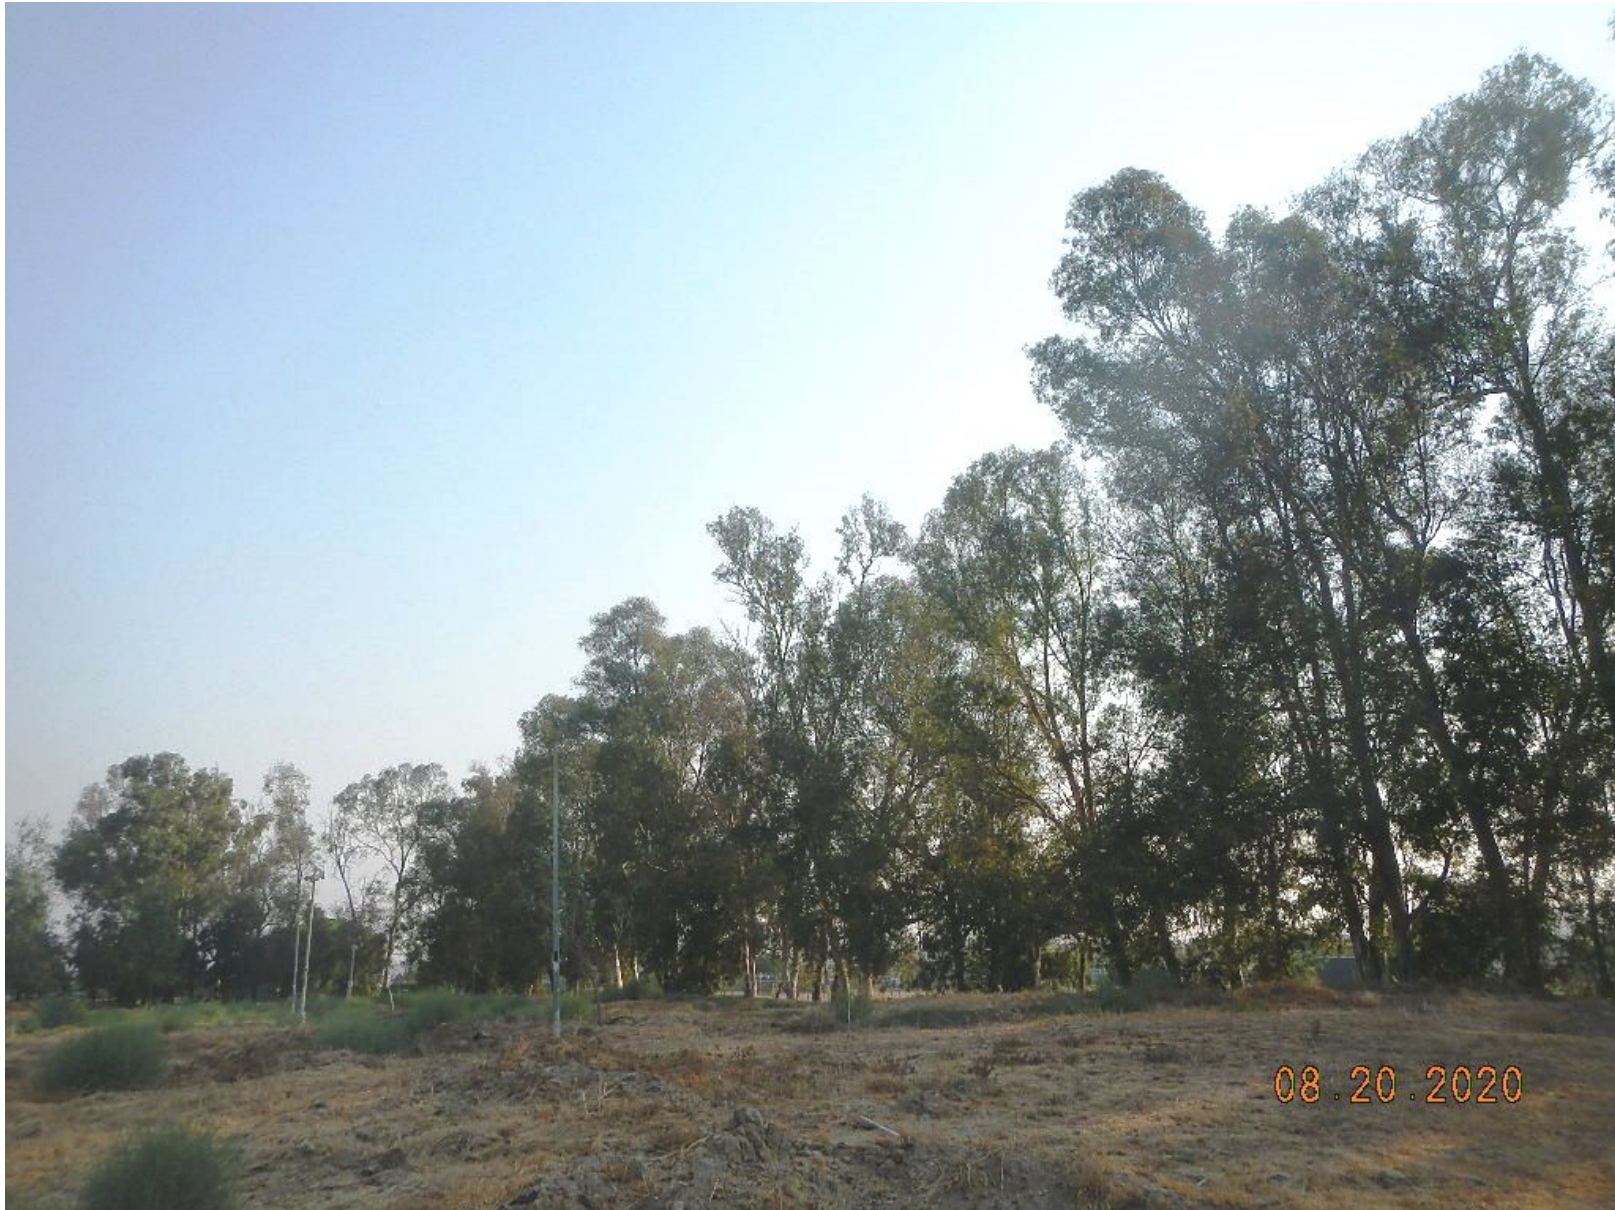
Two different species of eucalypts occur on the property, though only one is found in the north portion, the red gum, *Eucalyptus camaldulensis*. There are 71 red gums, nearly all of which are in the windrow that wraps around the north and east sides. Due to crowding and pest infestation, none were really healthy or structurally good specimens. Being crowded together in a windrow, they reach out in odd directions for light. Windrow trees have their roots intertwined and depend on each other for protection and support. Also, all the red gums are infested by redgum lerp psyllids, and have been chewed up by tortoise beetles.

Overall group of red gums in north area

1. Red gums are 53 of the 131 trees on site, but were recommended for removal. As such a large proportion of the total, this recommendation should be discussed further to decide to treat them for psyllids, and if that is allowed next to a school yard and seasonal water course. Also the amount of pruning that is needed should be considered. In addition, being large trees, they will have large protection zones where trenching for water lines could make them unstable.

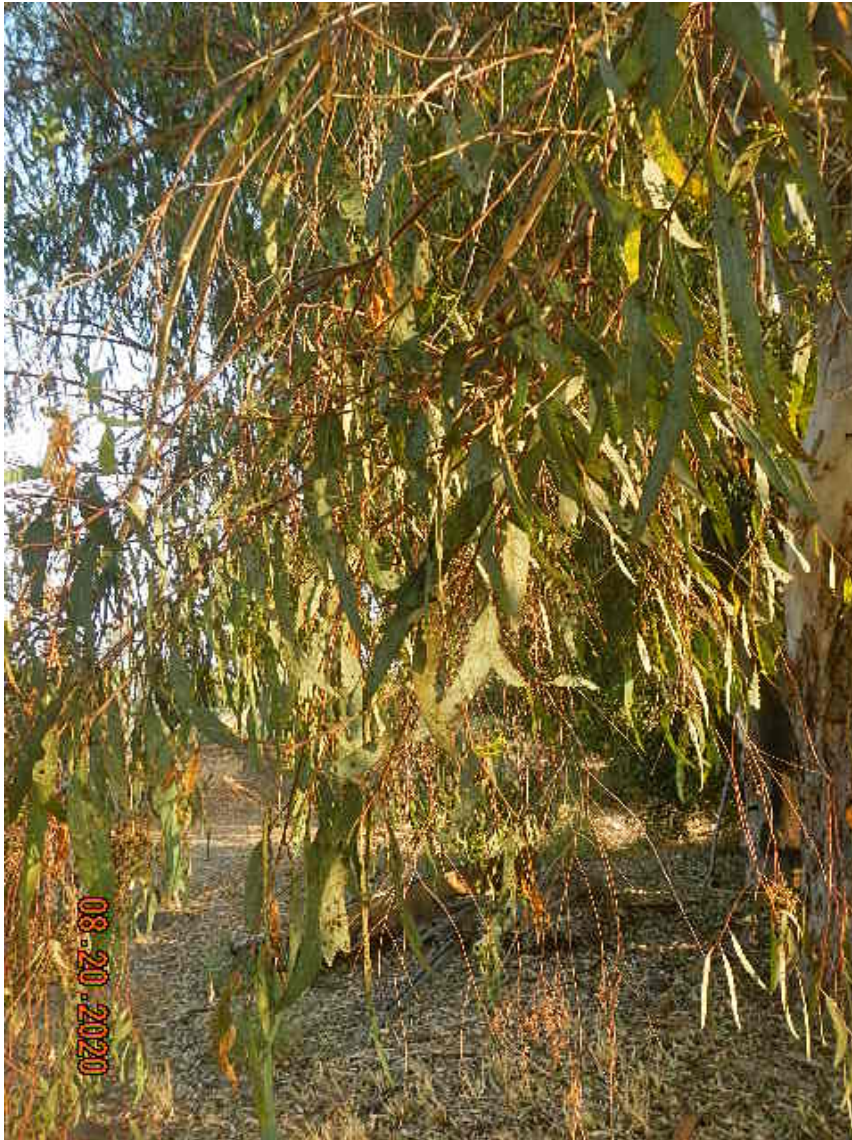
Note lerp psyllids and tortoise beetle feeding.

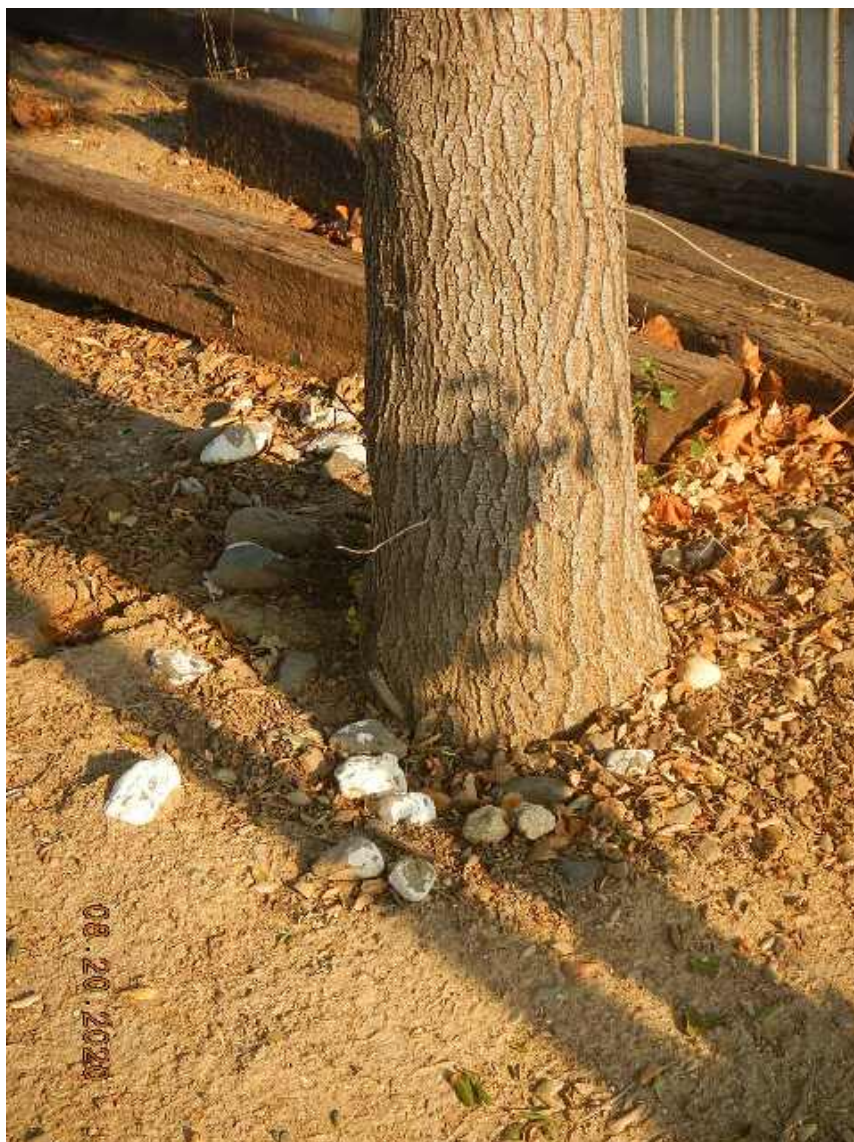
Base of oak #58 – note lack of basal flare.

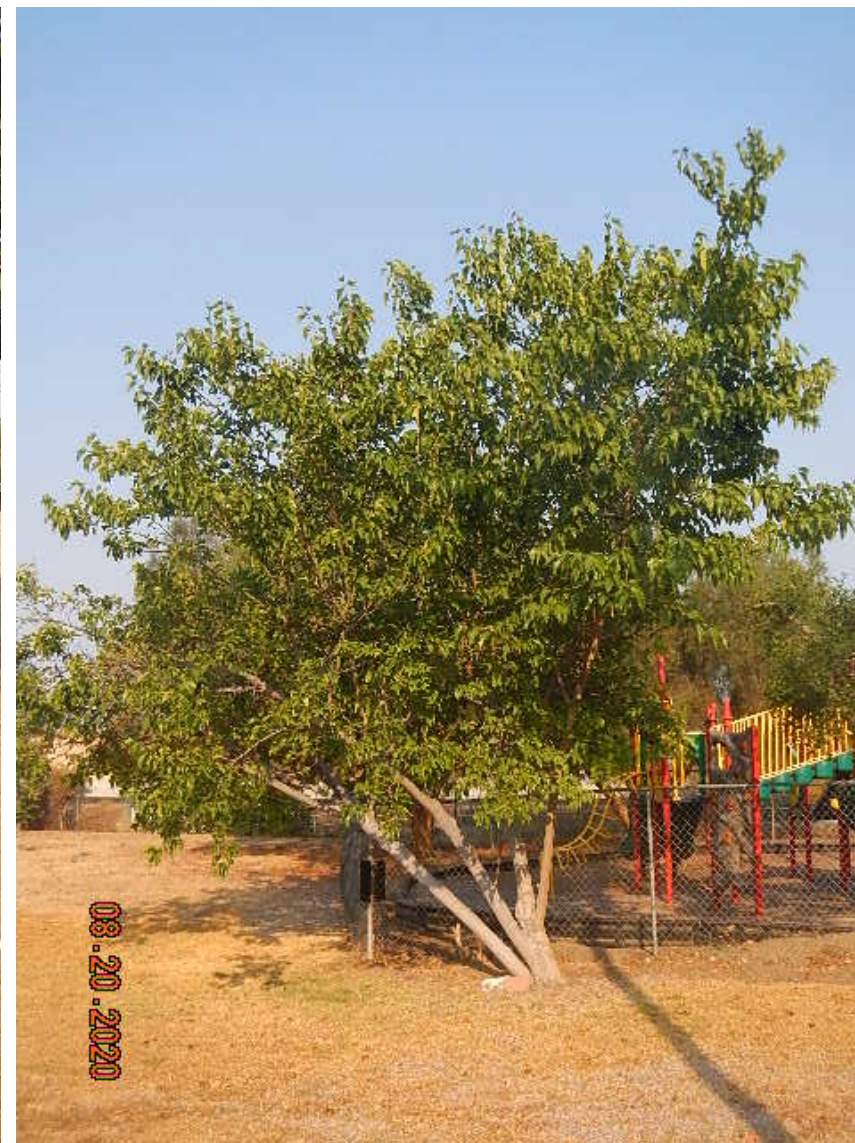
Fruitless mulberry #104

Fruitless mulberry, *Morus alba*,— there is only one, but it is not a good tree for such a site as this. They need frequent pruning, are decay prone, grow quickly, shallow rooted and eventually can become quite large. Not recommended for turf here.

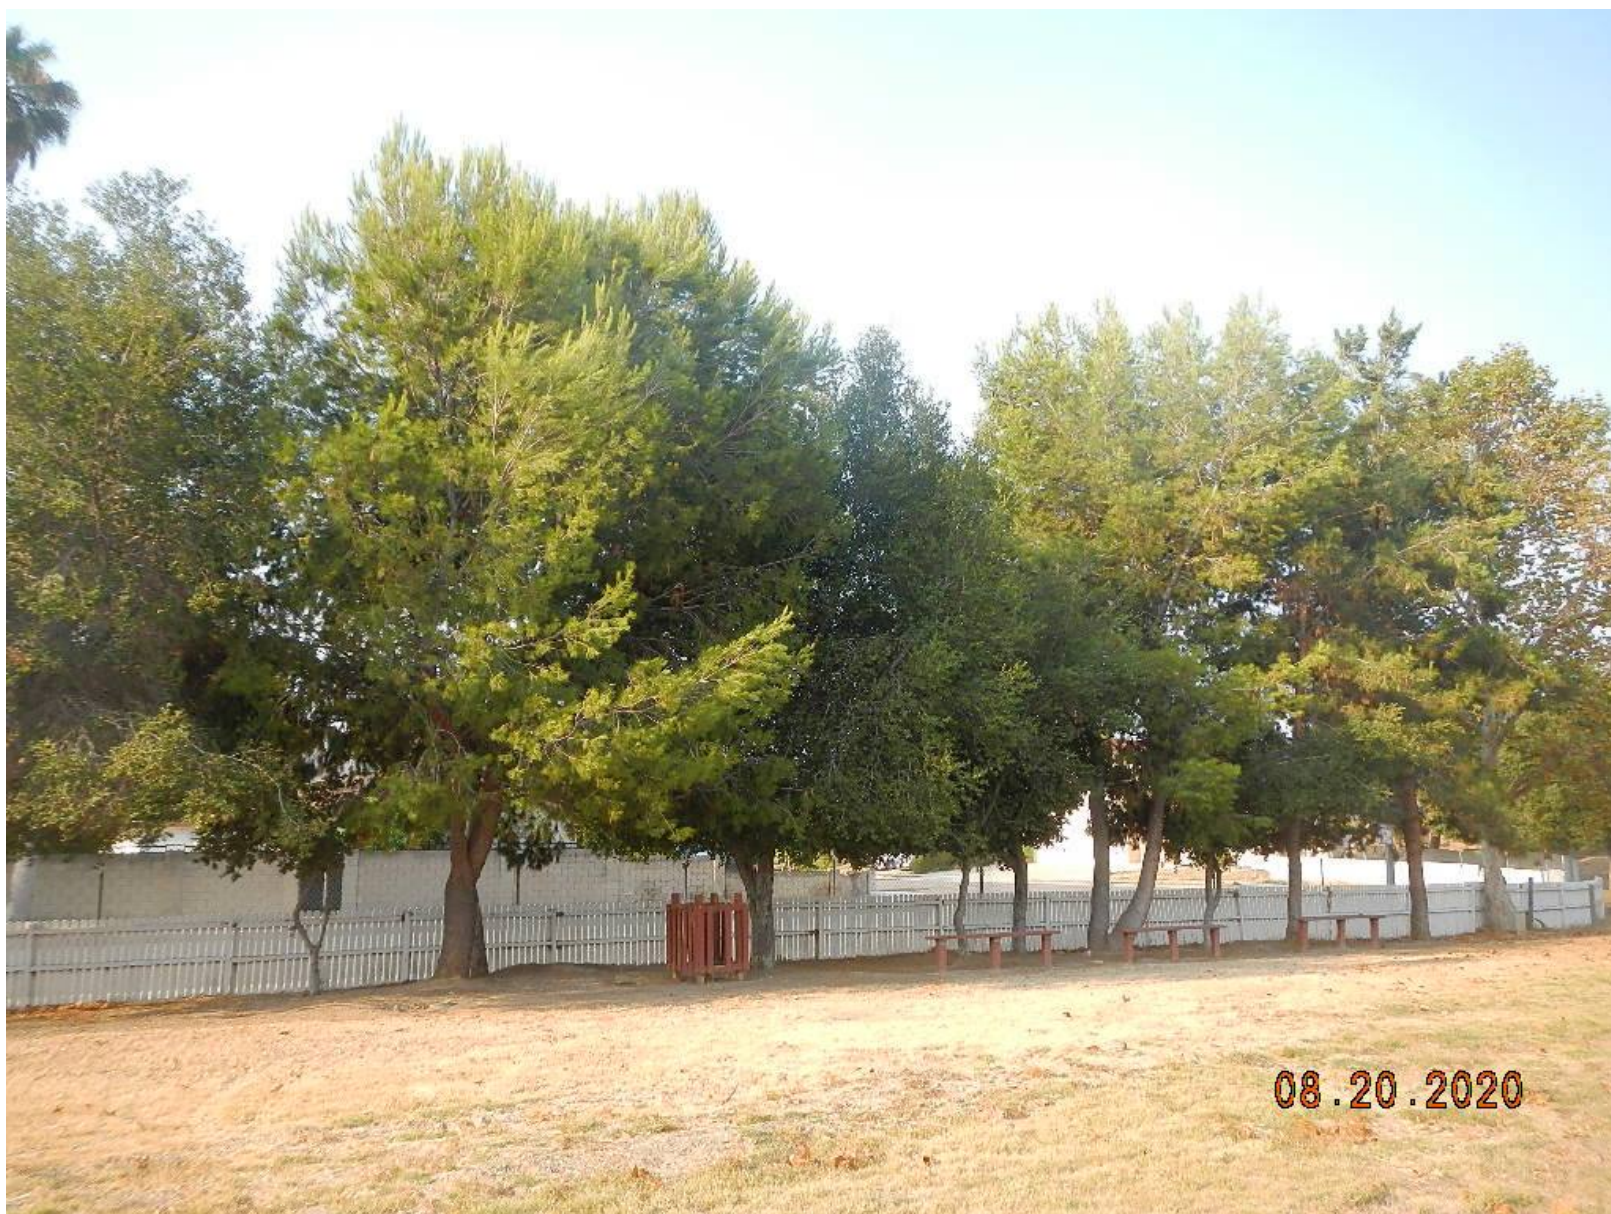
Crowded row of trees along south edge.

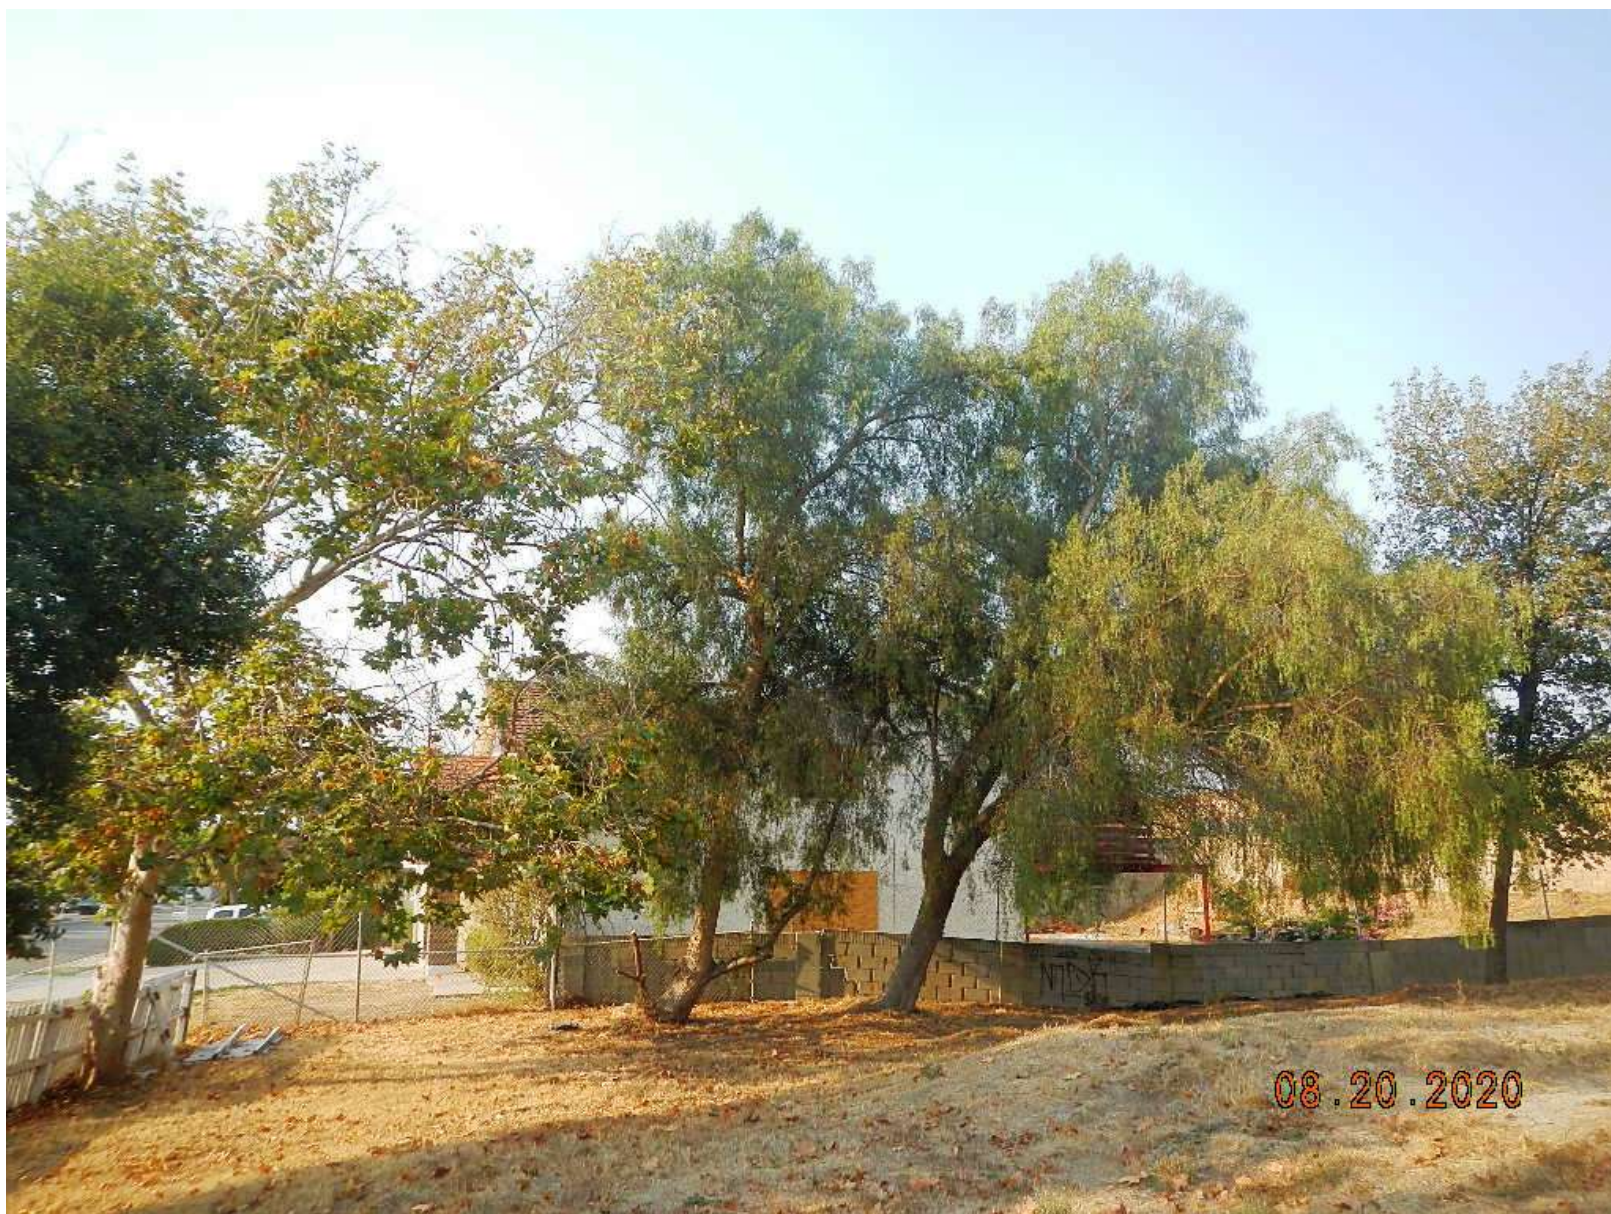
Peppers #84 & 85 – note block wall behind. Valley oak #86 at right.

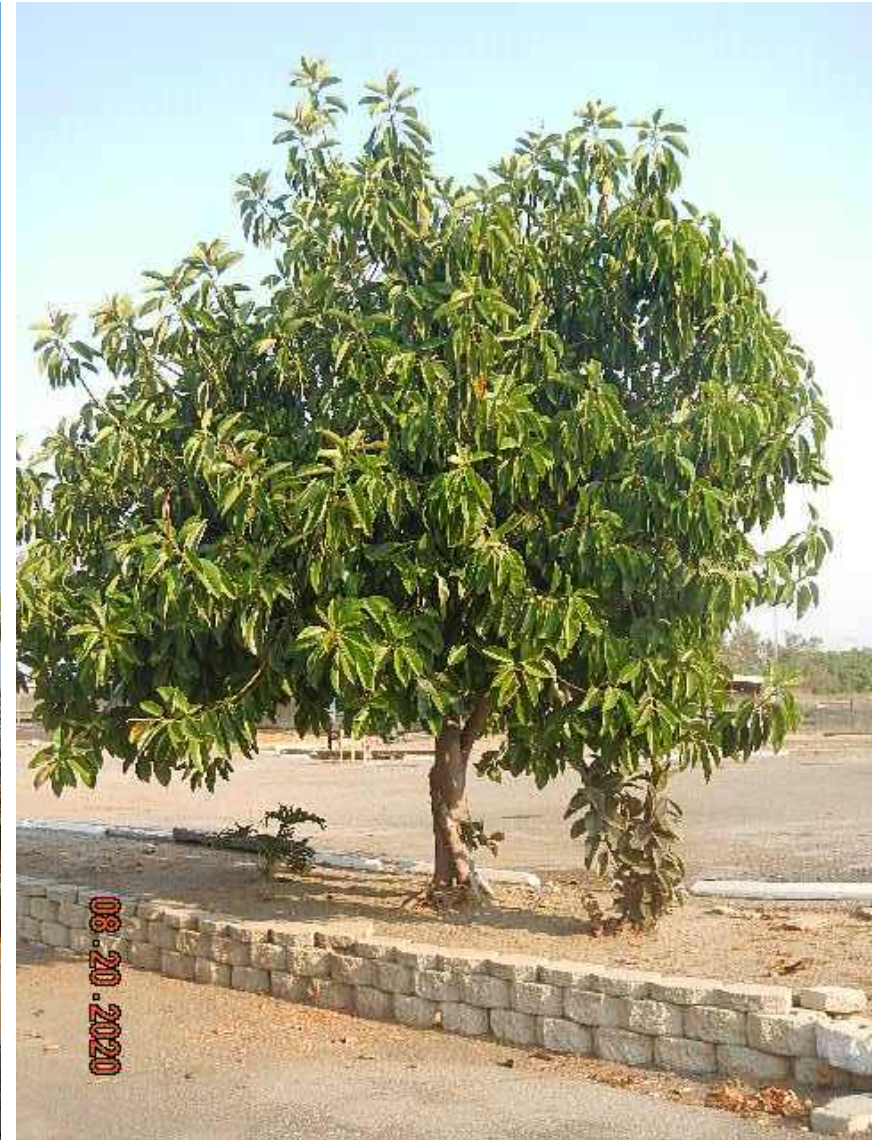
Rubber tree #100

There are two rubber trees and two Indian laurels. Both species have handled the drought conditions well. The Indian laurels are behind the building. Their health is good, but it looks like they were pruned to facilitate climbing by lion-tail pruning, i.e. stripping out the inner branch work and foliage. The rubber trees are both healthy, but poor pruning has left them less than attractive.
