**SUPPLEMENTAL ENGINEERING GEOLOGIC STUDY**  
***Onsite Wastewater Treatment System (OWTS)***  
Proposed Single-Family Residential Development  
634 Palomar Drive  
Redwood City, California

October 4, 2021  
ATLAS Project No. 91-55905-C  
(3067)

**RE: SUPPLEMENTAL ENGINEERING GEOLOGIC STUDY**  
***Onsite Wastewater Treatment System (OWTS)***  
Proposed Single-Family Residential Development  
634 Palomar Drive  
Redwood City, California  
**ATLAS #91-55905-C (3067)**

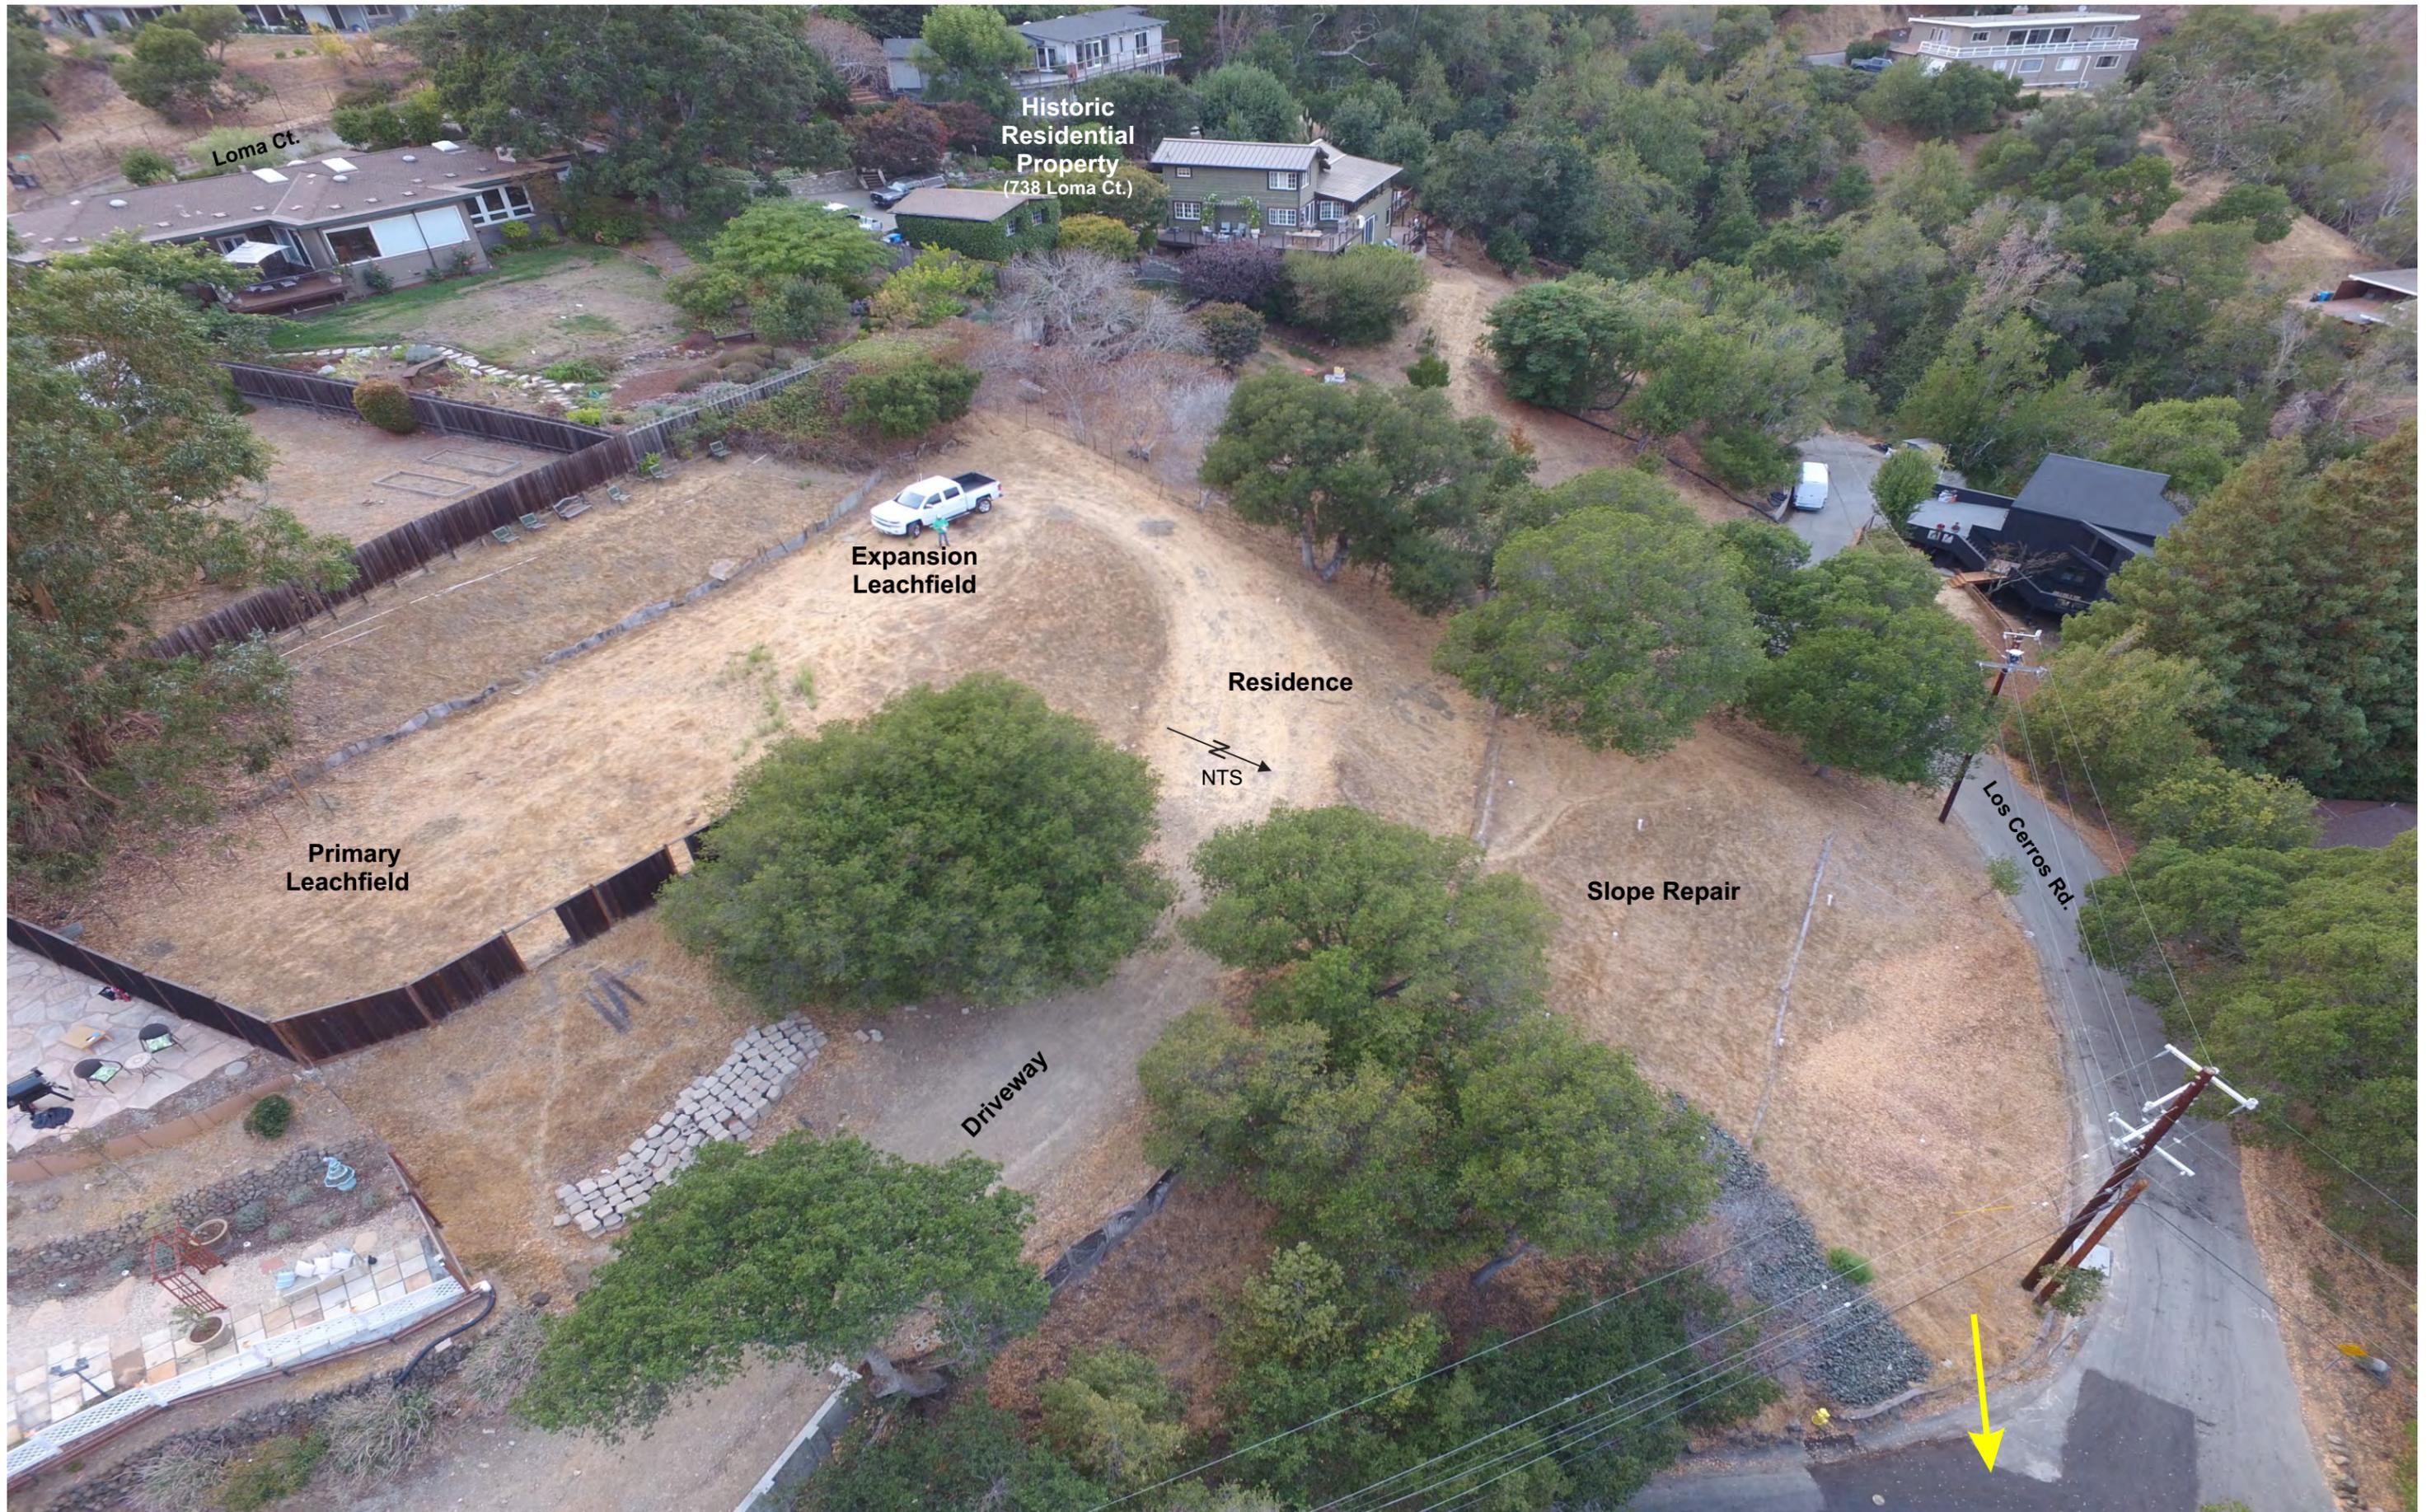
Figure 1. Westerly aerial drone view of proposed residential development area and adjoining area (09/25/2021). Arrow in lower left of view is recent replacement of Cal Water Service main that caused seepage onto Palomar Drive in winter of 2020.

The distribution of structurally-controlled seasonal drainage patterns depicted on Figure 1 suggests the subdued and locally steep hills that characterize Palomar Park are underlain by somewhat chaotically deformed Franciscan rock (Plate 4). Thus, the local geologic section would be unlikely to represent a sandstone-shale layer-cake assemblage as implied in letters contained in the compendium of documents submitted to the County Environmental Health Department from neighbors and other citizens concerned about local seepage mechanisms.

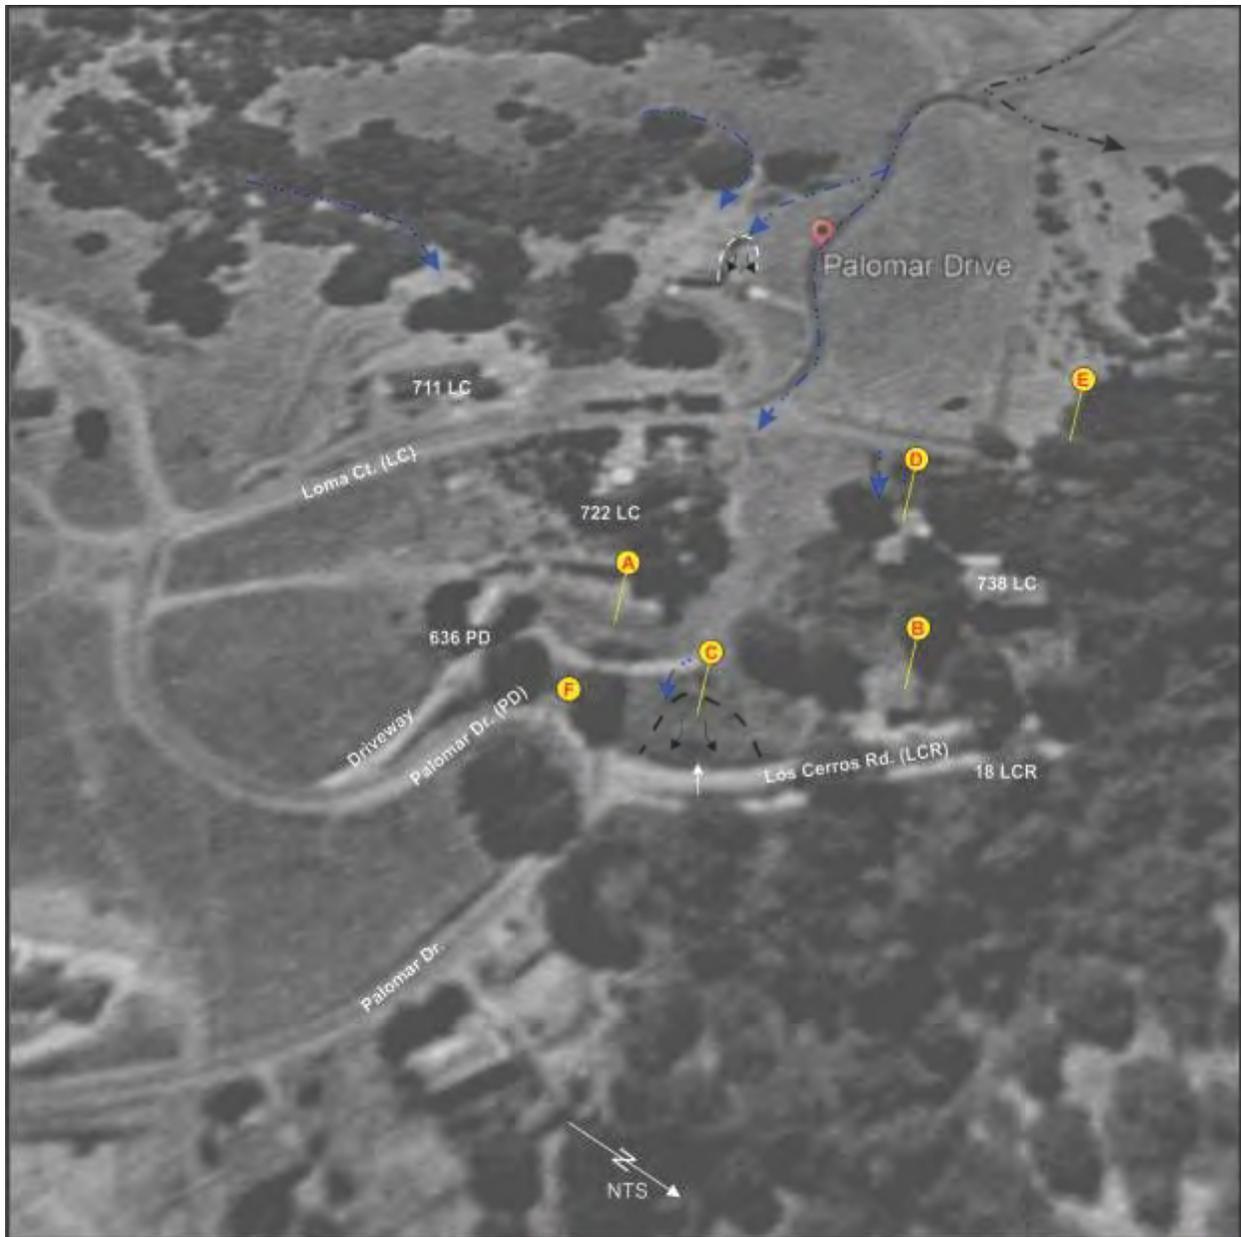
Figure 2. 1948 oblique Google Earth Pro image of site area. **A** is proposed leachfield site bordered by initial driveway grading across site; **B** is residence at 13 Los Cerros Rd. removed in 1982-83 due to reactivation of 1950's landslide (Michelucci & Assoc., 2015); **C** is incipient landslide that failed in 2017 (white arrow points to scar of small cut slope failure); **D** is 738 LC garage at foot of steep descending driveway; **E** is approximate location of existing California Water Service tank; **F** is approximate location of approx. 30-foot high cut slope; - - -> is concentrated runoff - note light tone on hillside above 711 Loma Ct. is interpreted as erosion/sedimentation from uncontrolled roadway runoff.

Figure 2 depicts early residential development in Palomar Park featured by an array of roadways likely to have directed uncontrolled storm drainage to undeveloped slopes in the neighborhood causing erosion as well as landsliding from the over-steepened Los Cerros Road cut slope coincident with the location of the 2017 landslide event on the east side of the site. Hillshade LiDAR imagery highlights deflections from apparent roadway runoff erosion on slopes in the site area that would be otherwise obscured by vegetation. An example is an inactive erosional inflection from runoff extending onto the northwest corner of the site from 730 Loma Court that imposes no potential impact to performance of the OWTS site.

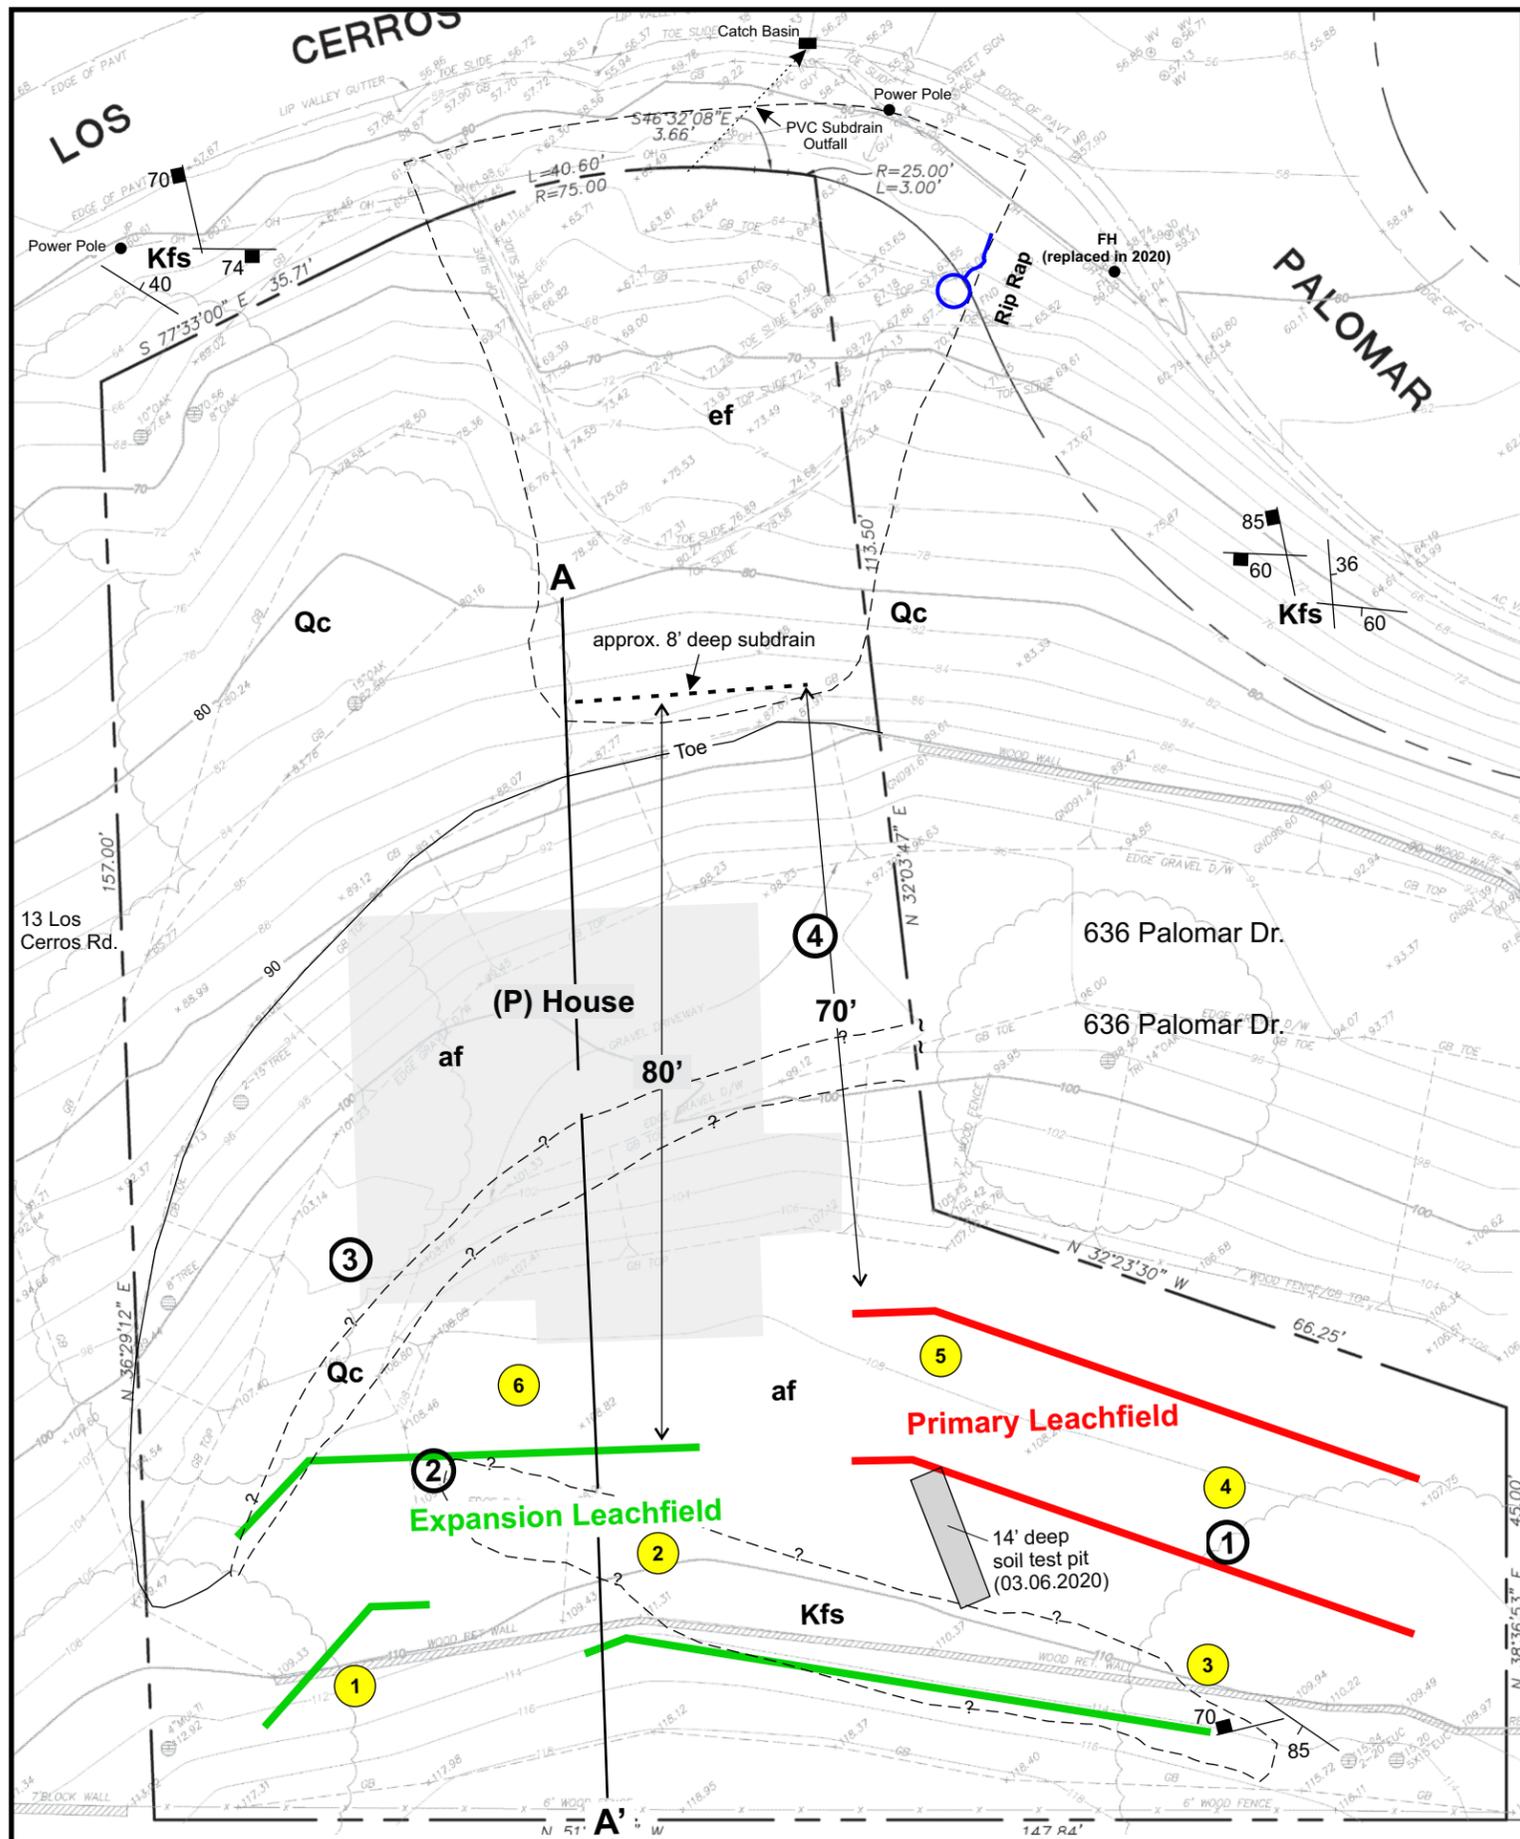
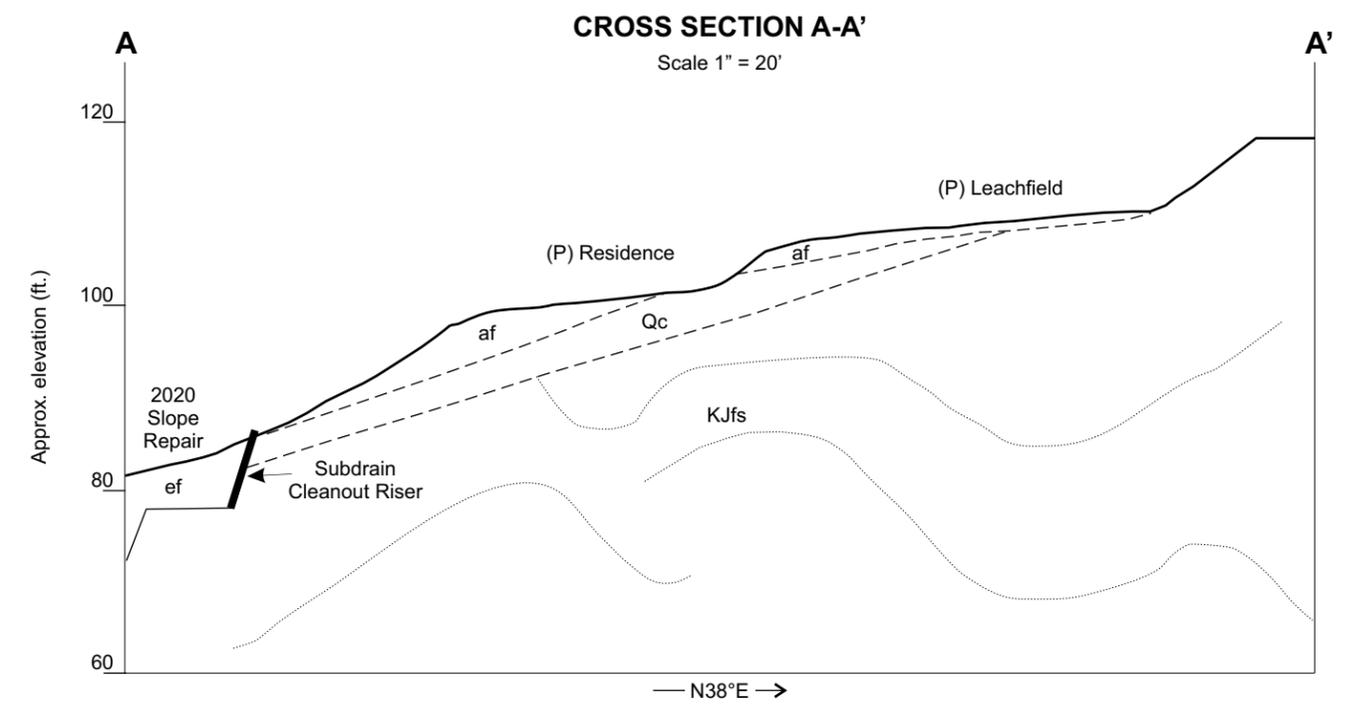
Job No.: 91-55905-C	<b>SITE PLAN,          CROSS SECTION A-A'</b> 634 Palomar Drive Redwood City, California	<b>Plate          2</b>
	Approved: JEB		
	Date: 09.27.2021

The supplemental subsurface exploration and surface mapping revealed competent sandstone to be underlying the proposed leachfield. Sandstone exposed in the cut slope above Boring 1 exhibited a favorably steep inclination relative to slope stability, and steep closely spaced jointing relative to optimum OWTS performance over the project lifetime (Plate 2).

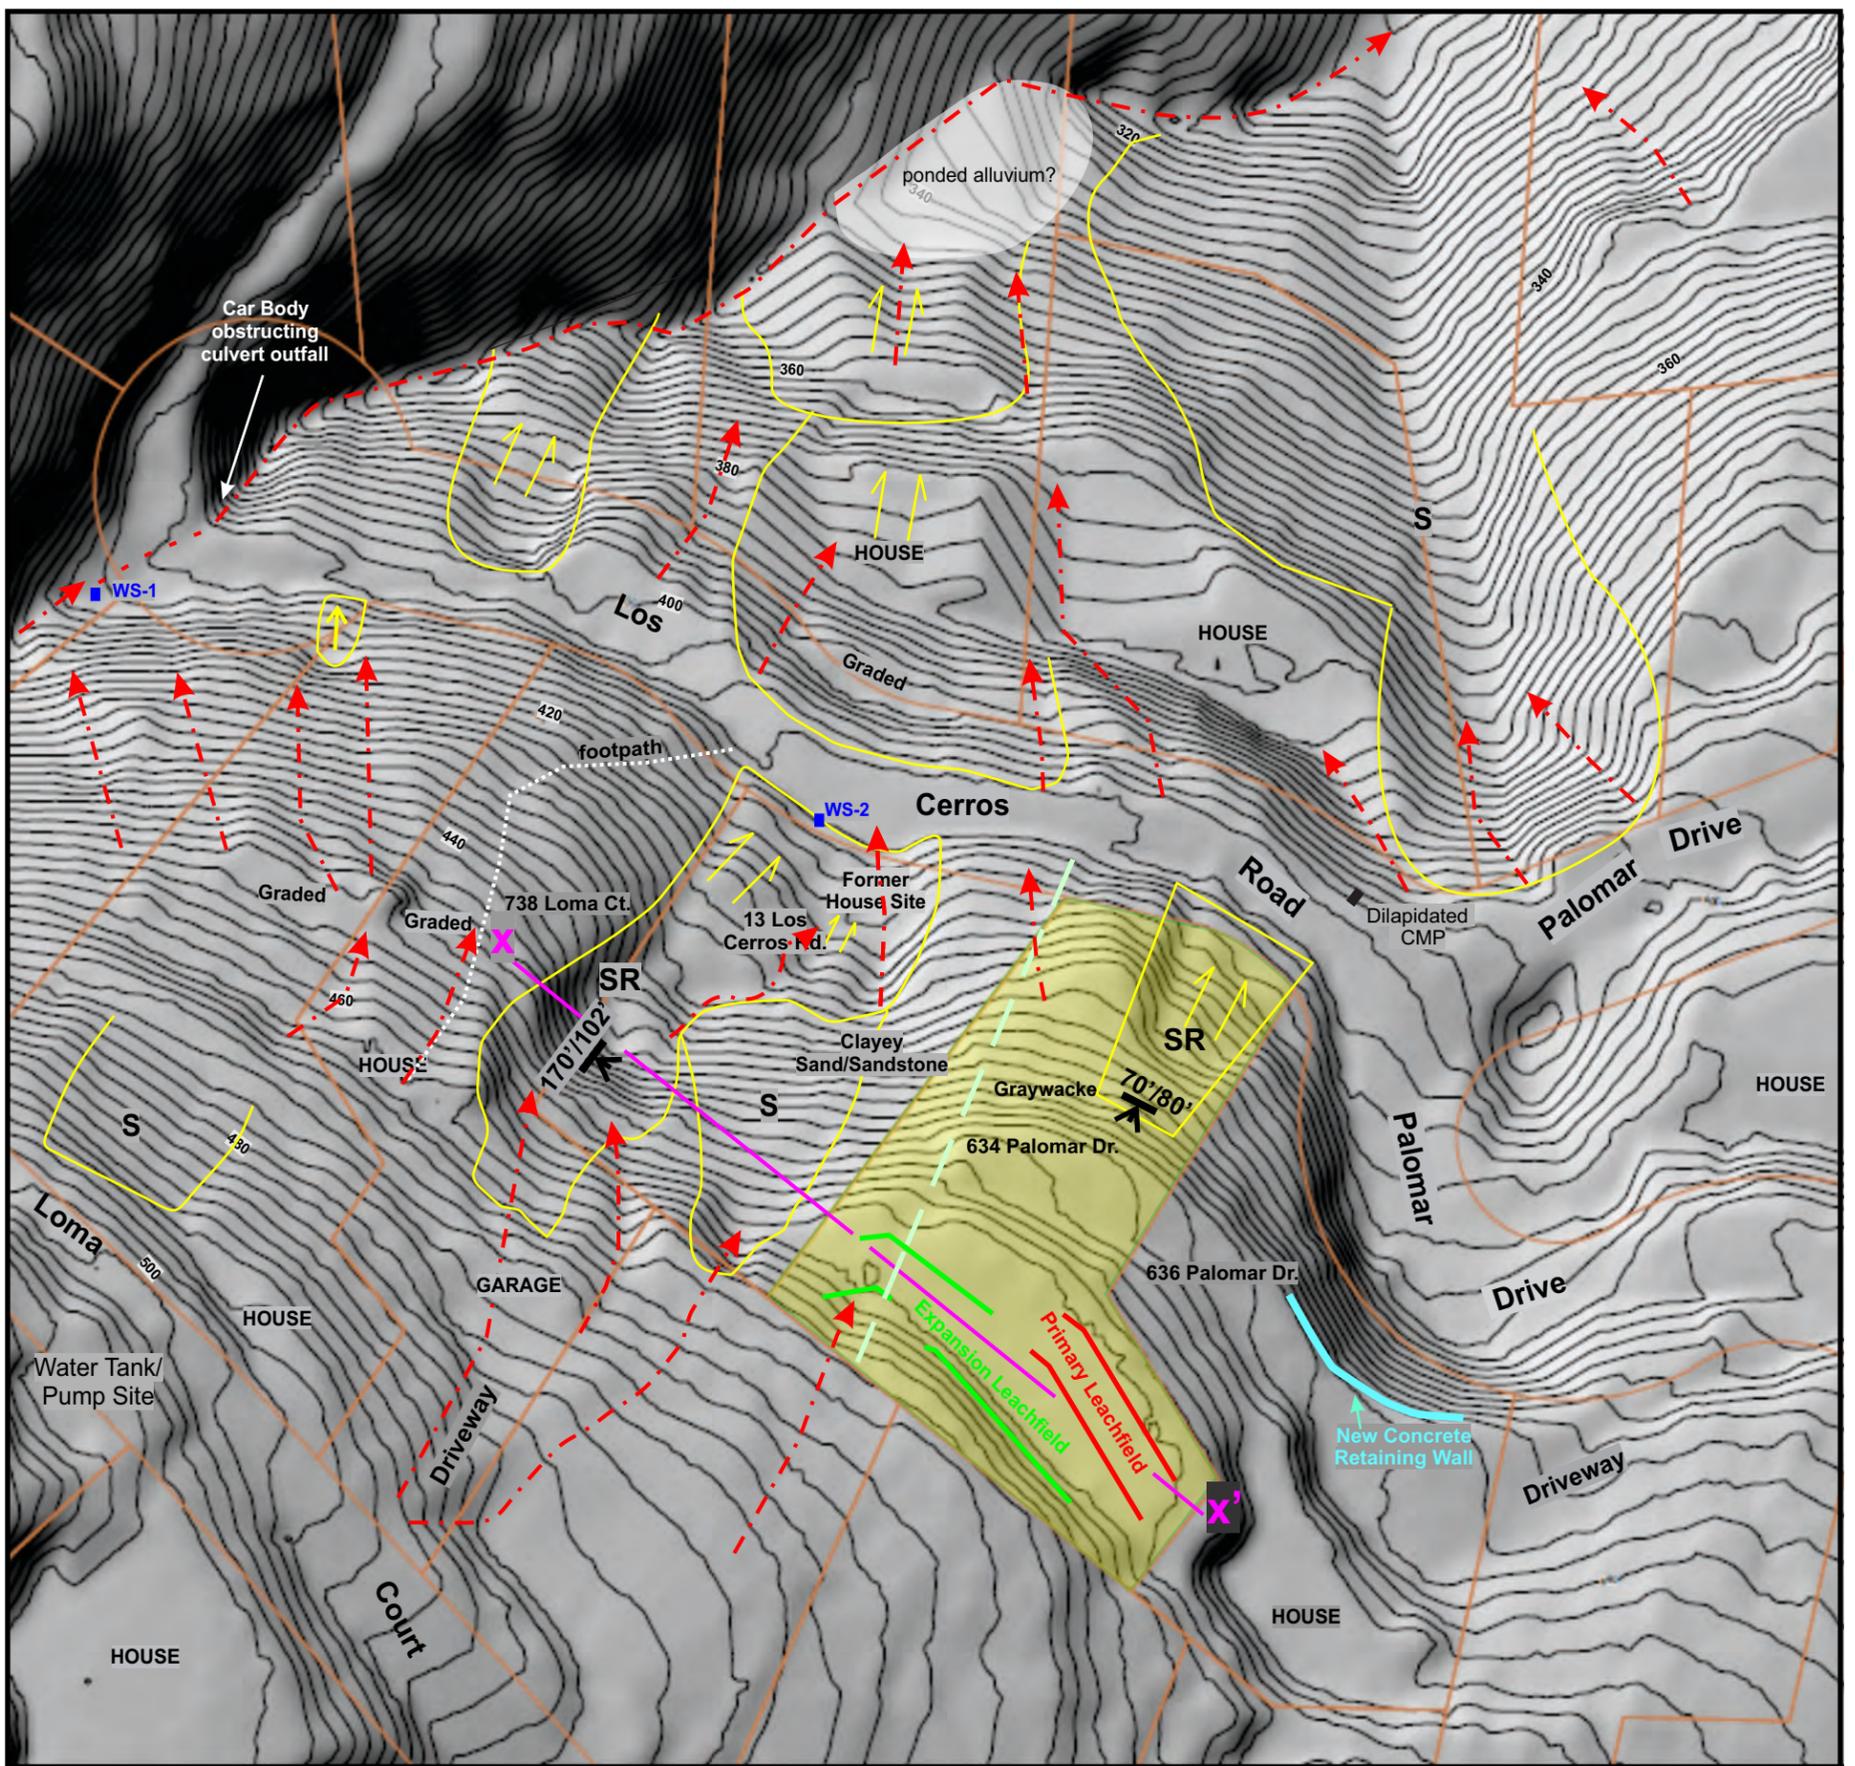
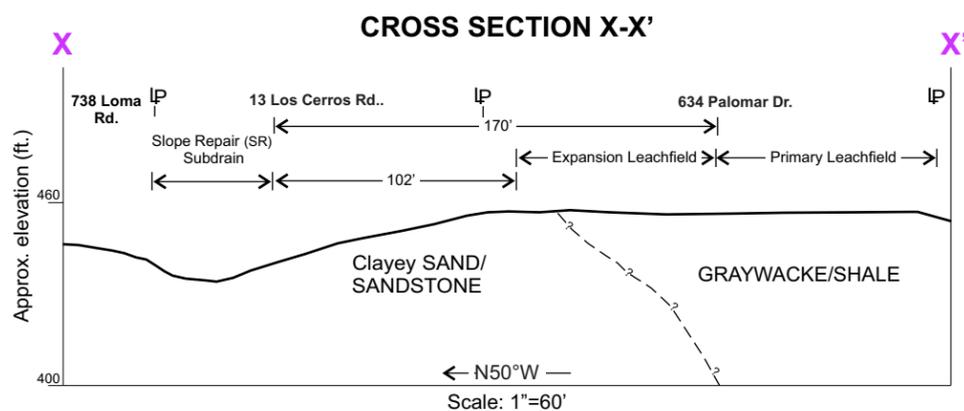
**GEOMORPHIC MAP,  
 CROSS SECTION X-X'**  
 634 Palomar Drive  
 Redwood City, California

There are no unmitigated landslides within 100 feet of the proposed OWTS (Plate 3). In our opinion, existing OWTS setbacks are sufficient.

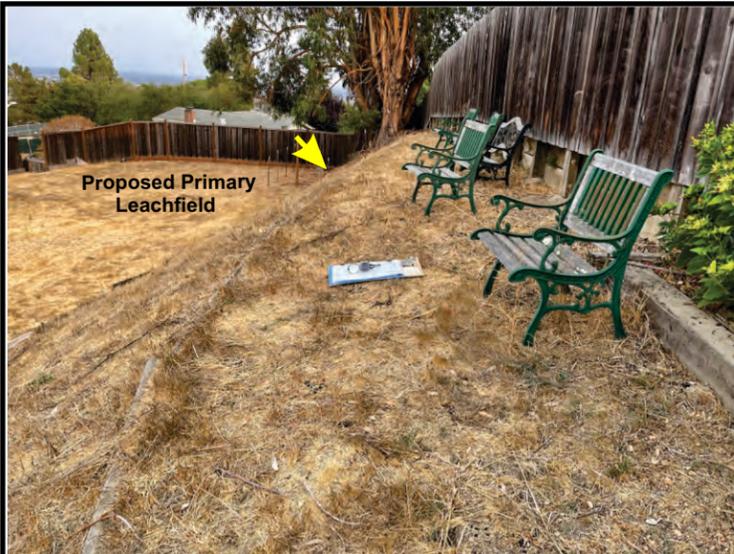
Photo 1a. Southeast view along top of cut slope along southwest margin of Site. Inferred 18% northeast facing native slope extends across property line fence.

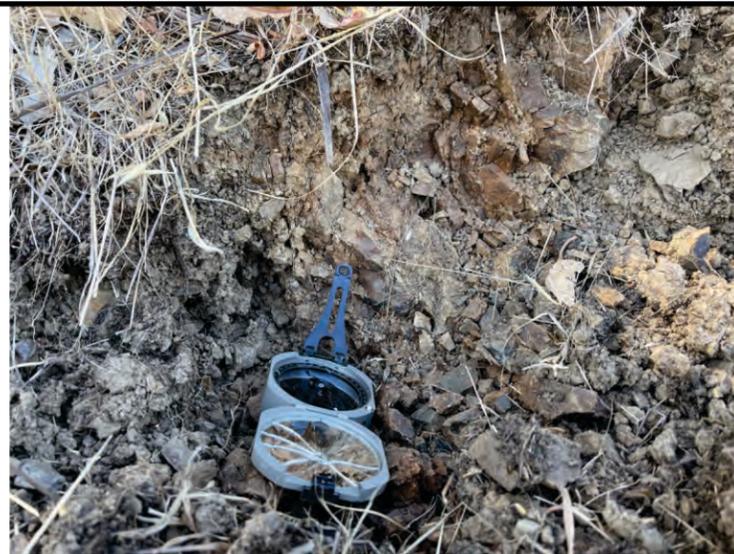
Photo 1b. Exposure of closely jointed shale and graywacke at arrow in Photo 1a.

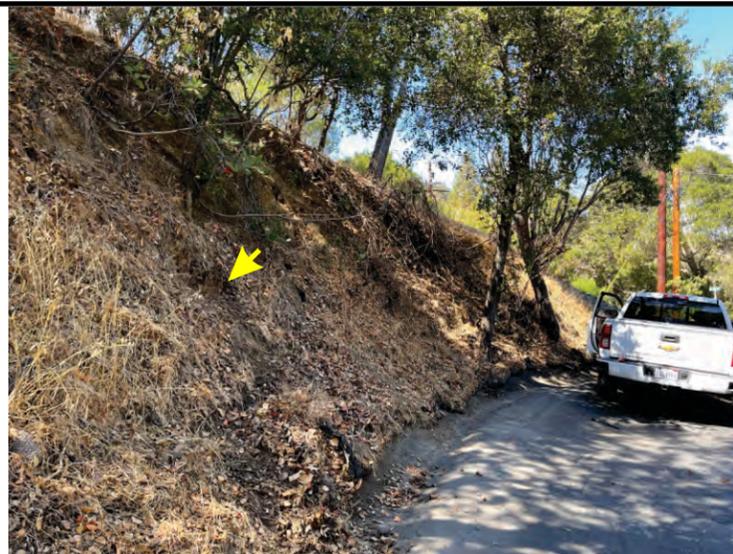
Photo 2a. Northerly view along Palmar Drive cut slope bordering northeast side of 636 Palomar Drive.

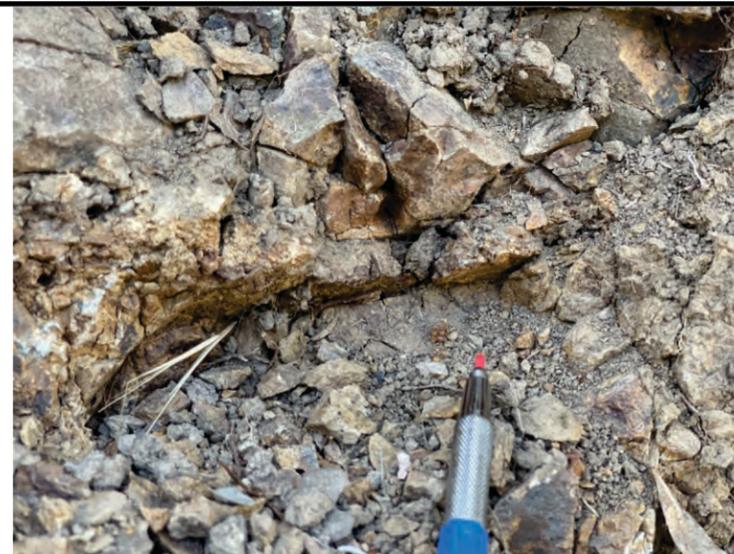
Photo 2b. Exposure of recumbent fold in closely jointed shale and graywacke at arrow in Photo 2a.

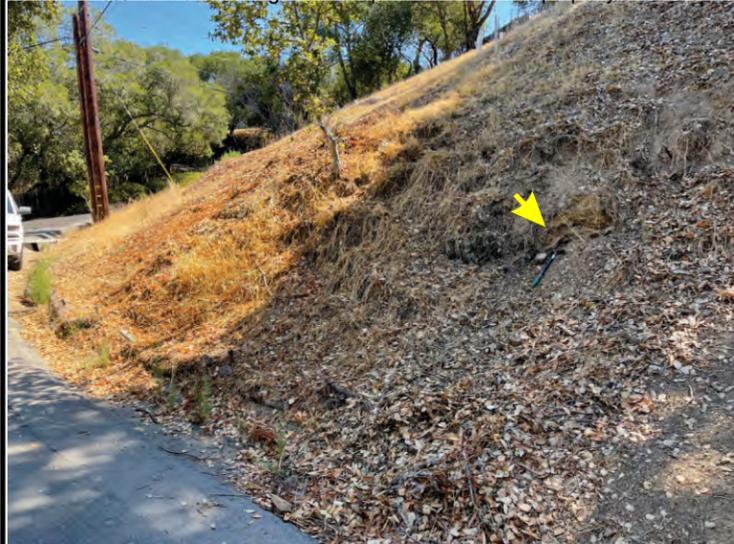
Photo 3a. Easterly view along Los Cerros Rd cut across nose of spur separating site from vacant lot at 13 Los Cerros Rd. where 1982 landslide damaged house.

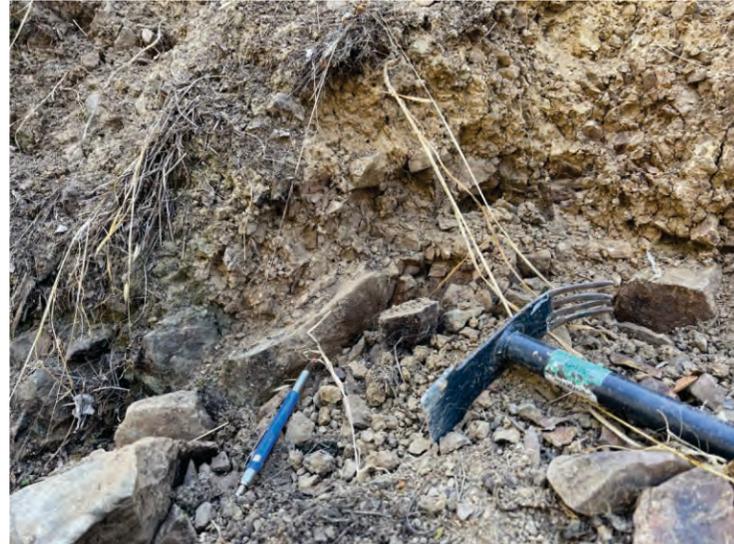
Photo 3b. Exposure at arrow in Photo 3a of closely jointed shale and graywacke mantled by Gravely Clayey Sand colluvium .

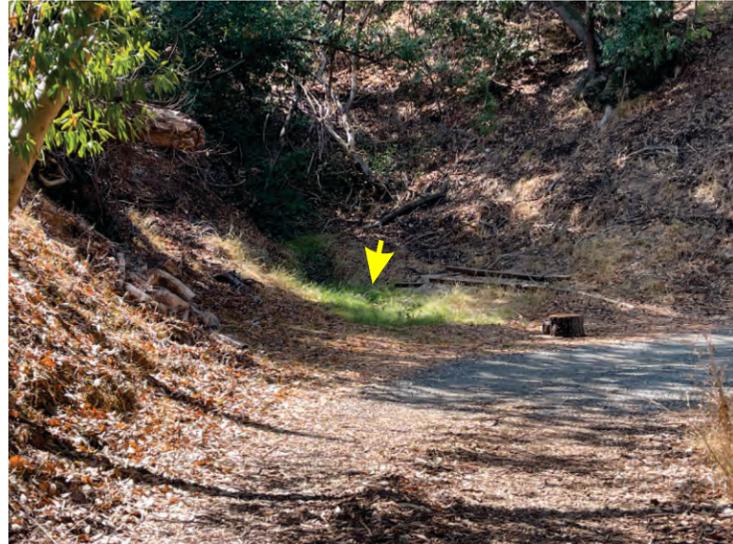
Photo 4a. Northwest view seasonal channel intersection with Los Cerros Road. Arrow points to location of Balance Hydrologics (2014) creek Water Sample.

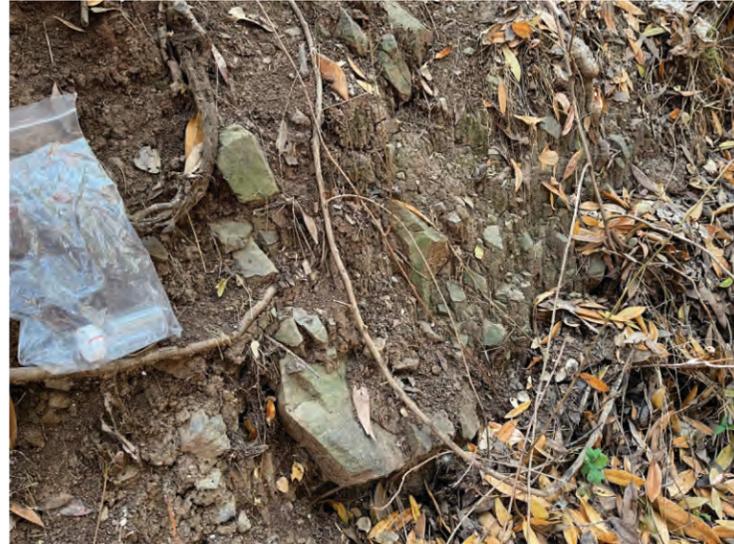
Photo 4b. Exposure of closely jointed graywacke in bank of the dry channel about 100 feet downstream from the sample location in Photo 4a.

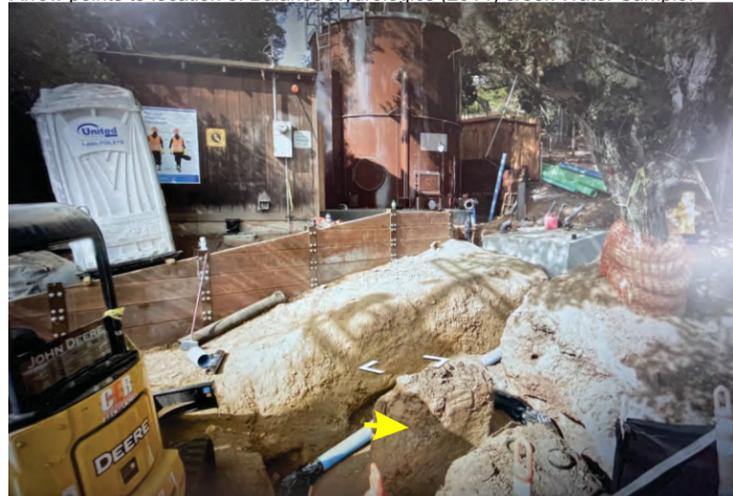
Photo 5. Northwest view of 2020 construction of water tank and booster pump at Cal Water Service Station 112 across from 742 Loma Ct. About 50 feet of new 6" diameter pressure line pipe was connected to the pre-existing line installed some time before 1985. Arrow points to trench exposure of soil similar to that reportedly underlying the landslide on 13 Los Cerros Rd. and 738 Loma Ct.

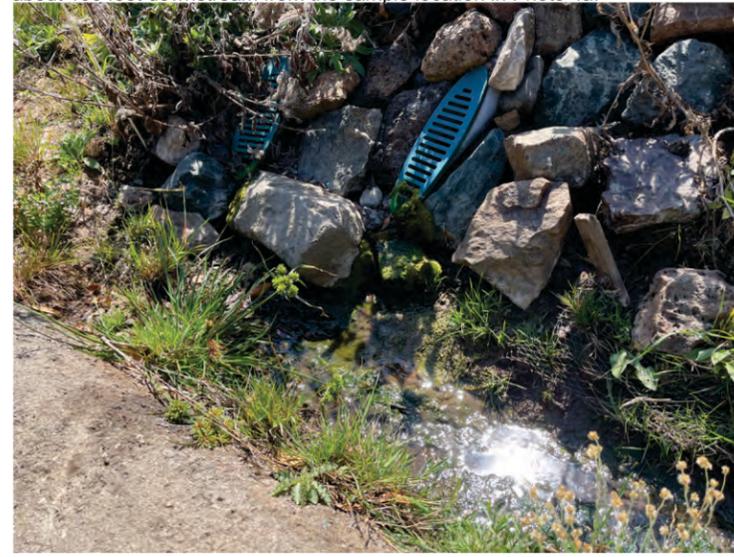
Photo 6. West view of Balance Hydrologics 738 Loma Ct. spring water sample onto Los Cerros Rd. Gutter that drains to catch basin/culvert system at head of stream across road from Photo 4a.
