GEOTECHNICAL INVESTIGATION
Landslide Mitigation
Lower Slope at 634 & 636 Palomar Drive
Redwood City, California

June 16, 2017
Job 2572.01.01

RE: GEOTECHNICAL INVESTIGATION
Landslide Mitigation
Lower Slope at 634 & 636 Palomar Drive
Redwood City, California

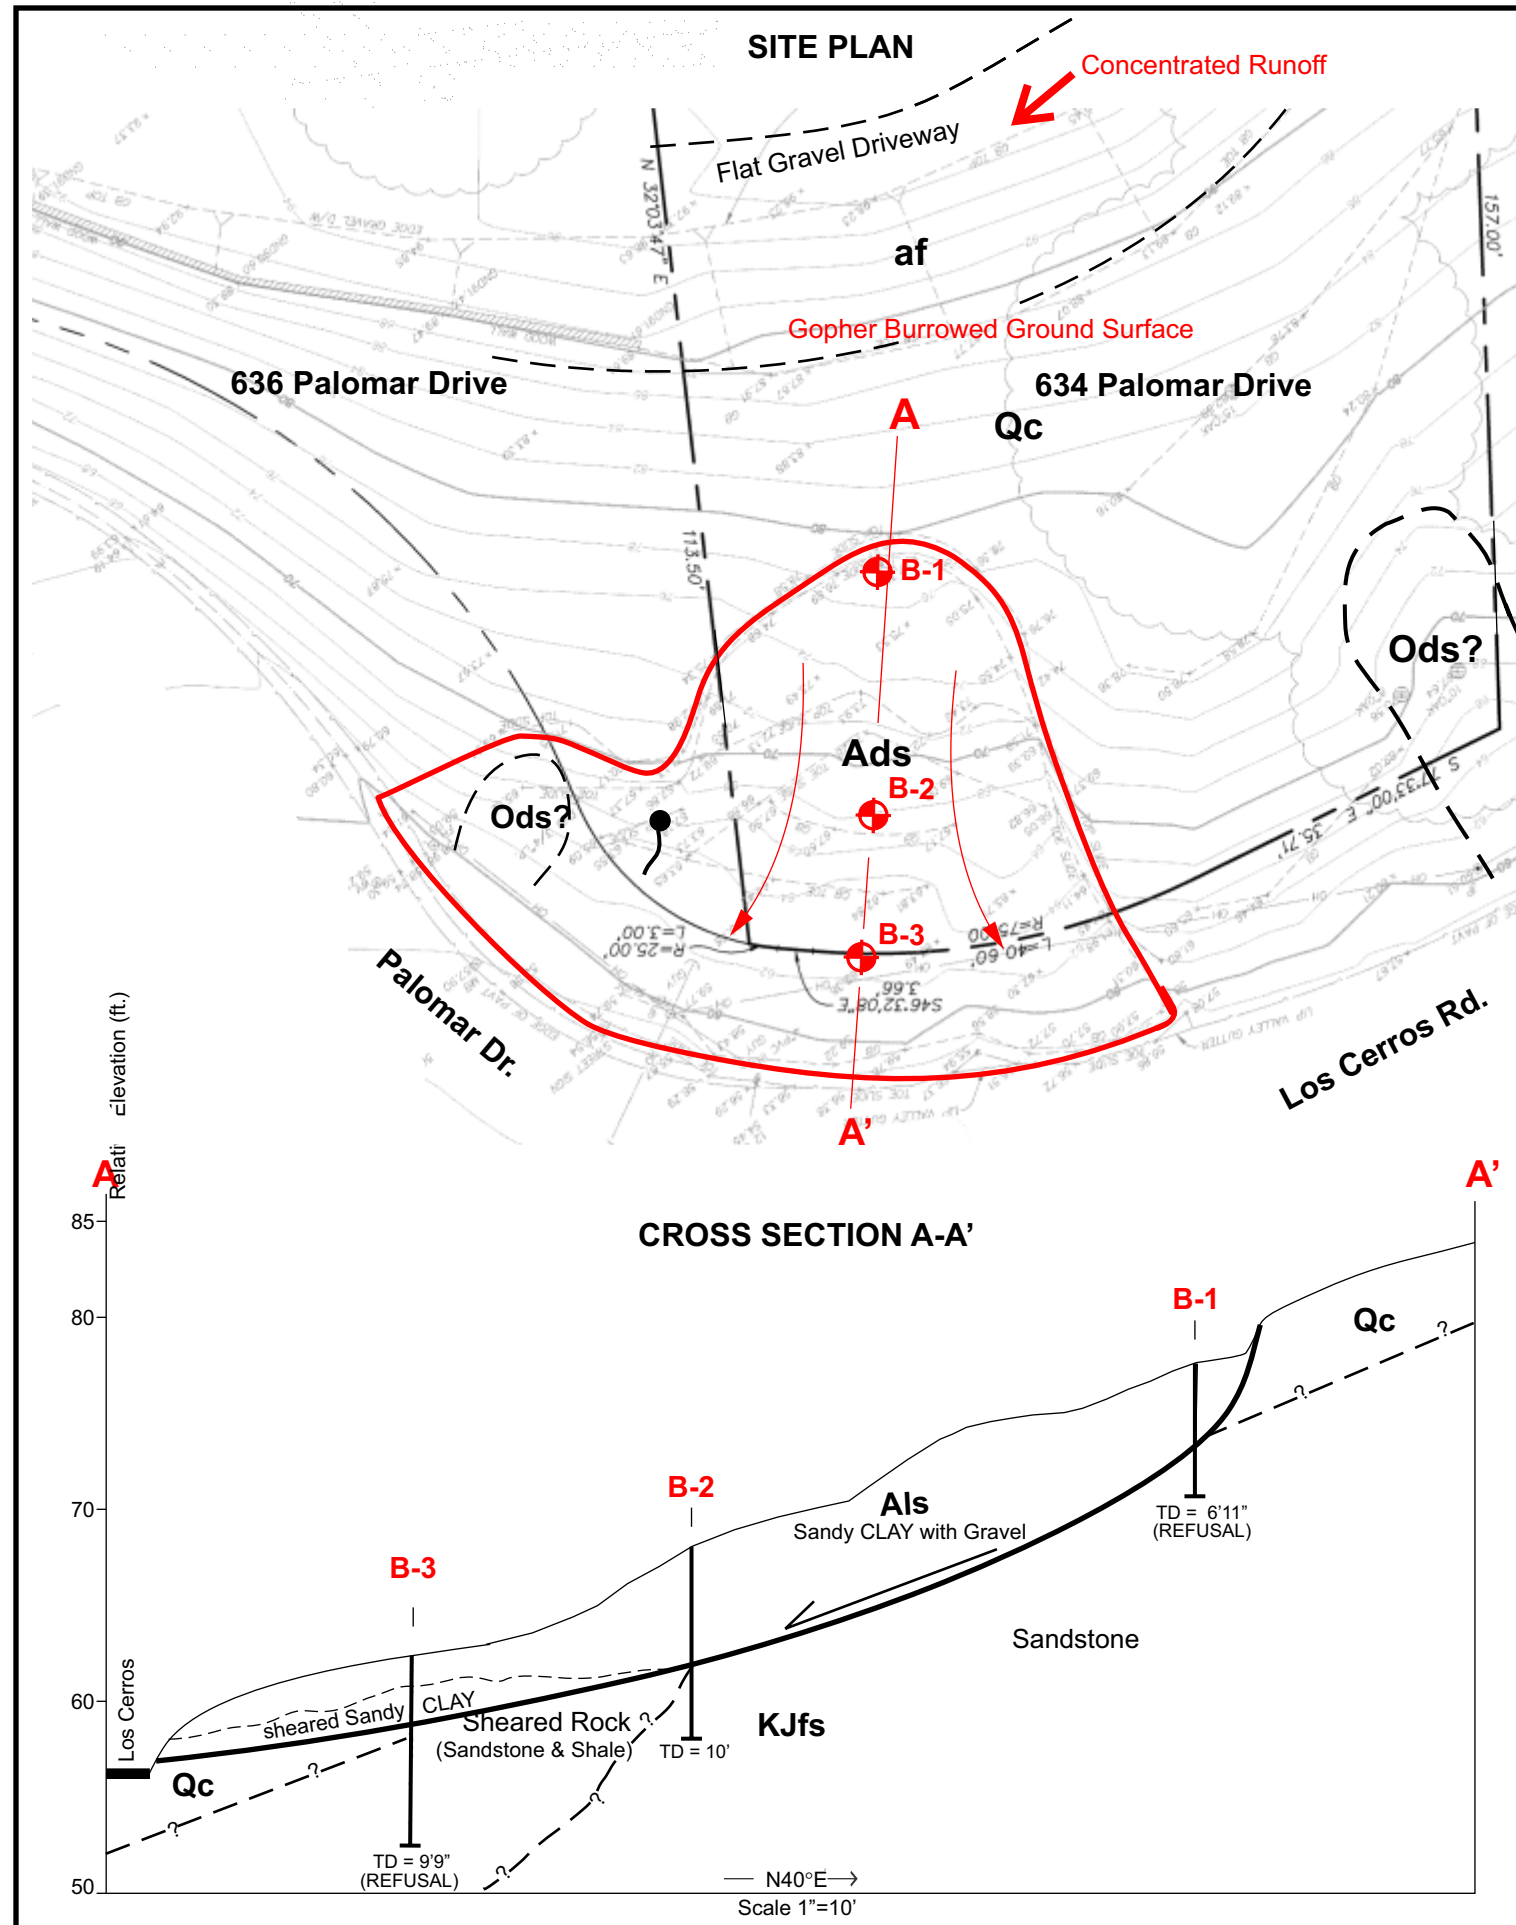
**SITE PLAN, CROSS SECTION
A-A' and PHOTOS 1 & 2**
634 Palomar Drive
Redwood City, California

The recent landslide depicted on Plate 2 occurred during sustained heavy rainfall this past winter. It comprises approximately 2500 square feet of moderately steep, grassy hillside between Los Cerros Road and Palomar Drive and an unimproved gravel driveway common across the neighbor's property (636 Palomar Drive) and your property (634 Palomar Drive). The surface expression of the slide reflects a retrogressive, primarily rotational failure mode (slump), and secondary translational, surficial debris slide/flow failure mode characterized by angular (serrated) source area headscarps corresponding to orientation of desiccation cracks in the upper-middle part (Plate 2, Photo 1). The headward and perimeter flanks were well-defined by generally vertical escarpments ranging from a few inches up to approximately 3 feet in height. The landslide toe apparently intersected the steep 3- to 4-foot high roadway just above the elevation of the roadway overriding a drainage gutter. Relief of the hummocky and fissured slide surface is approximately 25 feet with an average slope of 20 degrees; roughly the same as the adjoining intact native slope.

The borings indicate the central part of the landslide involved up to approximately 6½ feet deep of colluvium and bedrock, including approximately 3 to 4 feet of high plasticity (PI=23) sandy clay with a variable content of gravel-size angular rock fragments, and the upper 2 to 3 feet of Franciscan bedrock, including weathered sandstone and sheared rock (Plate 2, Cross Section A-A' and Plates A1 and A2). Slight seepage was encountered in the upper part of sheared SANDSTONE. Standing water was measured at an approximate depth of 7½ feet upon completion of drilling.

1. Surface infiltration of concentrated sheet flow (gully erosion was absent) from the poorly-drained, unimproved gravel roadway, and saturation of the pervasively cracked colluvial surface allowing infiltration to the top of the weathered and sheared bedrock encountered up to 6½' below the ground surface;
2. Absence of lateral slope support along the roadway cut at the toe of the slope. Relative deep desiccation cracks appear to have controlled the head and margins of the slide, and the basal rupture surface appears to coincide with the geologic contact between the colluvium and resistant bedrock.

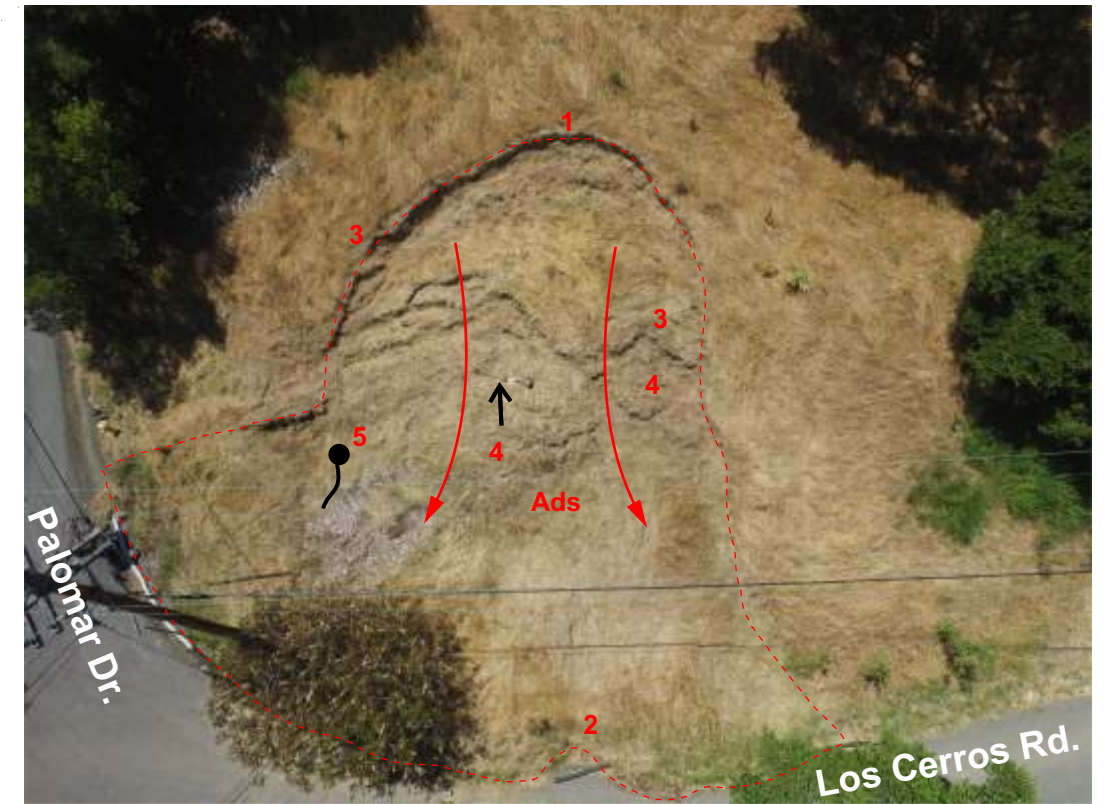
Seepage and pooled water was observed on the landslide surface in the lower part of the east flank. Saturated, highly plastic soil, probably representing the basal rupture surface, was observed at the intersection of the right flank and Palomar Drive.

Photo 1: Aerial view of Active Debris Slide. Arrow points to 5 1/2' long weed-wacker for scale.

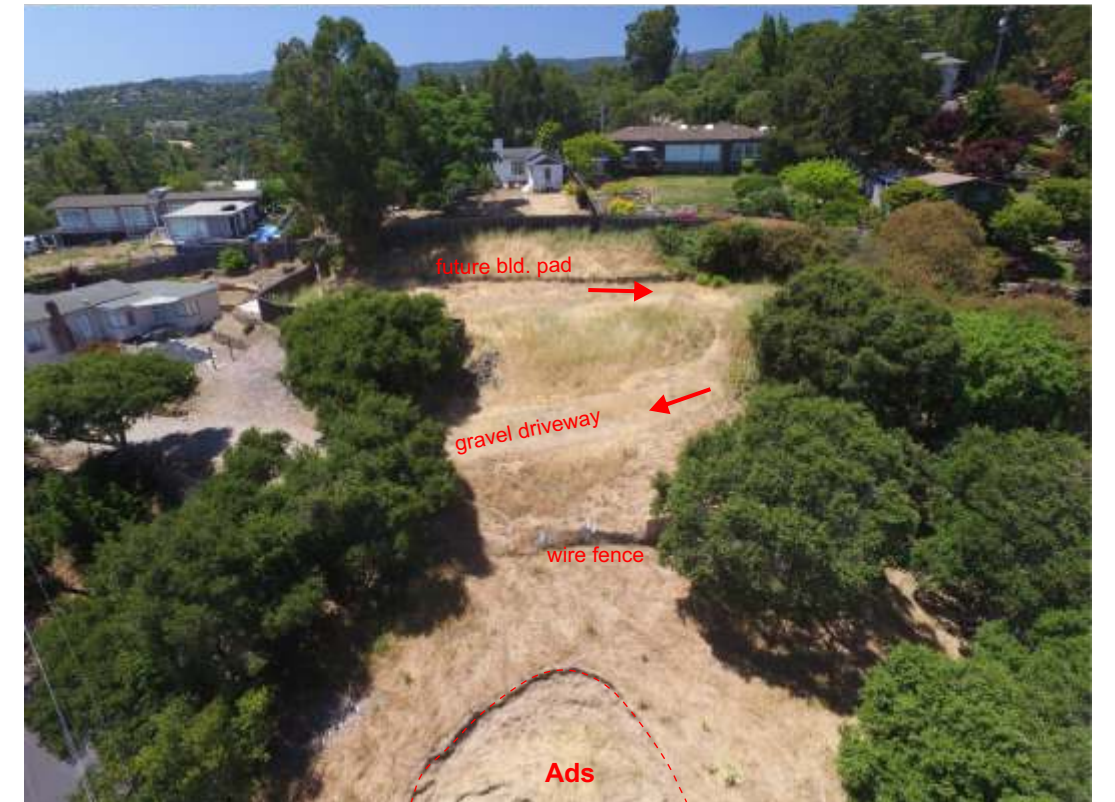
An unimproved dirt road, coinciding with the general alignment of the poorly-drained unimproved gravel road depicted on Plate 2, was detected on 1948 Google Earth imagery. The imagery also revealed substantial reduction of vegetation (clearing?) on the lower part of the slope sometime between 1991 and 2002. A debris flow scar was detected on March 2003 imagery, and previous site topographic mapping, including the recent mapping used for the base of Plate 2, reveal concave upward deflections indicative of past, localized erosion on the lower part of the slope within, and adjacent to the mapped limits of the recent landslide.

Photo 1. Southwesterly oblique view of property uphill of affected slope. Homes at top on Loma Rd.

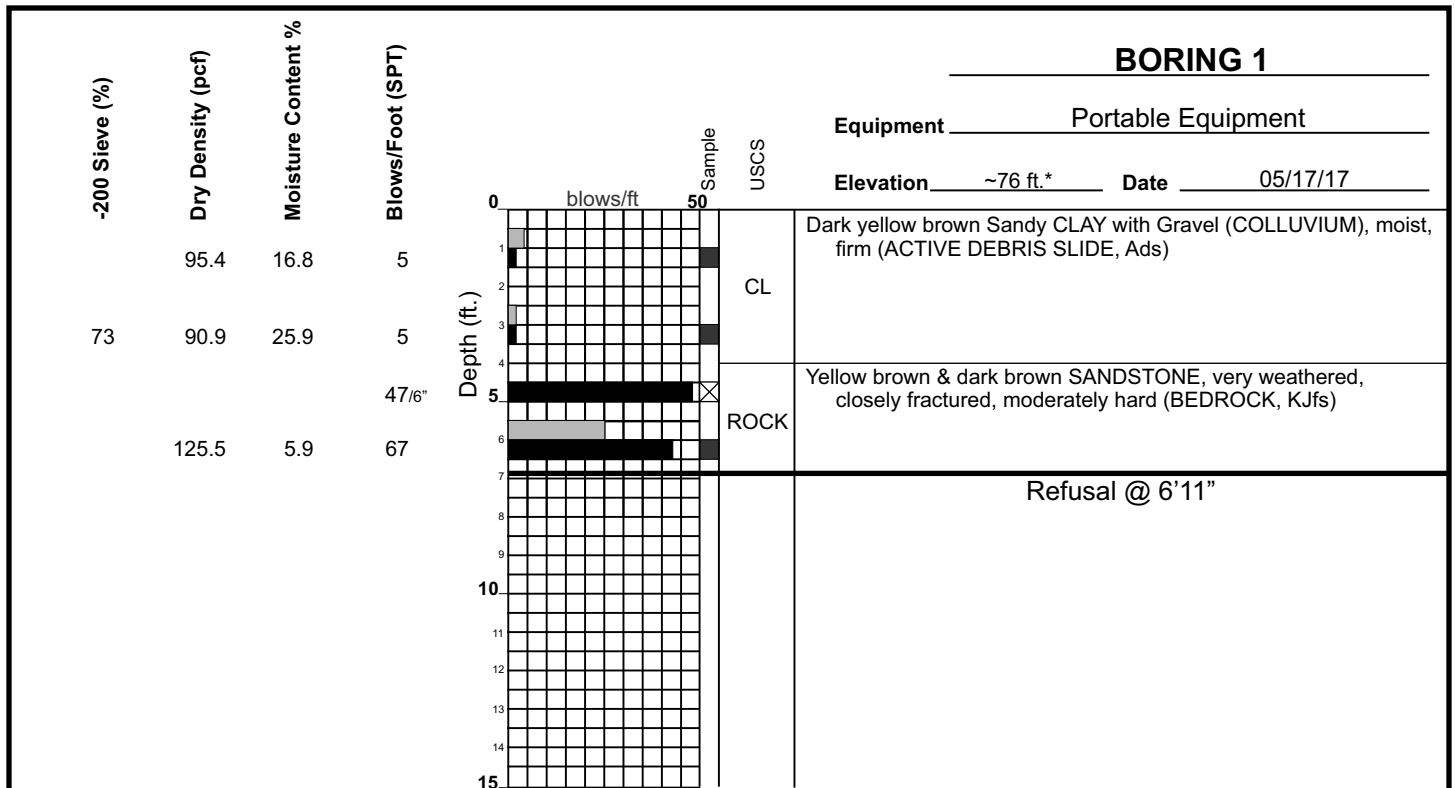
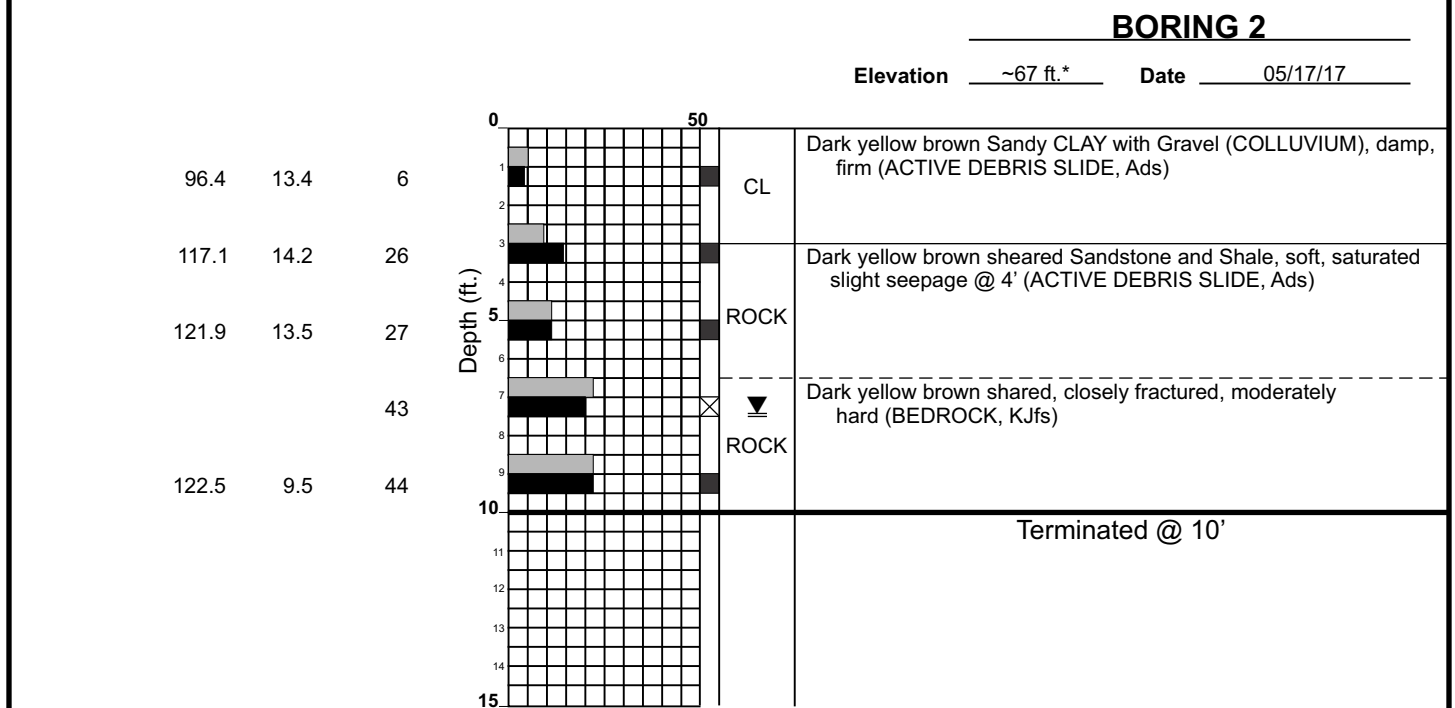
Earth Investigations Consultants, Inc.	Job No.: 2572.01.01 Approved By: JEB Date: 04/11/17	LOGS OF BORINGS 1 & 2 634 Palomar Drive Redwood City, California	Plate A1
---	---	---	-------------------------------

*approximate elevation from Giuliani & Kull, Inc. Sheet 1 dated 03/24/17
 water level @ approximately 7½' post drilling

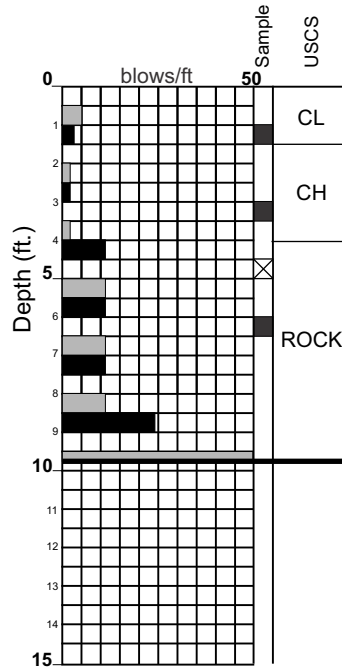
LOG OF BORING 3

Yellow brown Sandy CLAY with Gravel, moist, firm (ACTIVE DEBRIS SLIDE, Ads)

Dark yellow brown Sandy CLAY, damp, firm color grades to yellow brown @ 2'; sheared; very plastic CLAY (basal rupture surface) @ 3½'

Dark yellow brown SHEARED ROCK, very weathered, closely fractured, soft (BEDROCK, KJfs)
