# Tree Management Experts

RE: 634 Palomar Drive  
Redwood City, CA 94062

## ARBORIST REPORT

#### Arborist Report and Tree Protection Plan

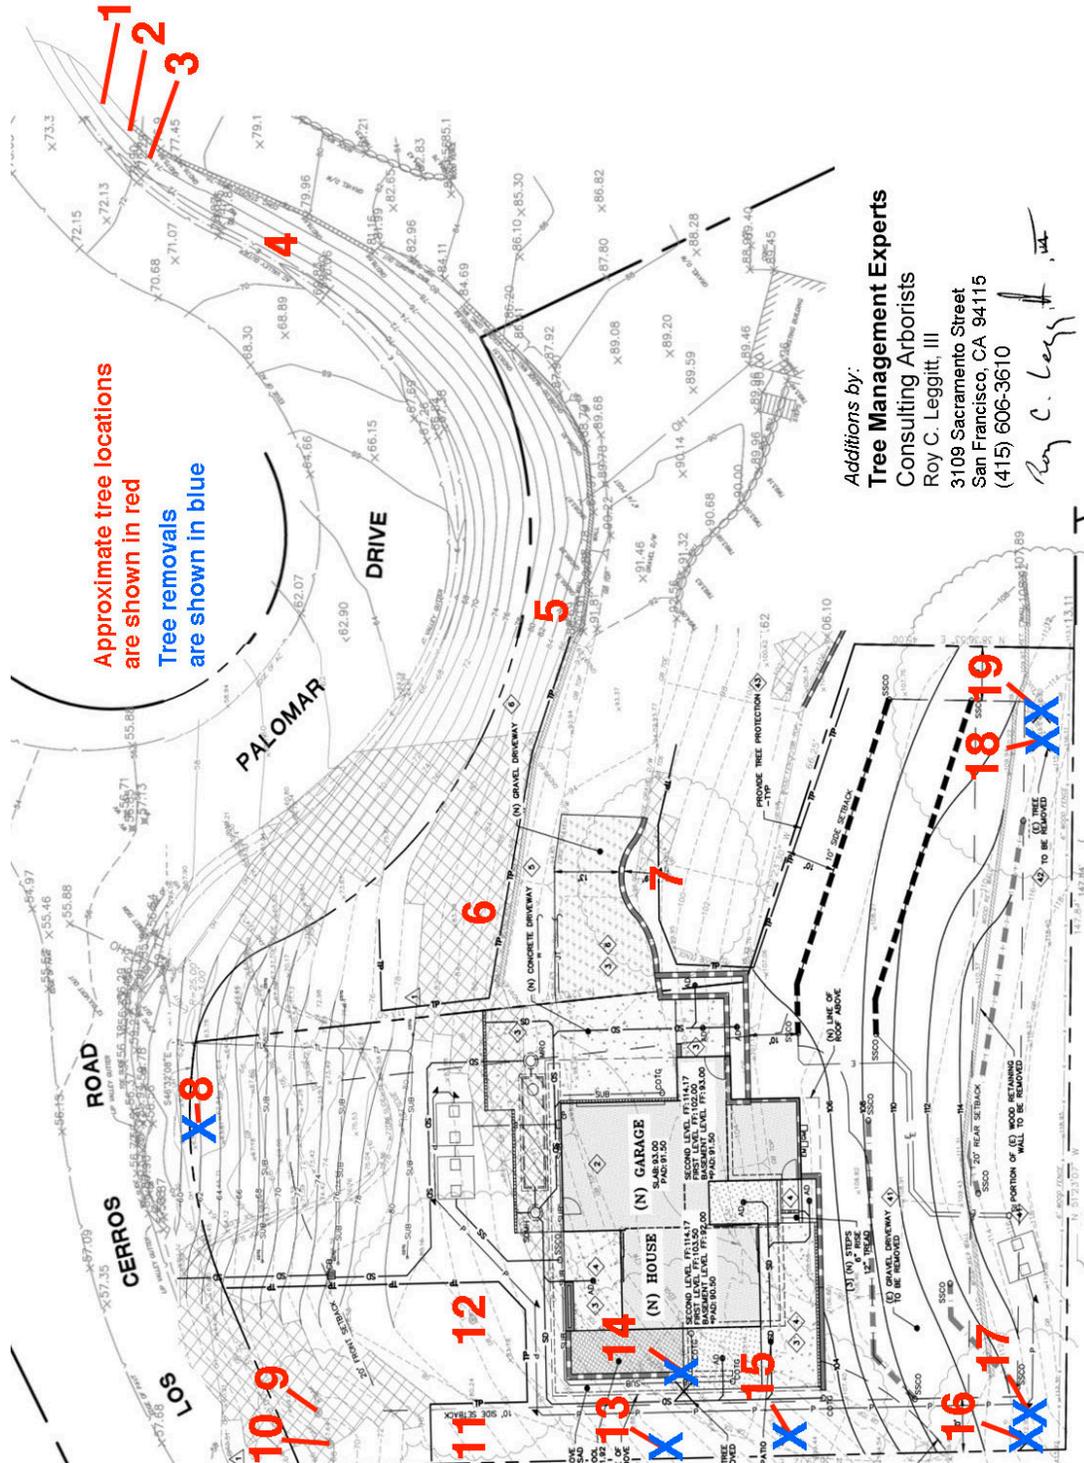
## Tree Removal Plan

A total of 8 trees must be removed due to poor health or structure, for purposes of construction, or both poor condition and construction. California bay carries sudden oak death, and this small tree should be removed to protect the health of the nearby coast live oaks. See page 10.

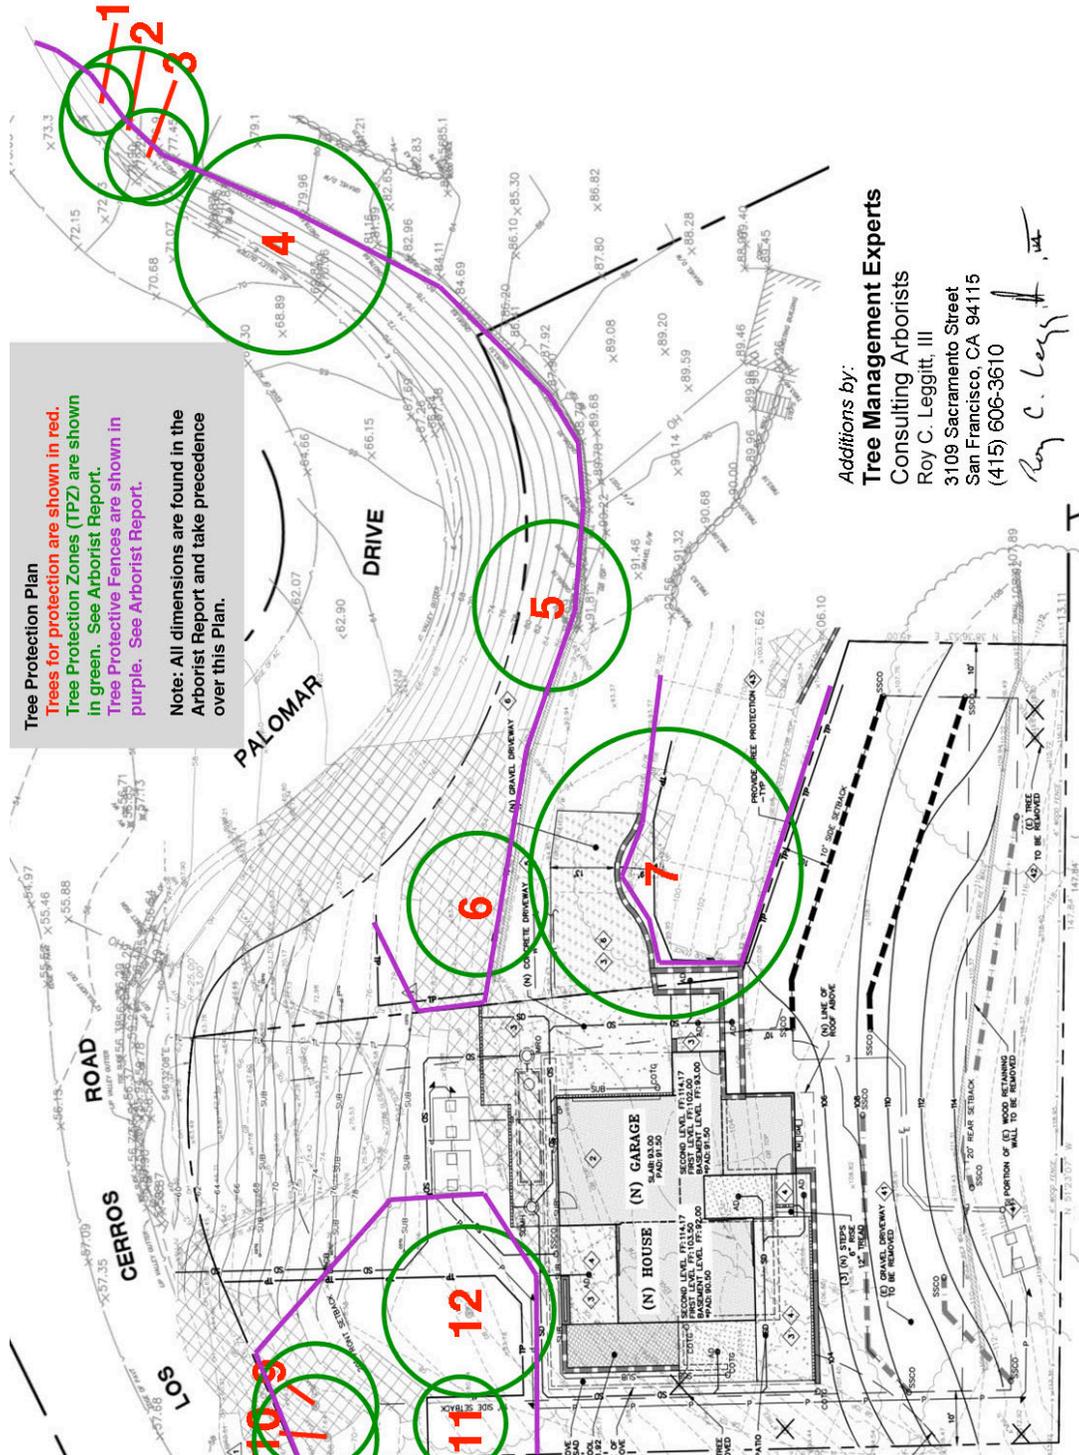
## Tree Protection Plan

A Tree Protection Zone (TPZ) has been established for each remaining tree. Because of the landslide repairs, potential for grading, building footprint, leach field and retaining walls, all trees will be affected by construction, both along the driveway and on this property. The TPZ areas are graphically illustrated on the Tree Protection Plan (page 11), and the measured radius distances are shown in Table 3.0 below. If there is any difference, the measured radius distances in Table 3.0 will take precedence. Whenever

Placement: all fence installation lines are indicated on the Site Plan. Trees affected will include Trees 1, 2, 3, 4, 5, 6, 7, 9, 10, 11 and 12.

Type and Size: 5 or 6-foot high chain link fencing shall be placed on 2 inch tubular galvanized iron posts driven a minimum of 2 feet into undisturbed soil and spaced not more than 10 feet on center.
