AMENDMENT
Arborist Assessment for Whitewood-29 in Murrieta

Arborist Assessment for Whitewood-29 in Murrieta

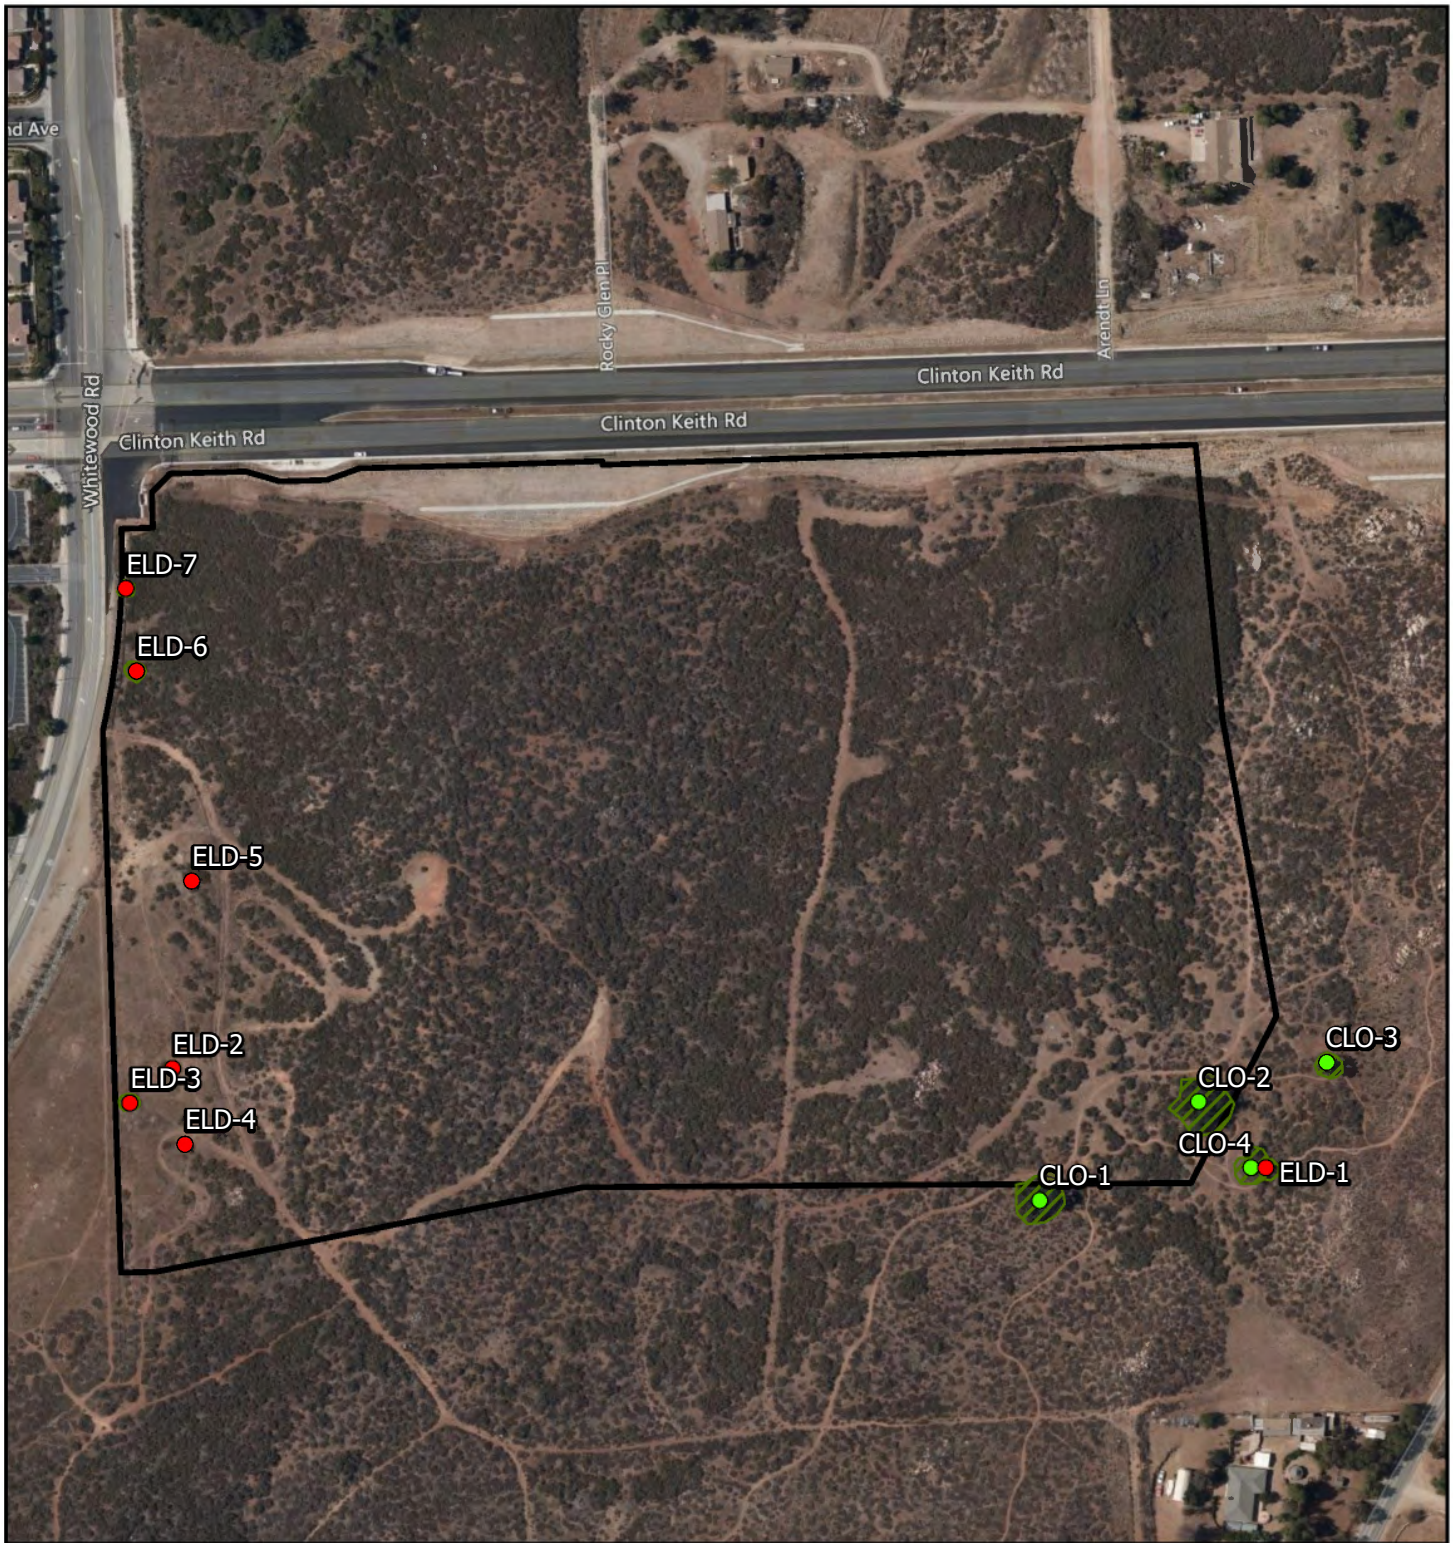
Figure 3. Tree Survey

All of the surveyed trees were rated in good to maximum health with generally good structure. The oak trees were mature with generous spreads. We observed no dead trees in the survey. Of the oaks, one tree (CLO-2) has a severe ant infestation on the main trunk. CLO-4 has one large dead main stem; and CLO-3 has a cavity in the trunk and has lost some large limbs.

elderberry trees (ELD-1) and three of the oak trees—CLO-1, CLO-3, CLO-4—fall outside the limits of construction and can be saved. They will need to be protected with fencing during construction. (*See Appendix C, Tree Preservation Guidelines.*) If possible, the project should avoid them or incorporate them into the design.
