Tree Resource Analysis

80-12 Industrial Center 300 Chadbourne Road, Fairfield CA APNs 028-750-240/50/60/70/80/90 & 300

Consulting Arborists

831.426.6603 office 831.234.7739 mobile Prepared for Dr. Terry Huffman, PhD Huffman-Broadway Group, Inc.

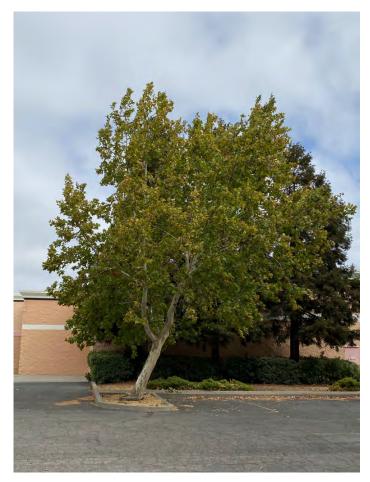
The site is subject to frequent, strong wind forces developing from the western direction. The western side of the more exposed trees display "burned" and thinning canopies typical of those affected by high winds, low soil moisture levels and/or salinity influences.

Many trees lean dramatically to the East as a direct result of the high winds.

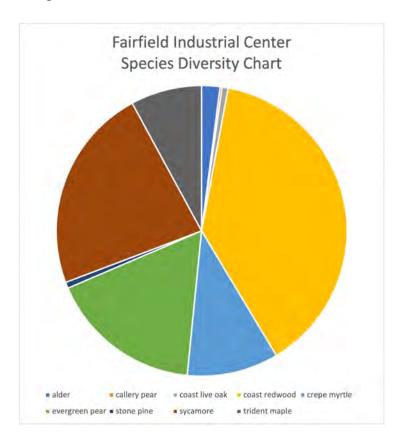
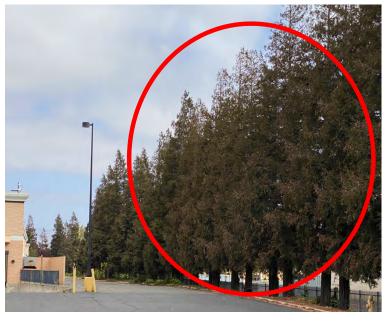
Coast redwood is the dominant species on this site representing 50% of the resource. They line the North, East and south property boundary, the main entry road and the entrance to the existing building. Preservation suitability for this species is generally rated as "Good" except for those individuals with poor trunk/stem attachments and/or wind-burned canopies. Individual trees displaying these conditions have been assigned a "Fair" preservation suitability

The western side of the canopy apex and lower canopies of the more exposed trees display "burned" and thin canopies typical of those influenced by high winds, low soil moisture levels and/or salinity effects.

Proposed grading in proximity to coast redwoods should respect Critical Root Zone (CRZ)extents of 18 to 24 radial feet from tree trunks.

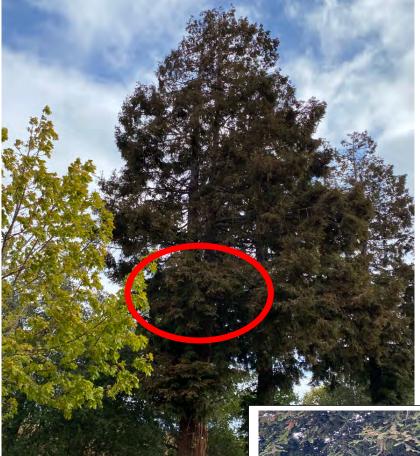
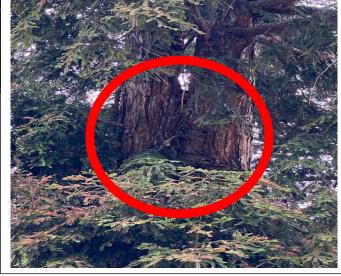
Many trees have serious, structurally weak conditions that have been in place since they were planted, validating that the nursery stock procured was of very poor quality and unsuitable for planting. Several trees have <u>poor trunk/stem attachments</u>: codominant stems with included bark, a system typical of those prone to failure. Codominant stems are by definition a structural defect.

They consist of stems that are of similar size that originate from the same position on the trunk. In cases where the bark ridge turns inward the union between the two stems is much weaker. These types of attachments with included bark do not form connective tissues between the stems. The stems push against one another as they develop, literally growing themselves apart.

Canopy weight exerts additional stresses on the weak attachment point(s). Weak unions of this type are hazardous; they can open and crack when stresses are applied to the upper crown of the tree. These conditions are typical of systems prone to failure and can create high risk conditions in the landscape.

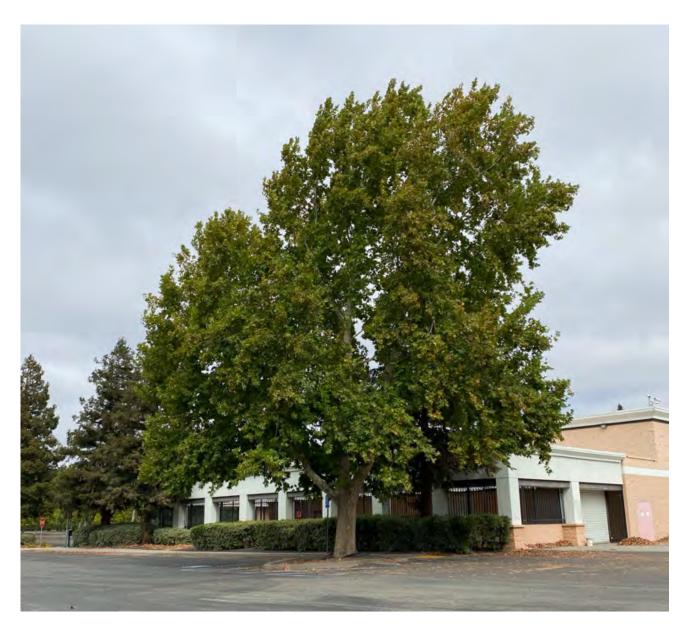
Sycamore trees represent 22% of the tree population. This species has acclimated well to this site, displaying healthy, vibrant canopies with good annual growth rates. Most of the sycamore trees have been assigned "Good" preservation suitability ratings unless they have exaggerated leans, poor trunk/stem attachments or are in decline.

Growth rates have resulted in over-weighted-extended branching that is at risk of breakage. Regular maintenance pruning would correct and effectively manage risk of branch breakage. Tree #49, pictured below is an excellent specimen with a high potential for branch failure due to rapid growth rates.

Proposed grading in proximity to the sycamore should respect Critical Root Zone (CRZ) extents of 8 to 20 radial feet from tree trunks depending on the size of the individual tree.

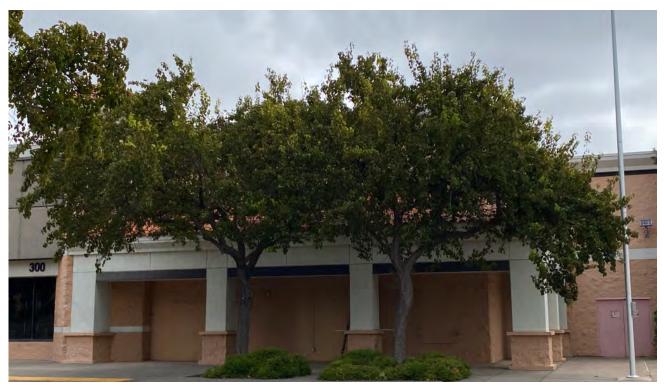
Evergreen pear composes 17% of the species on site. This species has been assigned "Fair to Poor" preservation suitability ratings. Many individuals of this species have asymmetrical canopies with over-weighted-extended branching. There are several branch failures visible within this species.

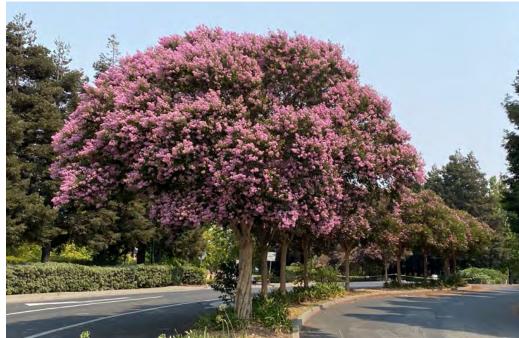
Crepe myrtle represent approximately 10% of the tree population and have performed well.

Preservation
Suitability is rated as "Good" with
CRZ extents
ranging from 8 to
14 feet from the
trunk of the tree.

Proposed grading in proximity to the evergreen pear and crepe myrtle should respect CRZ extents of 8 to 14 radial feet from tree trunks depending on the size of the individual tree.

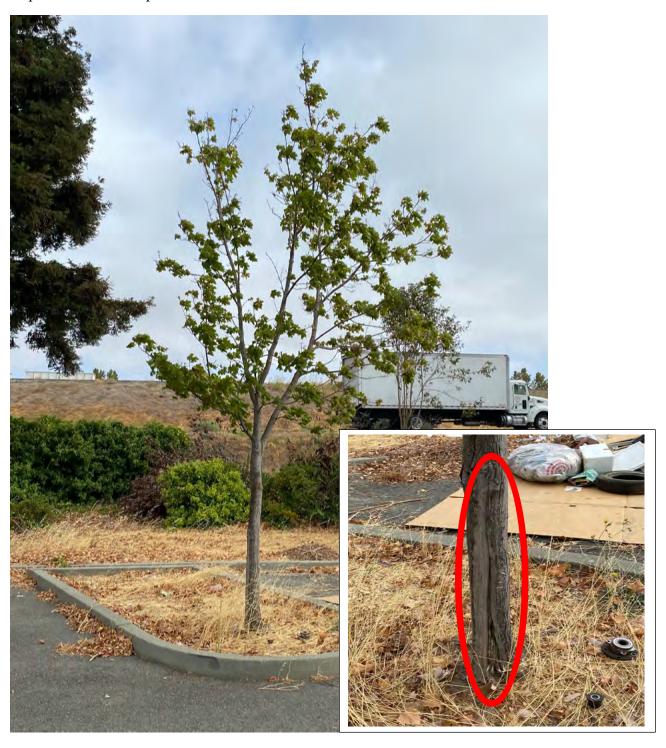
There are 35 trident maple trees on the project that have not performed well. Preservation Suitability ratings assigned to this species are mostly "Poor". Severe decay develops in the lower trunk area as depicted in the inset photo below.

This species as well as stone pine and plum species are not recommended for preservation and incorporation into the proposed project.
