Tree Survey Report

Roseland Creek Community Park SANTA ROSA, SONOMA COUNTY, CALIFORNIA

Date: October 2019

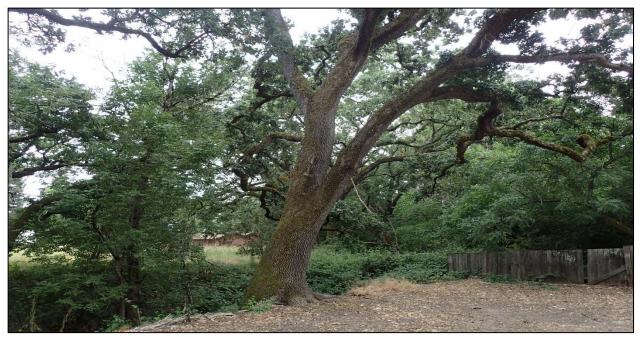
Tree #3. 43.0" DBH valley oak(*Quercus lobata*) in the southern portion of the Study Area adjacent to Roseland Creek.

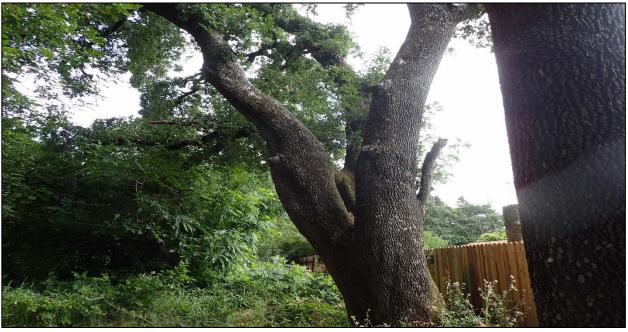
Tree # 113. 61.5" DBH valley oak(Quercus lobata) in the southeastern portion of the Study Area.

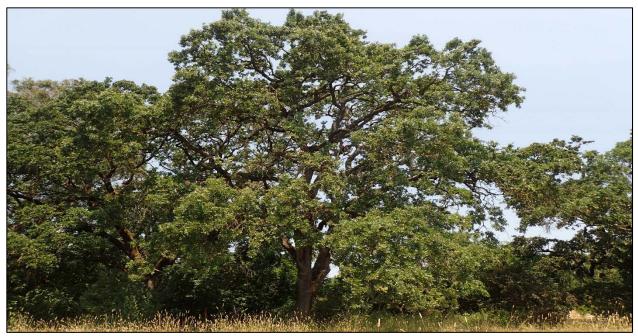
Tree #47. 39.0" DBH valley oak(*Quercus lobata*) in the southern portion of the Study Area.

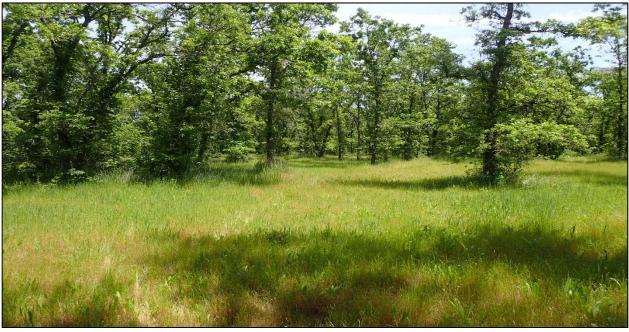
Representative photo of tree spacing in northern portion of the Study Area.
