# Exhibit C-1

**PJC & Associates, Inc.**

Job No. 9479.01

Subject: Stability Report & Landslide Repair  
Proposed Vineyard  
1889 West Zinfandel Lane  
St. Helena, California

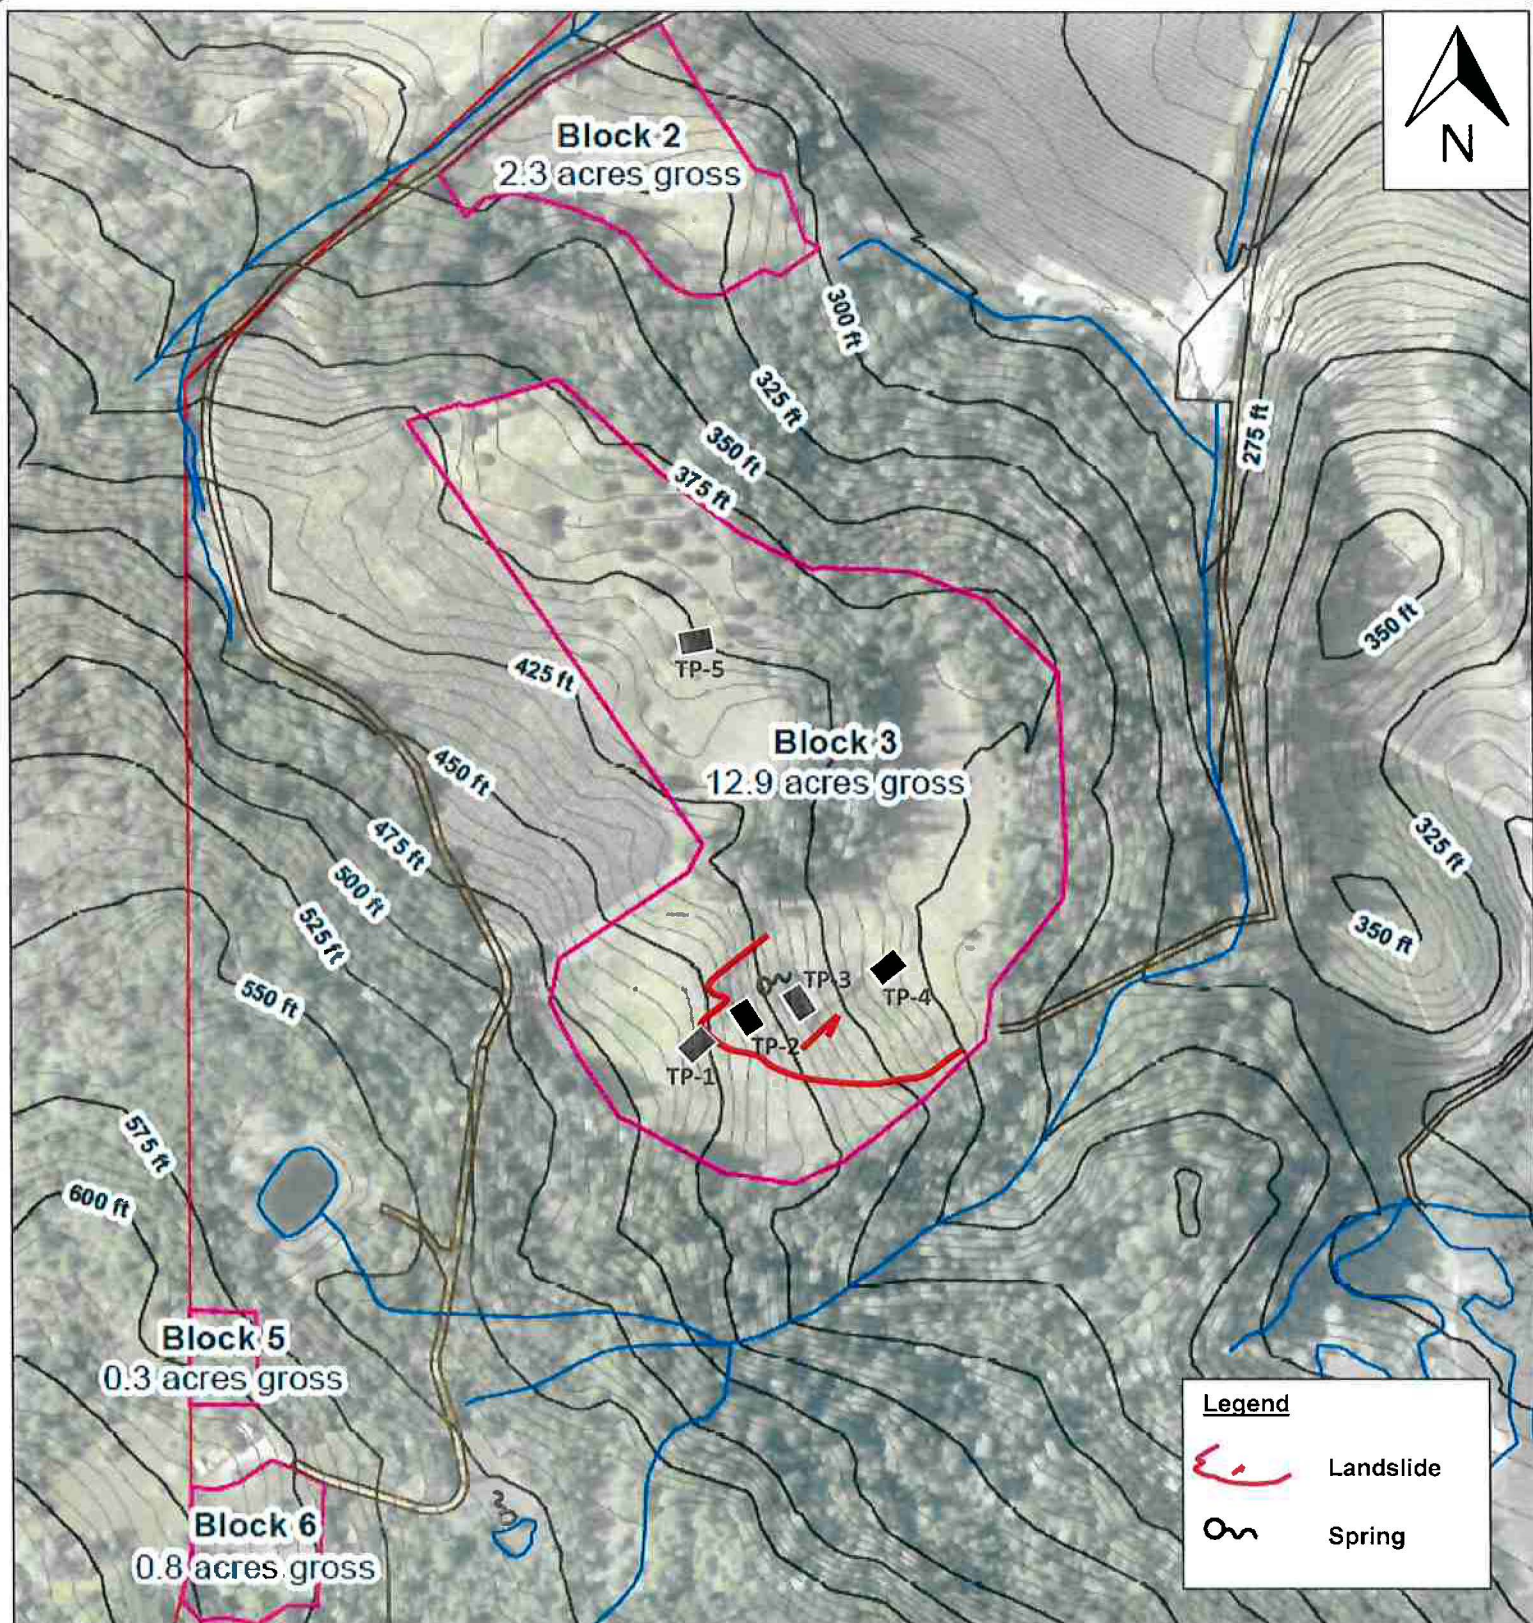
TEST PIT LOCATION MAP  
PROPOSED VINEYARD  
1889 WEST ZINFANDEL LANE  
ST. HELENA, CALIFORNIA

- a. General. Subsurface conditions were investigated by excavating five exploratory test pits (TP-1 through TP-5), three of which were located within the landslide area. The approximate test pit locations are shown on Plate 2. Test pit depths ranged from 6.5 to 12 feet below the ground surface. The test pits were excavated to observe the soil, bedrock, and groundwater conditions and to collect samples of the underlying soils for visual examination and laboratory testing. The excavation and sampling procedures, laboratory procedures, and test pit logs are presented in Appendices A and B, respectively.

- b. Local Landslide. The previously mentioned active landslide was observed in the southern margin of Block 3. The landslide covers an area of just over one acre and is covered in perennial grasses with a few blackberry brambles. The landslide consists of a translation block landslide which occurred due to the presence of weak clayey materials, slippery serpentinite bedrock, and poor surface and subsurface drainage conditions. The landslide occurred in a concave topographic feature with adverse geologic conditions. A map presenting the location of the mapped landslide is shown on Plate 2.

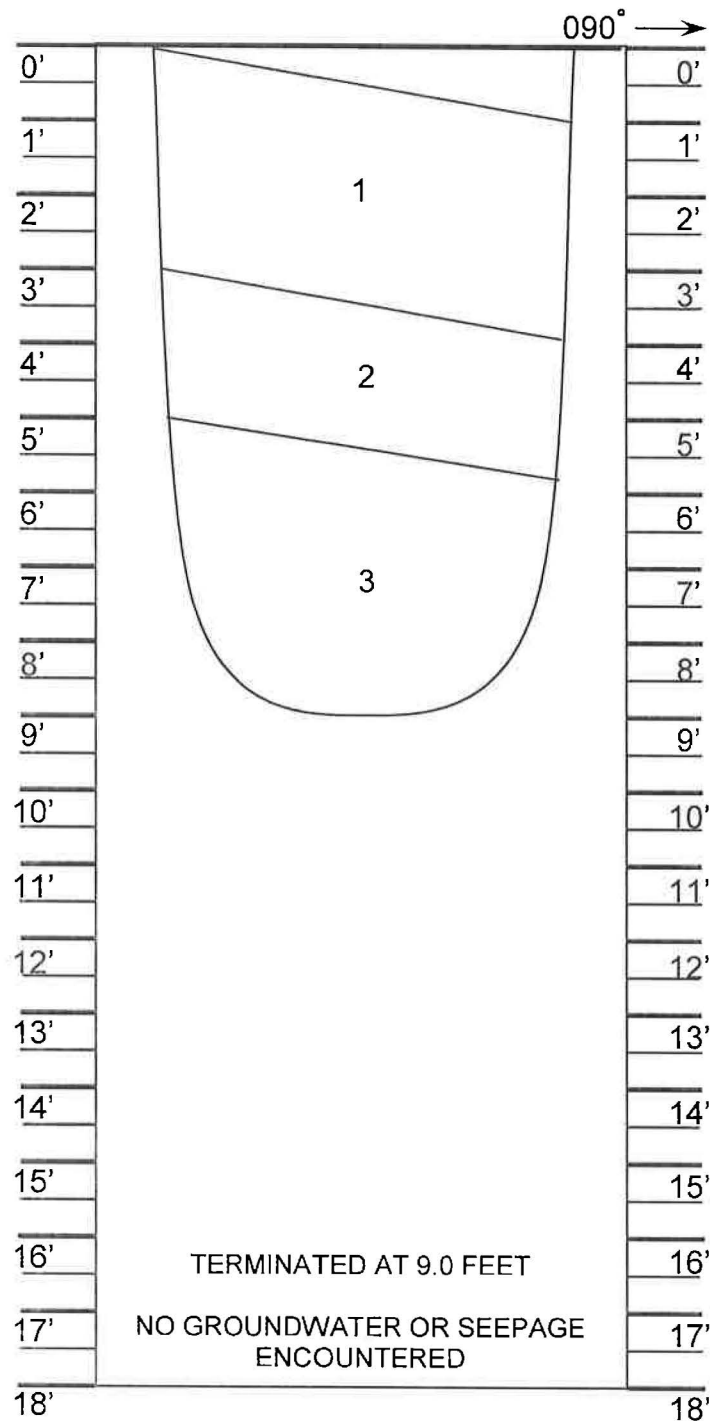
**LOG OF TEST PIT 1**  
**PROPOSED VINEYARD**  
**1889 WEST ZINFANDEL LANE**  
**ST HELENA, CALIFORNIA**

TP-1 was excavated southwest of the head scarp of the landslide. The test pit encountered three feet of sandy clay colluvium. The colluvium was very moist, medium stiff, exhibited high plasticity characteristics and desiccation cracks. Underlying the colluvium, a gravelly clay residual soil layer was encountered which extended 3 to 5 feet below the ground surface. This stratum appeared very moist, very stiff, exhibited high plasticity, and contained fine to coarse subangular gravels. Underlying this layer, an additional residual soil stratum of clayey gravel was encountered, which extended to the maximum depth explored. This layer appeared very moist, dense, and contained fine to coarse subangular serpentinite cobbles in a clay matrix.

- 1) 0.0'-3.0'; SANDY CLAY (CH); grayish brown, very moist, medium stiff, high plasticity, with desiccation cracks (COLLUVIUM).
- 2) 3.0'-5.0'; GRAVELLY CLAY (CL); grayish green, very moist, very stiff, high plasticity, with fine to coarse subangular gravels (RESIDUAL SOIL).
- 3) 5.0'-9.0'; CLAYEY GRAVEL (GC); grayish green, very moist, dense, fine to coarse subangular serpentinite cobbles in clay matrix (RESIDUAL SOIL).

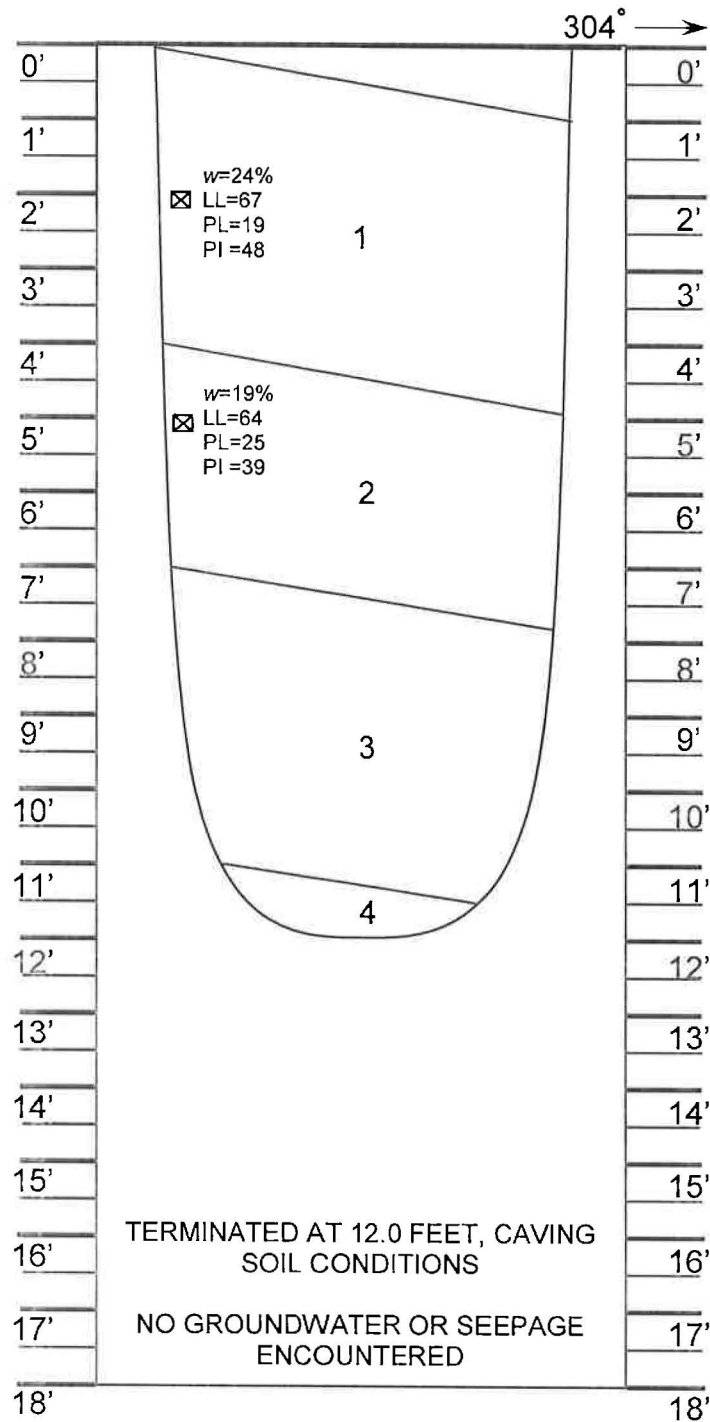
LOG OF TEST PIT 2  
PROPOSED VINEYARD  
1889 WEST ZINFANDEL LANE  
ST HELENA, CALIFORNIA

TP-2 and TP-3 were excavated in the middle of the landslide mass. The landslide deposits encountered consisted of sandy clay and extended 7 to 10 feet below the existing ground surface. The layers appeared moist to very moist, medium stiff to very stiff, and exhibited high plasticity characteristics. Underlying the landslide deposits in TP-2, sandy & silty clay residual strata were encountered which extended to the maximum depth explored. This strata appeared moist to very moist, very stiff, and exhibited high plasticity characteristics. Underlying the landslide deposit in TP-3, evidence of a landslide plane was observed, which extended 10 to 10.5 feet in depth. This layer appeared very moist, stiff, exhibited high plasticity, and contained obvious slickensided (polished) surfaces. Underlying this stratum, serpentinite bedrock was encountered which extended to the maximum explored depth of 12 feet. The bedrock appeared moderately hard, weak, and highly weathered.

- 1) 0.0'-4.0'; SANDY CLAY (CH); dark gray, very moist, medium stiff, high plasticity, with boulders (LANDSLIDE DEPOSIT).
- 2) 4.0'-7.0'; SANDY CLAY (CH); greenish orange, moist to very moist, stiff to very stiff, high plasticity, polished surfaces at 5-6'- steeply dipping downslope (LANDSLIDE DEPOSIT).
- 3) 7.0'-11.0'; SANDY CLAY (CH); greenish orange, very moist, very stiff, high plasticity, few subangular gravels (RESIDUAL SOIL).
- 4) 11.0'-12.0'; SILTY CLAY (CH), light gray, moist, very stiff, high plasticity (RESIDUAL SOIL).

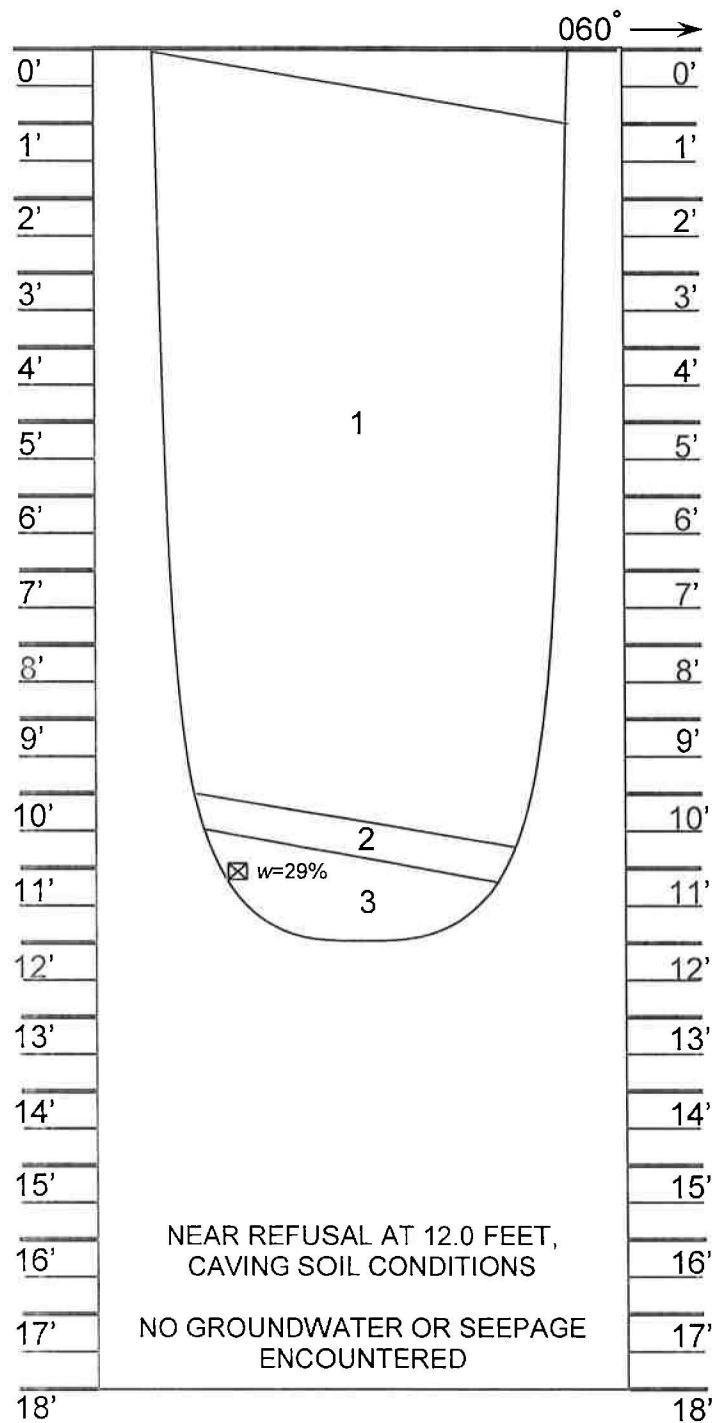
LOG OF TEST PIT 3  
PROPOSED VINEYARD  
1889 WEST ZINFANDEL LANE  
ST HELENA, CALIFORNIA

- 1) 0.0'-10.0'; SANDY CLAY (CH); grayish brown, very moist, medium stiff, high plasticity, with subangular gravels (LANDSLIDE DEPOSIT).
- 2) 10.0'-10.5'; SANDY CLAY (CL); yellowish orange, very moist, stiff, high plasticity, slickensides (LANDSLIDE PLANE).
- 3) 10.5'-12.0'; SERPENTINITE (sp); yellowish orange, moderately hard, weak, highly weathered (BEDROCK).

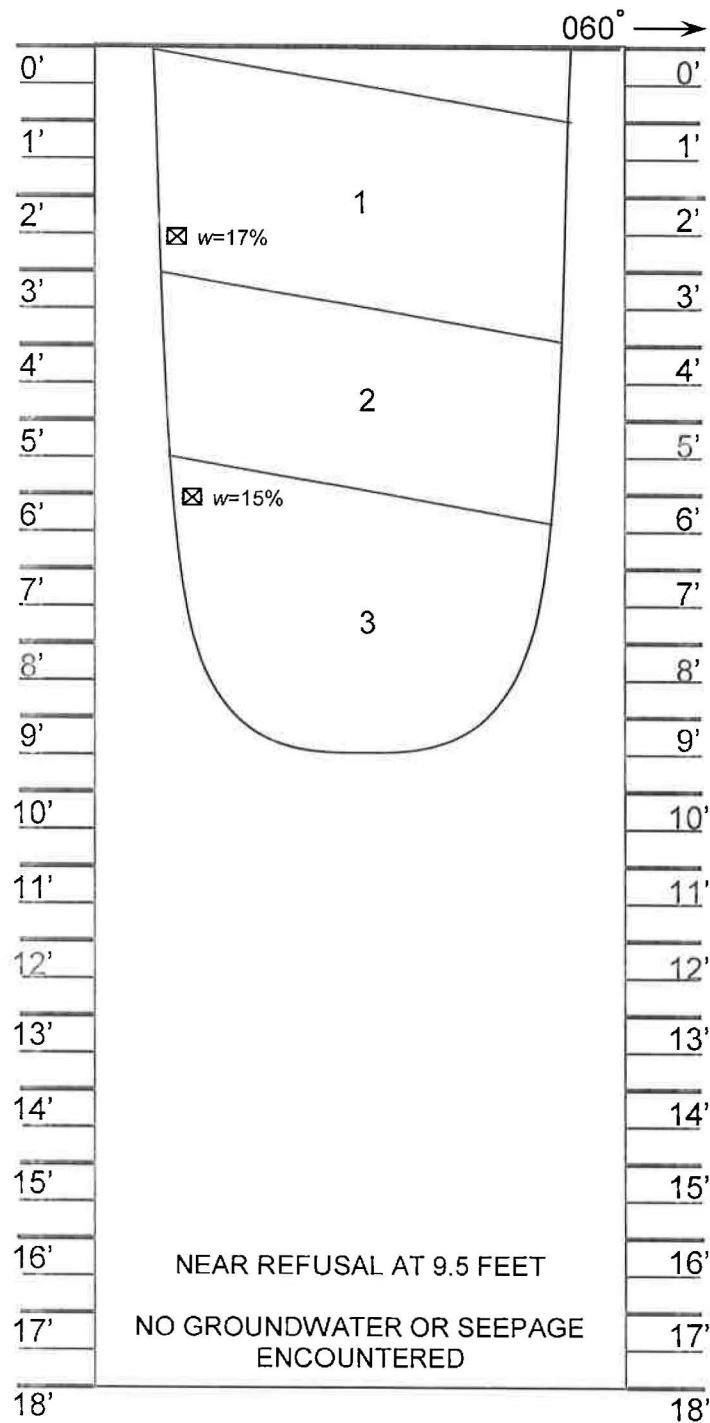
**LOG OF TEST PIT 4  
PROPOSED VINEYARD  
1889 WEST ZINFANDEL LANE  
ST HELENA, CALIFORNIA**

TP-4, which was excavated at the toe of the landslide mass and encountered landslide deposits overlying serpentinite bedrock. The landslide deposits consisted of sandy clay which extended to 5.5 feet below the ground surface. The deposits appeared moist to very moist, medium stiff to stiff, exhibited high plasticity, and contained rock fragments. Underlying the deposits, the serpentinite bedrock encountered extended to the maximum depth explored. The bedrock appeared moderately hard, weak, and highly weathered.

- 1) 0.0'-3.0'; SANDY CLAY (CH); dark black, moist, medium stiff, high plasticity, organic-rich (LANDSLIDE DEPOSIT).
- 2) 3.0'-5.5'; SANDY CLAY (CH); yellowish brown, very moist, stiff, high plasticity, with rock fragments (LANDSLIDE DEPOSIT).
- 3) 5.5'-9.5'; SERPENTINITE (sp); yellowish orange, moderately hard, weak, highly weathered (BEDROCK).

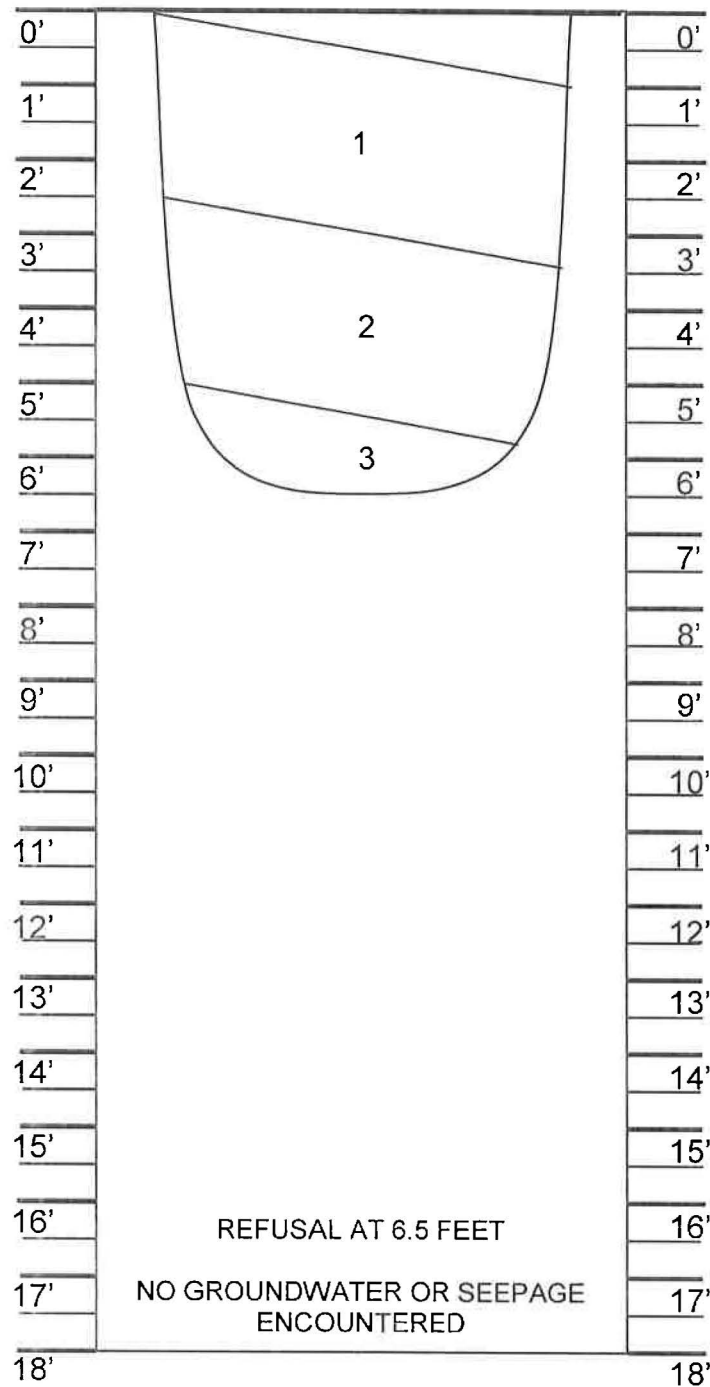
LOG OF TEST PIT 5  
PROPOSED VINEYARD  
1889 WEST ZINFANDEL LANE  
ST HELENA, CALIFORNIA

TP-5, excavated in the northern portion of Block 3 and well out of the landslide, encountered colluvial surface & near surface layers which extended approximately 5 feet below the surface. This stratum was composed of sandy clay which appeared very moist, stiff to very stiff, and exhibited high plasticity characteristics.

- 1) 0.0'-2.5'; SANDY CLAY (CH); dark brown, very moist, stiff, high plasticity, organic-rich (COLLUVIUM).
- 2) 2.5'-5.0'; SANDY CLAY (CH); moderate brown, very moist, very stiff, high plasticity (COLLUVIUM).
- 3) 5.0'-6.5'; SERPENTINITE BOULDERS IN CLAY (CL); greenish gray, moist, dense, fine to coarse subangular serpentinite boulders (RESIDUAL SOIL).
