# ROXFORD WAREHOUSE PROTECTED TREE REPORT

## 15825 ROXFORD STREET PROJECT

CITY OF LOS ANGELES, LOS ANGELES COUNTY, CALIFORNIA

WRA #30236  
MAY 2022

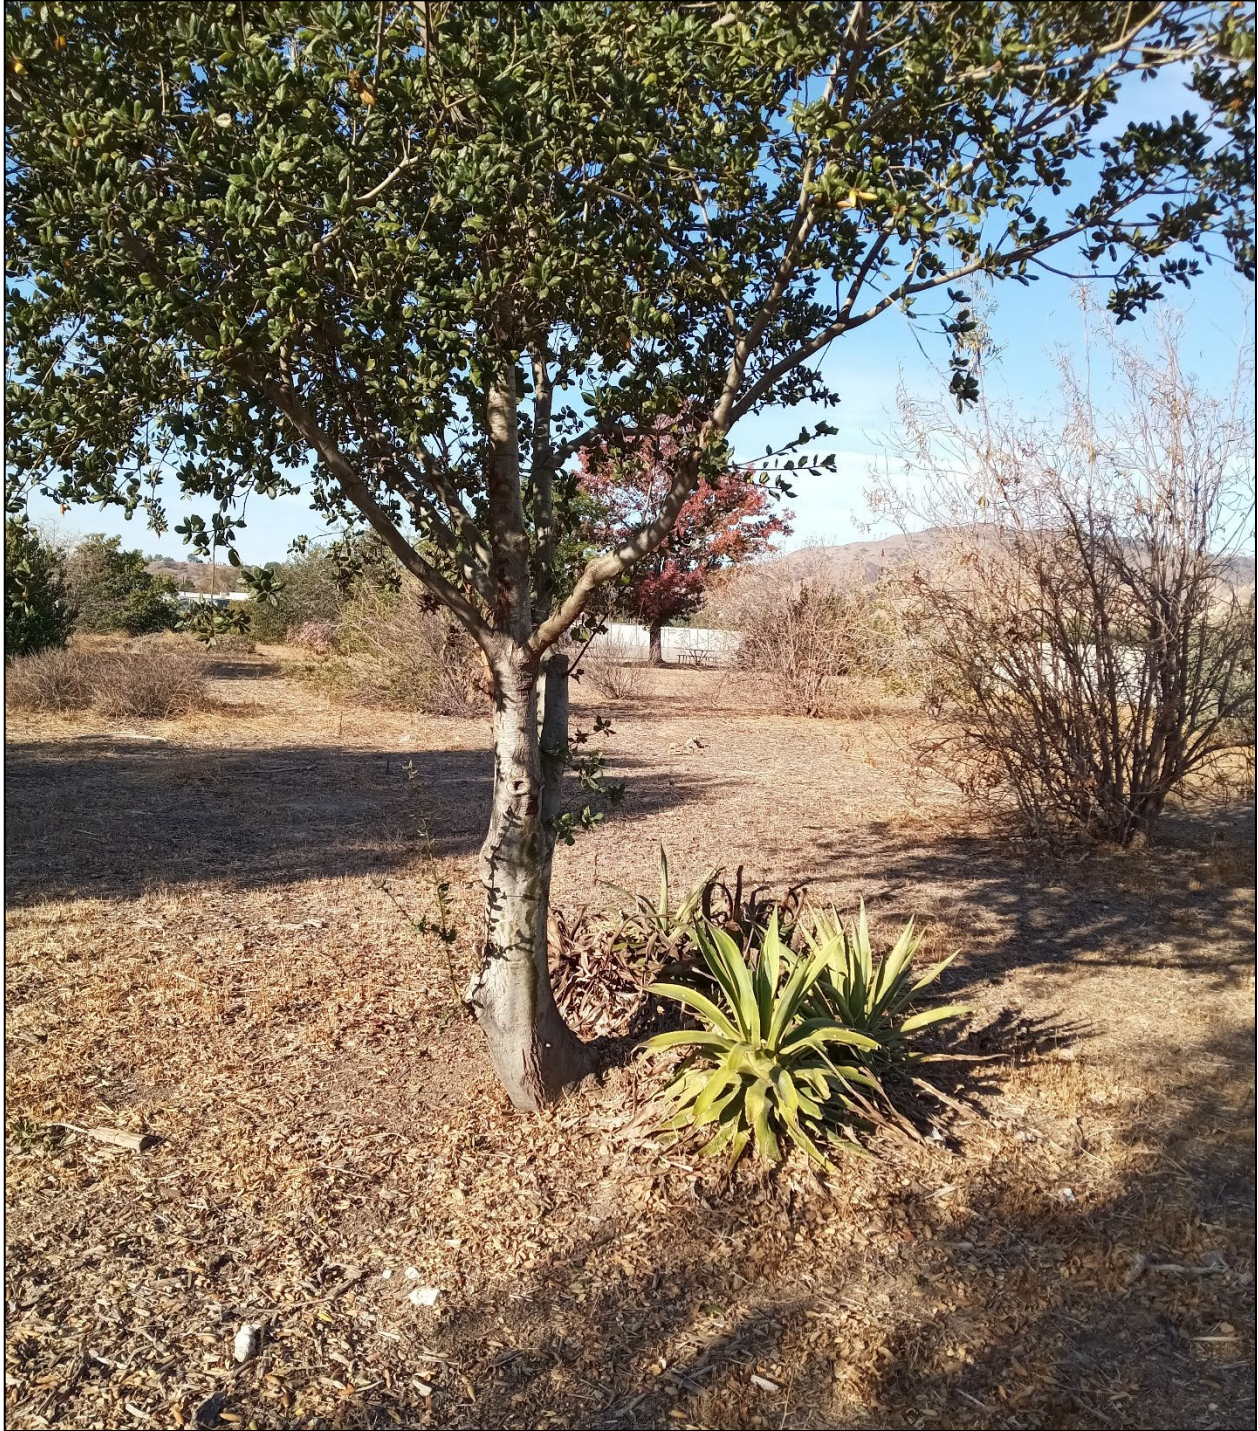
**Photograph 1.** Tree 231 is a protected 10.12-inch (multi) trunk coast live oak (*Quercus agrifolia*) located in the north center portion of the Project Area.

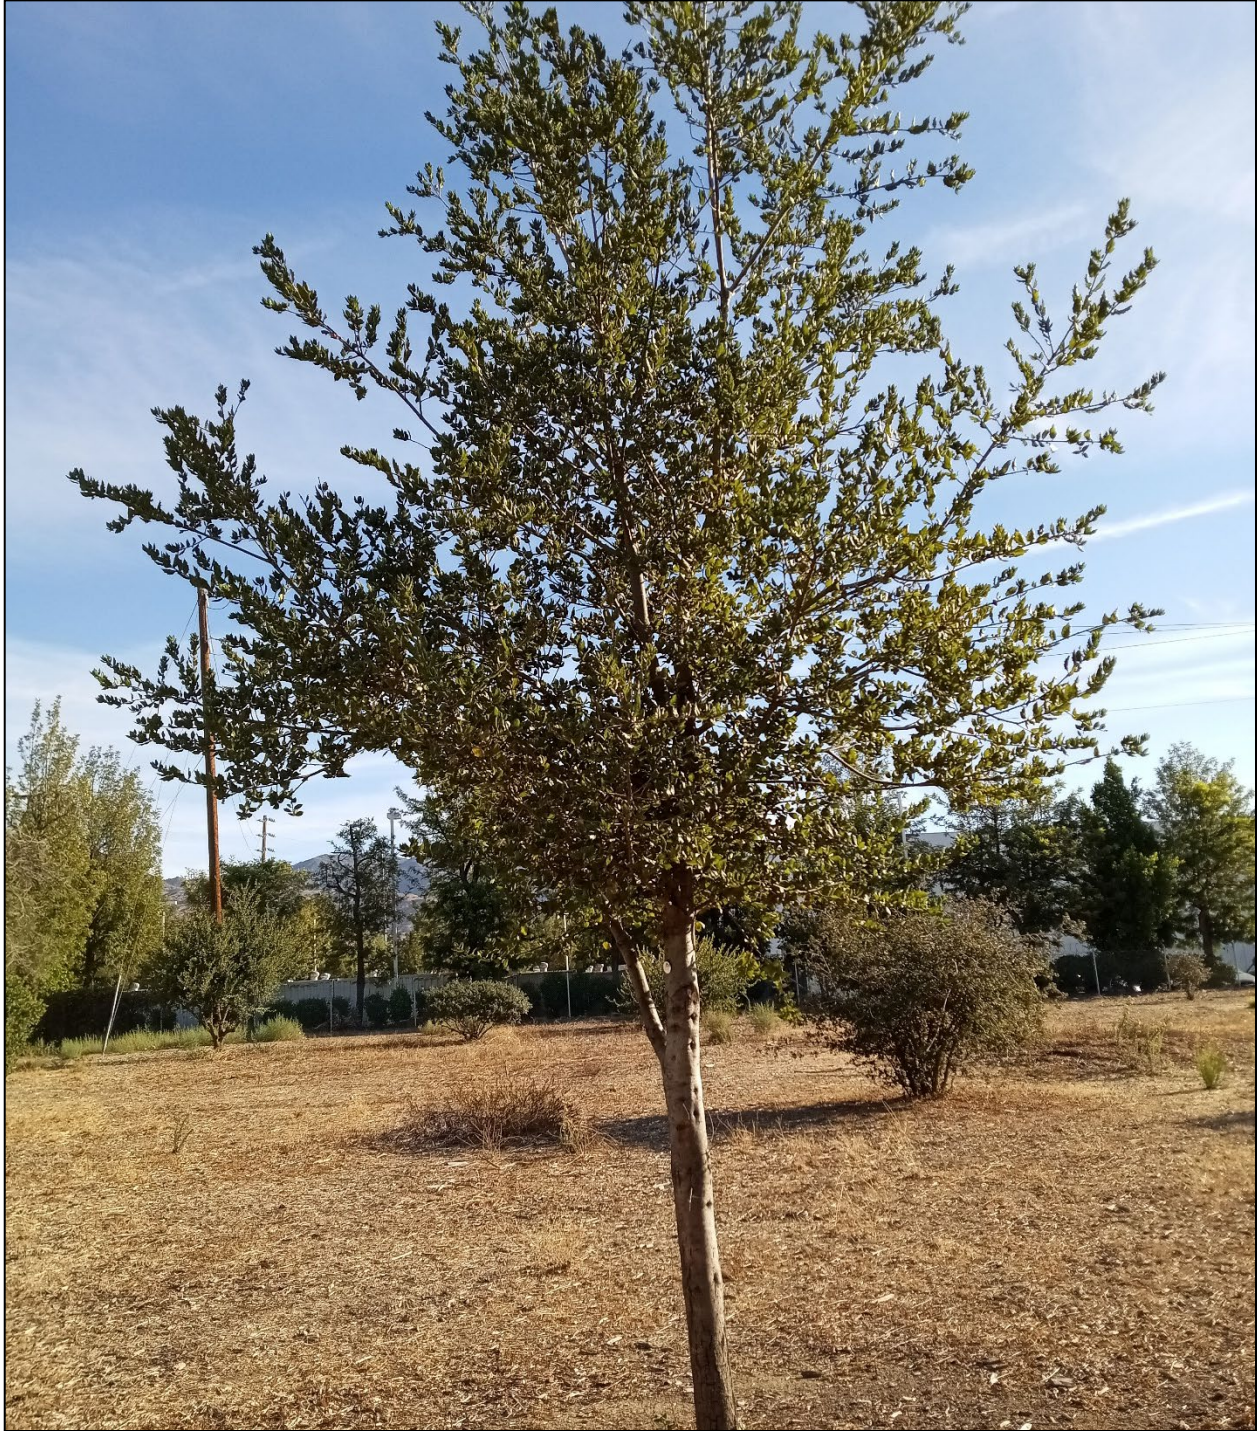
**Photograph 2.** Tree 232, a 5.4-inch protected (multi) trunk coast live oak protected tree located in the northern boundary portion of the Project Area with potential impacts.

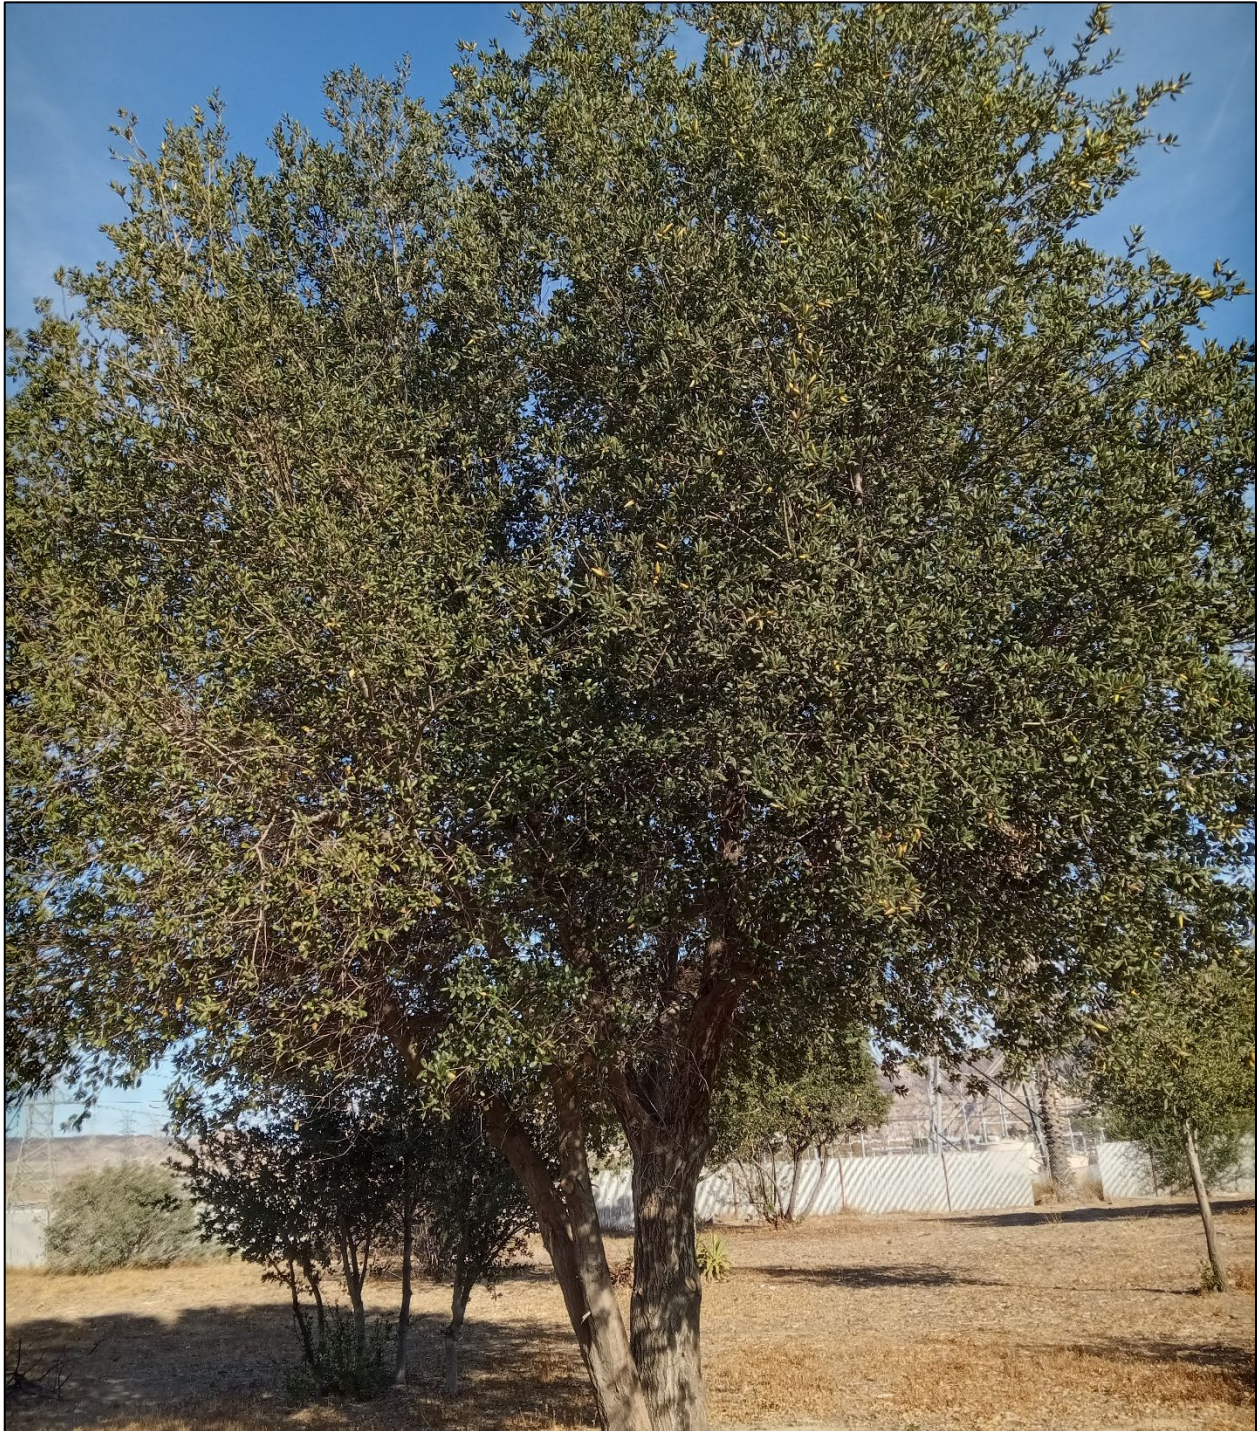
**Photograph 3.** Tree 233, a 24.30 protected (multi) trunk coast live oak protected tree at the north portion of the Project Area.

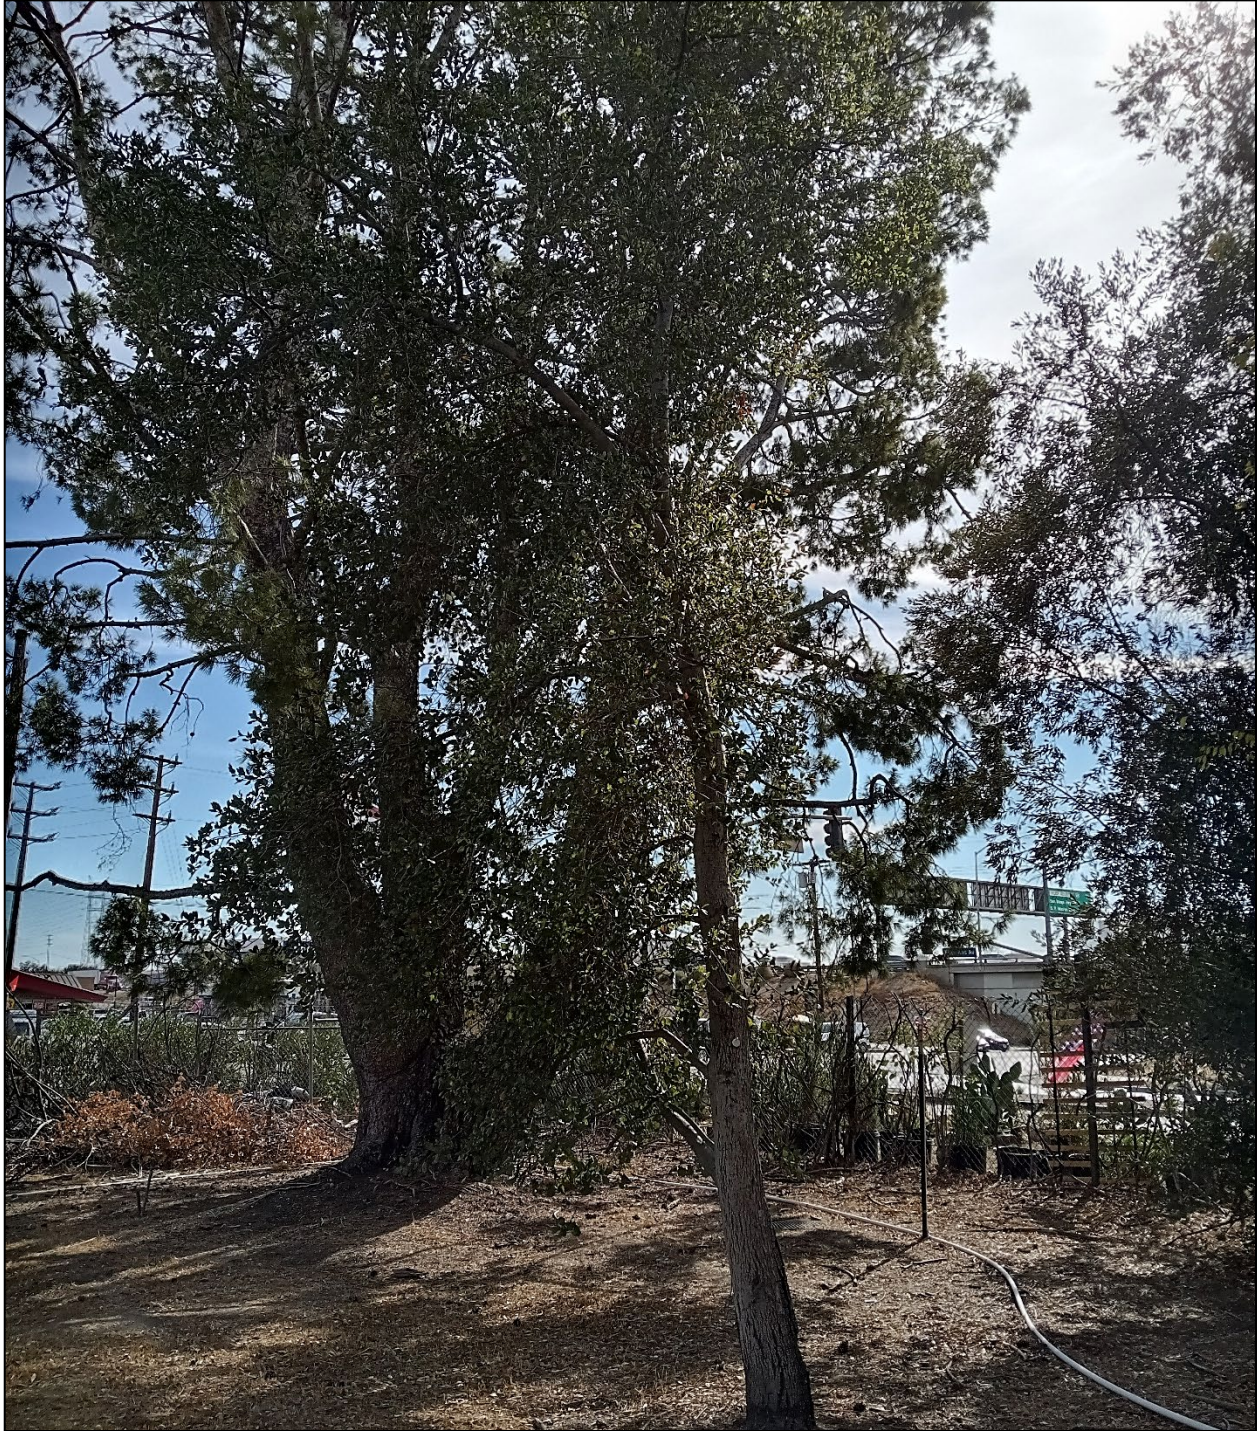
**Photographs 4.** Tree 335 is a protected 6.15-inch (single) trunk coast live oak with fair structure, located in the southwest part of the Project Area adjacent to a highway on ramp.

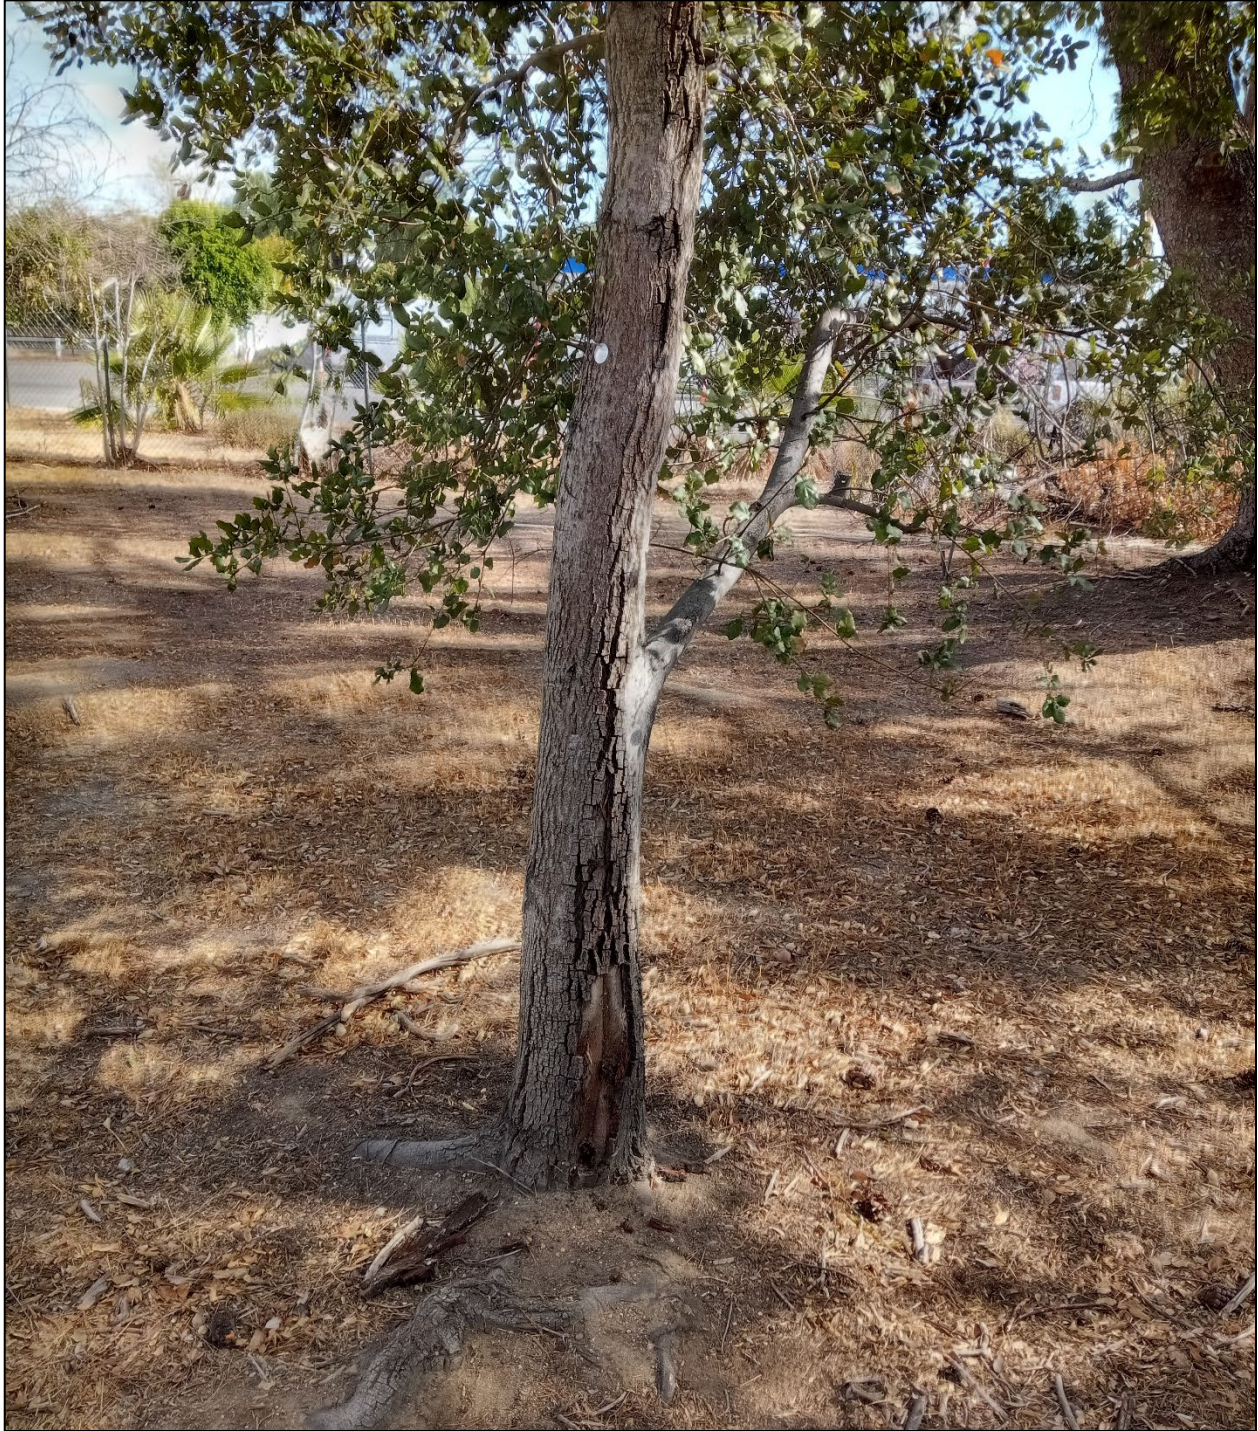
**Photograph 5.** Tree 335 at a different angle showing some cracking but still structurally stable.

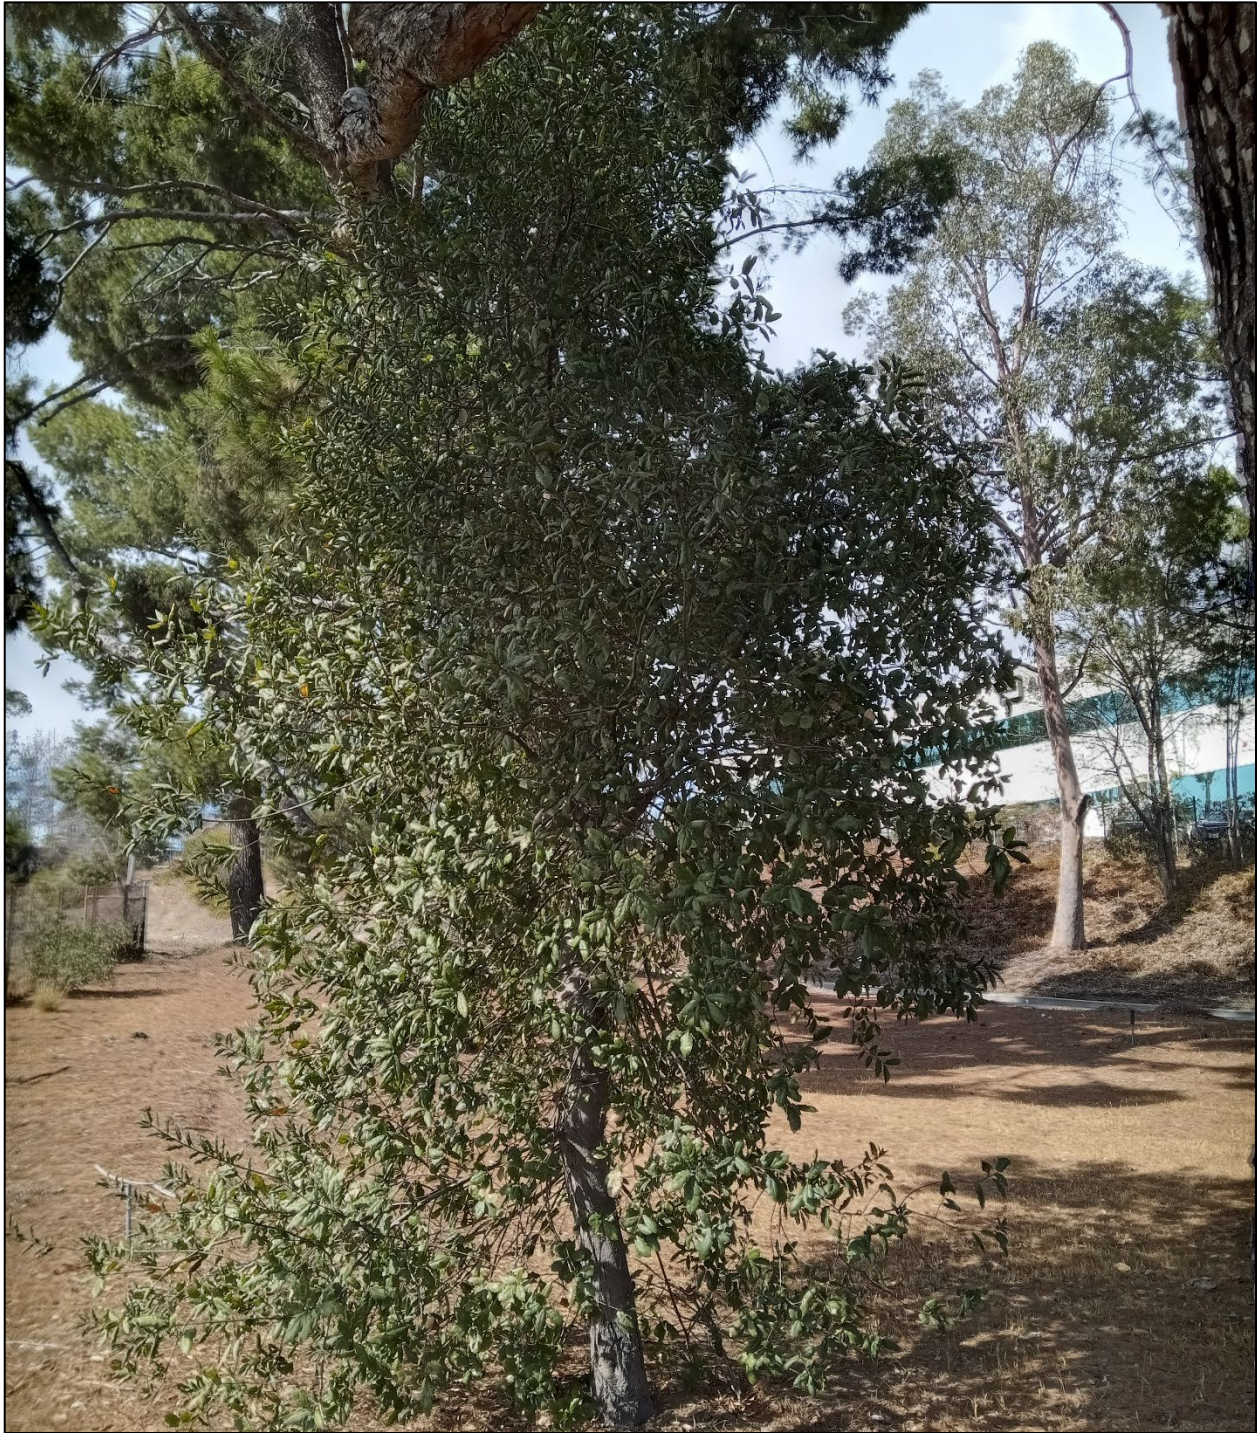
**Photograph 6.** Tree 339 is a protected 6.39-inch (multi) trunk coast live oak. Protected and located in the southwest portion of the Project Area.

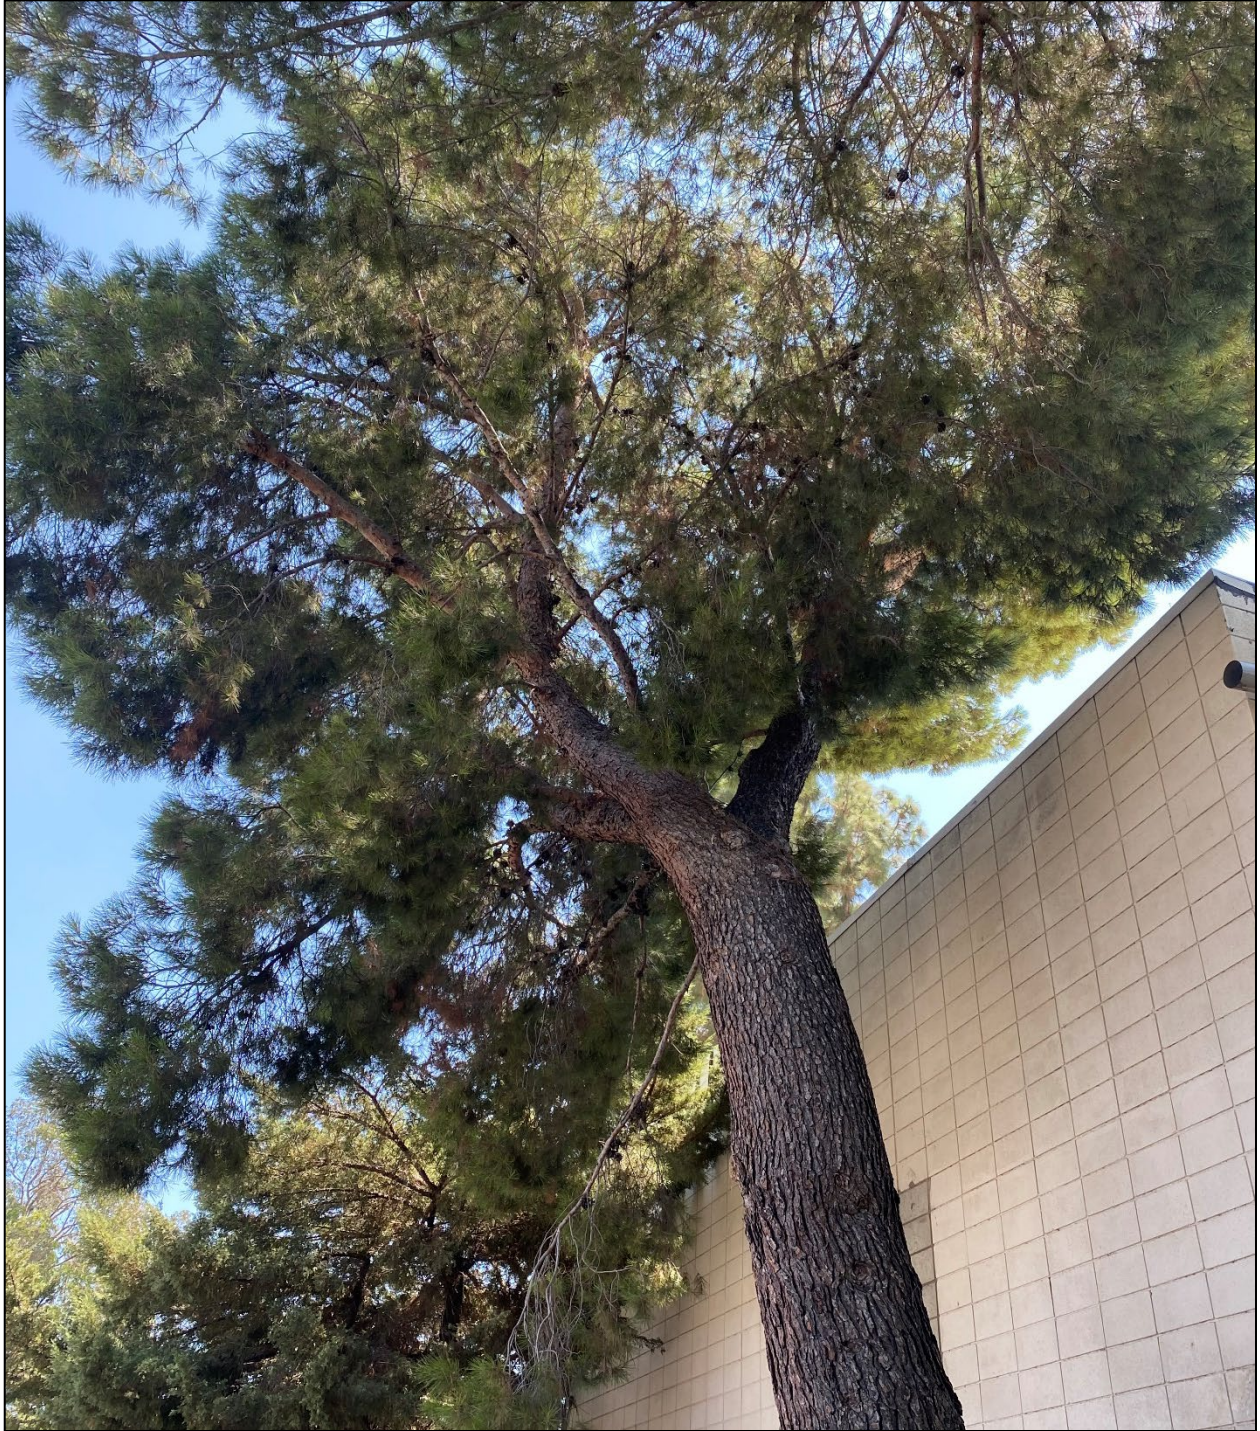
**Photograph 7.** Tree 242 is a 25-inch Italian stone pine (*Pinus pinea*) located in the southeastern boarder of the Project Area.

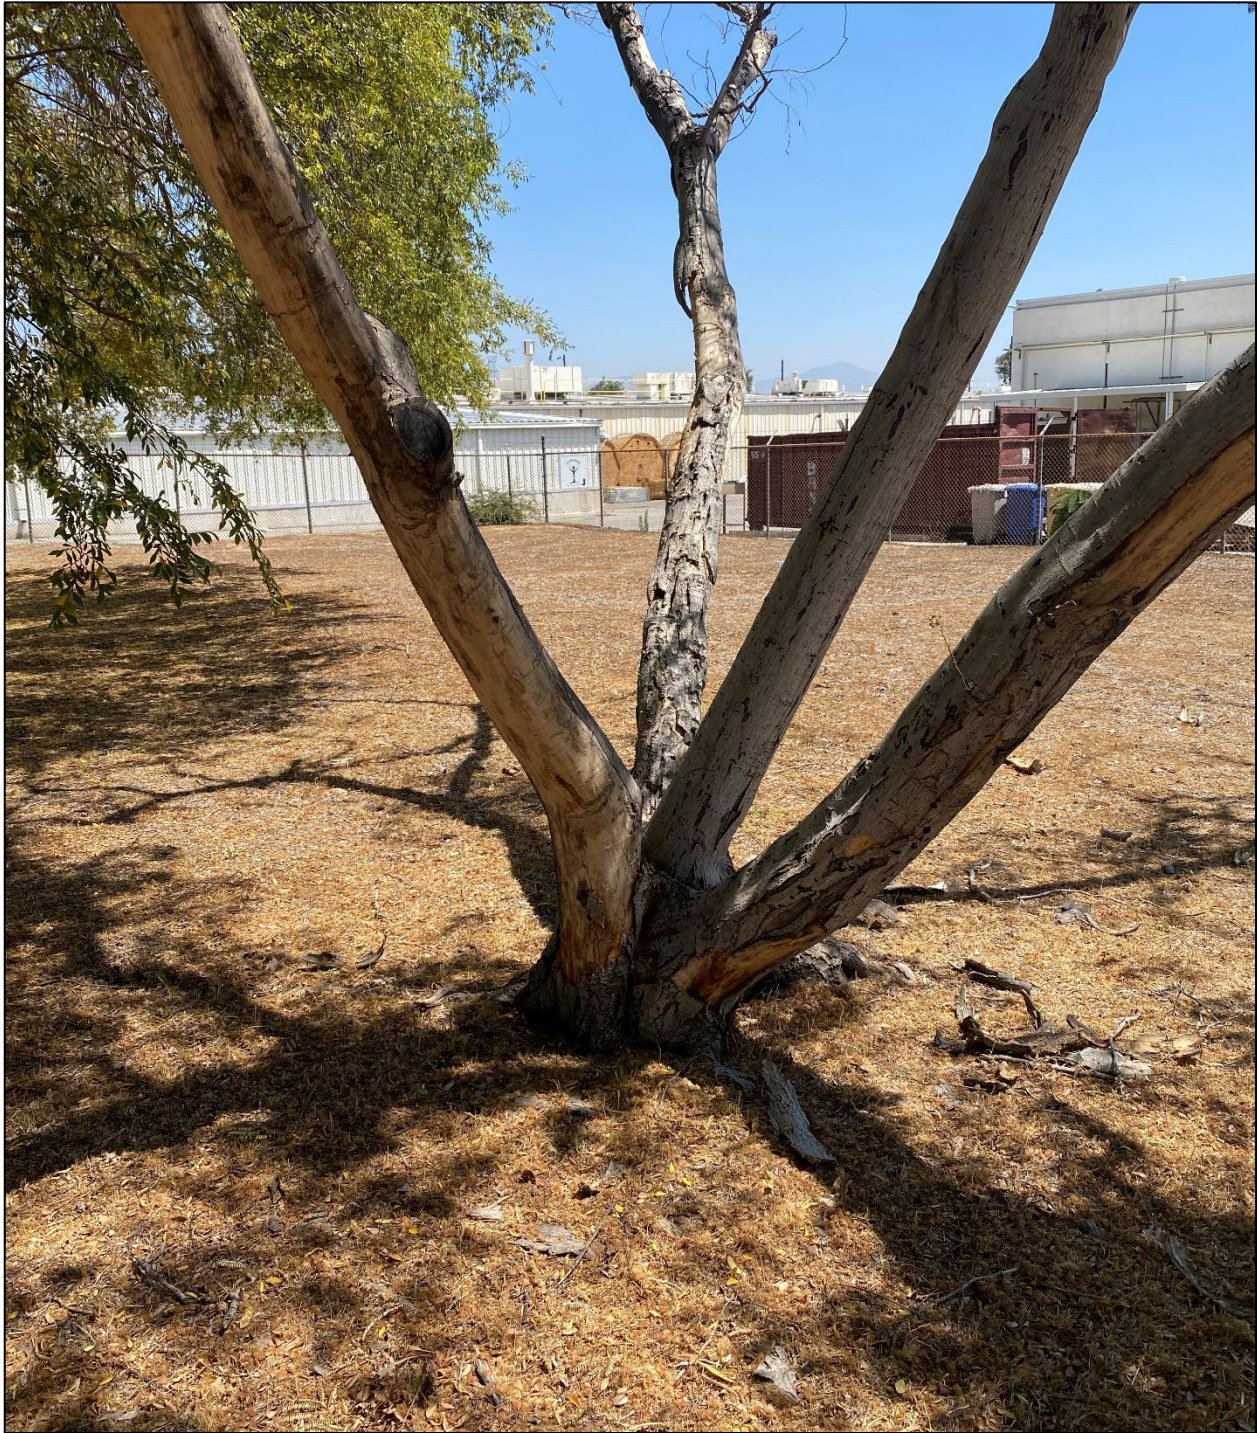
**Photograph 8.** Tree 208 is a 25-inch (multi-trunk) Chinese elm (*Ulmus parvifolia*) that is in the north center of the Project Area, tree is dying.

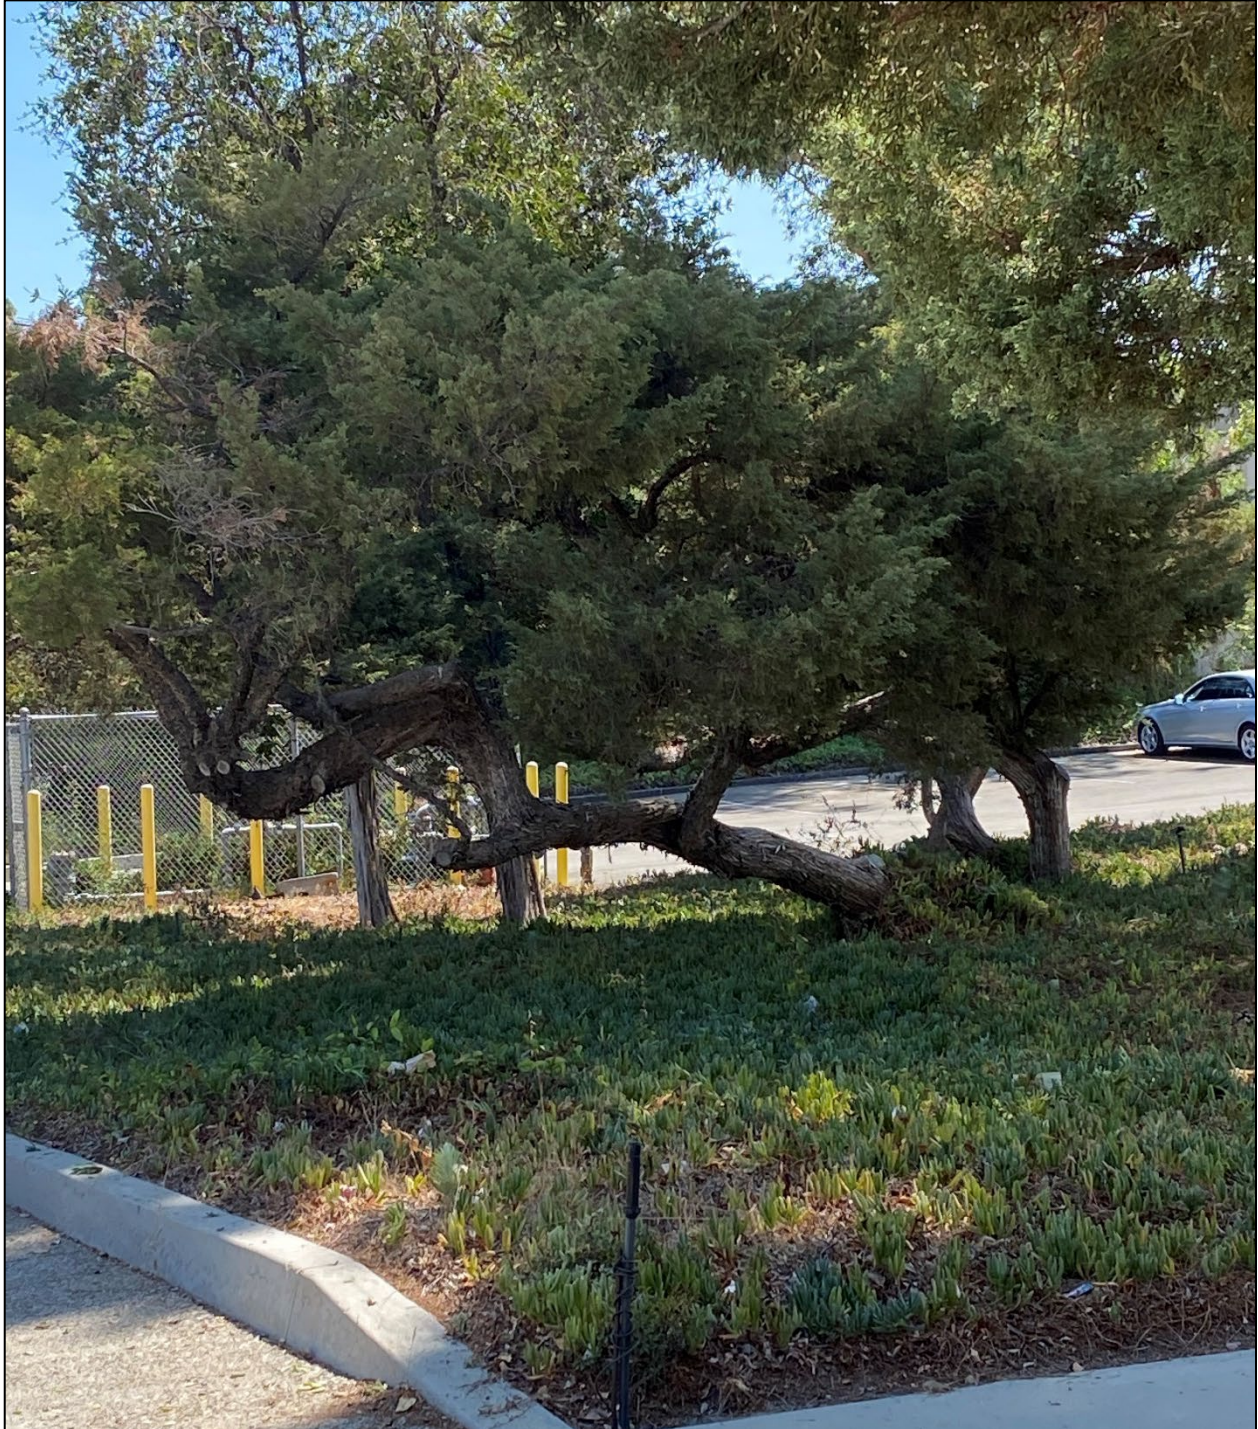
**Photograph 9.** Tree 243 is a 20.73 (multi) trunk Hollywood juniper (*Juniperus chinensis*) that is located in the southeastern boundary of the Project Area.

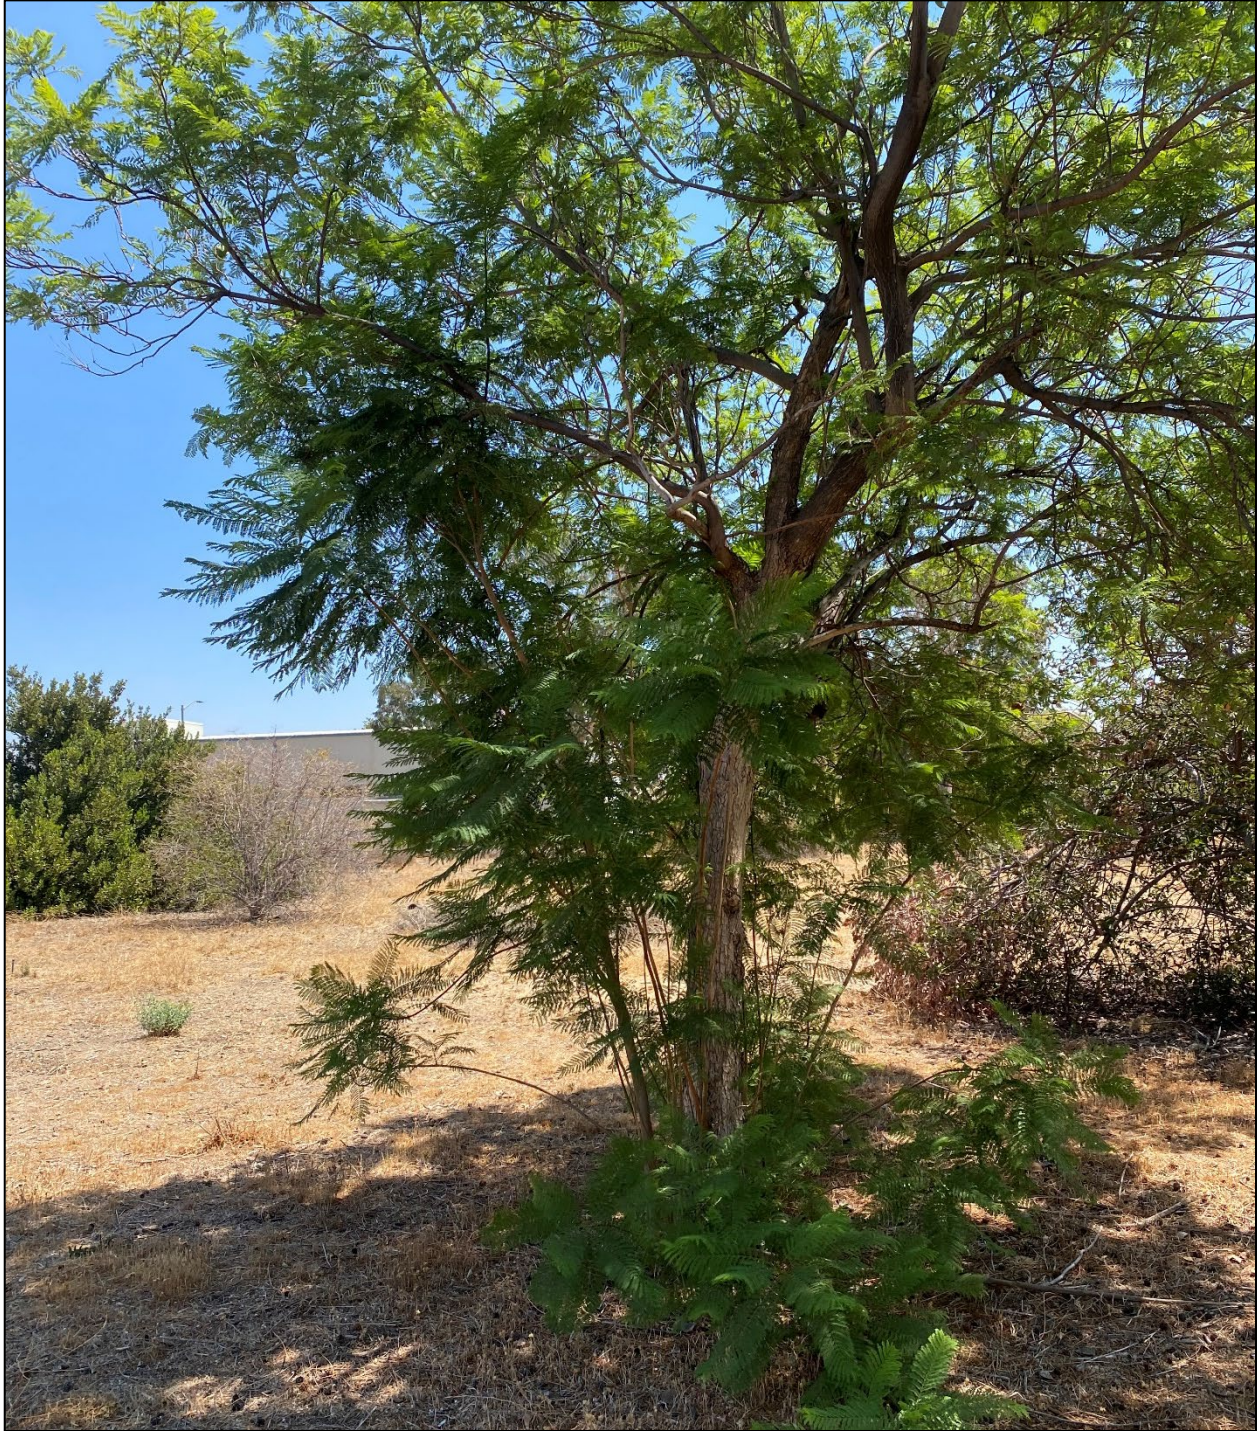
**Photograph 10.** Tree 230 is a 8.35-inch Jacaranda (*Jacaranda mimosifolia*) that is located in the center of the Project Area.
