# Native Tree Survey and Arborist Report

*for an approximate 0.36-acre Site*

*North of Wildrose Ave., between Deodar Ln. and Bradbury Rd.*

*Report Date: September 22, 2021 (Final Revision: May 5, 2022)*

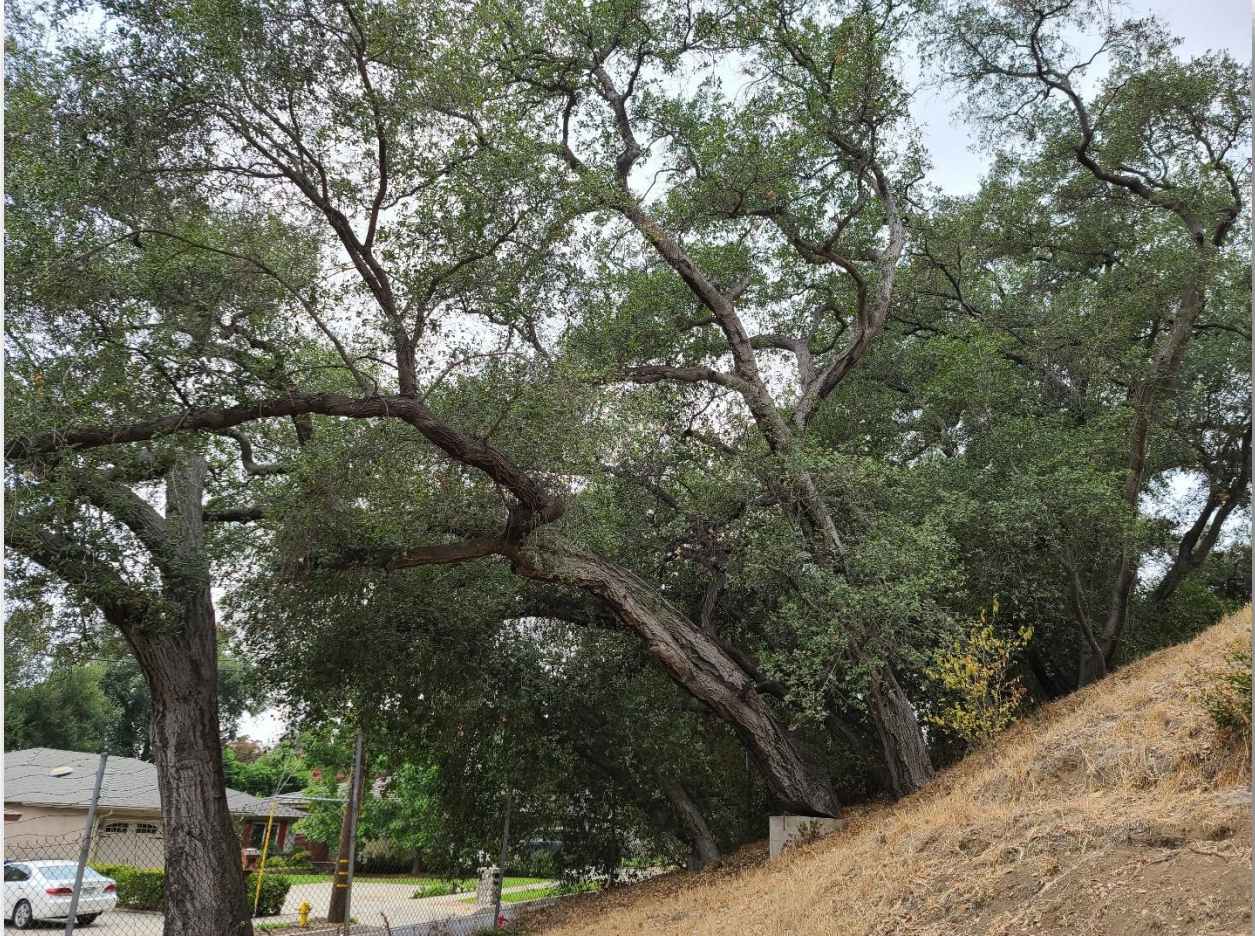
Plate 1. This is a western view of the dense stand of oaks within the project site; it is an isolated community of oak woodland with limited connectivity to other such woodlands along the local foothills.

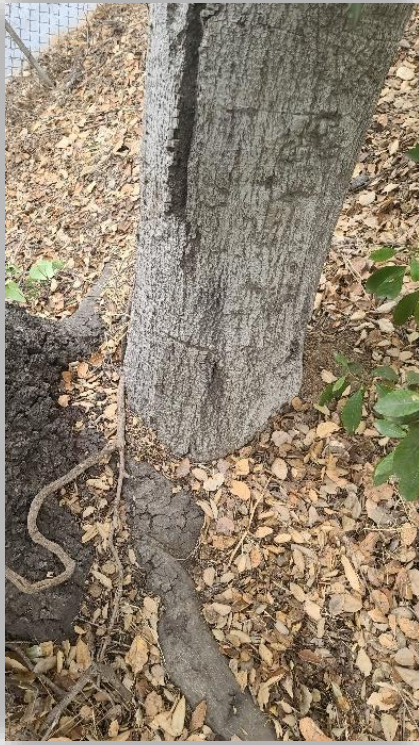
Plate 2. This is a view a large canker within a lower stem (#435).

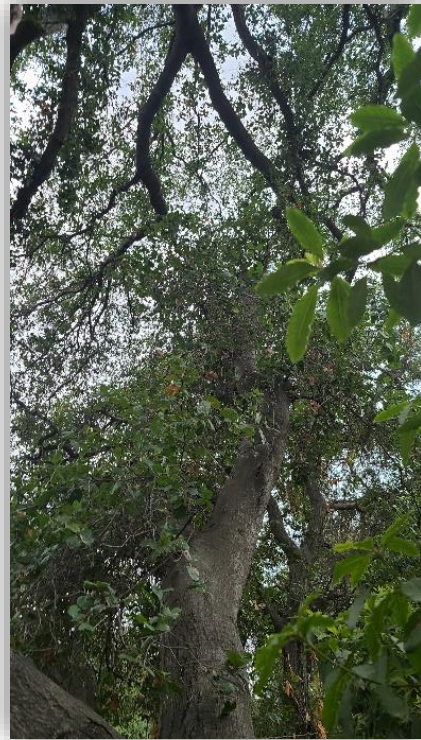
Plate 3. This is a view of multiple cankers along the stem in the upper canopy (#435).

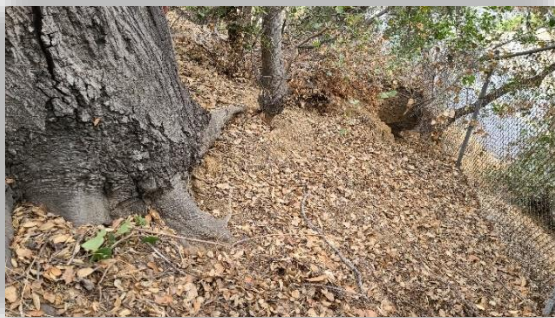
Plate 4. This is a view of eroded substrate resulting in exposed structural roots (#436).

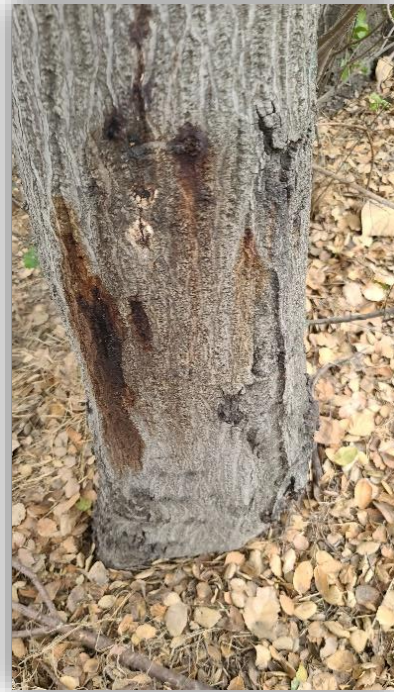
Plate 5. This is a view multiple cankers with stained bark (#437).

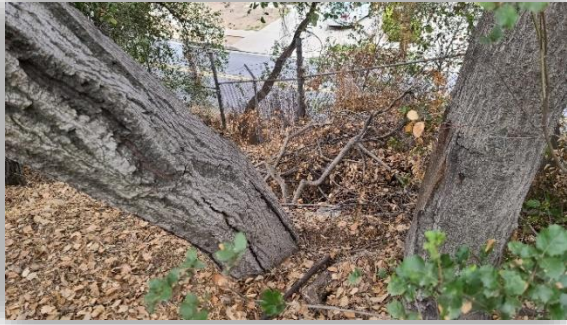
Plate 6. This is a view of a tree with a significant lean and vertical fissure (#439).

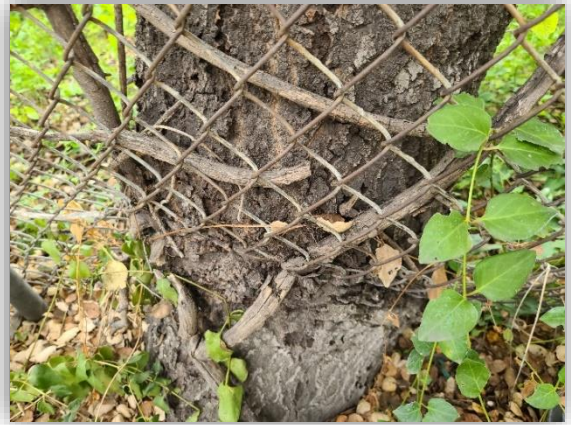
Plate 7. This is a view of embedded fence that has been compartmentalized within the stem tissue (#460).

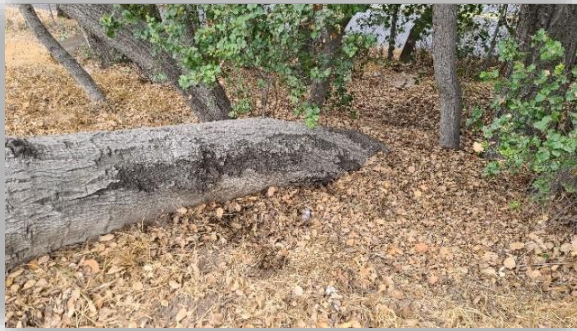
Plate 8. This is a view of horizontal stem growth along substrate lacking geotropism (#441).

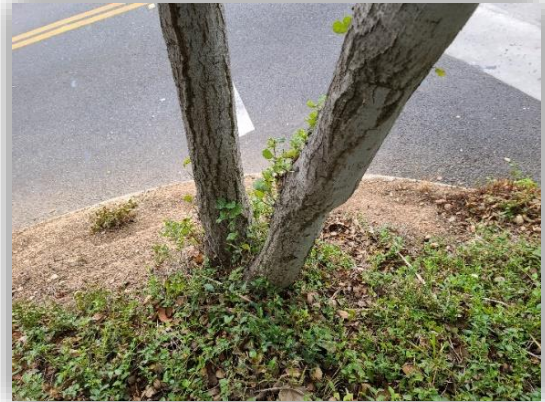
Plate 9. This is a view of a codominant stem system (#468).

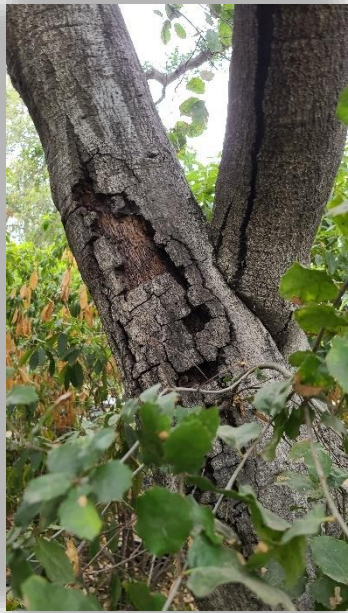
Plate 10. This is a view of severe decay on a stem (#435).

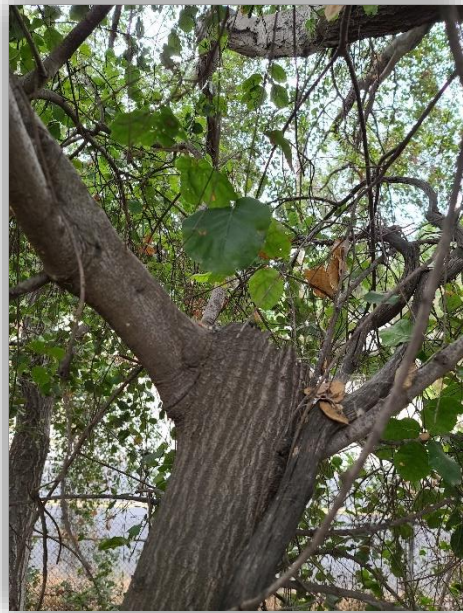
Plate 11. This is a view of a diseased tree in decline that has lost its central stem (#444).

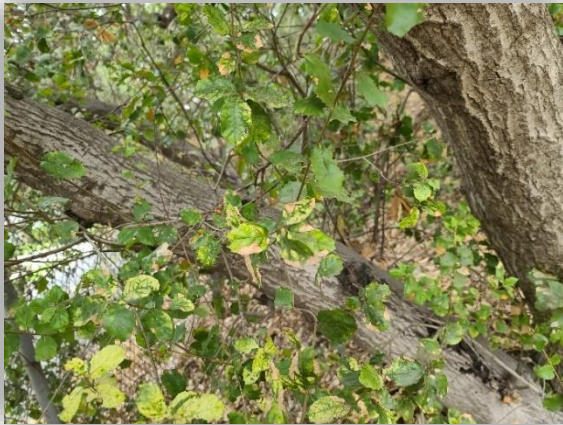
Plate 12. This is a view of diseased foliage, possible from a bacterial or viral pathogen (such as anthracnose) (#452). Chlorosis can be seen as well.

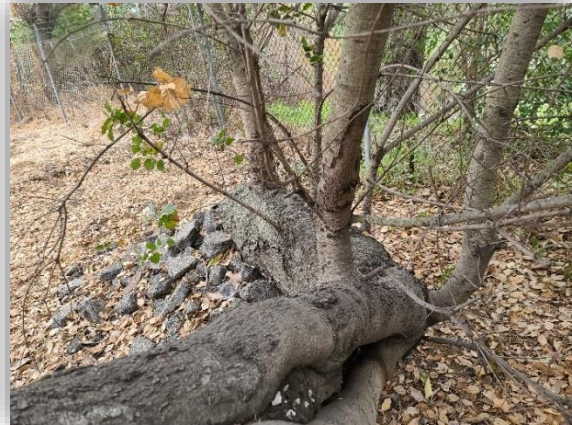
Plate 13. This is a view of a tree growing along the substrate redistributing dominance to upward facing limbs (#452).

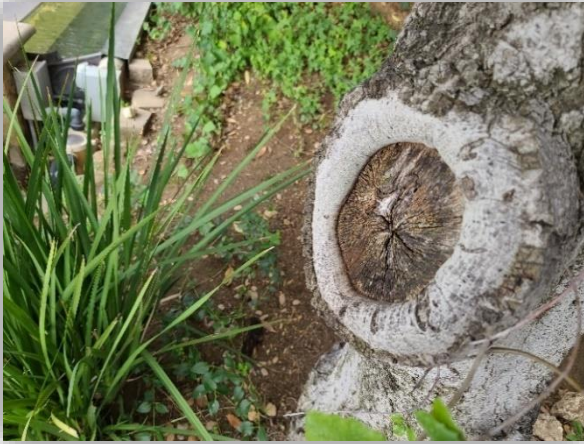
Plate 14. This is a view of an unclosed branch cut with decayed internal tissue (#464).
