October 24, 2020

**ASBESTOS SURVEY REPORT
SIX COMMERCIAL/INDUSTRIAL BUILDINGS LOCATED AT
759 & 748 N. ECKHOFF STREET AND 752 POPLAR STREET, CA 92868**

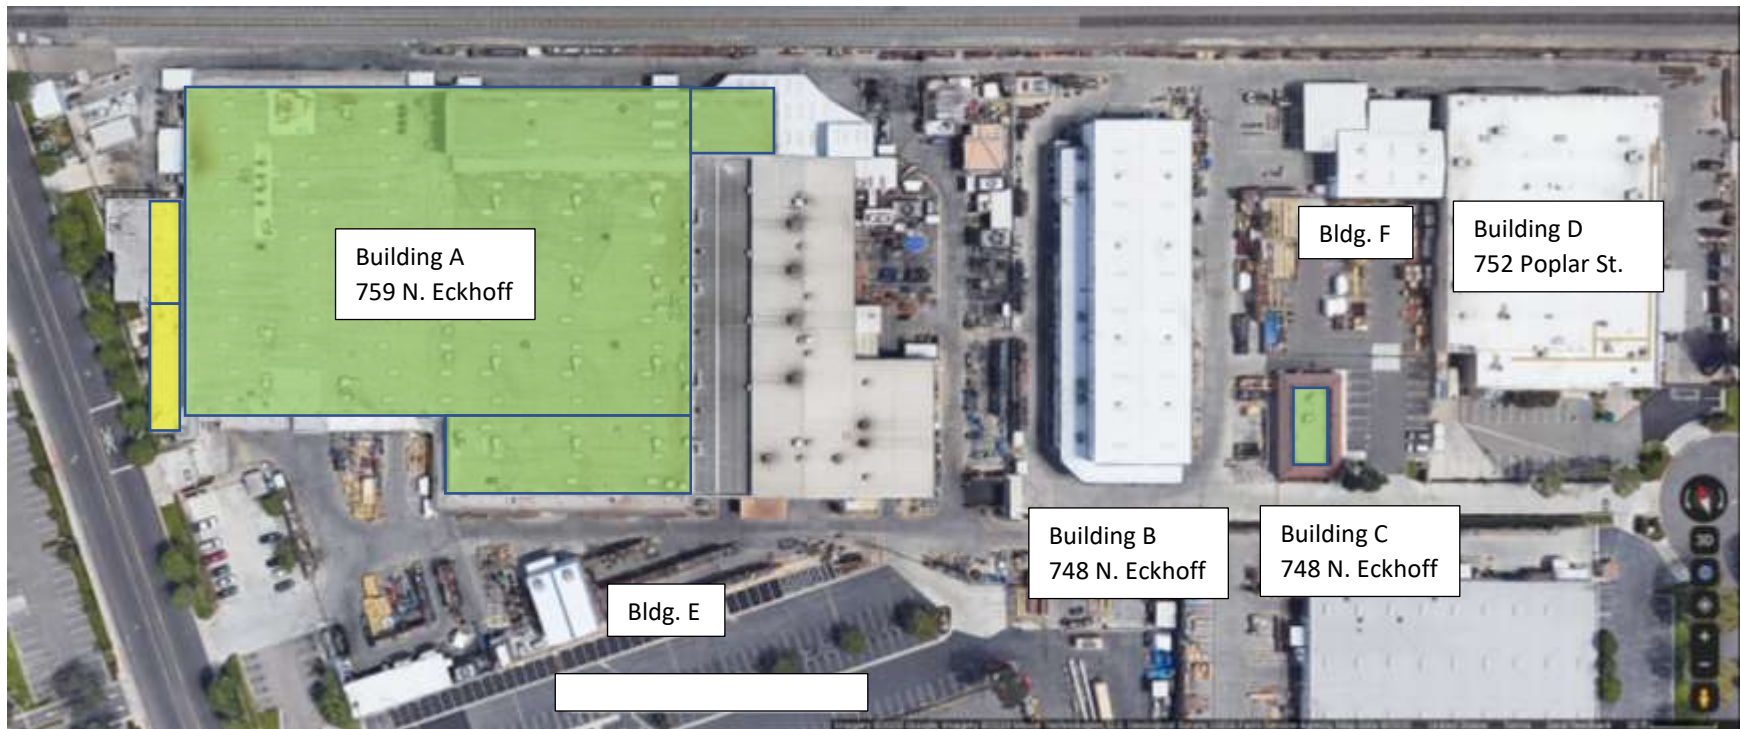
FIGURE 1

Tables A through D present descriptions of the materials sampled, sample collection locations, and a summary of laboratory analytical results. Figure 1 shows locations of identified ACMs in the buildings. Laboratory reports and chain-of-custody documents are presented in Appendix A.

- ACM Flooring Locations
- ACM Roofing Material Locations

759 N. Eckhoff Street, Orange, CA
 Site Map Showing ACM Locations
