# ARBORIST REPORT

## OYSTER COVE MIXED USE DEVELOPMENT PROJECT

### PETALUMA, SONOMA COUNTY, CALIFORNIA

WRA #30049  
JUNE 2022

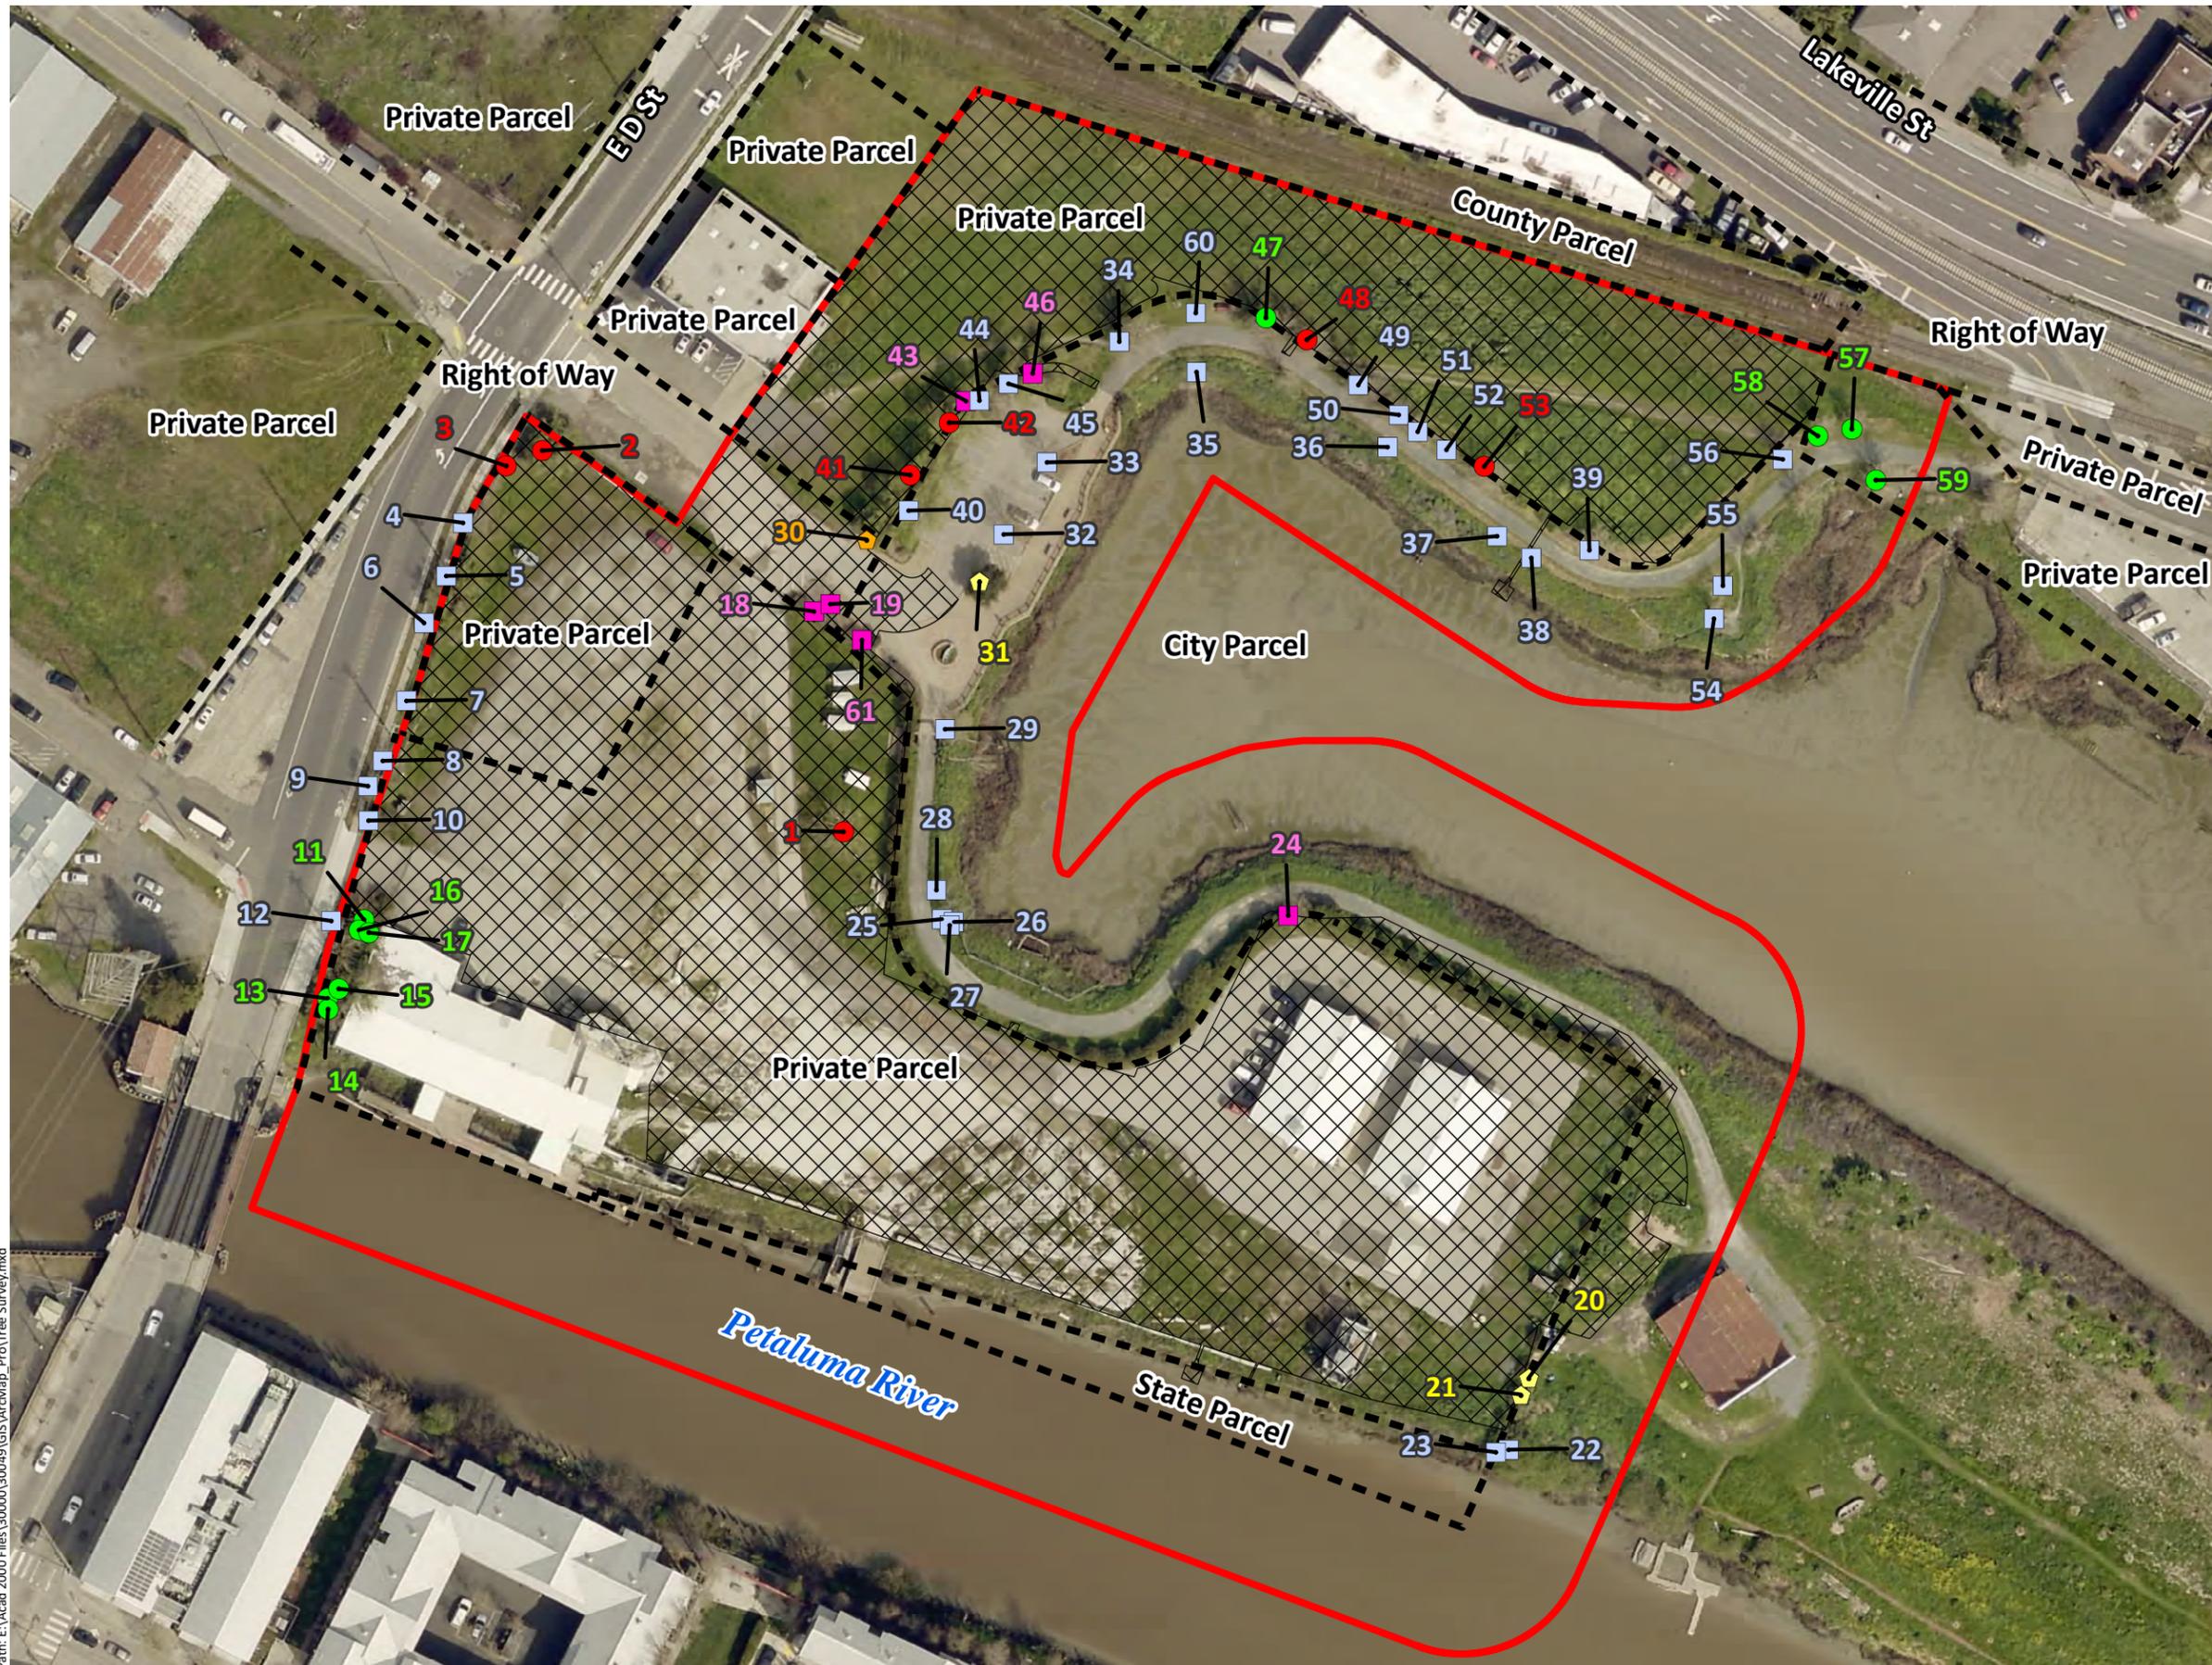
**Figure 2.**  
**Tree Survey**

The Project’s preliminary site plan (CBG 2022) was used to analyze potential impacts on trees within the Study Area. Trees within the interior of the limit of grade are more likely to be impacted and require removal than trees on the edge of the limit of grade as shown on the tree survey figure (Appendix B – Figure 2). Impacts to existing trees will include removal, and potential root disturbance and/or limb pruning. Based on the tree impact assessment, a total 15 trees are likely to require removal. Of those 15 trees, 7 are considered non-protected trees based on their species, size and location presumed to be on private property based on the overlay described in Section 2.3 above. Of the 15 trees likely to be removed, eight (8) trees are considered protected due to their location on City property, and in the case of tree #30, because the tree is a coast live oak of sufficient size to classify as protected per the Tree Ordinance. Of the 46 trees that are not identified as removals, several of those trees which are just outside of the limit of grade may be impacted by root disturbance or limb pruning. Recommended tree protection measures provided below shall be employed to preserve trees outside of the limit of grade to the maximum extent feasible. Representative photographs of trees to be removed can be found in Appendix C.

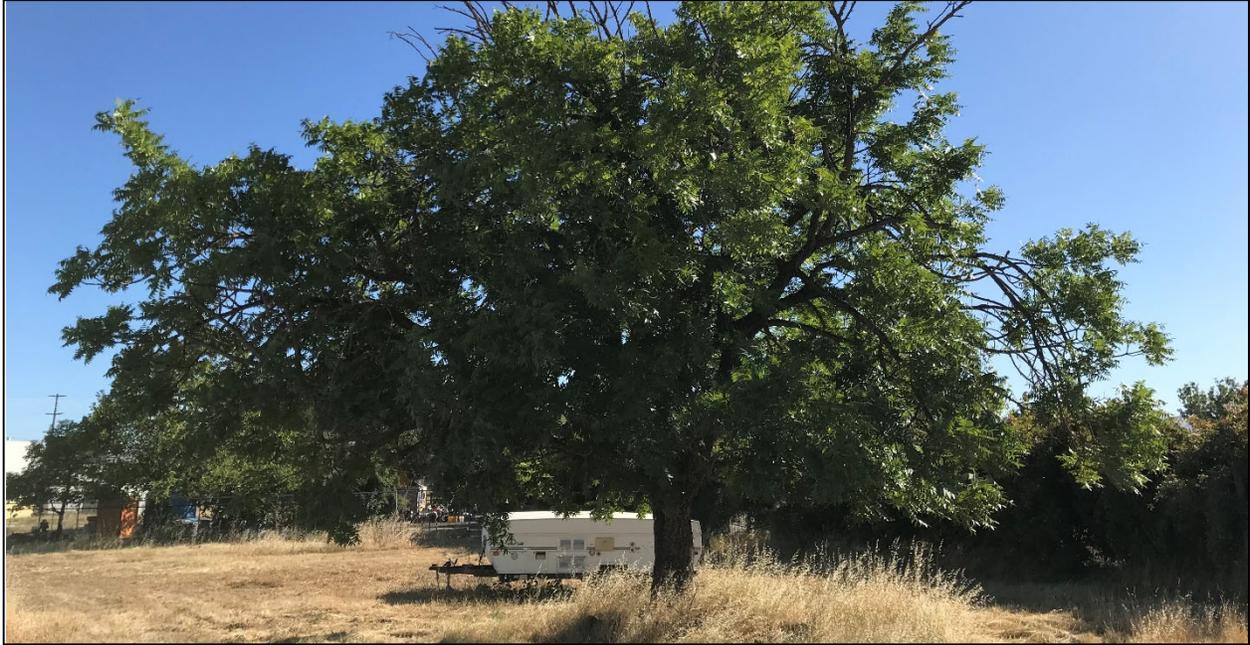
Photograph 1. Tree #1, a non-protected California black walnut exhibiting minor crown dieback. The tree is located on private property and requires removal.

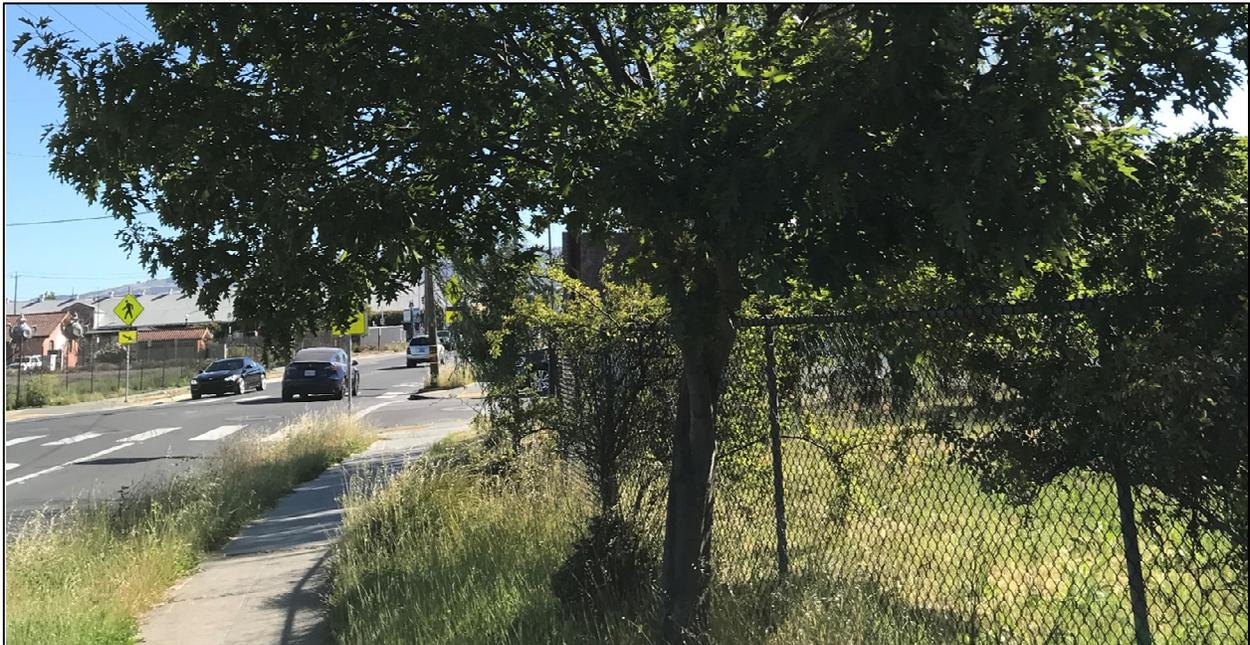
Photograph 2. Tree #4, a red oak City tree (protected) located in the City ROW along East D Street. This tree is to be preserved.

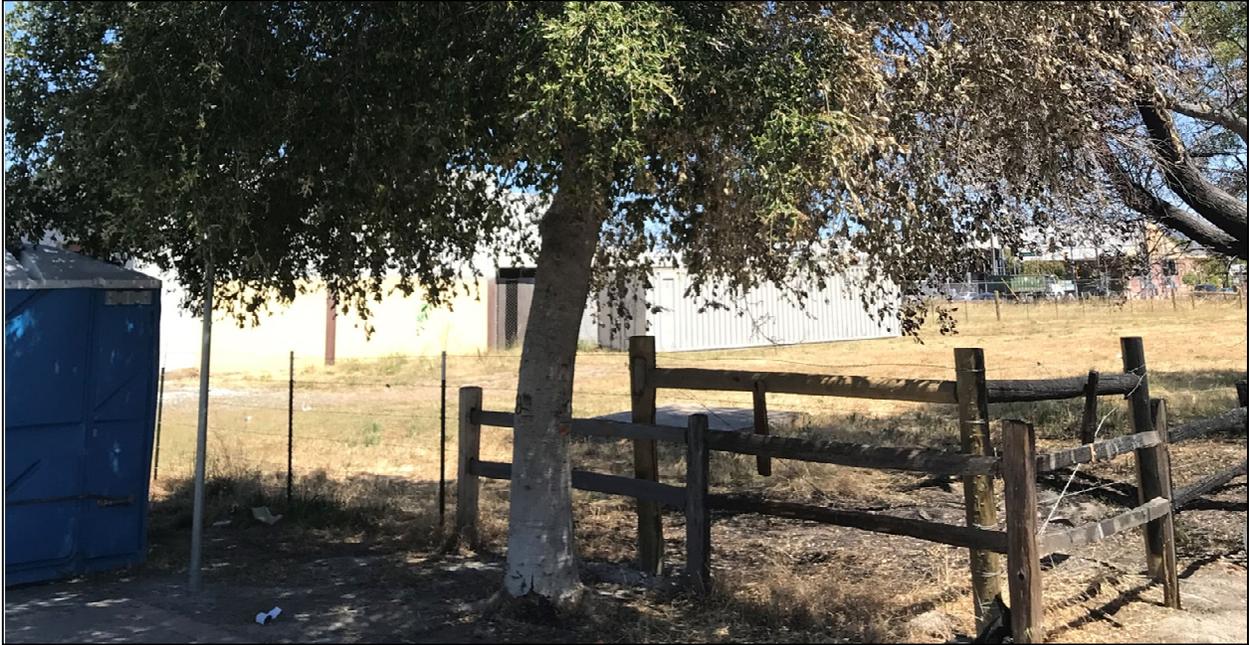
considered protected due to their location on City property, and in the case of tree #30, because the tree is a coast live oak of sufficient size to classify as protected per the Tree Ordinance.

Photograph 3. Tree #30, a protected City tree which is proposed for removal. The tree was assessed to be in fair condition despite sustaining some crown damage in a homeless encampment fire.

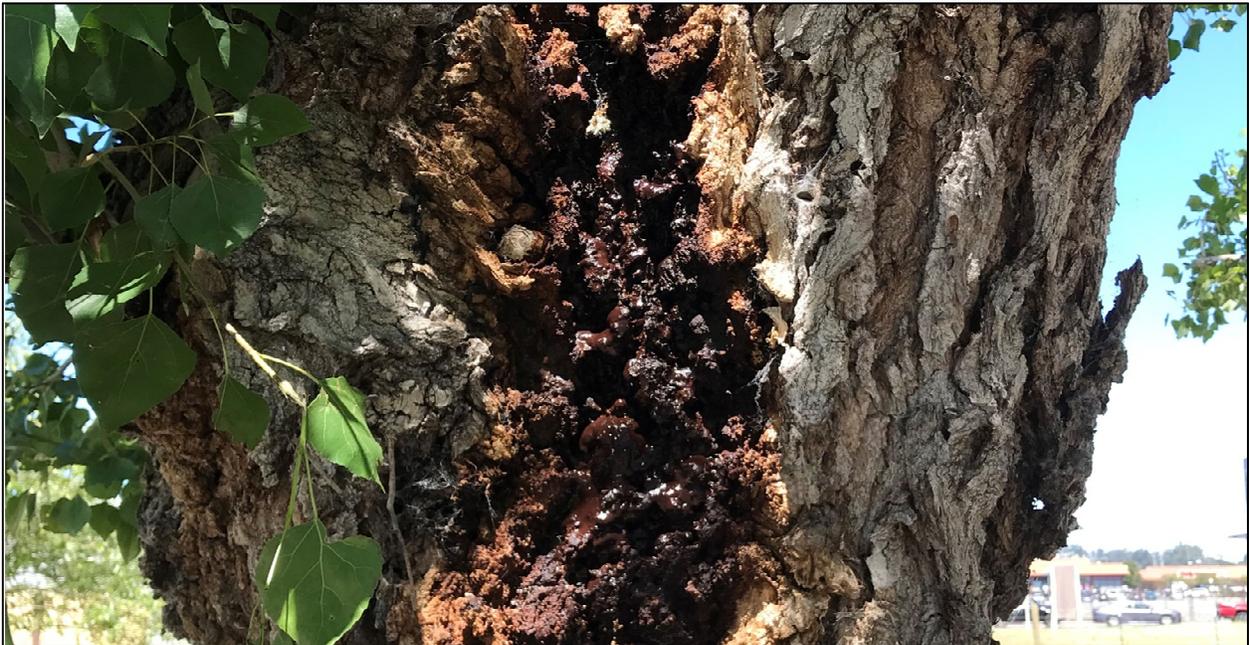
Photograph 4. Photograph depicting a canker caused by a fungal pathogen on tree #34 a protected City tree which was assessed in poor condition.

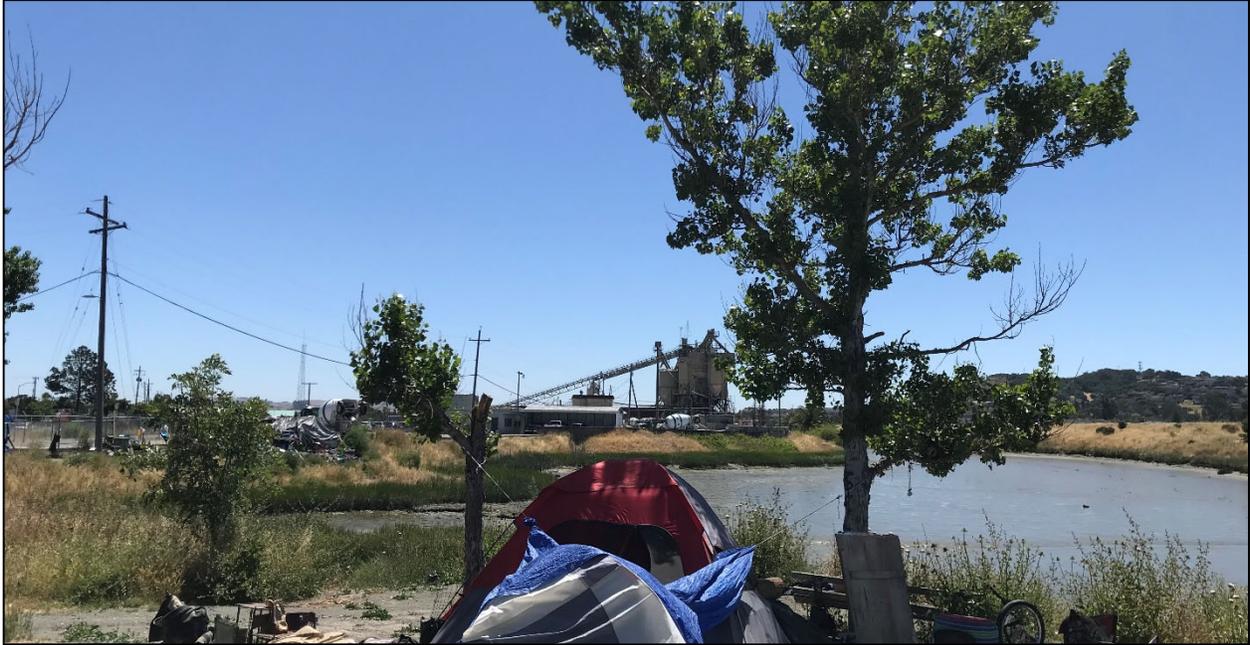
Photograph 5. Photograph depicting trees #54 and 55, two Fremont cottonwoods in poor condition. These trees are representative of trees that were surveyed from a distance due to the homeless encampment.

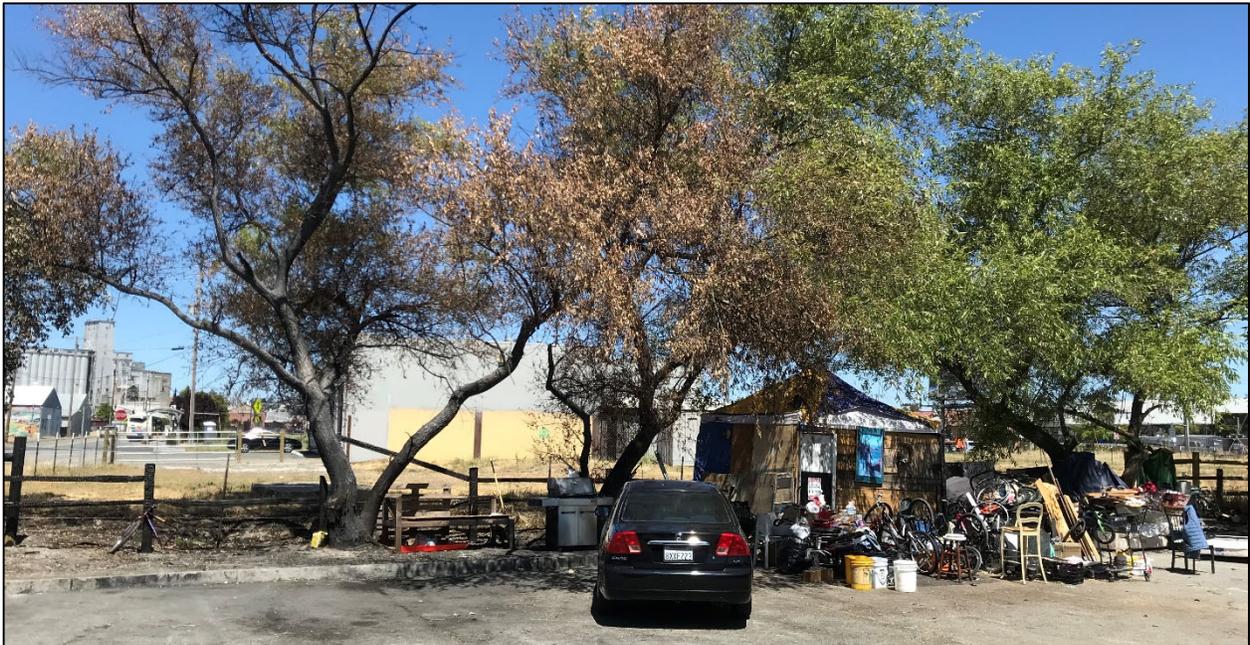
Photograph 6. Photograph depicting tree #40 at left, a red willow protected City tree which sustained heavy fire damage from a homeless encampment fire. Trees #41 through #43 are seen at right, in healthier condition, surrounded by homeless encampment
