Oak Tree Report

October 4, 2022 – Original April 18, 2023 – Revised

Oak Tree Letter / Report for 1300 Lawrence Dr., Thousand Oaks, Ca.

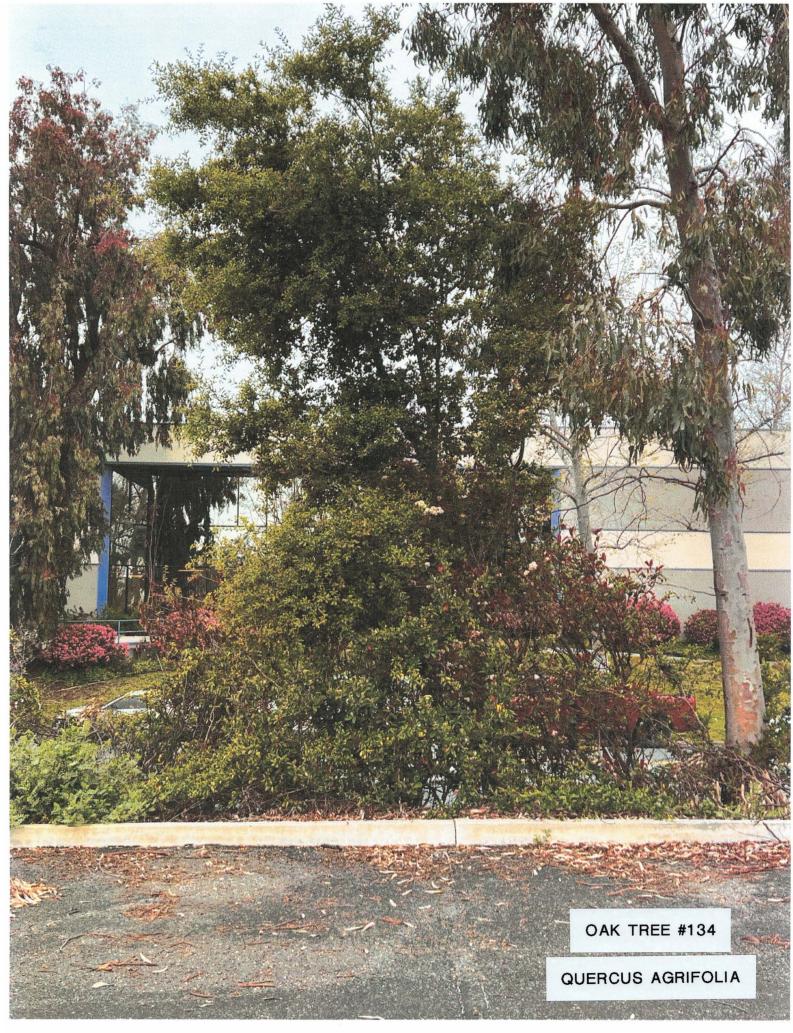
Oak Tree #134 - Quercus agrifolia - Coast Live Oak

This is a very healthy, small Coast Live Oak tree. The tree is approximately 20' high and has a canopy diameter of approximately 9'. The tree is approximately 3" in diameter at D.B.H and leans to the south. This tree we would grade as a B in health and aesthetics. According to the Grading Plan, the site will be graded up to the trunk of this tree, requiring it's removal since it falls within the Code criteria. We would recommend that as mitigation for this volunteer Oak that 2-24" box & 1-36" box to be planted as part of the future landscape plan.

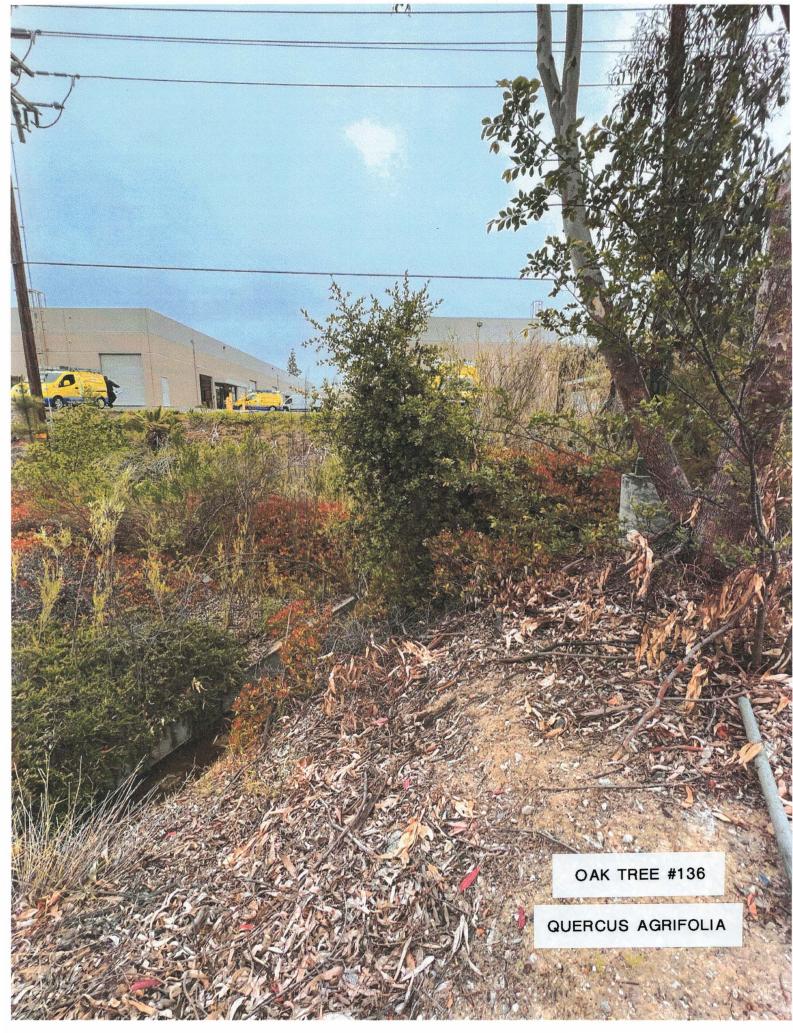
Oak Tree #136 – Quercus Agrifolia – Coast Live Oak

36" box Oaks to be planted. the Architectural Site Plan, there are proposed double retaining walls. These walls will cause the removal of this Oak. We recommend that the Landscape Plan reflect Oak Tree mitigation of 2-24" and 1-There is a small volunteer Oak located on the slope of an existing drainage area. According to
