GEOLOGIC RECONNAISSANCE

AVION SAN DIEGO, CALIFORNIA

**JANUARY 19, 2018
PROJECT NO. G2213-32-01**

Subject: GEOLOGIC RECONNAISSANCE
AVION
SAN DIEGO, CALIFORNIA

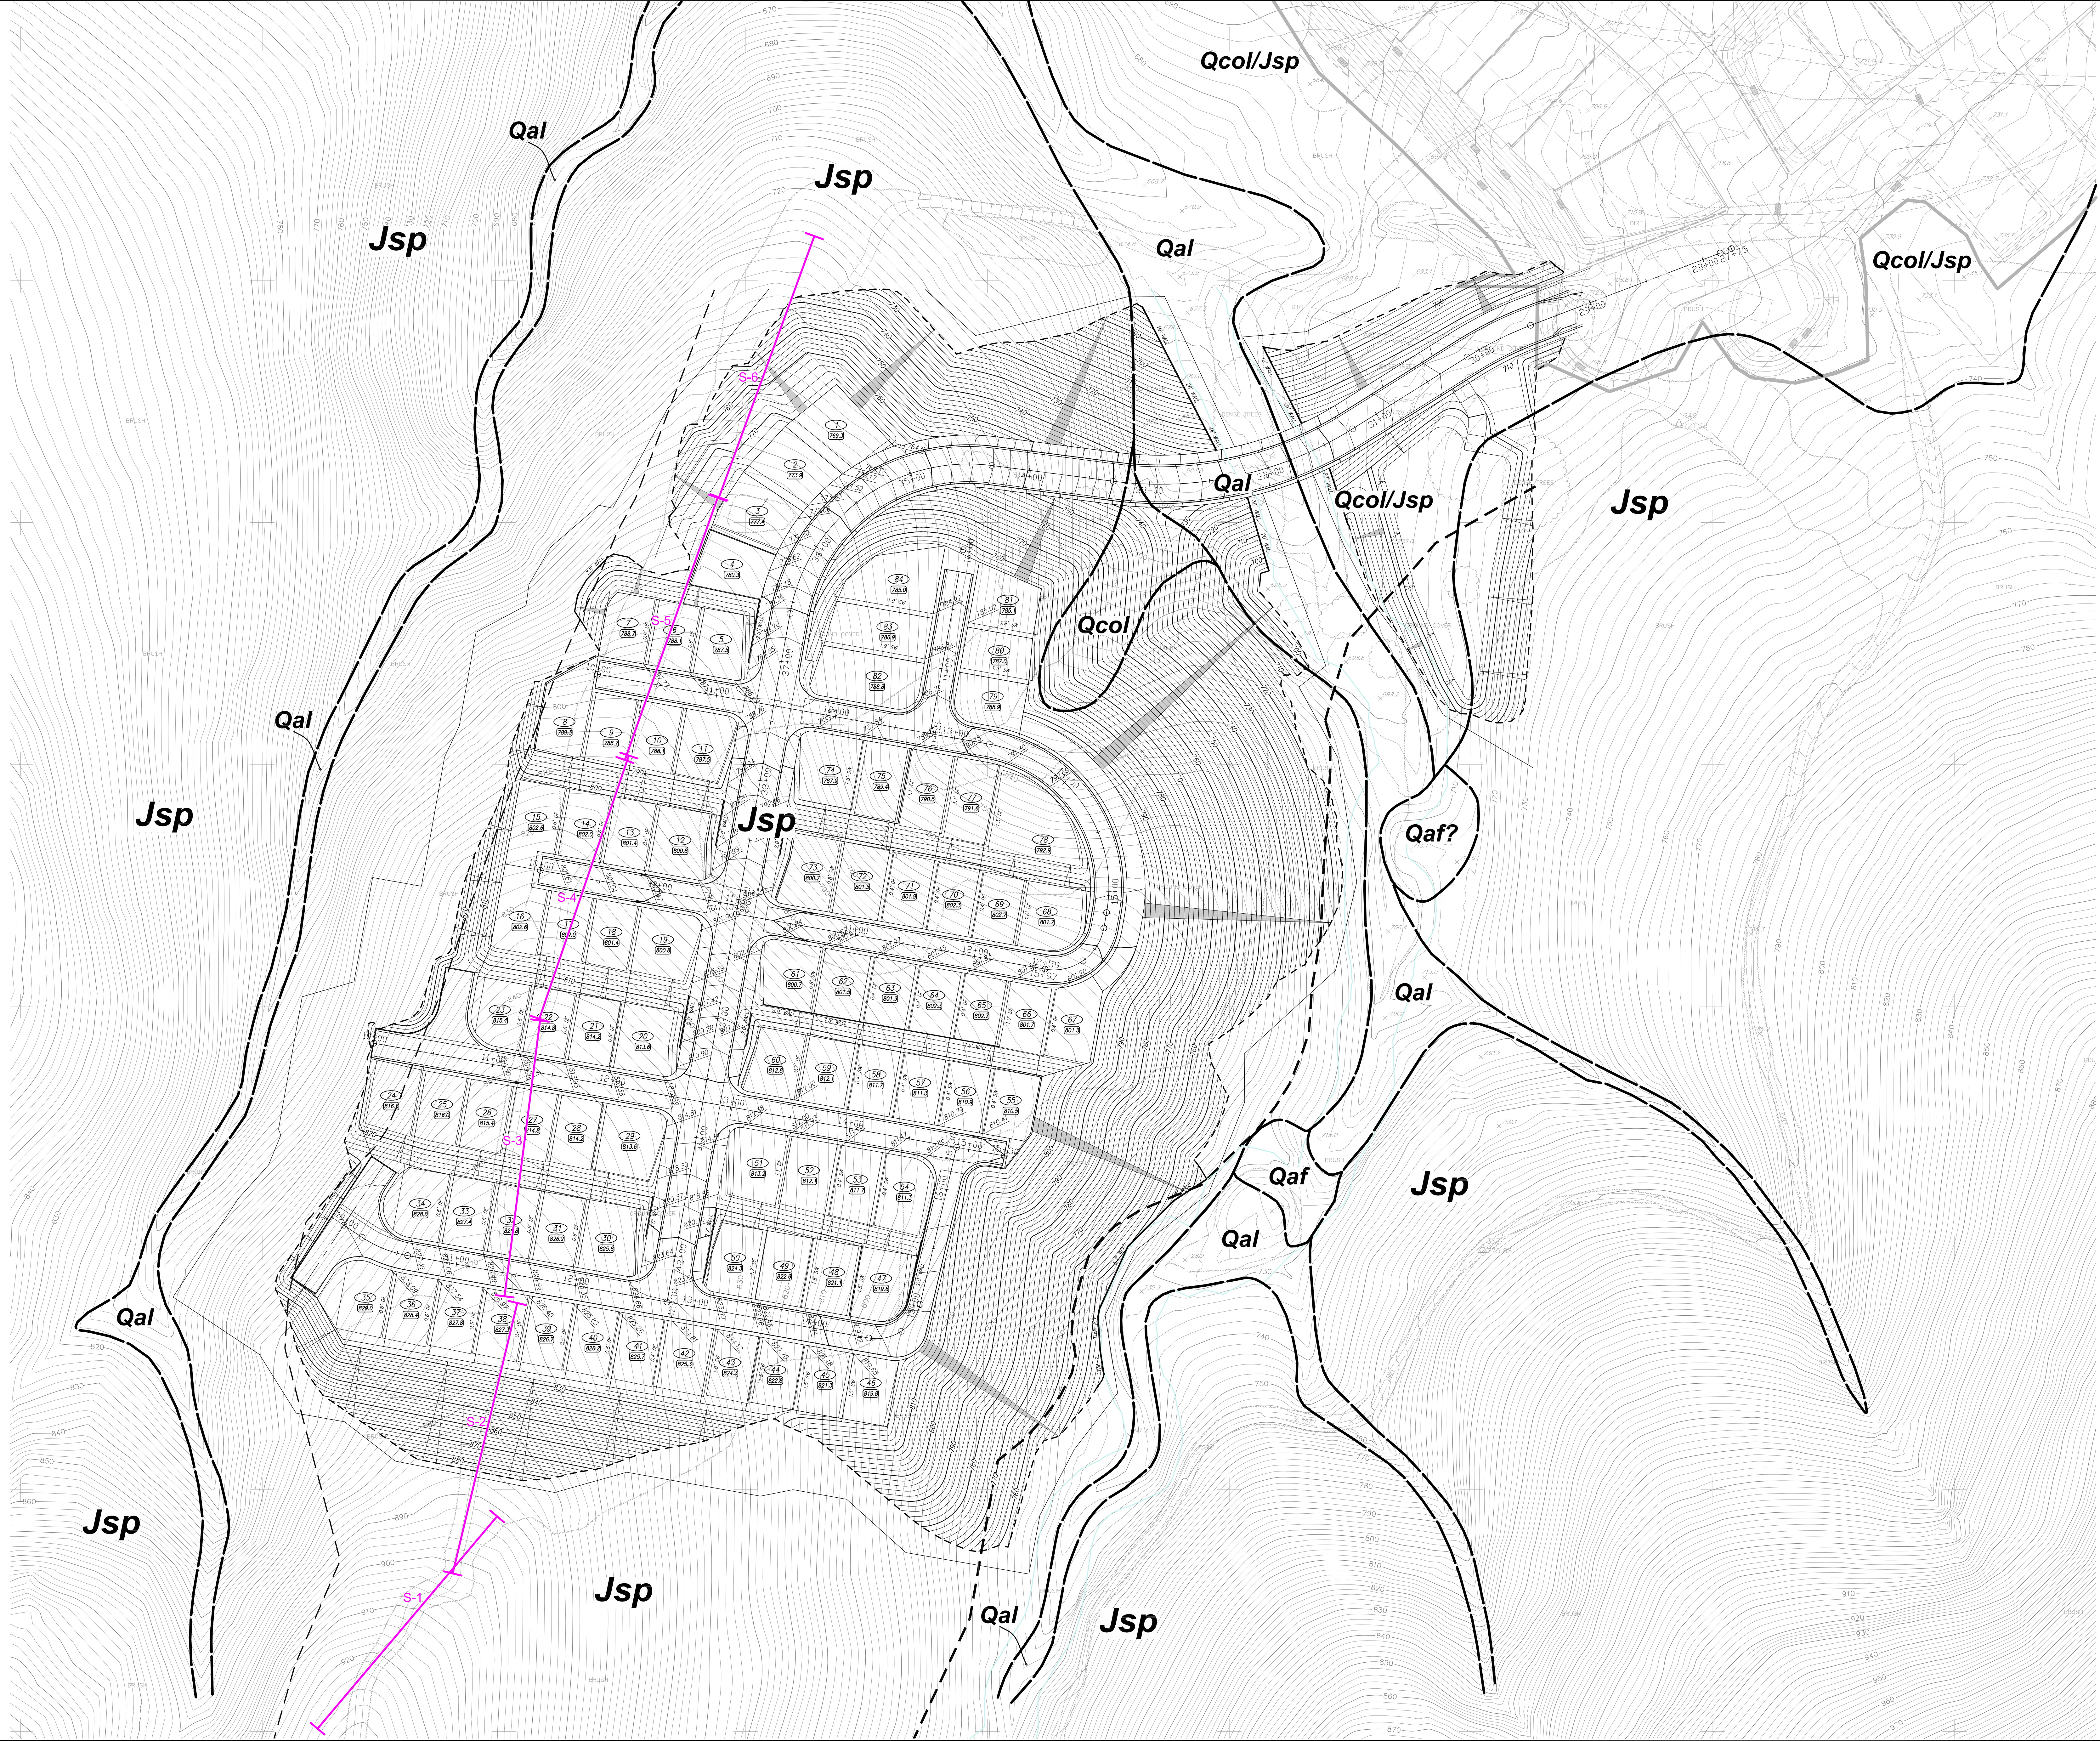
GEOLOGIC MAP
AVION
SAN DIEGO, CALIFORNIA

Two artificial fill deposits were observed in the form of dam embankments in the drainage that flanks the east side of the development. In addition, several relatively minor embankments, which were not mapped, are present in the northern portion of the development area where old structure foundations are present. It appears that minor grading occurred in this area to create level ground for these structures. The artificial fill deposits will require remedial grading where they are present within the development footprint.

Colluvial deposits have been mapped in the northern portion of the site where relatively gentle topographic conditions are present. We anticipate the colluvium will have similar physical characteristics as the topsoil. Based on remedial grading information from the adjacent cul-de-sac area of Heritage Bluffs II, we anticipate that the colluvial thickness could be up to six-feet-thick in some areas. Due to the relatively unconsolidated nature of these deposits, remedial grading will be necessary where these soils are present within the development footprint.

- 7.3 The site is underlain by surficial units that include artificial fill, topsoil, alluvial, and colluvial deposits. These deposits are unsuitable in their present condition and will require remedial grading in the form of removal and compaction where improvements are planned.

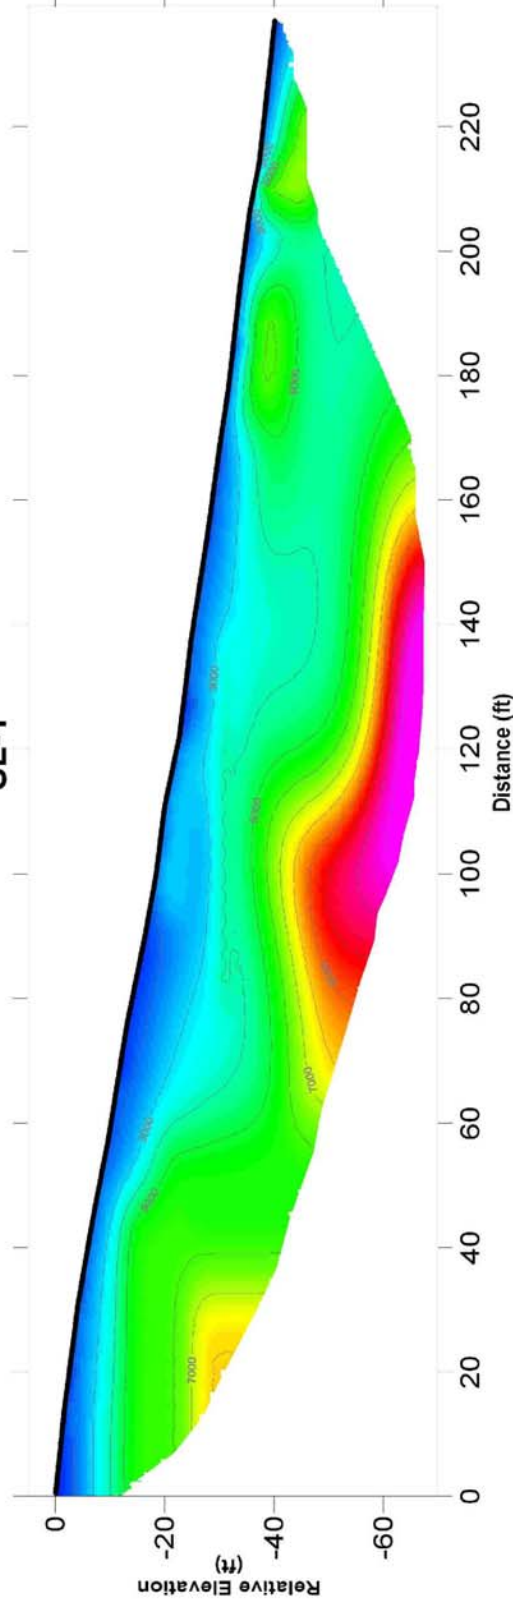
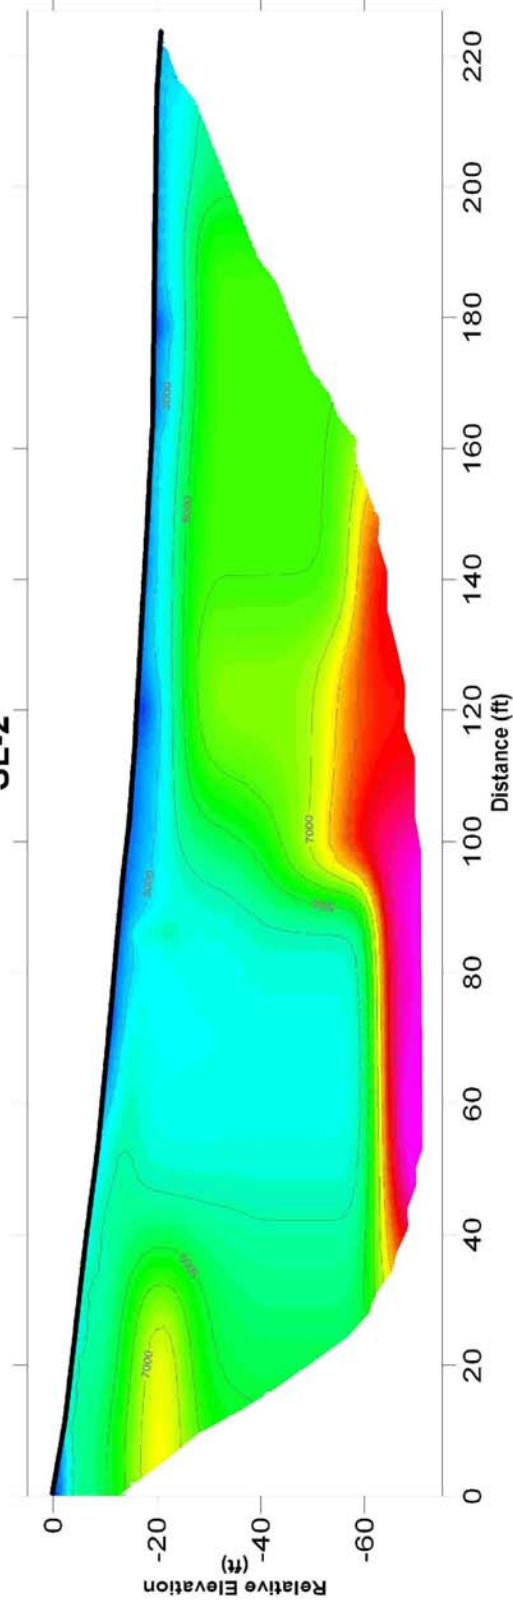
SEISMIC PROFILES SL-1 & SL-2

The results from our seismic survey revealed distinct layers/zones in the near surface that likely represent soil (topsoil and colluvium) overlying metavolcanic bedrock with varying degrees of weathering. Figures 4a through 4c provide the velocity gradient models calculated from SeisOpt Pro. Several feet of soil-like materials are present along portions of the lines, but in general weathered bedrock appears to be fairly shallow across the site. Based on the models, significant lateral variations in velocity are also present in the survey area. The cause of the velocity variations are likely related to remnant boulders, fracturing, and differential weathering of the bedrock materials. As a result, variability in the excavatability (including depth of rippability) of the subsurface materials should be expected across the project area.

Based on our results, very difficult conditions where blasting may be required will likely be encountered depending on the excavation depth, location, and desired rate of production. In addition, oversized materials should be expected. A contractor with excavation experience in similar difficult conditions should be consulted for expert advice on excavation methodology, equipment and production rate. In addition, once grading plans have been prepared we recommend that additional seismic lines be conducted in areas of proposed significant cuts.
