**FAULT RUPTURE HAZARD
INVESTIGATION**

**PROPOSED MULTI-FAMILY
RESIDENTIAL DEVELOPMENT
HAWTHORNE BOULEVARD AND
VIA VALMONTE
TORRANCE, CALIFORNIA**

PROJECT NO. A9201-06-01C

JANUARY 21, 2016

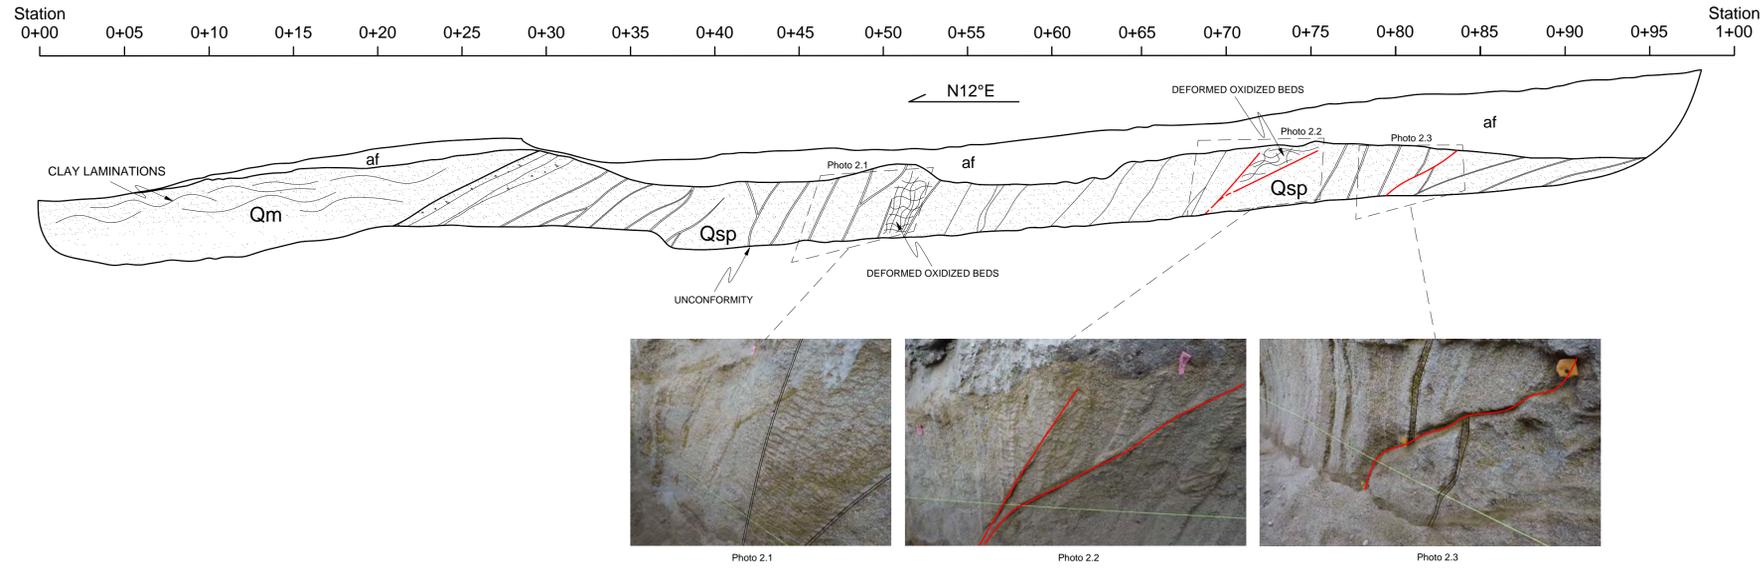
TRENCH 2

Trench 2 was excavated topographically higher than Trench 1 and therefore exposed a younger section of the San Pedro Sand. As shown on Figure 7 (Log of Trench 2 and Trench 3), only two minor shears were observed in this trench, both confined to the San Pedro Sand. The northern shear bifurcates into two branches as it extends upward and each branch terminates within the San Pedro Sand. The second shear extends to the base of the fill materials and the upward termination of the shear could not be determined. Each of these shears exhibited minor offsets on the order of a few inches or less. The number of minor shears observed in Trench 2 was far fewer than the number of minor shears observed in Trench 1, which suggests that the minor shears may die out upward in the San Pedro Sand, and are therefore middle Quaternary in age.

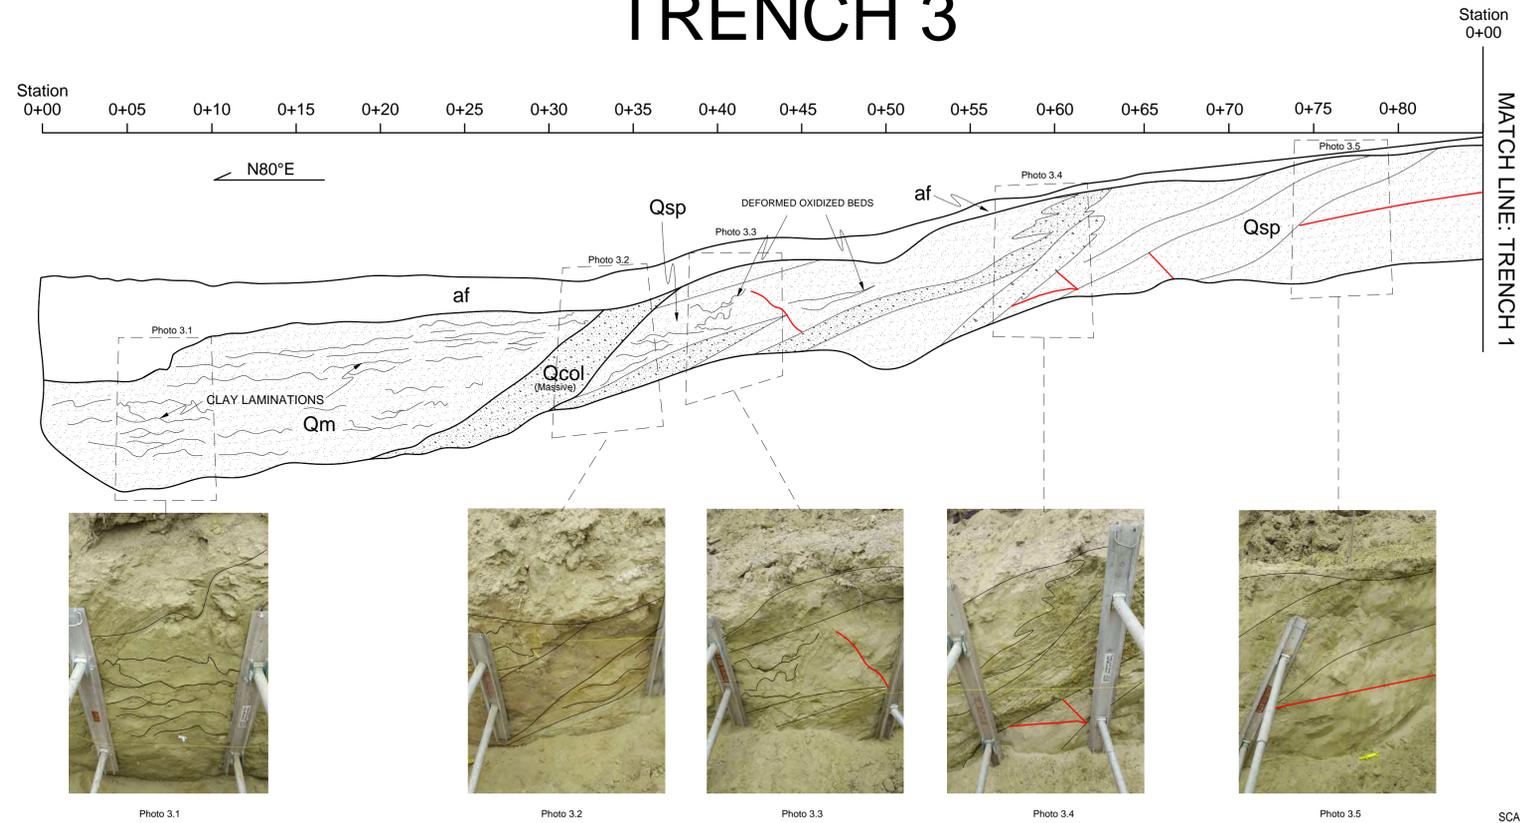
TRENCH 3

Trench 3, excavated from the northern terminus of Trench 1 to the north and east (See Figure 2), exposed older marine sand that lapped onto the older colluvial soils (between approximately Station 0+3- and 0+35) and the San Pedro Sand. As shown in Figure 7, only four minor shears were observed in the San Pedro Sand, all exhibiting minor offsets of about 2 inches. More importantly, all of these shears were observed to terminate within the San Pedro formation so we can confidently demonstrate that these shears are not related to active faulting (by the State definition). Minor shears were not observed in the older colluvial soils.

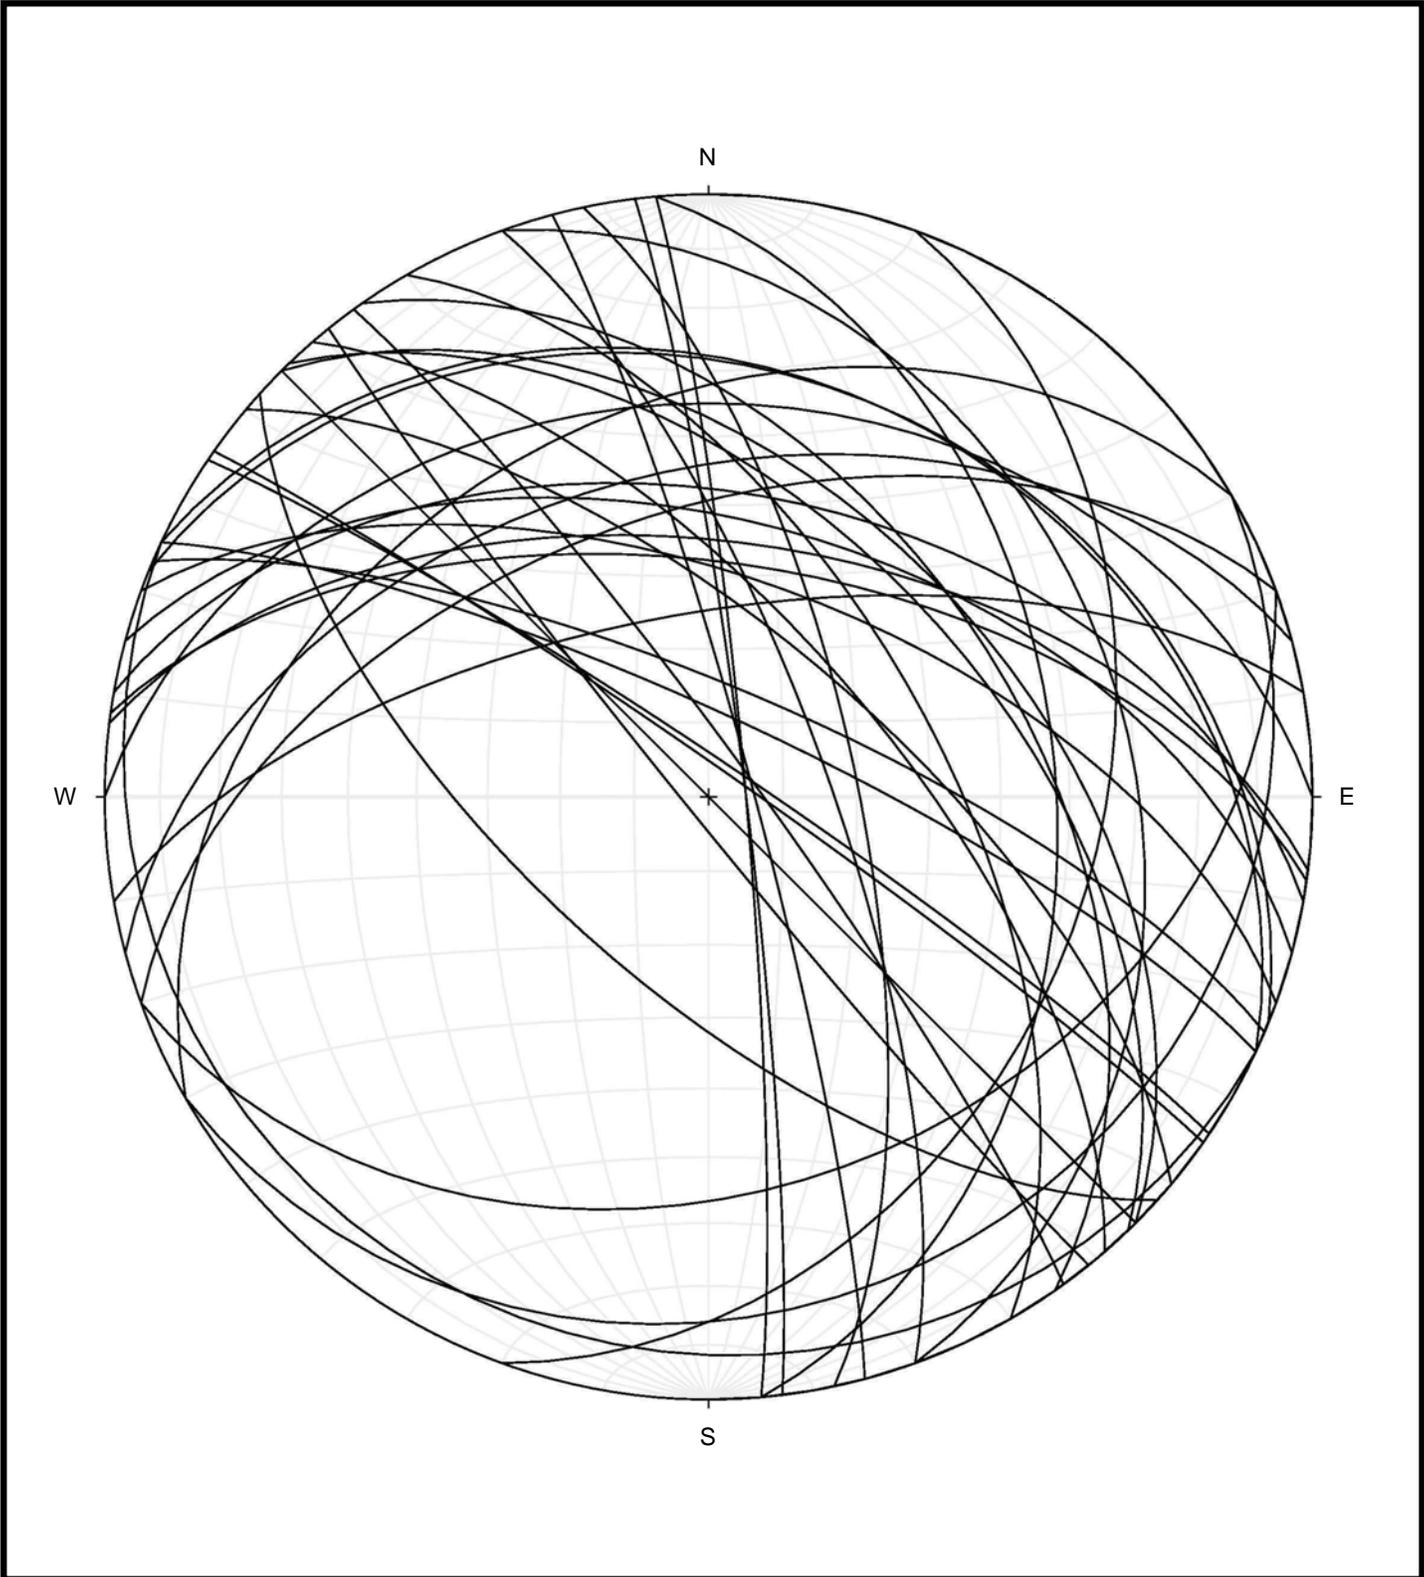
The orientations of the minor shears observed in the trenches and the northwest quarry wall are shown on Figure 2 and in Figure 8, Stereonet of Minor Shears. The variable orientations of the observed shears not only argue that they are minor in nature but also that they are not structurally related to the main fault. We interpret these minor shears as the consequence of folding of the northeastern flank of the Palos Verdes Hills rather than as rooted tectonic features. Alternatively, they could represent minor movement during periods of strong ground shaking (ground shatter) or minor movement during liquefaction prior to uplift of this portion of the peninsula.

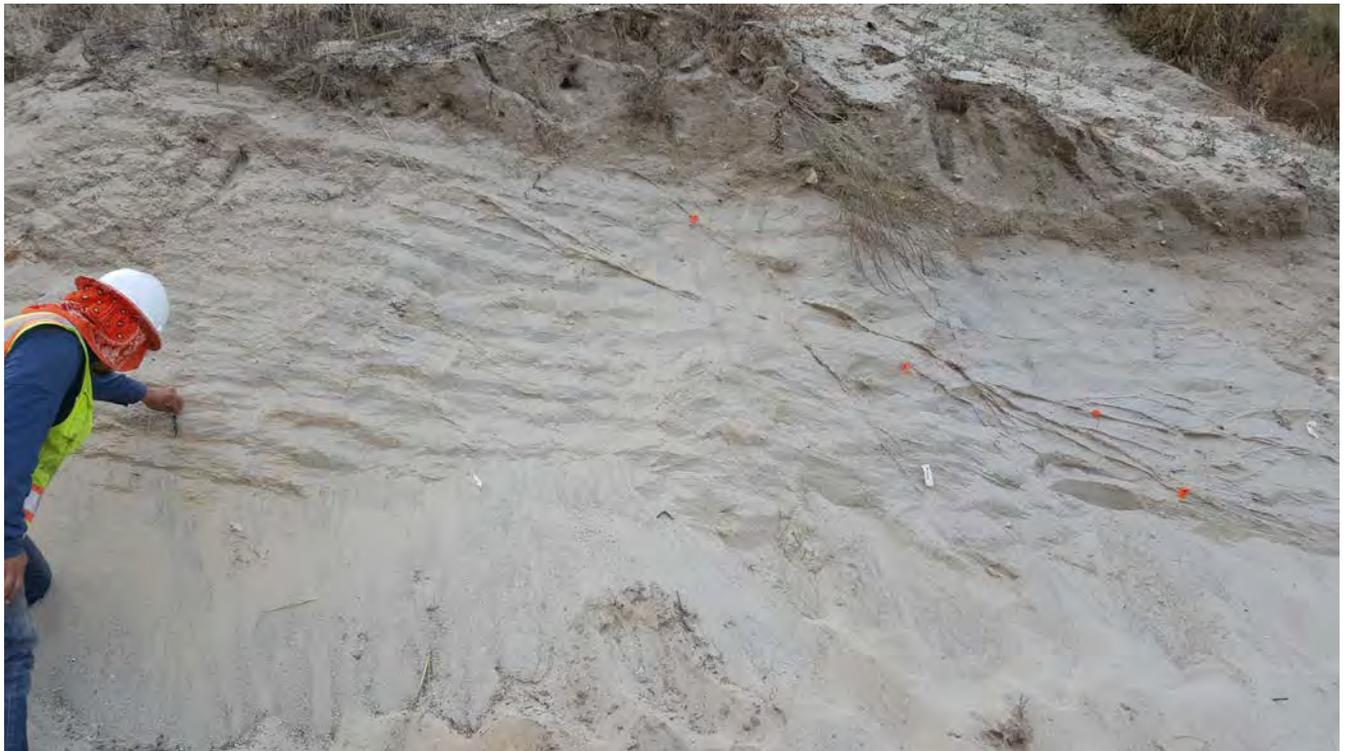
The entire length of the northwest quarry wall was cleared to expose a clean exposure of the San Pedro Sand. Only a small area did not expose native sediments, but rather, exposed fill soils. The location and orientation of the minor faults we observed on the northwest quarry slope are shown on Figure 2. The majority of the observed minor shears that were exposed are confined to the San Pedro Sand. We can confidently eliminate these features as active faults. However, because of thick fill soils (up to 5 feet thick) covering the northwest quarry slope in some areas, and because of the surficial instability of the slopes in their current condition, several of the observed shears could not be traced up the slope to determine where they terminate. With respect to those shears, we could not determine if they cut the modern soil, which would indicate young activity, or whether the soil is formed across the shears, which would indicate inactivity. As for the shears for which absolute determination could not be made, all had minor displacements of a few inches or less and were similar to the shears that could be shown to be inactive. This observation argues that, as a set, the entire group of very minor shears are inactive, as we discuss later.

Photo 10: Minor Faults Observed Along Northwest Quarry Slope

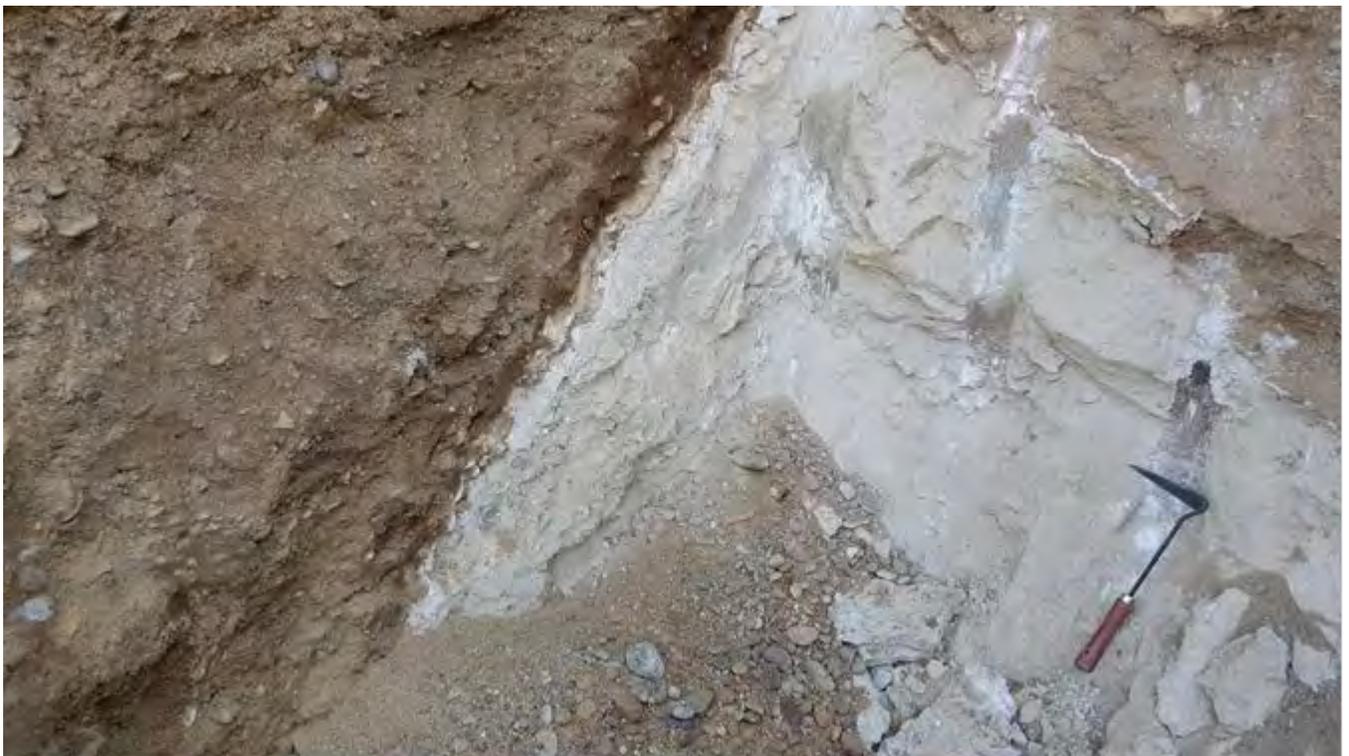
We excavated several pot-holes (pits) along the base of the north-facing slope at the locations shown on Figure 2. We observed a gravelly sand unit in the pits that could be interpreted as either non-marine terrace deposits or San Pedro Sand overlying the Monterey Formation bedrock. However, the sand was friable and uncemented and, due to caving conditions, it was difficult to conclude with a high degree of confidence whether the sand was non-marine terrace or San Pedro Sand and whether the contact between the two formations is depositional. The results of the “pot-holing” were inconclusive, although we found no evidence for the presence of a fault nor evidence of secondary shears in either formation that would be expected had a fault been present at the contact. Together, the likelihood of the presence of a fault between the San Pedro Sand and Monterey Shale was considered very low.

Photo 12: Depositional Contact - San Pedro Sand (or Terrace Deposit) over Monterey Formation

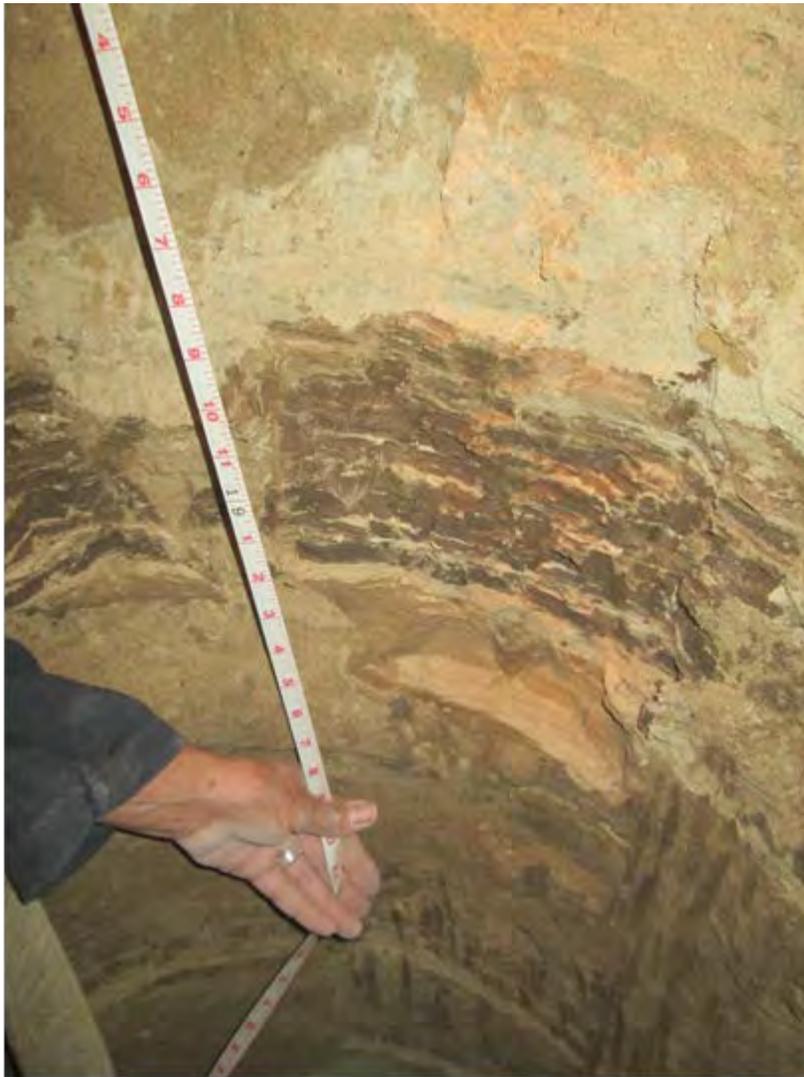
Photo 13: San Pedro Sand over Monterey Formation Siltstone

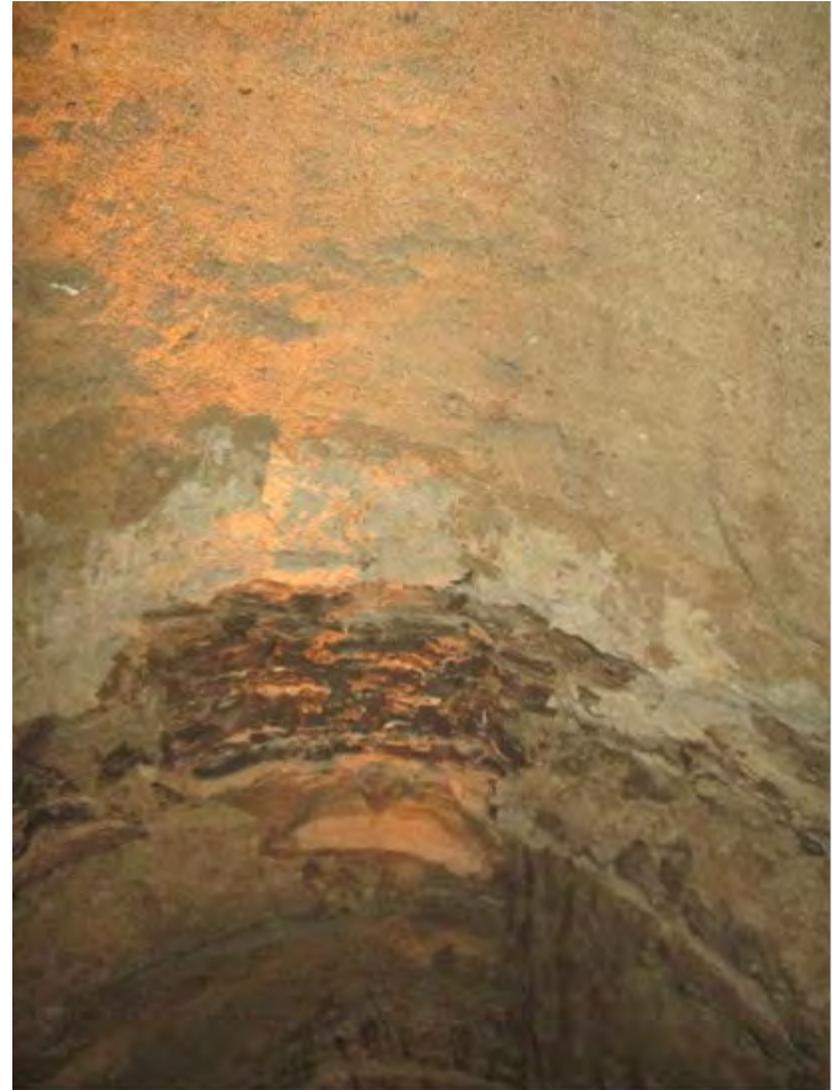
Later, as part of our concurrent geotechnical investigation, we observed in detail the contact between the San Pedro Sand and the Monterey Formation in large-diameter boring B2. Based on our observations in this boring, it was determined with a high degree of confidence that the contact between the San Pedro Sand and the underlying Monterey Formation bedrock is depositional in nature. Photo 13 and Photo 14 in Appendix A show the depositional contact between the San Pedro Sand and the underlying Monterey Formation siltstone.

Photo 14: Weathering Profile at Contact between San Pedro Sand and Monterey Formation Siltstone

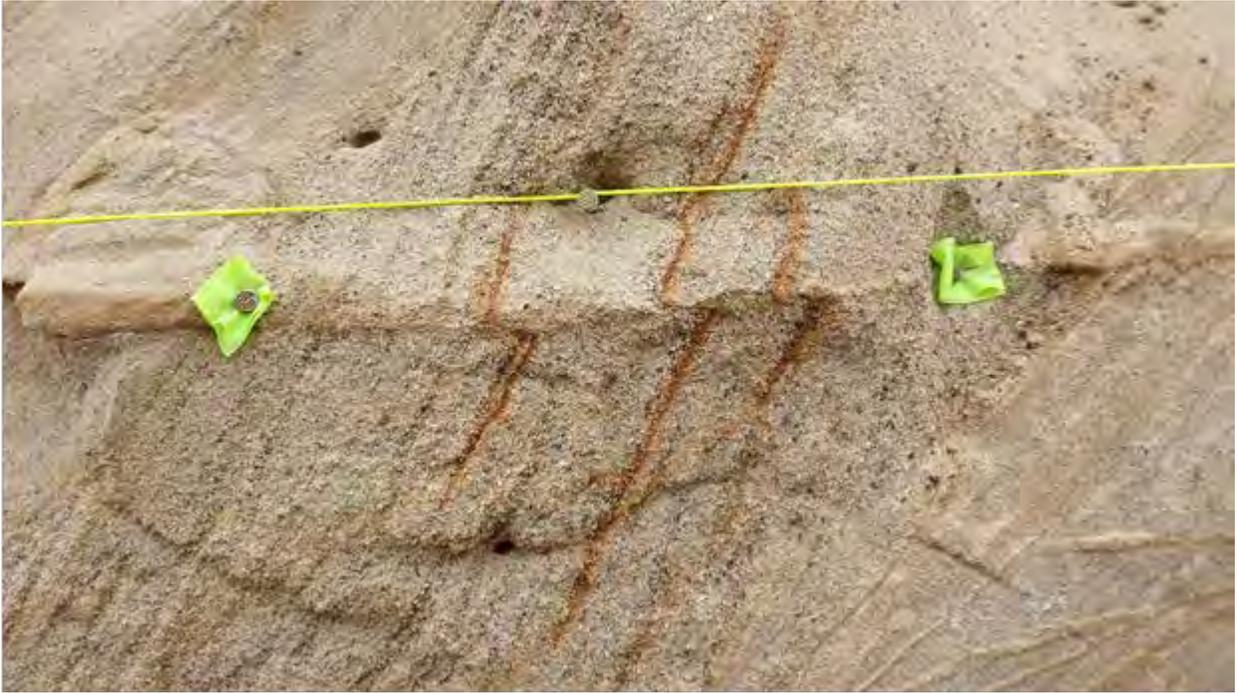
Trench 1: Station 0+36 Closeup of Offset Beds

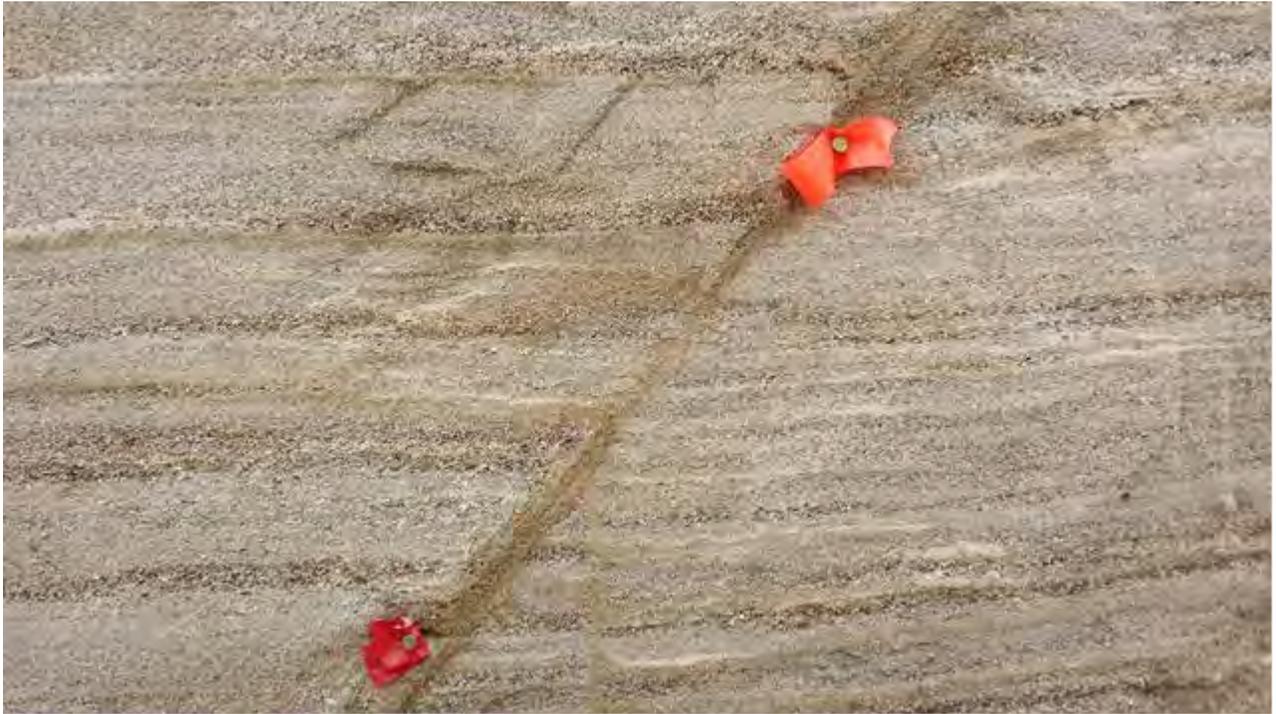
Trench 1: Station 0+60 Closeup of Offset Beds
