Transportation Study for San Miguelito Road  
Strauss Wind Energy Project

**Transportation Study**  
*for*  
**San Miguelito Road**  
**Strauss Wind Energy Project**  
Santa Barbara County, California

**Revised: March 1, 2018**

Project No. 16-702

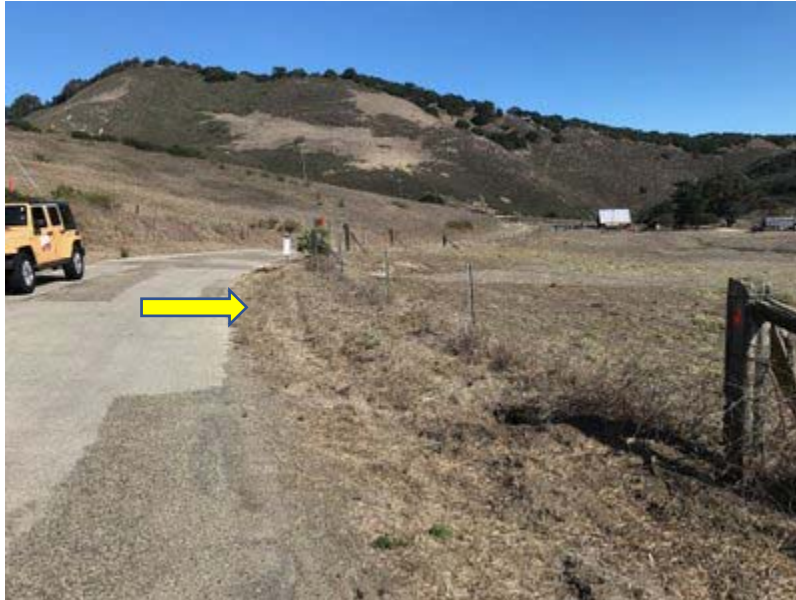
Photo 1: Modification #1 – Photo faces “up-station” (Northeast) from reference point No. 1/**Station 17+00**. Between **Stations 16+75 and 19+25, right side**, remove 250 linear feet of fencing along the southeast side of roadway; place and compact one foot of native material fill to extend the width of the road 12 feet at mid-chord location – (lesser at curve BC and EC). Replace barb wire fencing in-kind to accommodate modified alignment.

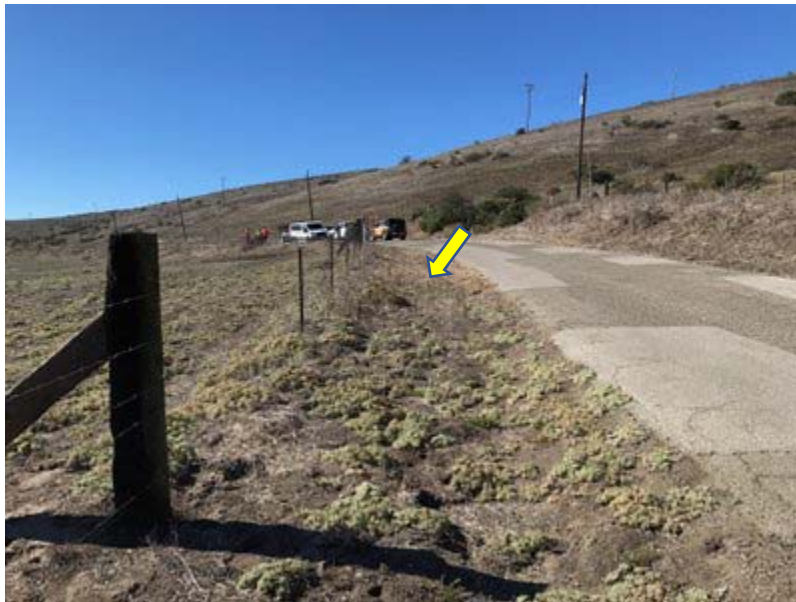
Photo 2: Modification #1: Photo faces “down-station” at reference point No. 2 – Approximate **Station 19+00**. Photo provide for information.

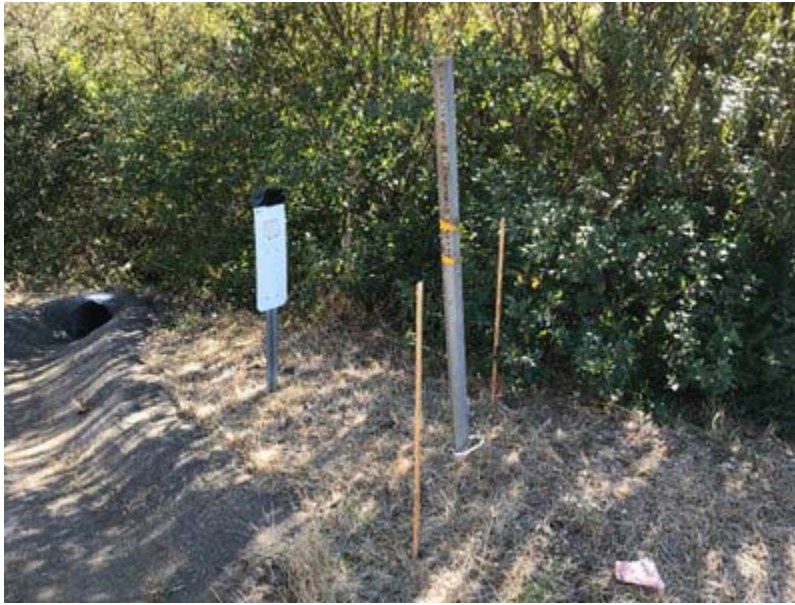
Photo 3: Modification #3: Photo was taken at reference point No. 5/ **Station 36+25**: Work includes removal of the paddle marker and metal tee bar along southeast edge of pavement (right side facing “up-station”).

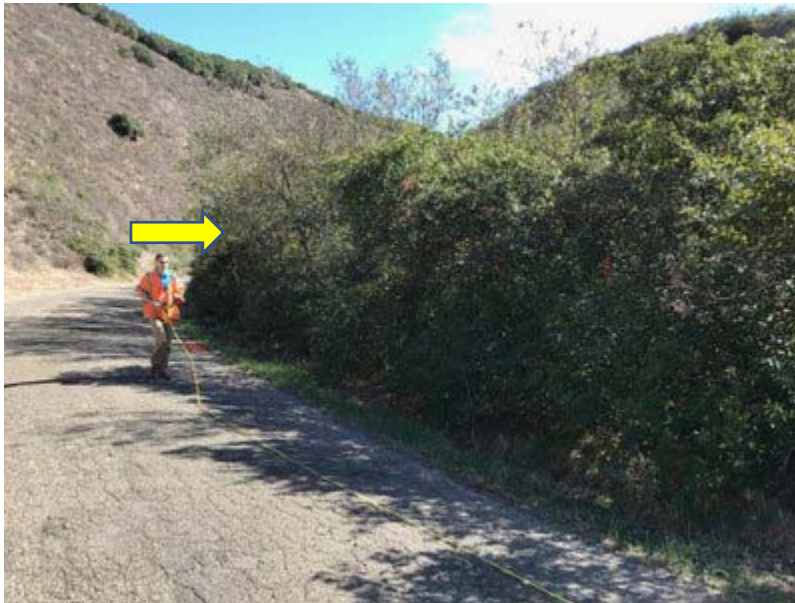
Photo 4: Modification #4: Photo was taken at reference point No. 6/**Station 37+30** facing “up-station”. Between **Stations 35+75 and 38+25, right side**, clear brush within 8 feet from edge of pavement and place roughly an 8-inch depth of base material to raise low shoulder.

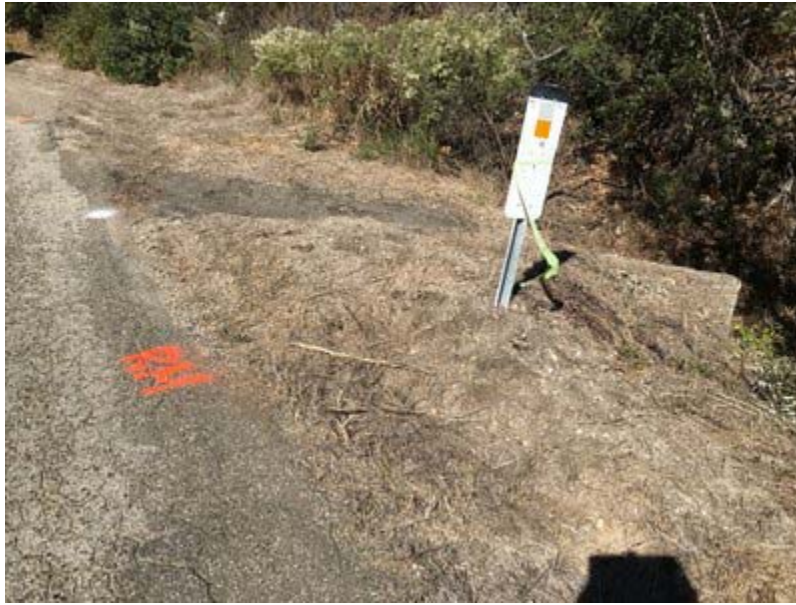
Photo 5: Modification #5: Photo was taken at reference point No. 7/**Station 40+50**, facing “up-station”. At this location furnish and install steel plates over the existing culvert to disperse wheel loads. Culvert has minimal cover at inlet side. Temporarily remove the existing paddle at the culvert.

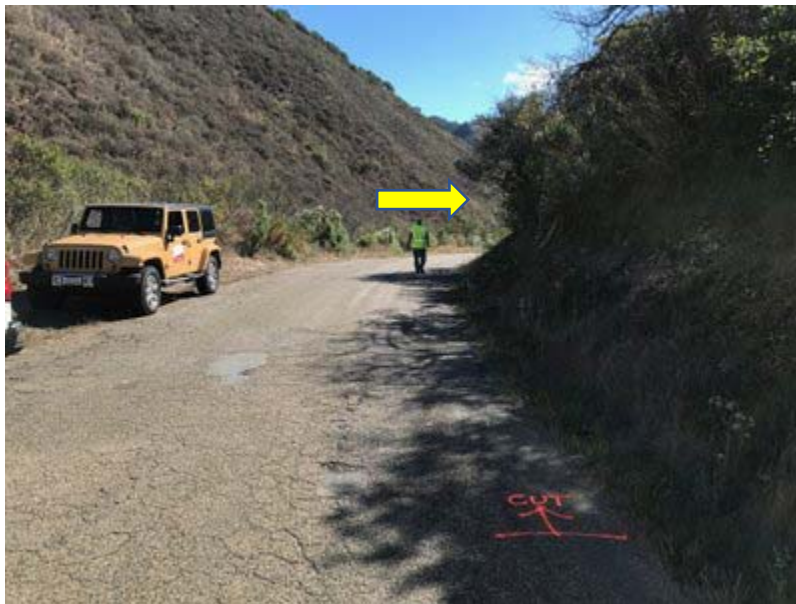
Photo 6: Modification #6: Photo was taken at reference point No. 8/**Station 42+50** and faces “up-station”. Between **Stations 42+00 and 43+50**, cut into the slope 8 feet (horizontal from inside edge of pavement) for a longitudinal distance of 150 feet. Excavate material and slope to “daylight” at 1-1/2 Horizontal to 1 Vertical.

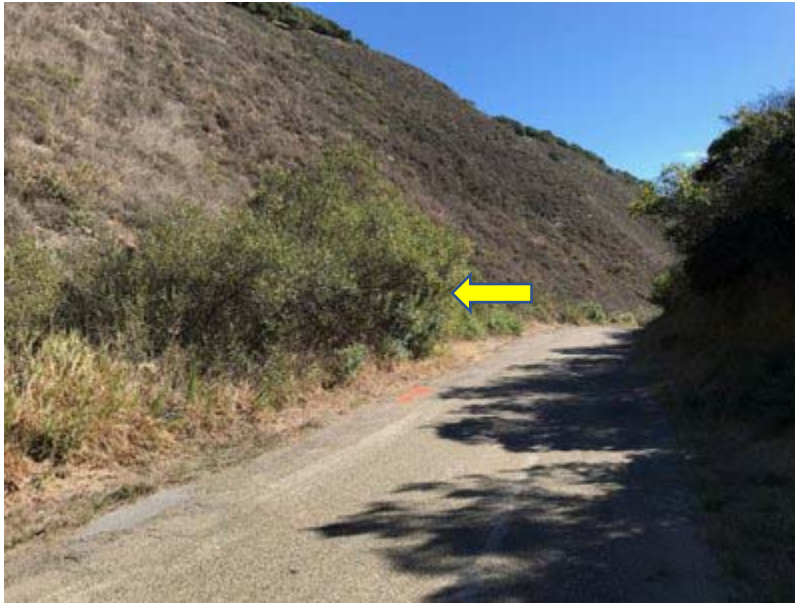
Photo 7: Modification #7: Photo was taken at reference point No. 10/**Station 42+00**, and faces “up-station”. Between **Stations 40+00 and 43+00**, clear the brush on the “left” side for a width of 6 feet.

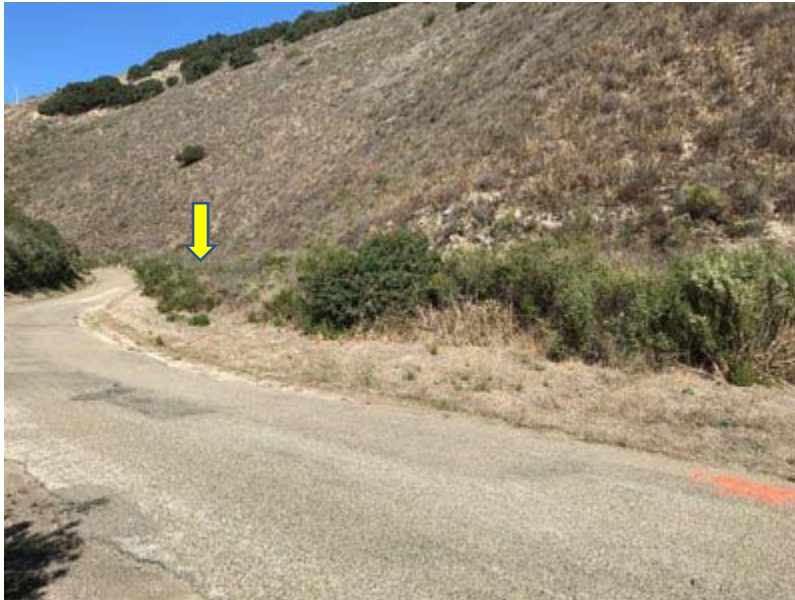
Photo 8: Modification #8: Photo was taken at reference point No. 12/**Station 47+25** and faces “down-station”. Between **Stations 45+70 and 48+70**, clear an 8-foot width of brush along “left” side of roadway for 300 linear feet. Perform minor grading within limit to remove some material to create smooth shoulder. Remove the paddle and underground conduit markers.

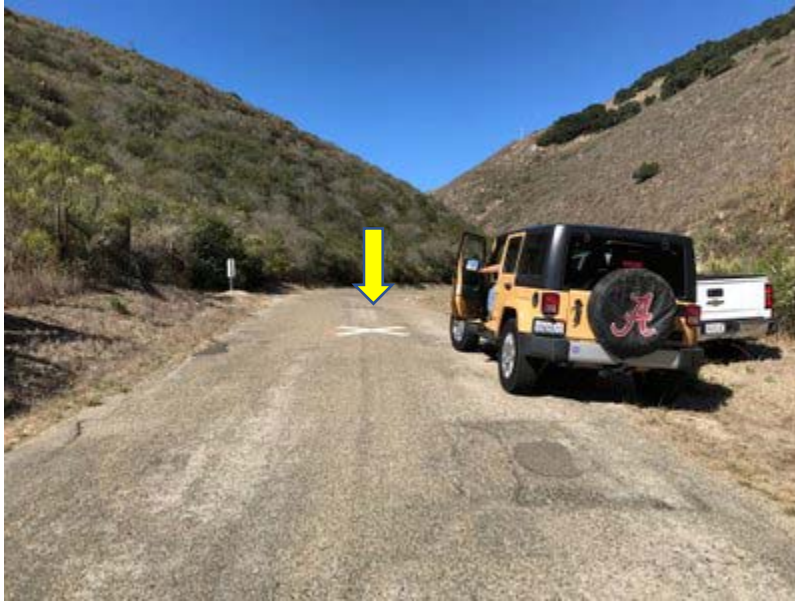
Photo 9: Modification #9: Photo was taken at reference point No. 13/**Station 48+00** and faces “down-station”. Between **Stations 46+00 and 49+30**, (330 linear feet), remove the “hump” in the roadway profile – roughly located at “X” in pavement. Re-pave limits of removal with asphalt concrete upon completion of the profile modification.

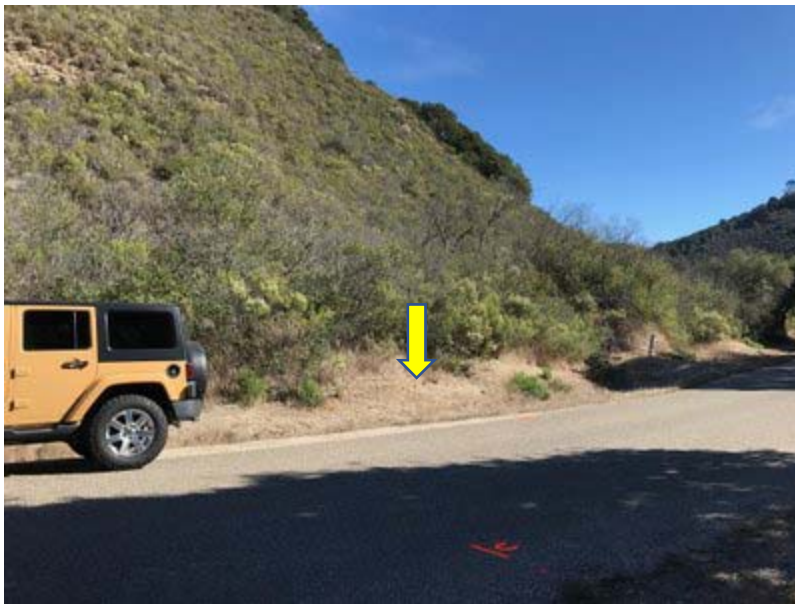
Photo 10: Modification #10: Photo was taken at reference point No. 15/**Station 59+25** and faces generally “up-station”. Although difficult to see in the photo, a swale exists along the “left” side of the roadway. Between **Stations 58+50 and 60+00**, work includes the import and placement of native material to fill in a swale.

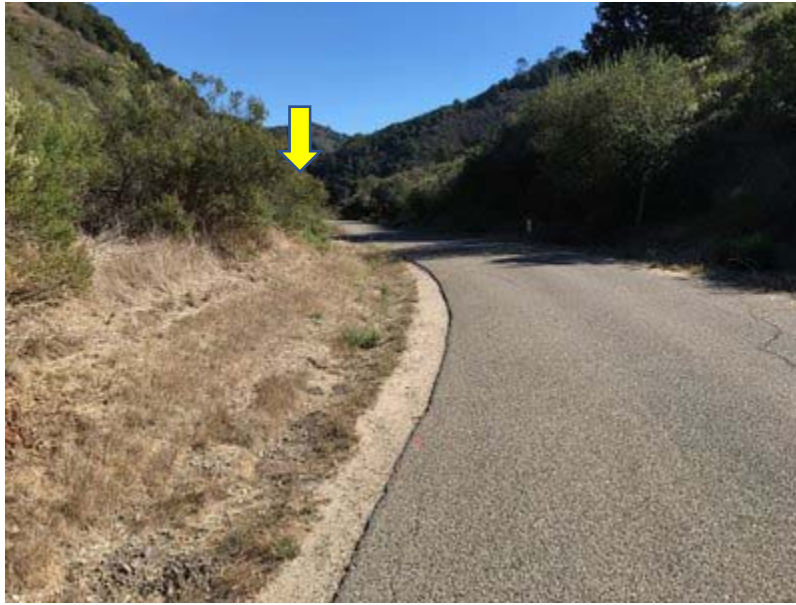
Photo 11: Modification #11: Photo faces “up-station” at reference point No. 17/**Station 62+45**: Between **Stations 62+45 and 63+95**, this work includes widening the “left” side shoulder by cutting the slope back an additional horizontal distance of 8 feet from the existing toe of slope. Excavate material and slope at 1-1/2 Horizontal to 1 Vertical to daylight. Grade new shoulder and place base if necessary for stability.

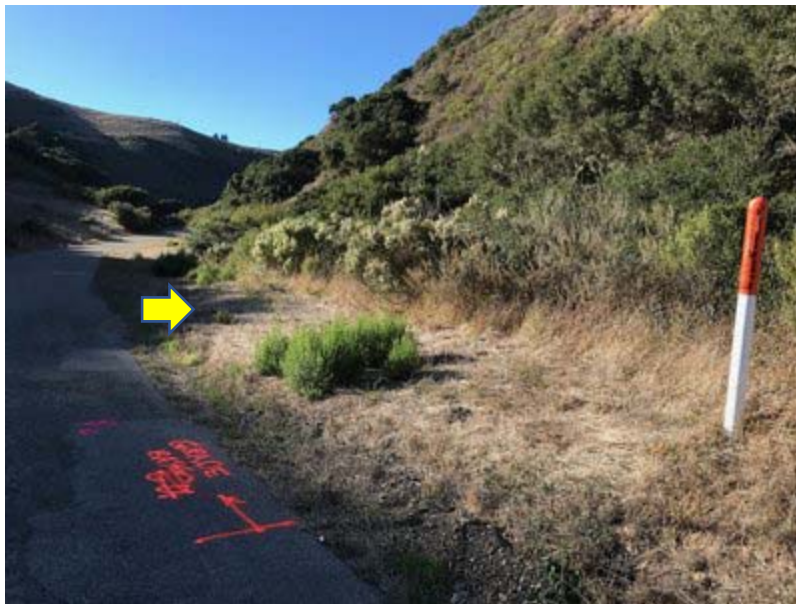
Photo 12: Modification #12. Photo was taken facing “down-station” at reference point No. 20/**Station 73+25**. Between **Stations 68+00 and 73+25**, work includes clearing a 10-foot swath of brush along the left side or inside edge of pavement, grading to create a smooth shoulder, importing and placement a maximum of 6-inch depth of aggregate base to stabilize soft shoulder.

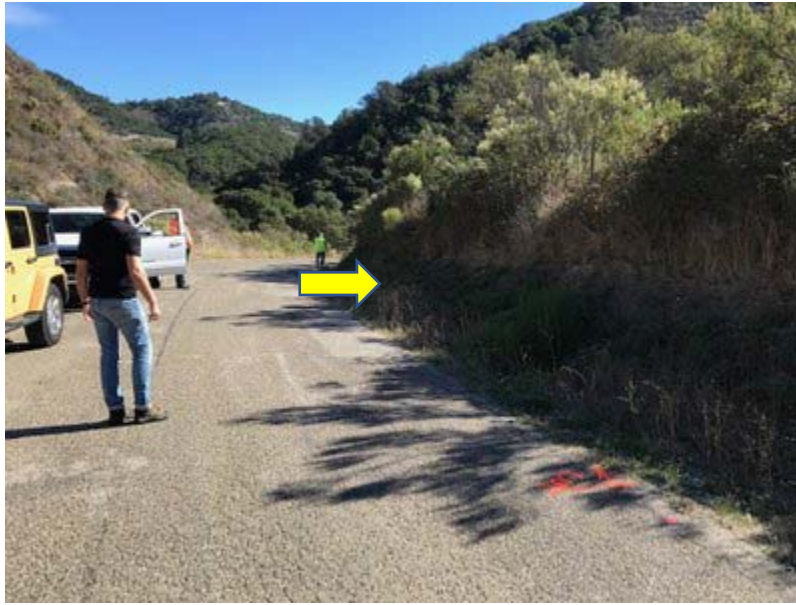
Photo 13: Modification #13. Photo was taken facing “up-station” at reference point No. 21/**Station 73+75**. Between **Stations 73+25 and 76+00**, work includes cutting the slope back for a horizontal distance of 8 feet measured from the existing edge of road. Excavate material and slope at 1-1/2 Horizontal to 1 Vertical to daylight.

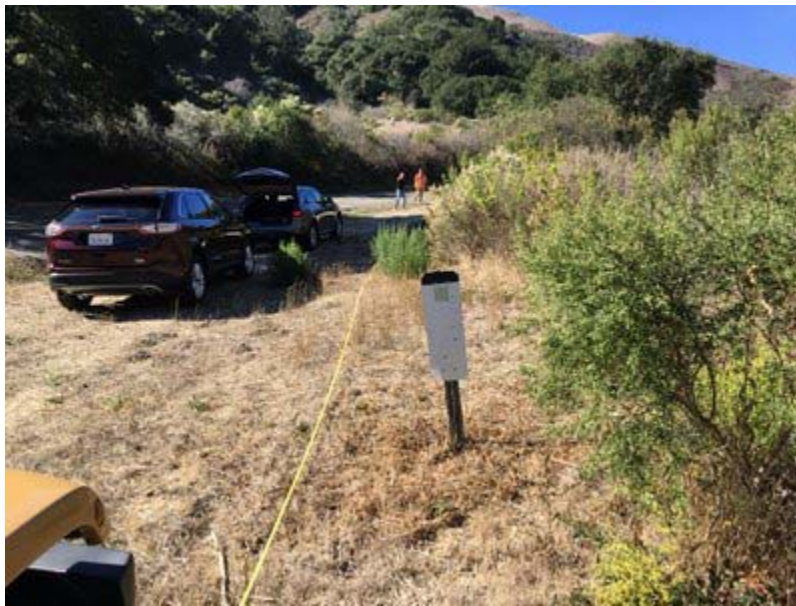
Photo 14: Modification #14. Photo was taken facing “down-station” at reference point No. 23/**Station 77+75**. Between **Stations 76+00 and 78+50**, work includes removal of a paddle marker and minor brush trimming.

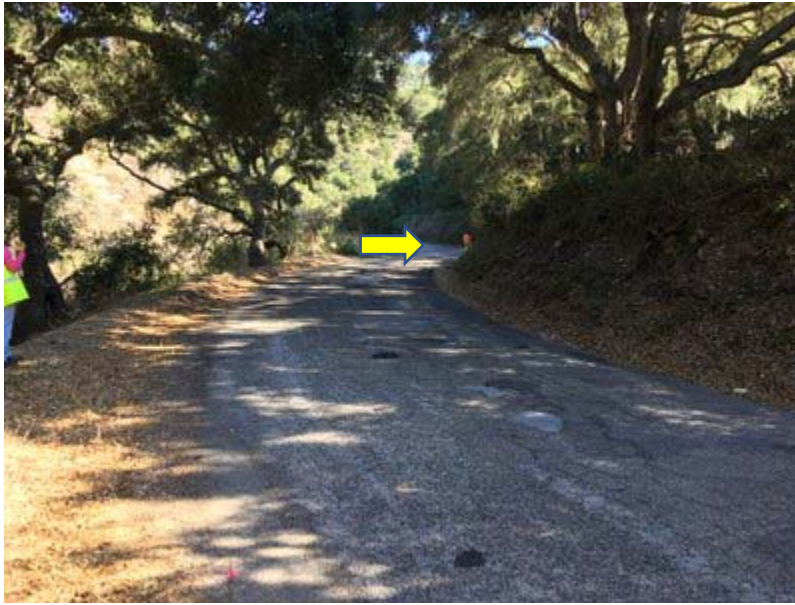
Photo 15: Modification #15: Photo was taken facing “up-station” at reference point No. 24/**Station 78+50**. Between **Stations 78+00 and 80+00**, work includes cutting the slope back to a horizontal distance of 7 feet from the existing edge of road. Excavate material and slope at 1-1/2 Horizontal to 1 Vertical to daylight.

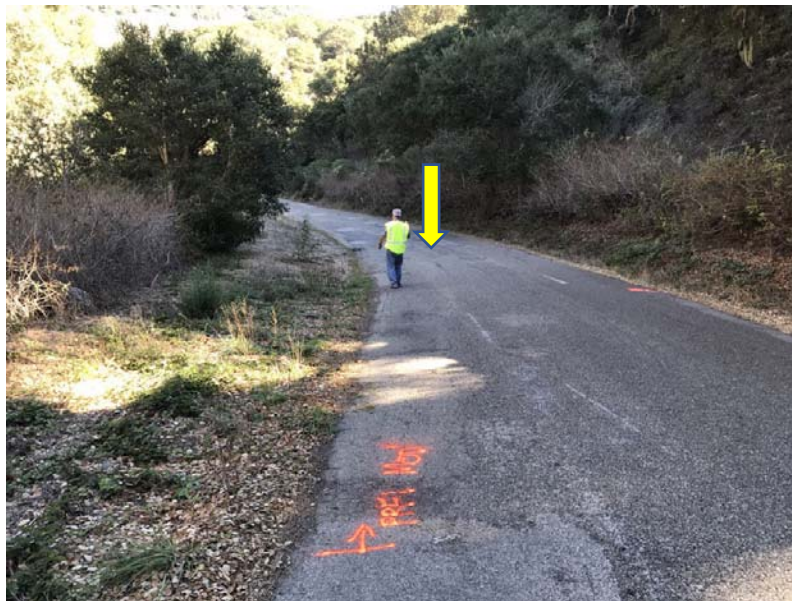
Photo 16: Modification #16: Photo was taken facing “up-station” at reference point No. 26/**Station 80+60**. Between **Stations 80+00 and 81+50**, work includes modifying roadway profile to remove “dip”. A transverse cold-planed joint will be cut at limits of profile modification, and existing pavement will be overlain with new asphalt concrete to span and remove the “dip”.

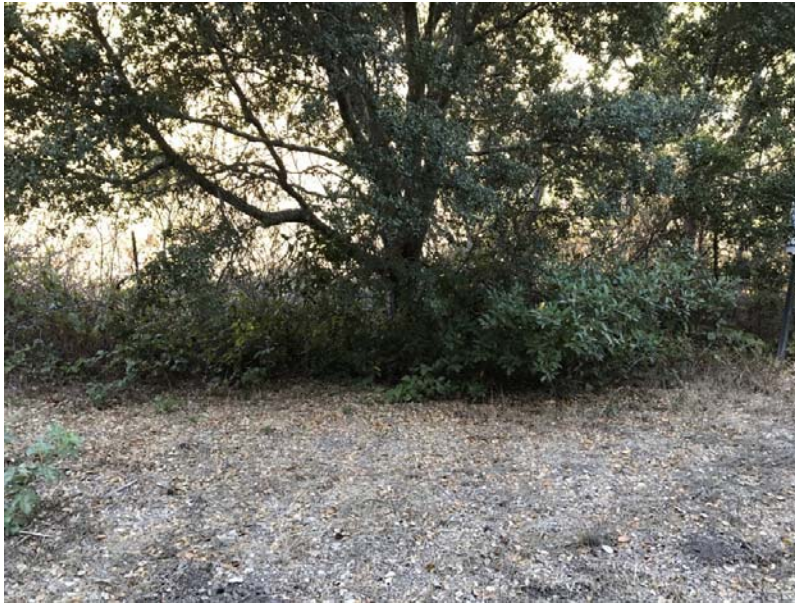
Photo 17: Modification #17. Photo was taken at reference point No. 27/**Station 81+40** facing a tree to be removed on the “left” side of the road, within the inside radius of curve.

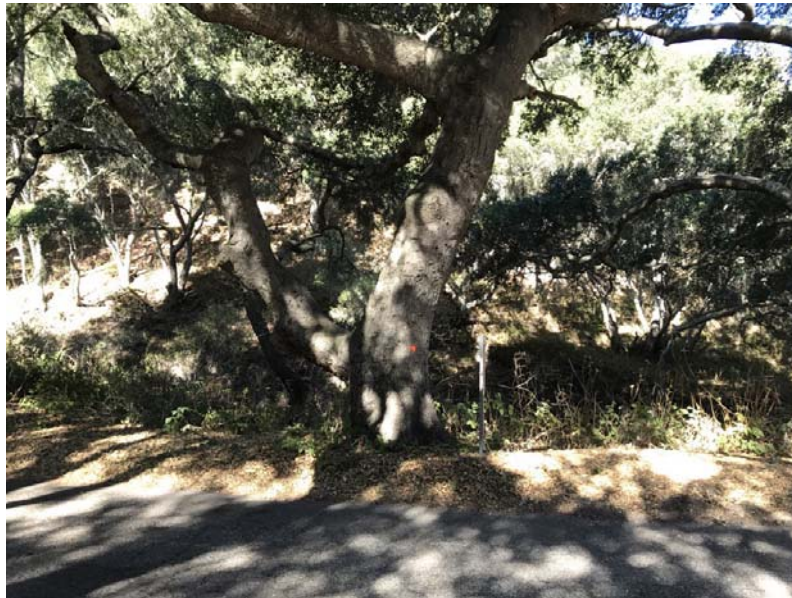
Photo 18: Modification #18: Photo was taken at reference point No. 30/**Station 84+95** facing the tree on inside radius of curve that may need to be removed. It is possible removal may be avoided with substantial trimming of overhanging limbs (See Photo 20). Although, not shown in this photo, two other similar and adjacent trees may also need to be removed in this vicinity (for a total of (3) trees to be removed).

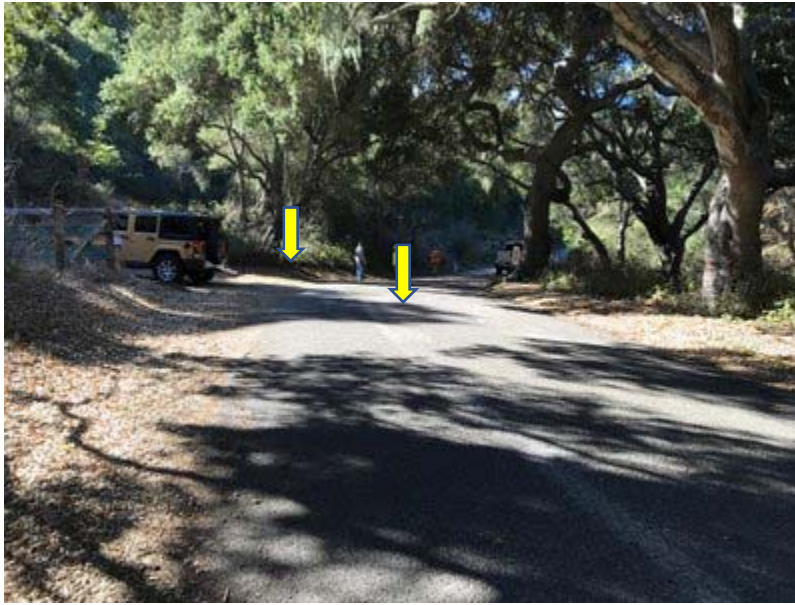
Photo 19: Modification #19: Photo was taken facing “down-station” at reference point No. 32/**Station 85+50**. Between **Stations 83+30 and 87+00** work at this location includes modification of roadway to lower the profile a maximum of 4-feet (at the crest of the vertical curve). Total length of the modified profile section of roadway will be re-paved after completion of profile modification. In addition, work at this location includes cutting the slope back 2 feet into the outer radius (right side – when facing “up-station”) of the road.

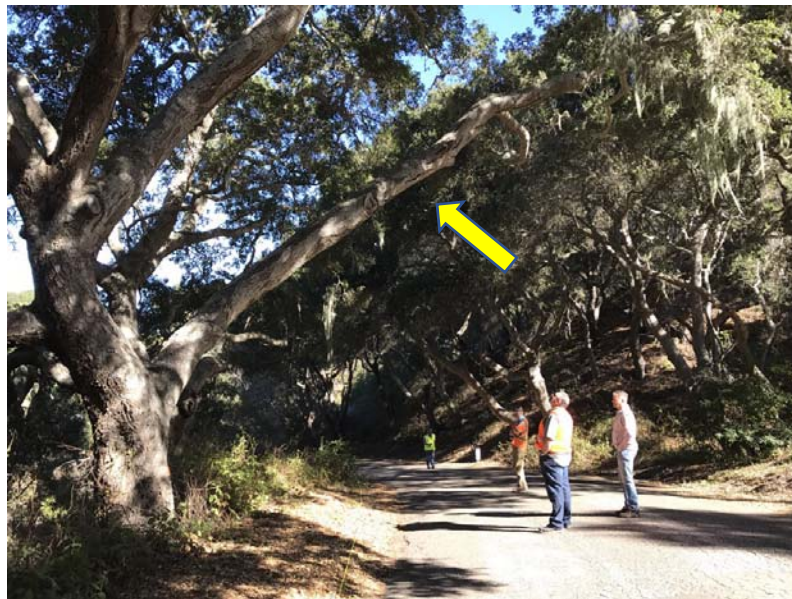
Photo 20: Modification #20. Photo was taken facing “up-station” at reference point No. 33/**Station 86+00**. In lieu of complete tree removal, (as described in Photo 18/**Station 84+95**), removal of large overhanging limbs may be an option.

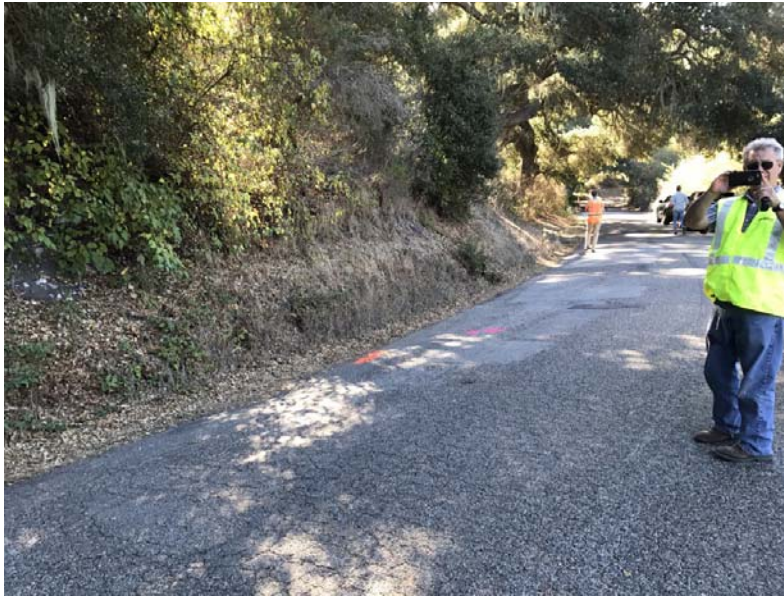
Photo 21: Modification #21: Photo was taken facing “down-station” at reference point No. 34/**Station 89+65**. Between **Stations 89+50 and 94+00** work includes removal of brush for a width of 8 feet along both the inside and outside radius of the curve.

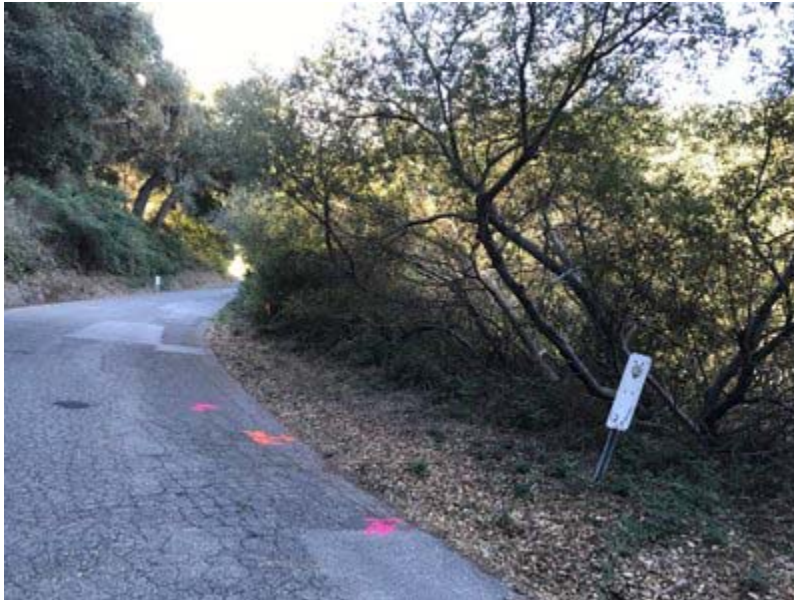
Photo 22: Modification #21. Photo was taken facing “down-station” at reference point No. 38/**Station 92+00**. Work includes brush removal as described in Photo 21. Paddle markers will also be temporarily removed.

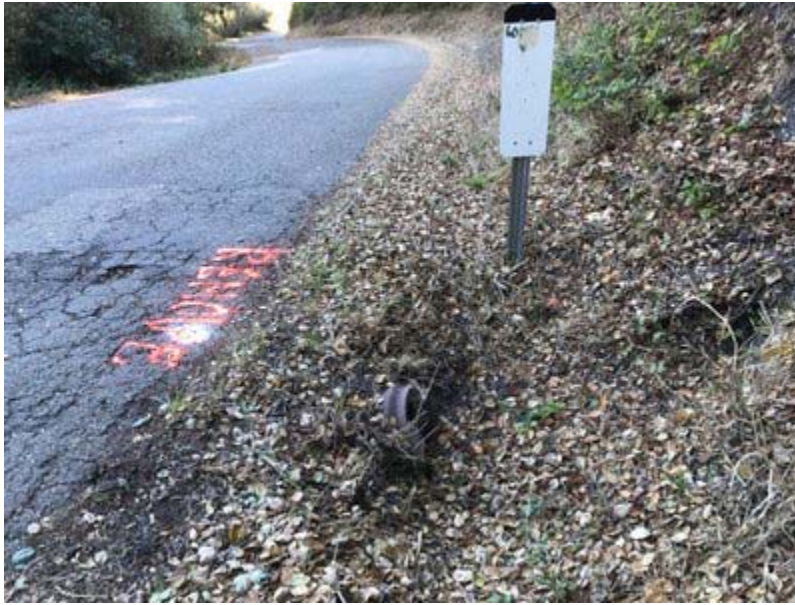
Photo 23: Modification #22. Photo was taken facing “up-station” at reference point No. 35/**Station 90+50**. Work includes removal of culvert paddle markers. In addition, steel plates should be placed to protect culvert pipe with very little cover and failing pavement.

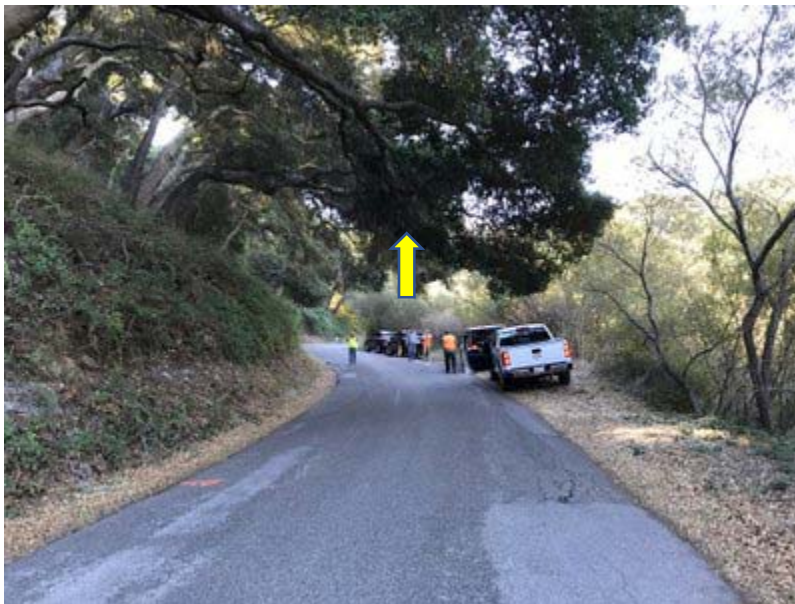
Photo 24: Modification #24. Photo was taken facing “down-station” at reference point No. 39/**Station 93+00**. Work includes trimming overhead trees to provide vertical clearance of 16.1 feet. Tree removal is not needed.

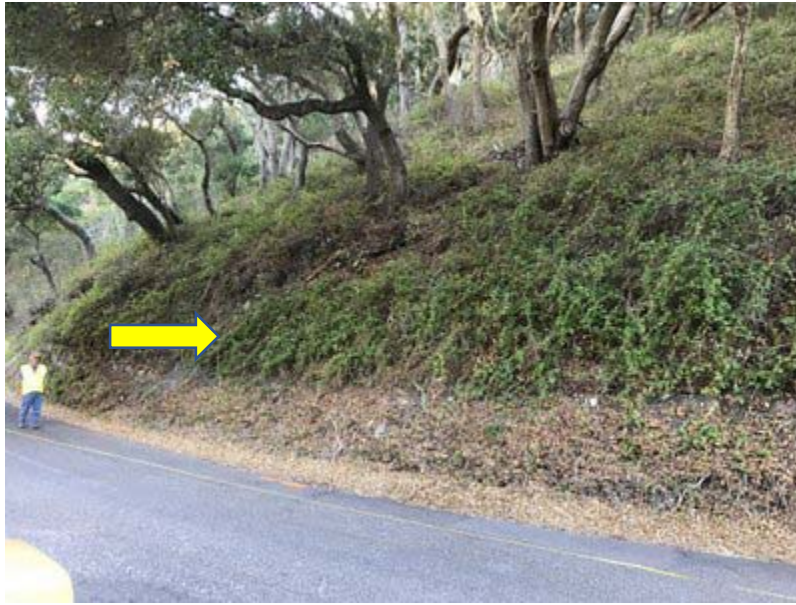
Photo 25: Modification #25. Photo was taken generally facing “up-station” at reference point No. 40/**Station 93+25**. Between **Stations 92+25 and 94+00**, work includes cutting the slope back 3 feet, (measured horizontally from the existing toe of slope). Excavate excess material and slope to daylight at 1-1/2 Horizontal and 1 Vertical. Excavation will require the removal of 3 mature trees. (Tree clumps have been considered one tree).

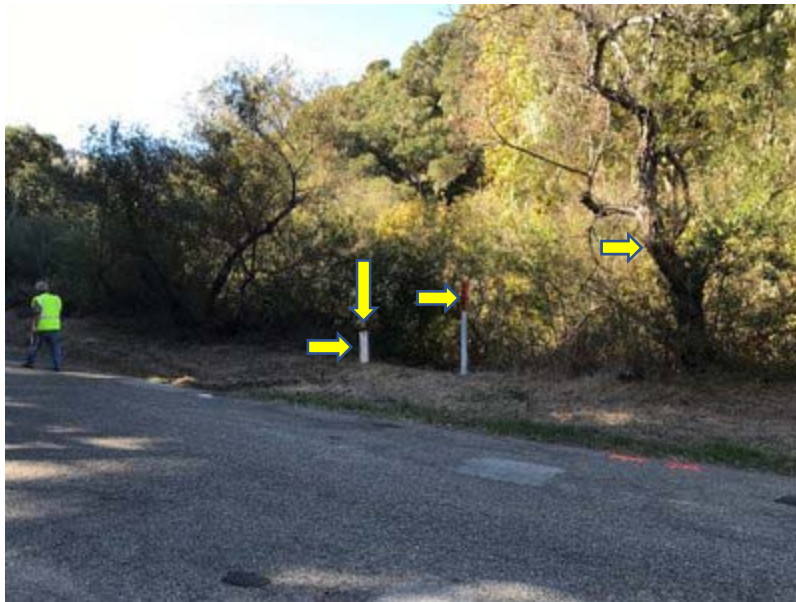
Photo 26: Modification #26: Photo was taken generally facing “down-station” at reference point No. 41/**Station 99+50**. Between **Stations 99+00 and 100+00**, work includes removing the existing willow tree (in the foreground), and removal of brush for a distance of 50 feet either side of tree. Additional work at this location includes placement of steel plates over the existing culvert pipe, and grading to create a 4 foot wide shoulder along the limit of brush removal.

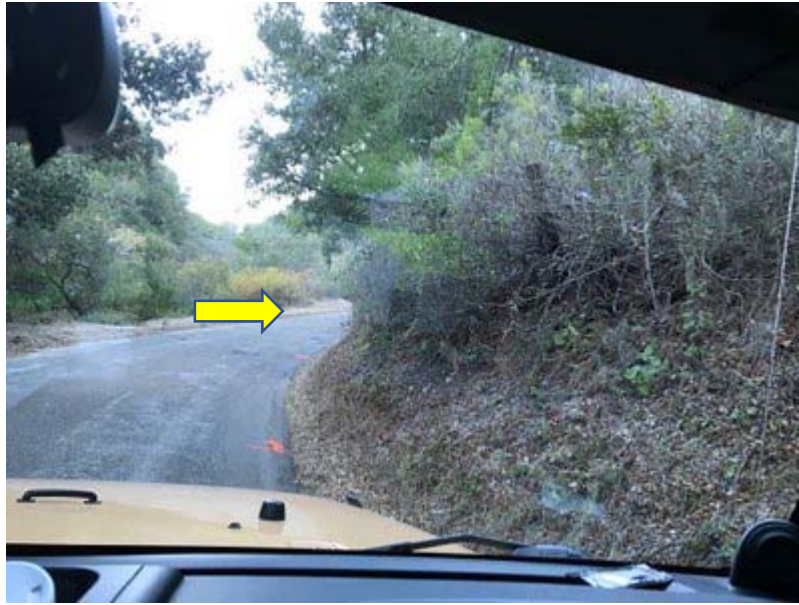
Photo 27: Modification #27: Photo was taken generally facing “up-station” at reference point No. 42/**Station 105+00**. Between **Stations 104+00 and 106+00**, work includes cutting the slope back 8 feet measured from the inside/right side edge of pavement (also toe of slope). Excavate slope at 1-1/2 Horizontal to 1 Vertical to daylight.

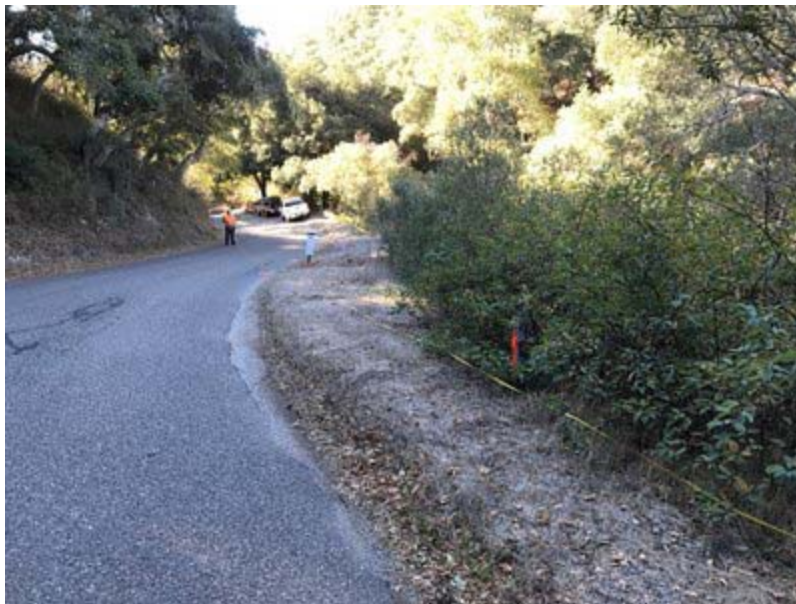
Photo 28: Modification #28: Photo was taken facing “down-station” at reference point No. 46/**Station 107+55**. Between **Stations 106+50 and 109+00**, work includes removal of an underground cable marker, two mature trees, brush along the “left” side (or inside radius of curve) and minor grading to smooth and extend shoulder.

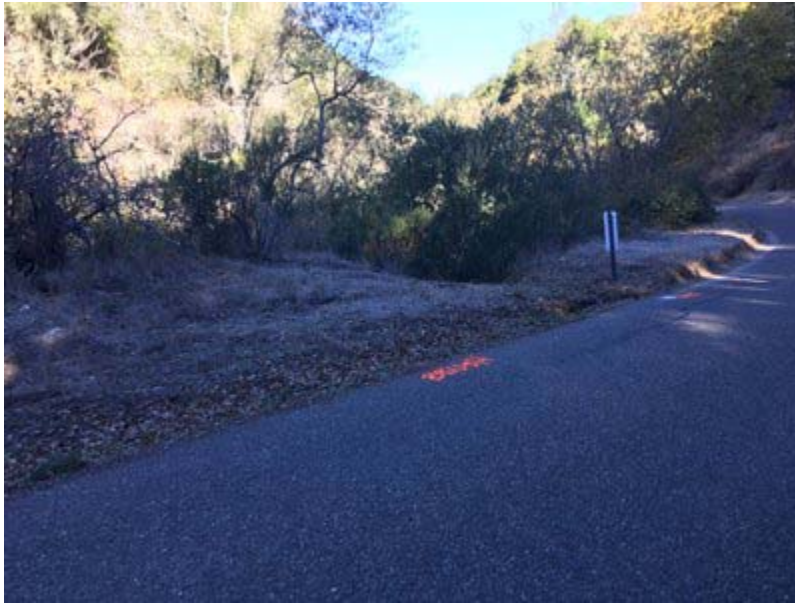
Photo 29: Modification #28: Photo was taken facing “up-station” at **Station 106+50**. Photo provided for information (see Photo 28 for work description).

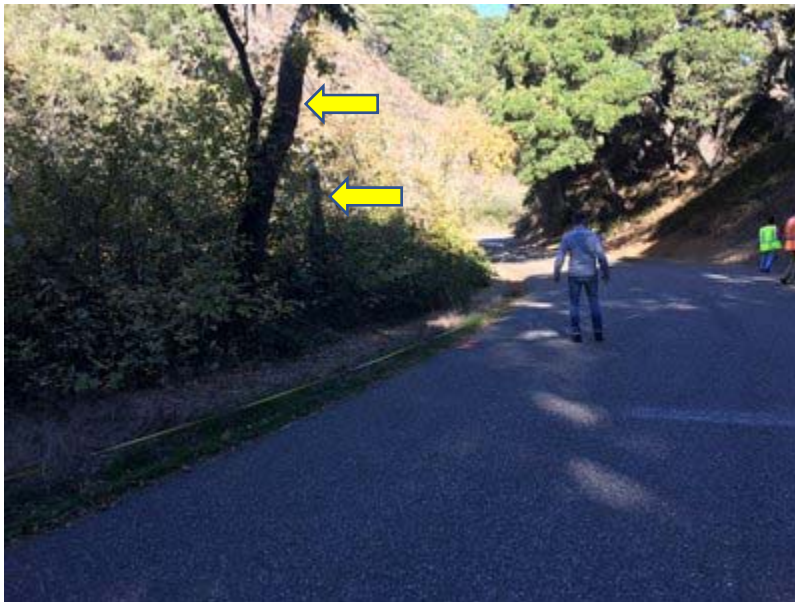
Photo 30: Modification #29: Photo was taken facing “up-station” at reference point No. 48/**Station 108+00**. Between **Stations 107+50 and 108+50**, work includes removing 2 trees on the inner radius of the road (left side); and a 6-foot width of brush removal.

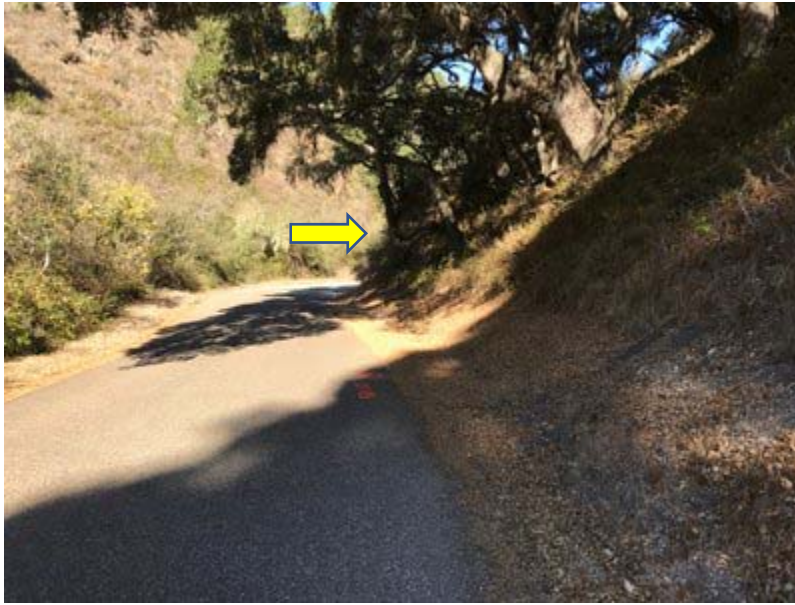
Photo 31: Modification #30: Photo was taken facing “up-station” at reference point No. 51/**Station 109+15**. Between **Stations 108+50 and 110+90**, work includes cutting the slope back 5 feet from the inside radius of the curve (right side), measured horizontally from the existing toe of slope. Excavate material and slope cut at 1-1/2 Horizontal to 1 Vertical to daylight.

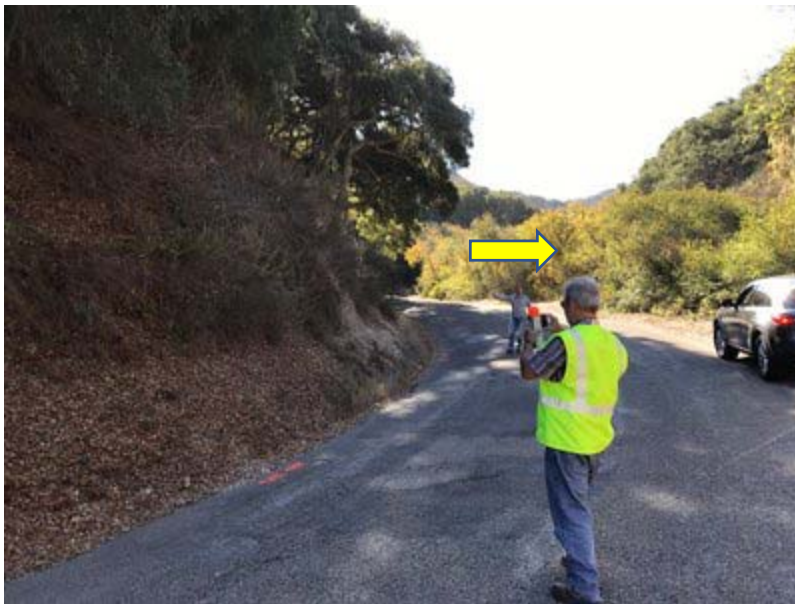
Photo 32: Modification #31: Photo was taken facing “down-station” at reference point No. 52/**Station 111+00**. Between **Stations 110+00 and 111+50**, work includes removing brush on the outer radius of the road (left side) and adding 8 feet of road base to the shoulder.

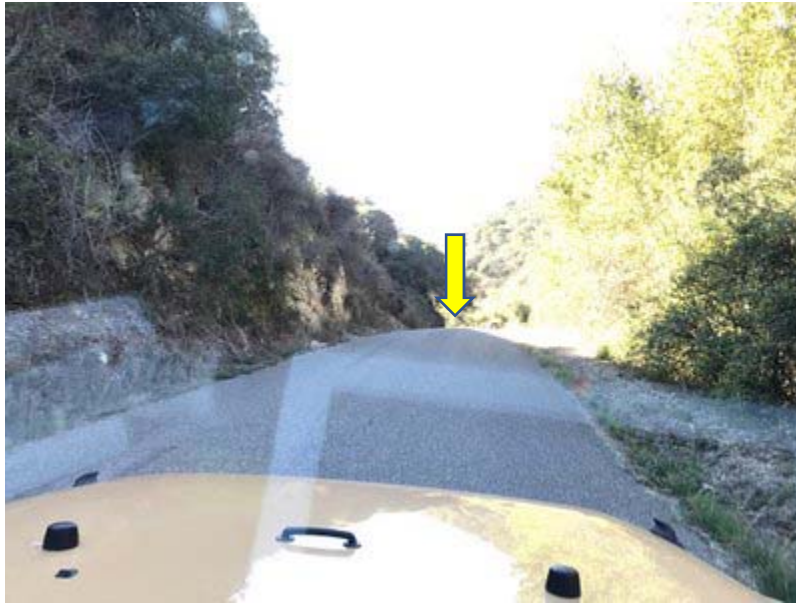
Photo 33: Modification #33: Photo was taken facing “down-station” at reference point No. 54/**Station 113+50**. Between **Stations 111+90 and 114+10**, work requires removal of the “hump” in the roadway profile – roughly located at the yellow arrow. Pavement to be removed and roadway re-graded within said limits. Roadway section to be re-paved with asphalt concrete upon completion of profile revision.

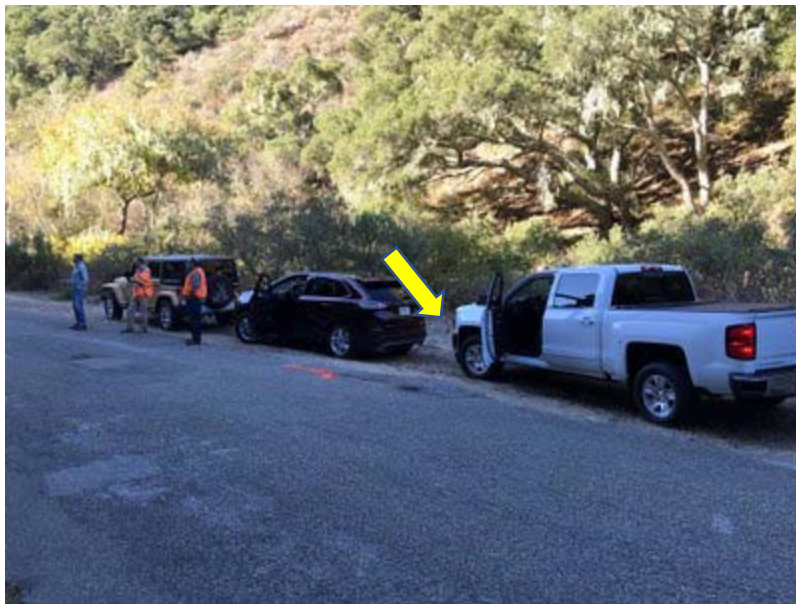
Photo 34: Modification #34: Photo was taken generally facing “down-station” at reference point No. 55/**Station 115+75**. Between **Stations 114+75 and 116+00**, work includes placement of a 3 to 4-inch depth of aggregate base to the “left” shoulder (left side) to provide a width of 8 feet.

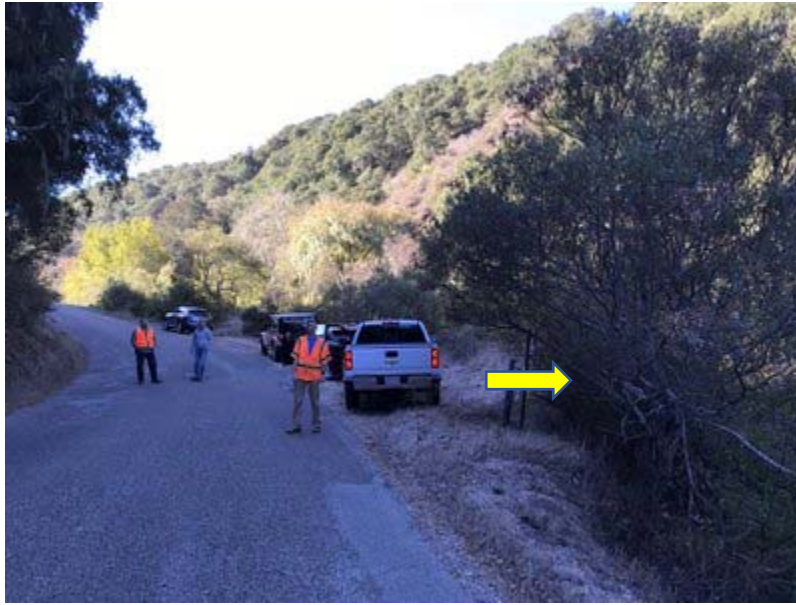
Photo 35: Modification #35: Photo was taken facing “down-station” at reference point No. 56/**Station 116+00**. Work includes removing a tree on the outer radius of the road (left side).

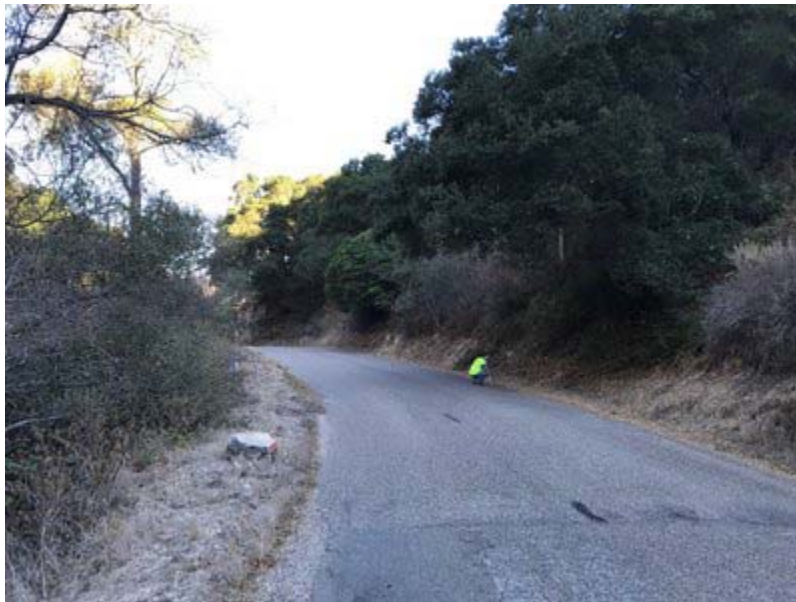
Photo 36: Modification #36: Photo was taken generally facing “up-station” at reference point No. 57/**Station 116+35**. Between **Stations 116+35 and 117+50**, work includes removing a rock on the inner radius of the road and trimming back brush and trees on inside radius (right side) to provide 8 more feet of clear area.

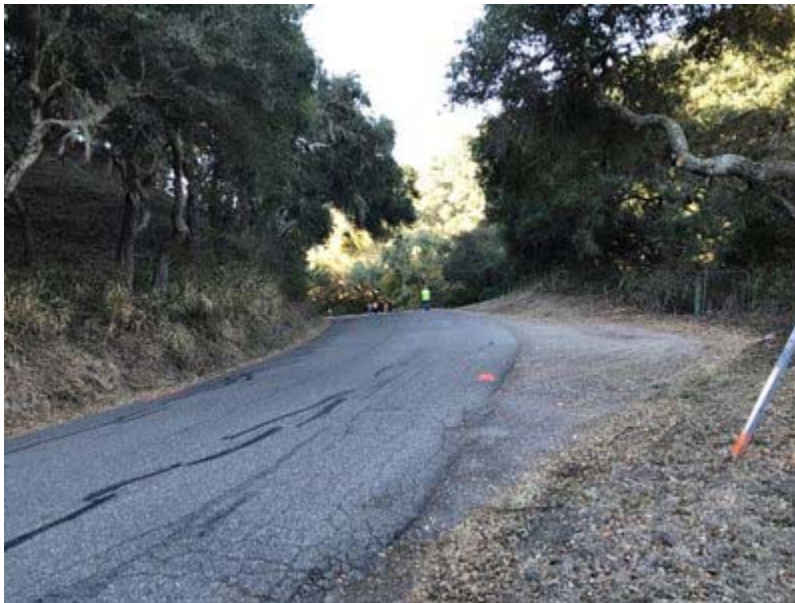
Photo 38: Modification #38: Photo was taken generally facing “down-station” at reference point No. 60/**Station 123+00**. Between **Stations 122+00 and 124+00**, work includes removing a paddle marker and cutting the slope 6 feet back from the inside radius of the road, and daylighting at a 1 Horizontal to 1 Vertical slope. Excavation will require the removal of 4 trees located at the top of the existing slope.

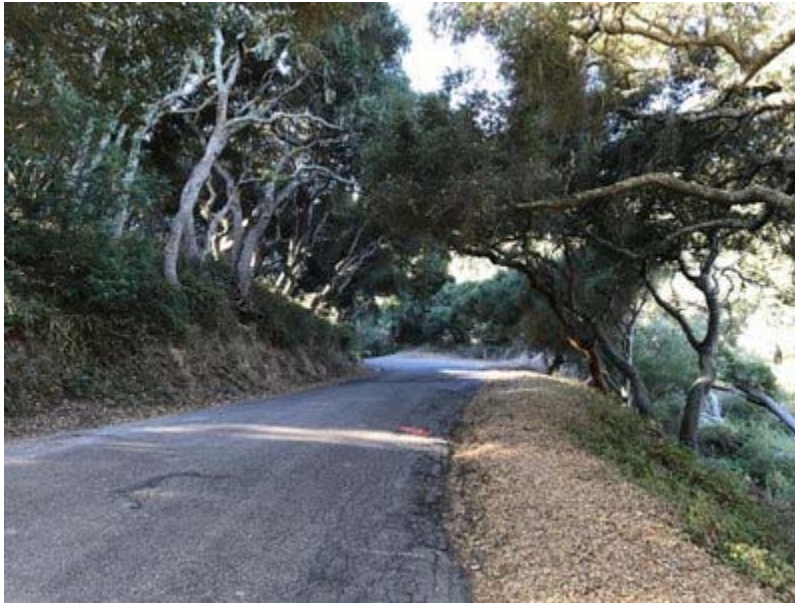
Photo 39: Modification #39: Photo was taken generally facing “down-station” at reference point No. 63/**Station 124+15**. The canopied trees need to be trimmed to provide 16.1 feet of vertical clearance.

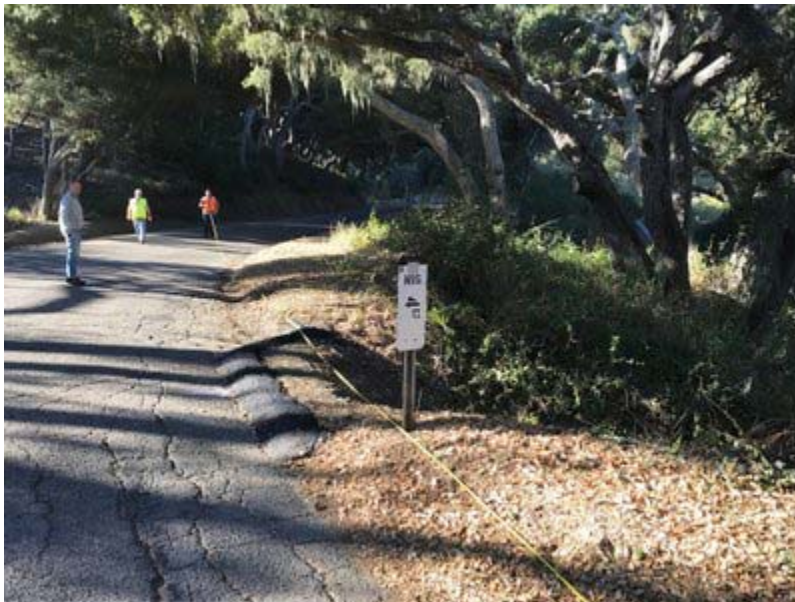
Photo 40: Modification #40: Photo was taken general facing “down-station” at reference point No. 64/**Station 125+00**. Work includes plating the culvert and removing a paddle marker.

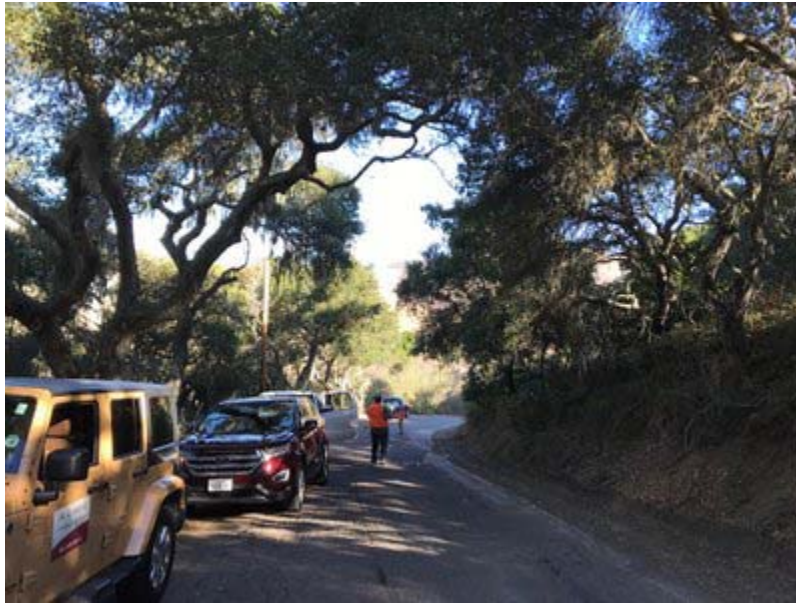
Photo 41: Modification #41: Photo was taken generally facing “up-station” at reference point No. 65/**Station 125+75**. Between **Stations 124+50 and 126+30**, work includes removing a 6-foot width of brush from the inner radius (right side) of San Miguelito Road.
