Transportation Study for San Miguelito Road  
Strauss Wind Energy Project

**Transportation Study**  
*for*  
**San Miguelito Road**  
**Strauss Wind Energy Project**  
Santa Barbara County, California

**Revised: March 1, 2018**

Project No. 16-702

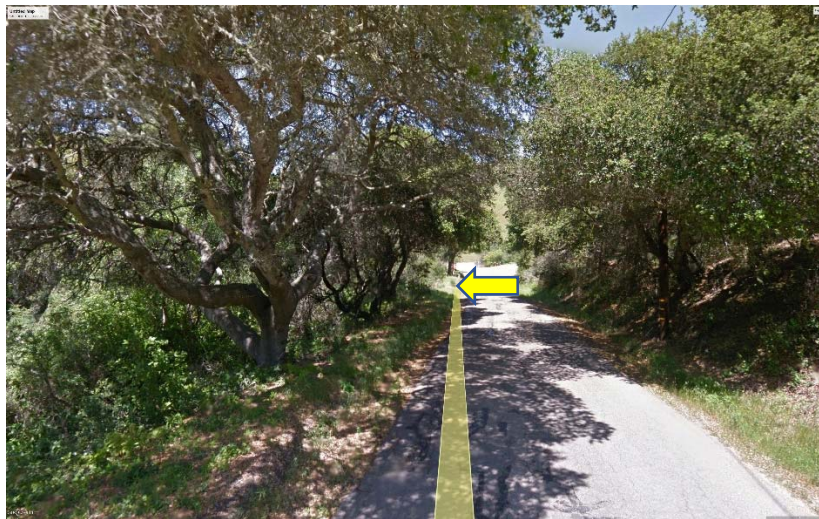
Photo 42: Modification #42: This Google Earth photo was taken generally facing “up-station” at reference point No. 66/**Station 130+50**. Between **Stations 130+00 and 131+00** work includes removing three mature trees on the left side of the road. In addition, remove miscellaneous brush within the limits of the tree removal.

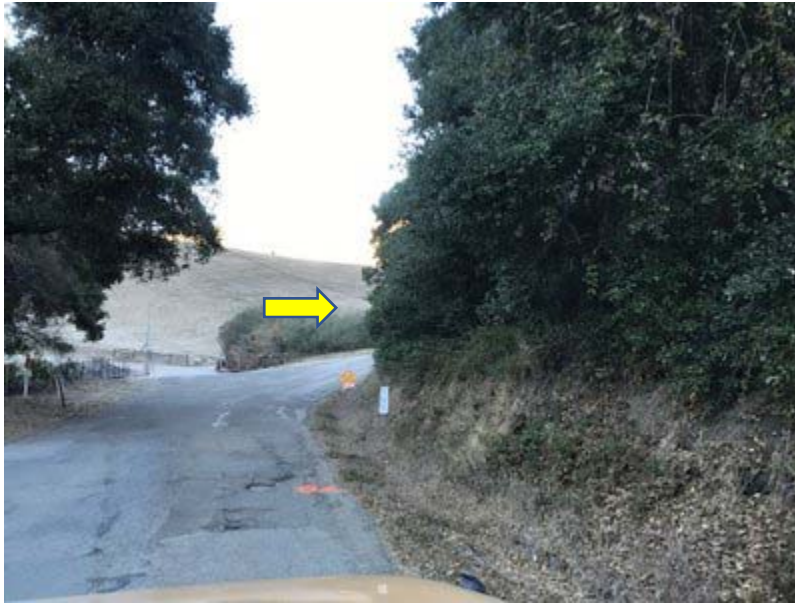
Photo 43: Modification #43: Photo was taken generally facing “up-station” at reference point No. 67/**Station 131+65**. Between **Stations 131+30 and Station 136+00**, cut back slope such that the face of cut is a minimum of 10-feet from existing edge of pavement. Given the rocky nature, a steep cut slope of 1 Horizontal to 1 Vertical may be possible. Although not visible in the photo, there are 10 trees that need to be removed at the top of the slope.

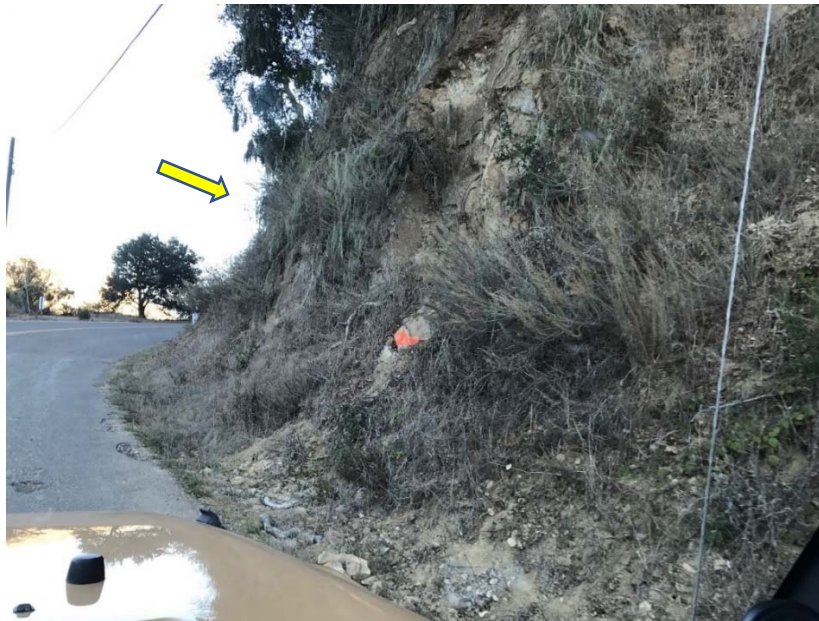
Photo 44: Modification #43: Photo was taken generally facing “up-station” at **Station 134+00**. This photo is for information only (see Photo 43 for description of work).

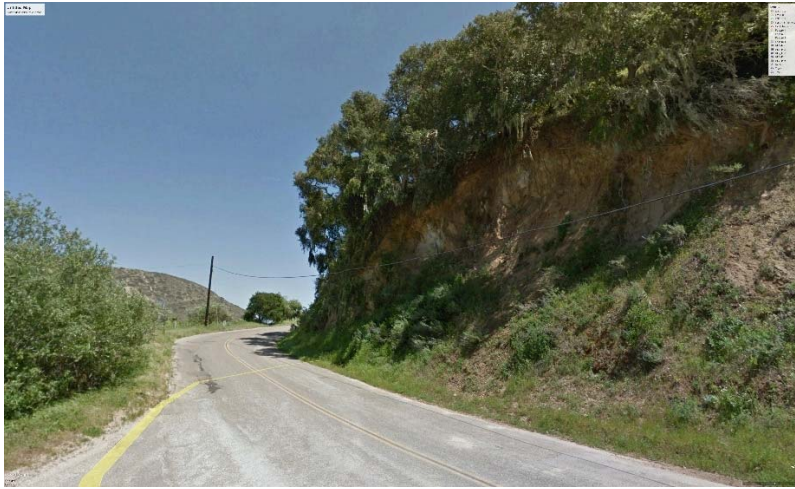
Photo 45: Modification #43: Photo was taken generally facing “up-station” at **Station 134+00**. This photo is for information only (see Photo 43 for description of work).

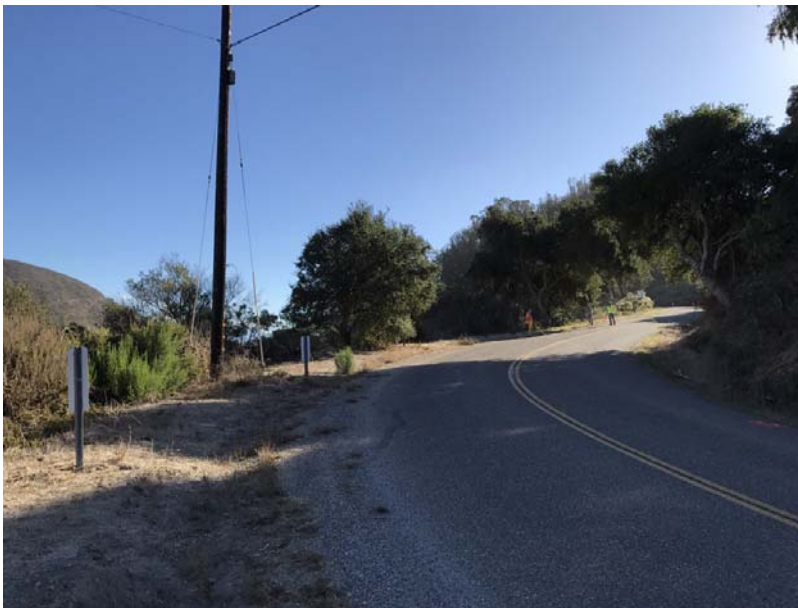
Photo 46: Modification #44: The photo was taken facing “up-station” at reference point No. 68/**Station 134+65**. Consideration was given to raising utility line, or completely removing pole. However, it was decided that no work would be done at this location. Photo was included for reference only.

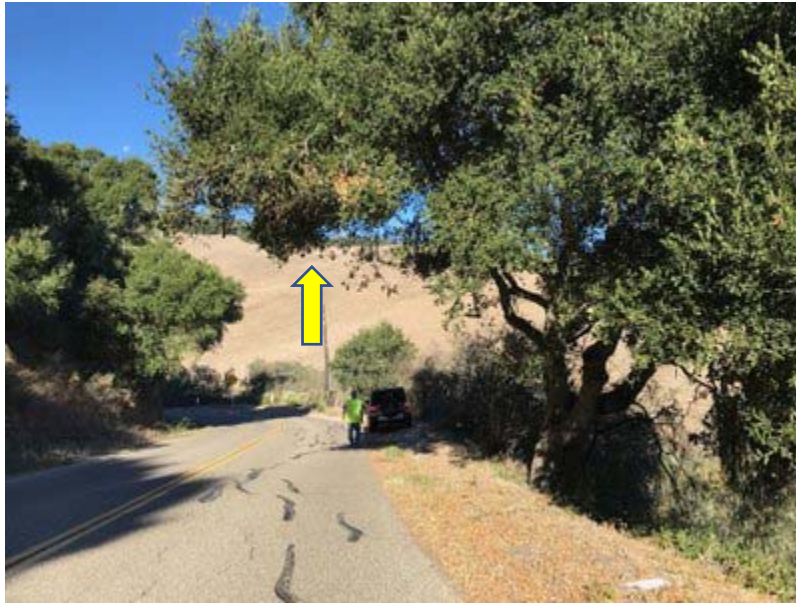
Photo 47: Modification #46: Photo faces “down-station” at reference point No. 70/**Station 136+00**. Work includes trimming the tree on the right side of the road to provide vertical clearance of 16.7 feet.

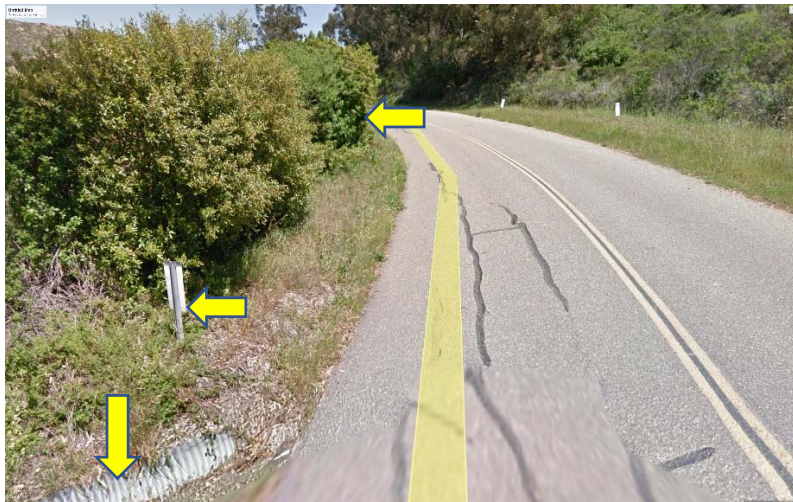
Photo 48: Modification #47: Photo taken using Google Earth and faces “up-station” at reference point No. 71/**Station 139+90**. Between **Stations 139+50 and 142+50** includes cutting back existing brush on the left side of the road a roughly of 8 feet from the edge of pavement. Additional work will include, removing reflector signs (left and right side of the road), and plating the open exposed culvert (left side).

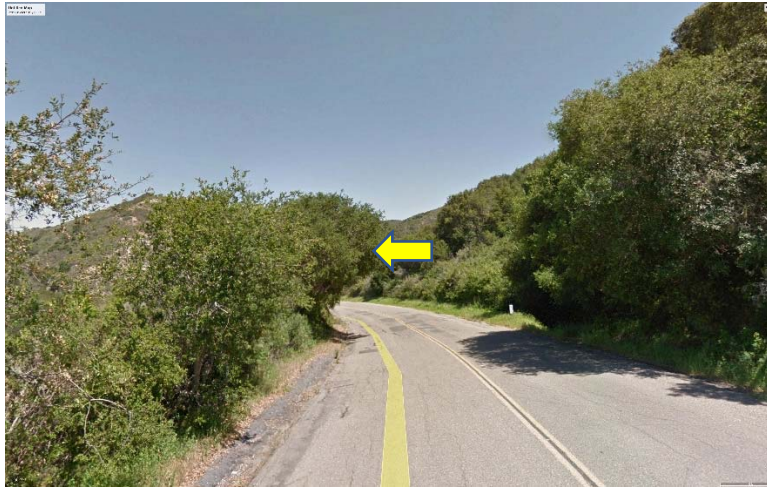
Photo 49: Modification #48: Photo was taken from Google Earth and faces “up-station” at reference point No. 72/**Station 189+00**. Work includes trimming the indicated tree on the left side of the road. Additionally, any brush encroaching into the plane of the edge of pavement should be cut back.

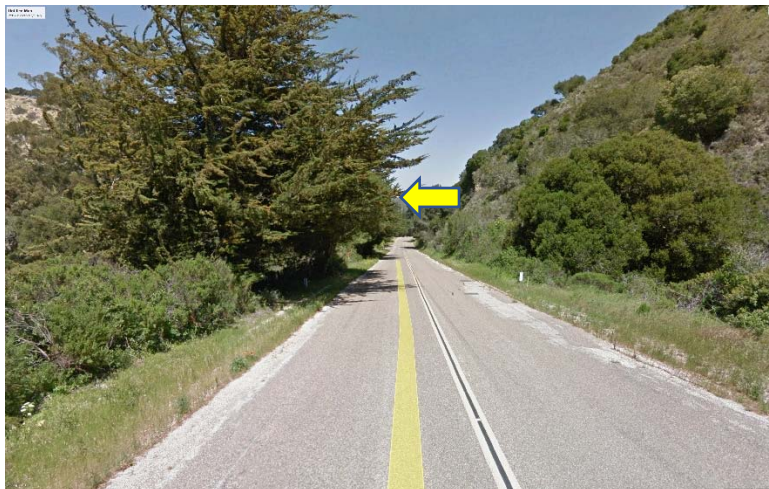
Photo 50: Modification #49: Photo was taken from Google Earth and faces “up-station” at reference point No. 73/**Station 205+30**. Work includes trimming the trees along the on the left side of the road.
