COOKE PROPERTY
VALLEJO, CALIFORNIA

PRELIMINARY GEOTECHNICAL REPORT

April 17, 2017

Project No.
13495.000.000

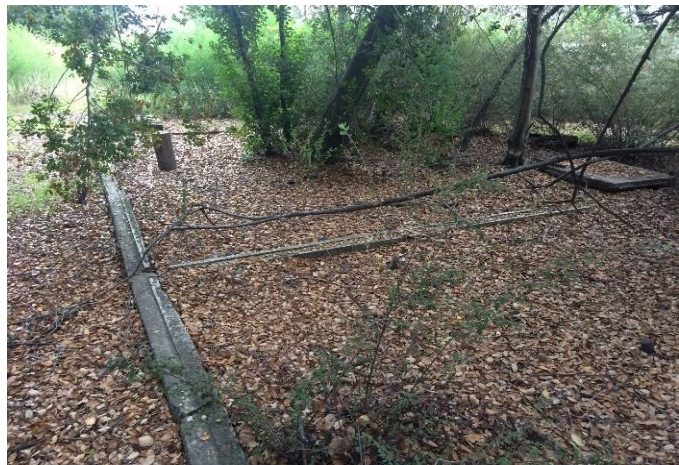
PHOTO 2.1-1: Existing Foundations located in the Western Parcel

Our review of historical aerial photographs and topographic maps indicates that the eastern parcel was unoccupied as far back as 1937 and was used for grazing until the early 1970s. The aerial photographs show that the western parcel had several structures located on site from the mid-1940s to the early 1980s. Parts of the foundations for these structures were visible during our site reconnaissance throughout the western parcel as shown in Photo 2.1-1.

Non-engineered fills can undergo excessive settlement, especially under new fill or building loads. Because the fill contained some debris, we recommend complete removal of the existing fill, as presented in Section 4.1.2.

We recommend that any existing fill be removed to competent native soil. The excavated soil may be reused as engineered fill provided it meets the requirements under Acceptable Fill. We encountered fill at TP-5 to a depth of approximately 7 feet; the lateral extent and depth of fill is expected to vary.

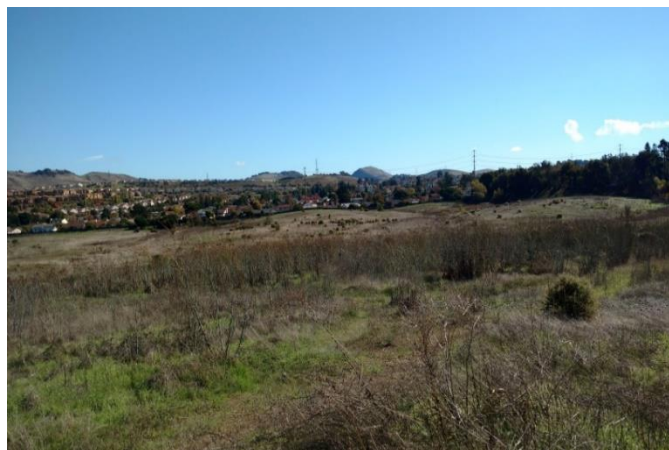
PHOTO 2.4-1: Eastern Parcel

At the time of our field exploration, much of the eastern parcel, as shown in Photo 2.4-1, was covered with grasses and tall shrubs. Site topography included a hill, approximately 20 feet in height, covering the western half of the site. The hill sloped to the east into a natural drainage swale that splits the property in a north-south direction; drainage appears to flow towards the north. The eastern side generally sloped downward towards the north with two swales that fed into the center swale. We did not observe any water in the swales during our field exploration.

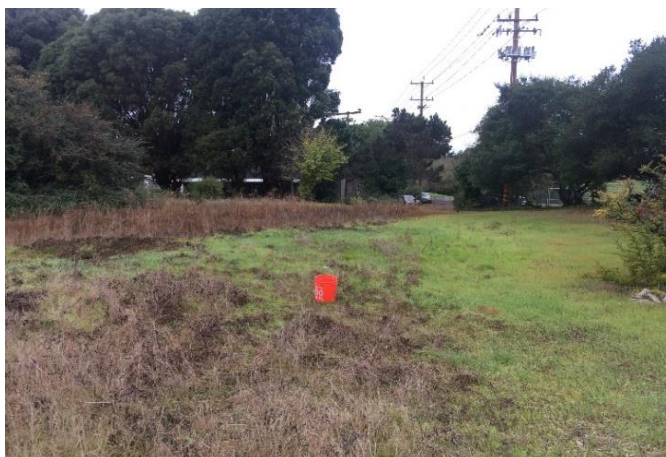
PHOTO 2.4-2: Western Parcel

The western parcel was generally flat with a 6 to 10 foot high 2:1 (horizontal:vertical) slope along the western border, as shown in Photo 2.4-2. The western parcel was covered with grass and several large trees and bushes.

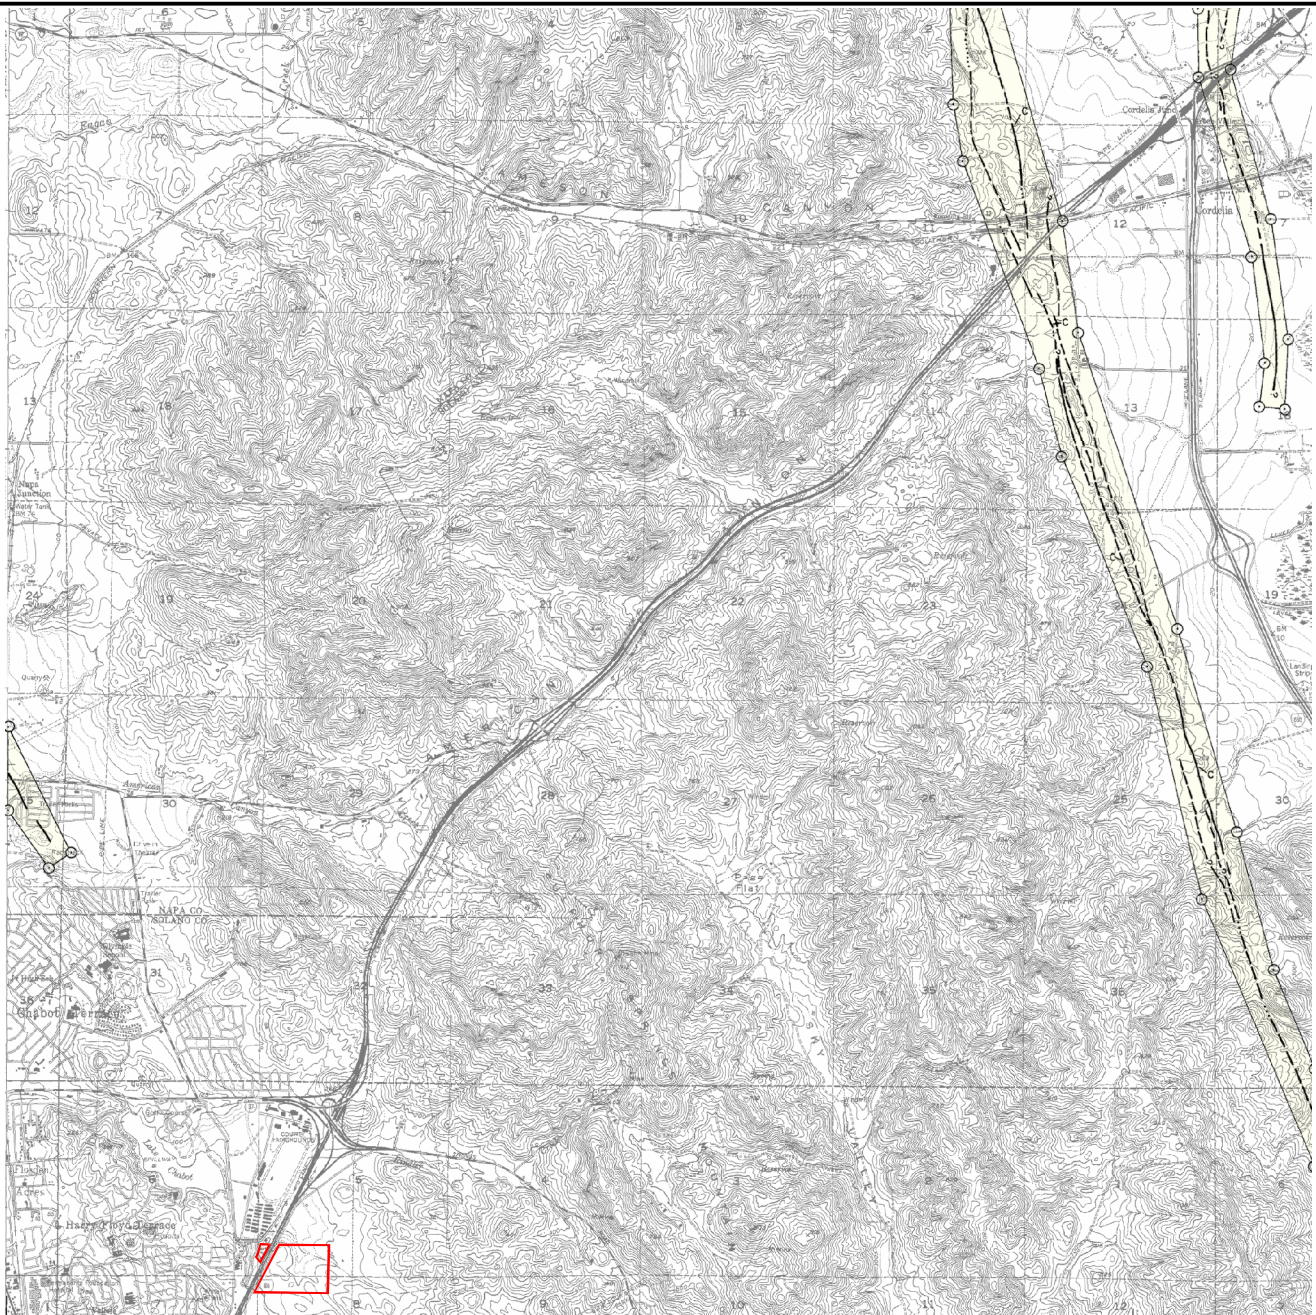
As shown on Figure 4, the site is not located within a State of California Earthquake Fault Hazard Zone (1982). Therefore, since no known active faults cross the site, it is our opinion that ground rupture is not likely to occur at the site.
