# Appendix C Arborist's Report

CHRIST'S CHURCH OF THE VALLEY CAMPUS EXPANSION AND IMPROVEMENTS INITIAL STUDY (DRC2018-00001, DRC2018-00023, & DRC2018-00843) CITY OF RANCHO CUCAMONGA

**Re: Arborist Report**

**CCV Children Center Project**

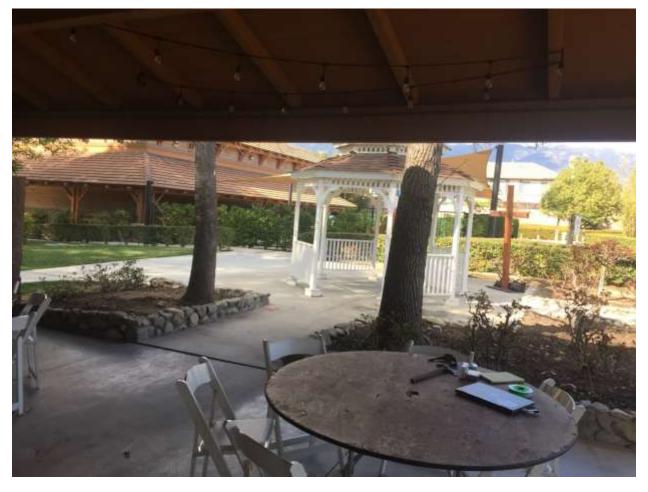
Tree numbers 1 (right) and 2 (left) American sweetgum, Liquidambar styracaflua.

Both trees are proposed for removal based upon their locations within the construction foot print and their dispositions as being highly vulnerable to experiencing bacterial scorch disease which cannot be prevented over the long run.

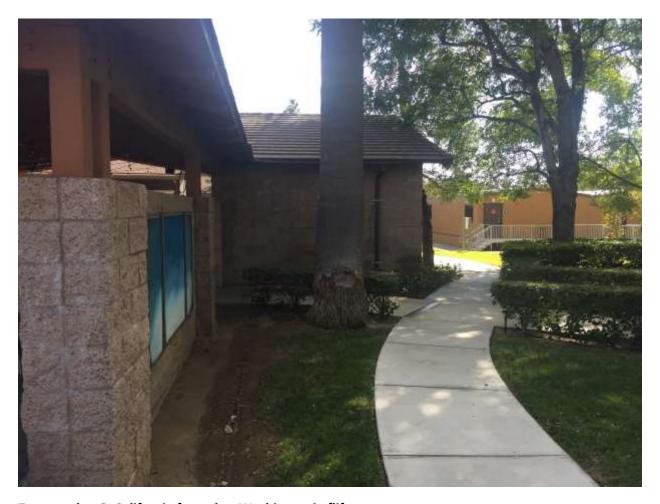
One of the individuals, #3 which is a California fan palm, is a California native species (native to the Coachella Valley) although is not native to the Rancho Cucamonga area or the project location.

The Mexican fan palm exhibits archetypal form and character although it exhibits a significant wound on its lower trunk that compromises its long-term viability based upon palms' inability to compartmentalize decay and disease. The other 19 'Heritage Trees' consist of mostly two species, Liquidambar (6) and evergreen ash (9) trees, that are mature specimens that are considered to perform poorly in maturity. Liquidambars are failing throughout southern California from bacterial scorch disease (*Xylella fastidiosa*) and evergreen ash are known to experience decline and failure in maturity due to their predisposition to developing defects within their structures in maturity.

Tree number 3, California fan palm, Washingtonia flifera.

This palm is proposed for removal in light of its location within the construction footprint and the presence of the very large wound on the lower trunk.

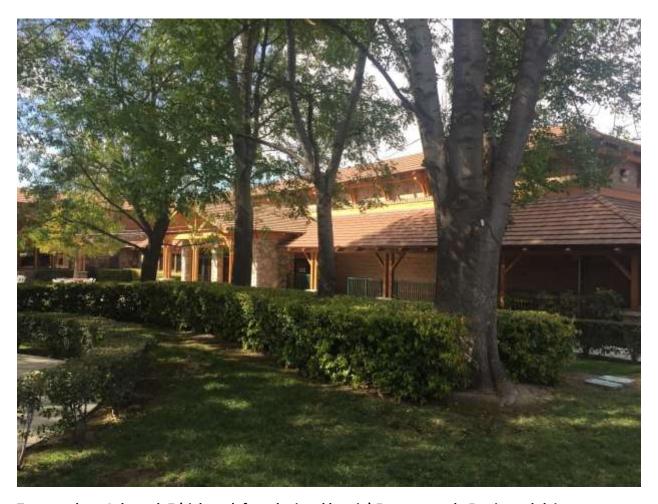
Tree numbers 4 through 7 (right to left as depicted herein) Evergreen ash, Fraxinus uhdei.

Tree number 4 is proposed for removal based upon its location very near the construction footprint and the nature of its dispersed and large woody root system. Tree numbers 5, 6, and 7 are all proposed for conservation based upon their more removed locations from the margin of the construction footprint.

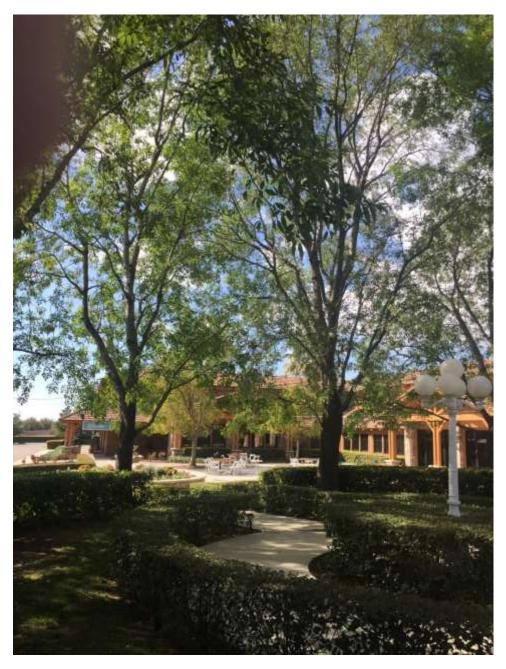
Tree number 9 (left) and 8 (right).

Proposed for conservation based upon their reasonable distance from the margin of the construction footprint.

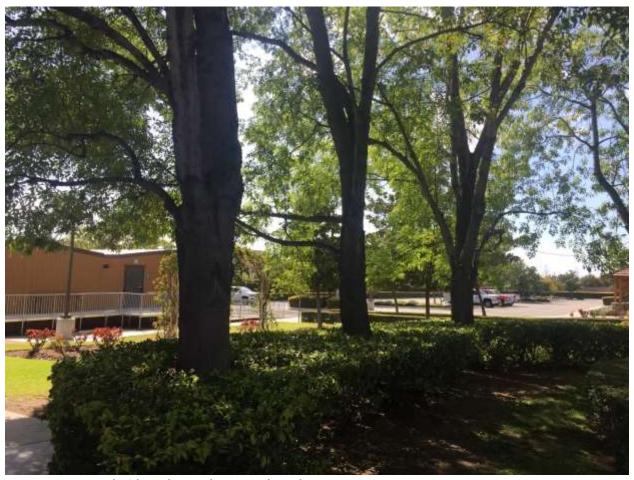
Tree numbers 12 (left), 11 (center), and 10 (right).

Tree number 12 is proposed for removal due to very close proximity to construction and very substantial defect in main trunk while number 11, and 10 are proposed for conservation based upon reasonable distance to edge of the construction footprint.

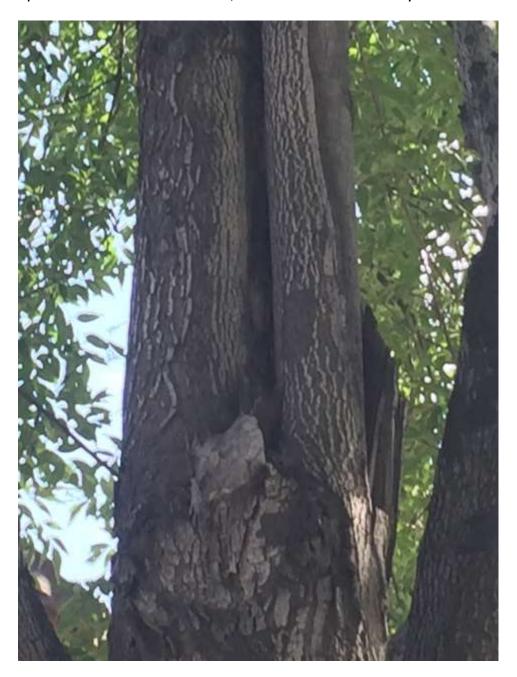
Tree number 12, evergreen ash, Fraxinus uhdei.

Proposed for removal due to location very near the construction footprint, nature of the dispersed and large woody root system, and presence of substantial wound on the lower trunk near main branch union.

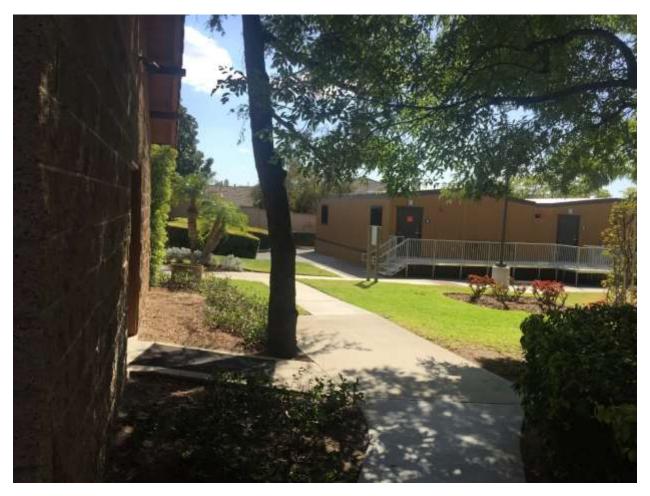
Tree number 13, deodar cedar, Cedrus deodara.

Proposed for removal based upon location within new building footprint and poor systemic performance (i.e. poor foliage quality and density due to drought conditions and mite infestation issues.

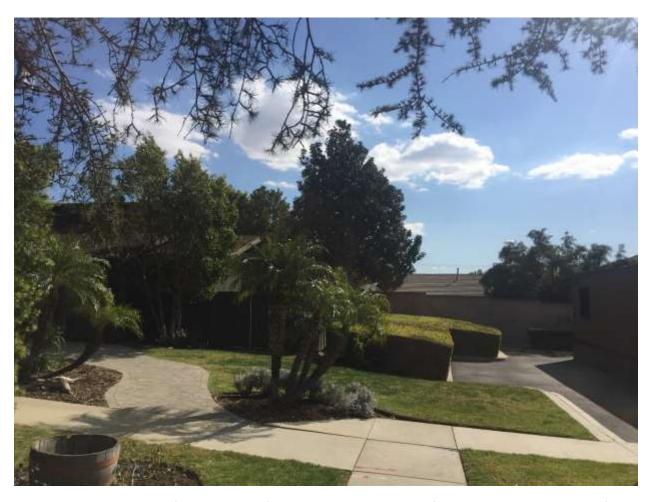
This photograph, hanging foliage at top of photograph, depicts poor foliage quality and density of cedar tree, number 13.

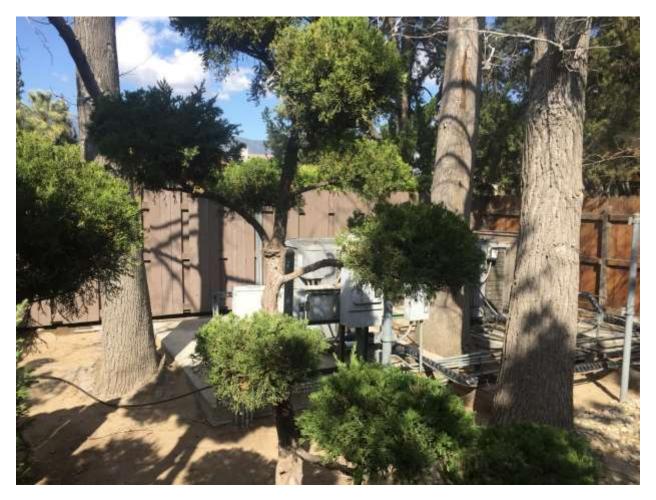
Tree number 17 (left), 18 (right), and 19 (center back of photo). American sweetgum, Liquidambar styracaflua.

Existing locations within proposed project footprint.

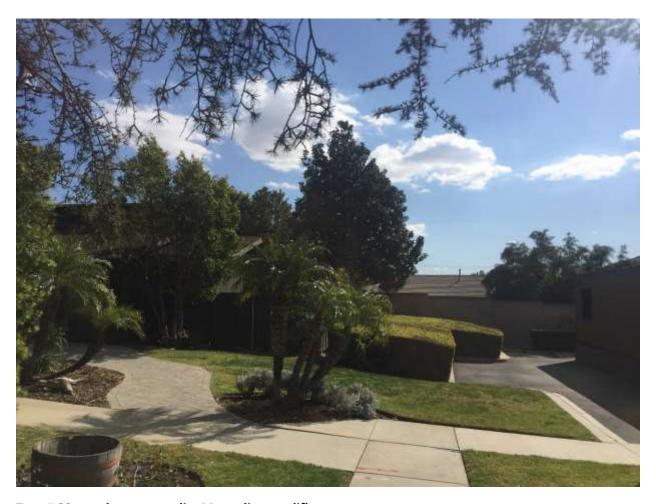
Tree # 20, southern magnolia, Magnolia grandiflora

Dark green colored canopy beneath the cedar foliage in top of photo. Within existing children's center play area.
