Appendix D: **Biological Resources Supporting Information**

D.2 - Arborist Report

Re: Arborist Report for 85 Cleaveland Road, Pleasant Hill

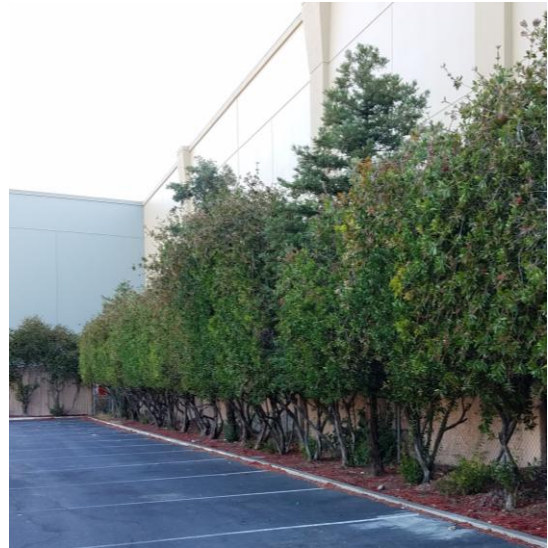
All trees on the property will need to be removed due to high anticipated encroachment or poor condition. The Italian cypresses are located in the proposed buildings, while the liquidambar are located within several feet of a proposed building or in the proposed plaza. High anticipated encroachment requires removal of the trees. Additionally, the redwoods along the east property line (Figure 1) may be subject to moderate encroachment from excavation of the subterranean parking garage. Although young redwoods would technically be highly resilient, these trees are drought-stressed and do not contribute significantly to existing canopy cover. I recommend removing and replacing the redwoods as a more cost effective approach to increasing tree canopy.

Figure 1. The young redwoods along the east property line are drought stressed and provide low benefits to the property.

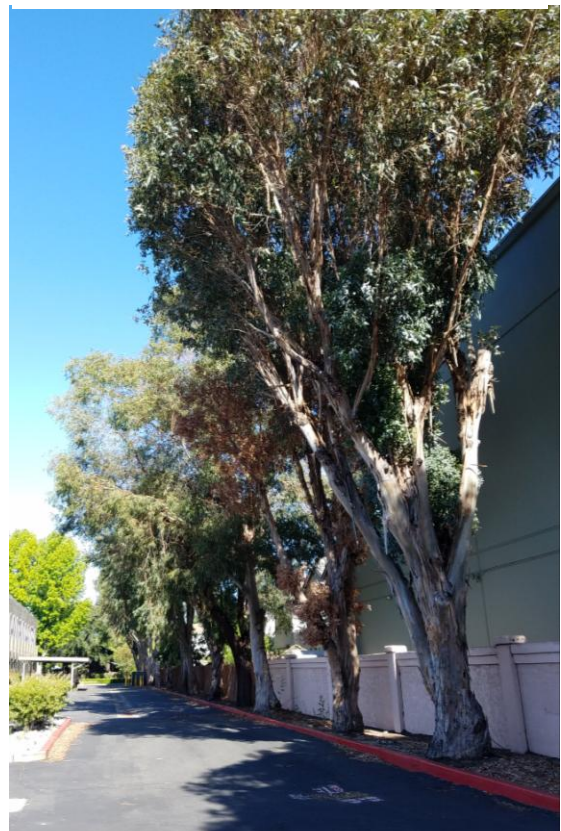
The proposed driveway is roughly in the same area as the existing driveway; the widening of the entrance requires removal of two trees. However, I recommend removing the entire row of eucalyptuses due to their structure (Figure 2). Eucalyptuses are notorious for limb failure, more so when improperly pruned as were these trees. Nearly every eucalyptus was topped at 20', with lower foliage removed to the same height. All large branches growing over the north property line were removed for clearance. Since the canopies have been significantly raised, the trees only provide minor screening for the second story. Since they are not protected trees, I recommend removing them and replacing them with smaller-statured plants appropriate for the narrow planting strip.

Figure 2. The row of eucalyptus trees along the north property line have nearly all been topped and excessively raised. Since they are not protected trees, I recommend replacing them with plantings more appropriate to the location.

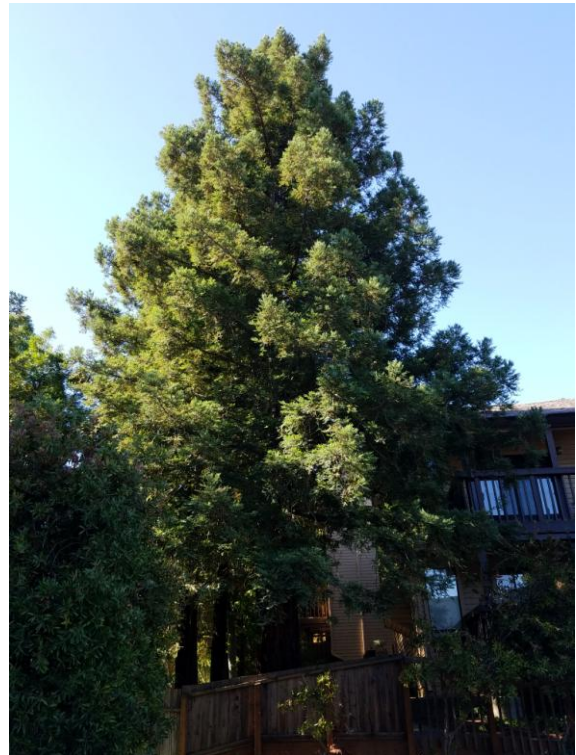
Protection efforts thus should be focused on the neighbor's trees. Of primary concern is the large redwood (22B, Figure 3) located 1'-2' from the south property line. Proposed grading and landscaping plans were not yet available, but I anticipate there will be dripline encroachment beyond the proposed building footprint. An arborist shall be on-site during grading within its dripline to prune large roots (if needed) and provide additional recommendations. Landscaping improvements shall be installed by hand to minimize damage to large roots. Supplemental irrigation may be necessary during and after construction to mitigate the impacts of root loss. Additionally, clearance pruning may be required for the Raywood ash (22C).

Figure 3. The neighbor's redwood was not surveyed but is located close to the property line. Root disturbance shall be minimized.
