STREAM INVENTORY REPORT

Stitz Creek

A stream inventory was conducted July 29, 2010 on Stitz Creek. The survey began at the confluence with Eel River and extended upstream 0.6 miles.

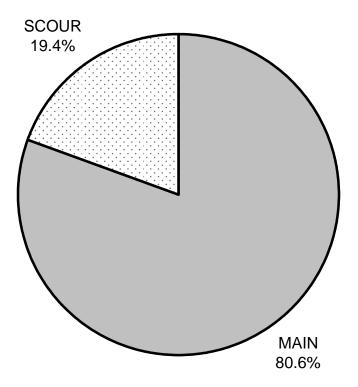
STITZ CREEK 2010 POOL TYPES BY PERCENT OCCURRENCE

A total of 31 pools were identified (Table 3). Main channel pools were the most frequently encountered at 81% (Graph 4), and comprised 87% of the total length of all pools (Table 3).

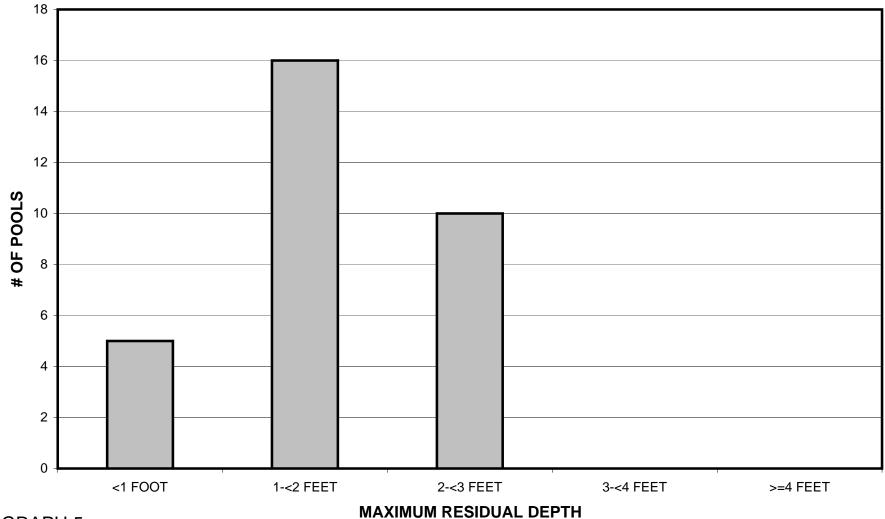
STITZ CREEK 2010 MAXIMUM DEPTH IN POOLS

Table 4 is a summary of maximum residual pool depths by pool habitat types. Pool quality for salmonids increases with depth. Ten of the 31 pools (32%) had a residual depth of two feet or greater (Graph 5).

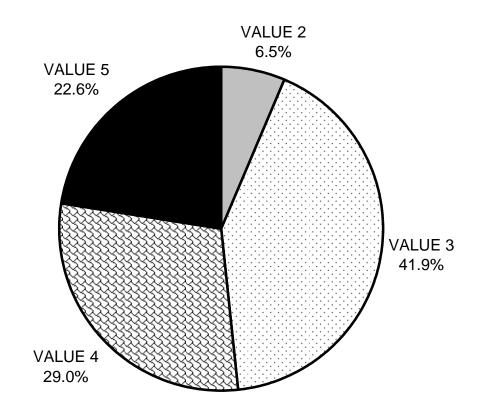
STITZ CREEK 2010 PERCENT EMBEDDEDNESS

The depth of cobble embeddedness was estimated at pool tail-outs. Of the 31 pool tail-outs measured, 2 had a value of 2 (6.5%); 13 had a value of 3 (41.9%); 9 had a value of 4 (29%); 7 had a value of 5 (22.6%) (Graph 6). On this scale, a value of 1 indicates the best spawning conditions and a value of 4 the worst. Additionally, a value of 5 was assigned to tail-outs deemed unsuited for spawning due to inappropriate substrate such as bedrock, log sills, boulders, or other considerations.

Two of the 31 pool tail-outs measured had embeddedness ratings of 1 or 2. Twenty-two of the pool tail-outs had embeddedness ratings of 3 or 4. Seven of the pool tail-outs had a rating of 5, which is considered unsuitable for spawning. Cobble embeddedness measured to be 25% or less, a rating of 1, is considered to indicate good quality spawning substrate for salmon and steelhead. Sediment sources in Stitz Creek should be mapped and rated according to their potential sediment yields, and control measures should be taken.

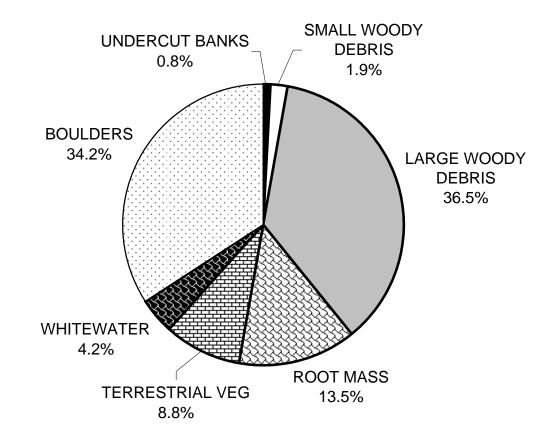
STITZ CREEK 2010 MEAN PERCENT COVER TYPES IN POOLS

Table 5 summarizes mean percent cover by habitat type. Boulders are the dominant cover type in Stitz Creek. Graph 7 describes the pool cover in Stitz Creek. Large woody debris is the dominant pool cover type followed by boulders.

The mean shelter rating for pools is 19. The shelter rating in the flatwater habitats is 20. A pool shelter rating of approximately 100 is desirable. The amount of cover that now exists is being provided primarily by boulders in Stitz Creek. Large woody debris is the dominant cover type in pools followed by boulders. Log and root wad cover structures in the pool and flatwater habitats would enhance both summer and winter salmonid habitat. Log cover structure provides rearing fry with protection from predation, rest from water velocity, and also divides territorial units to reduce density related competition.

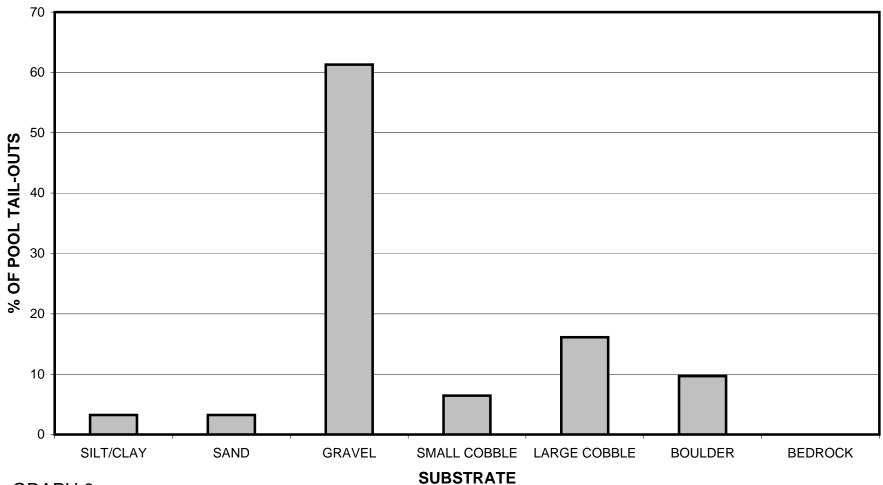
STITZ CREEK 2010 SUBSTRATE COMPOSITION IN POOL TAIL-OUTS

Table 6 summarizes the dominant substrate by habitat type. Graph 8 depicts the dominant substrate observed in pool tail-outs. Gravel was the dominant substrate observed in 61% of the pool tail-outs. Large cobble was the next most frequently observed dominant substrate type and occurred in 16% of the pool tail-outs.

Twenty-one of the 31 pool tail-outs measured had gravel or small cobble as the dominant substrate. This is generally considered good for spawning salmonids.

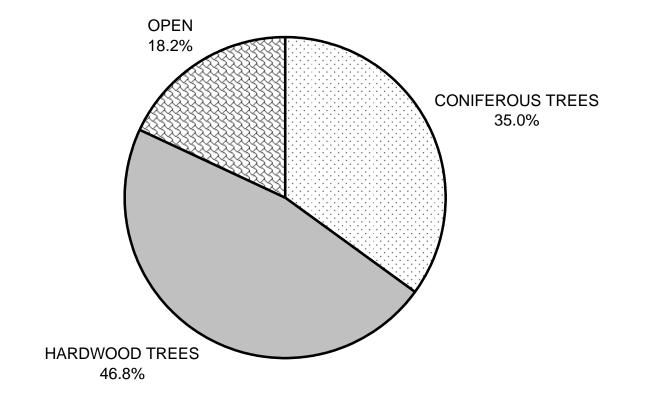
STITZ CREEK 2010 MEAN PERCENT CANOPY

The mean percent canopy density for the surveyed length of Stitz Creek was 82%. Eighteen percent of the canopy was open. Of the canopy present, the mean percentages of hardwood and coniferous trees were 57% and 43%, respectively. Graph 9 describes the mean percent canopy in Stitz Creek.

The mean percent canopy density for the stream was 82%. In general, revegetation projects are considered when canopy density is less than 80%.

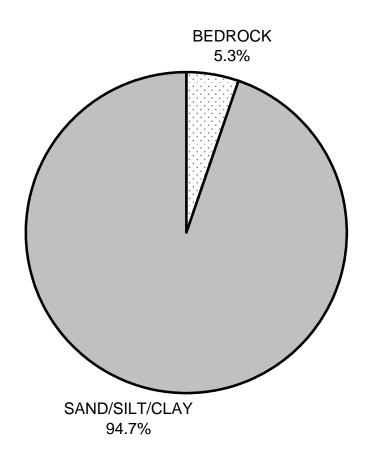
STITZ CREEK 2010 DOMINANT BANK COMPOSITION IN SURVEY REACH

For the stream reach surveyed, the mean percent right bank vegetated was 98%. The mean percent left bank vegetated was 99%. The dominant elements composing the structure of the stream banks consisted of 95% sand/silt/clay and 5% bedrock (Graph 10). Coniferous trees were the dominant vegetation type observed in 43.4% of the units surveyed. Additionally, 42.1% of the units surveyed had deciduous trees as the dominant vegetation type, and 14.5% had brush as the dominant vegetation type (Graph 11).
