Subject: Clarification to Geotechnical Evaluation
Sycuan-Sloane Canyon Trail Improvements
Dehesa Road and Sloane Canyon Road
San Diego County, California

Geotechnical Evaluation

Sycuan-Sloane Canyon Trail Improvements

May 10, 2019 | Project No. 108748001

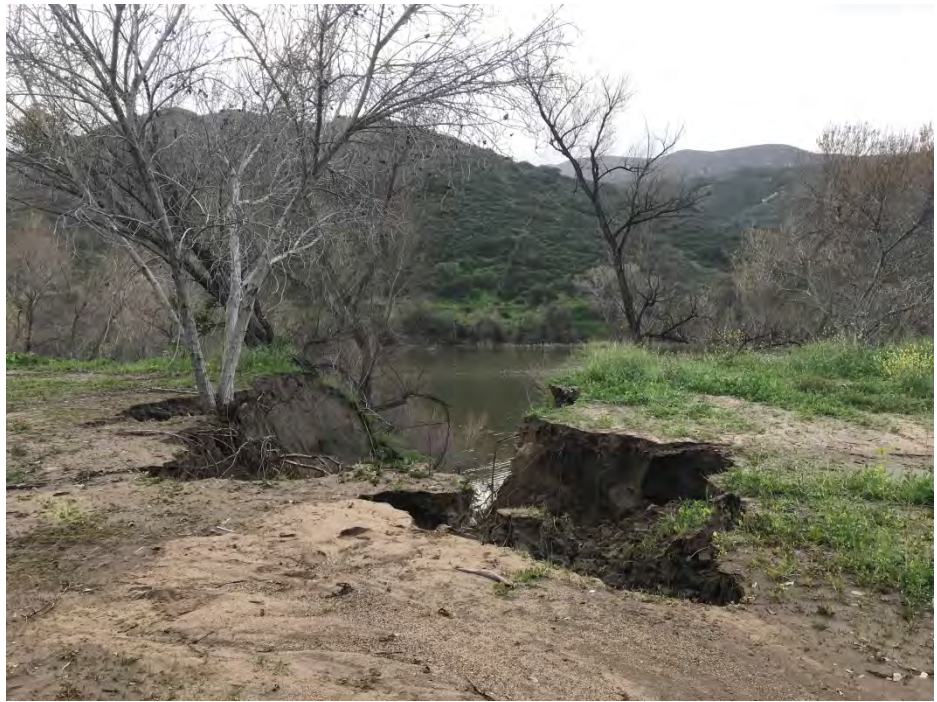
As previously described, areas of bluff and slope erosion were observed adjacent to the Segment 1 alignment (Photographs 1 through 3) and along the alignment of Segment 3 (Photographs 4 through 6). Due to the presence of loose, surficial soils, the potential for surficial erosion along the proposed alignment should be a design consideration. Efforts to mitigate the erosion potential adjacent to the proposed trail should be incorporated into the design.

Photograph 1: View looking south at bluff erosion near the alignment of Segment 1.

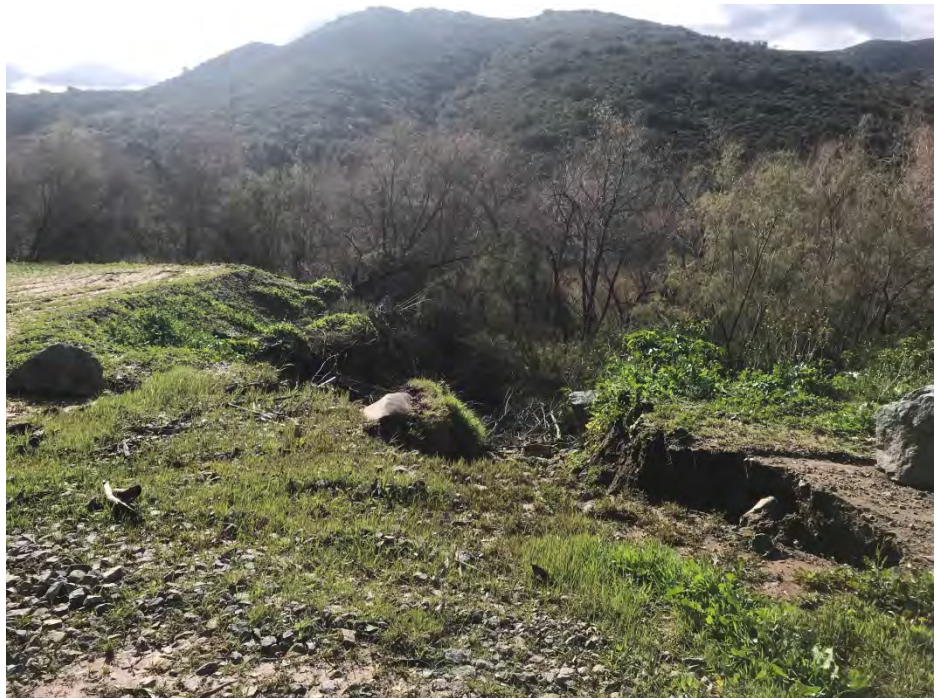
Photograph 2: View looking south at bluff erosion near the alignment of Segment 1.

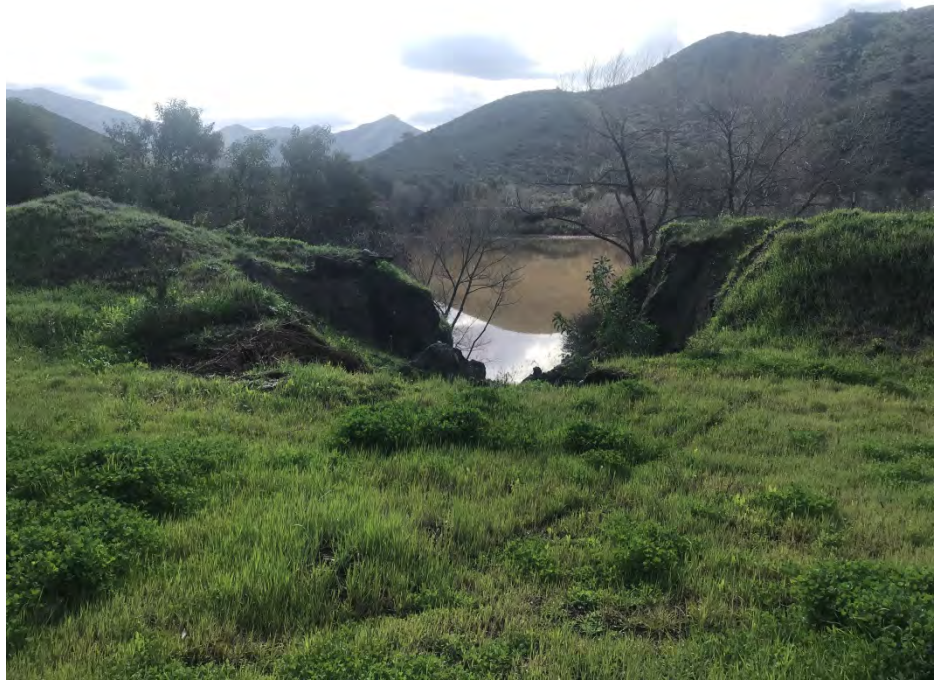
Photograph 3: View looking south at bluff erosion near the alignment of Segment 1.

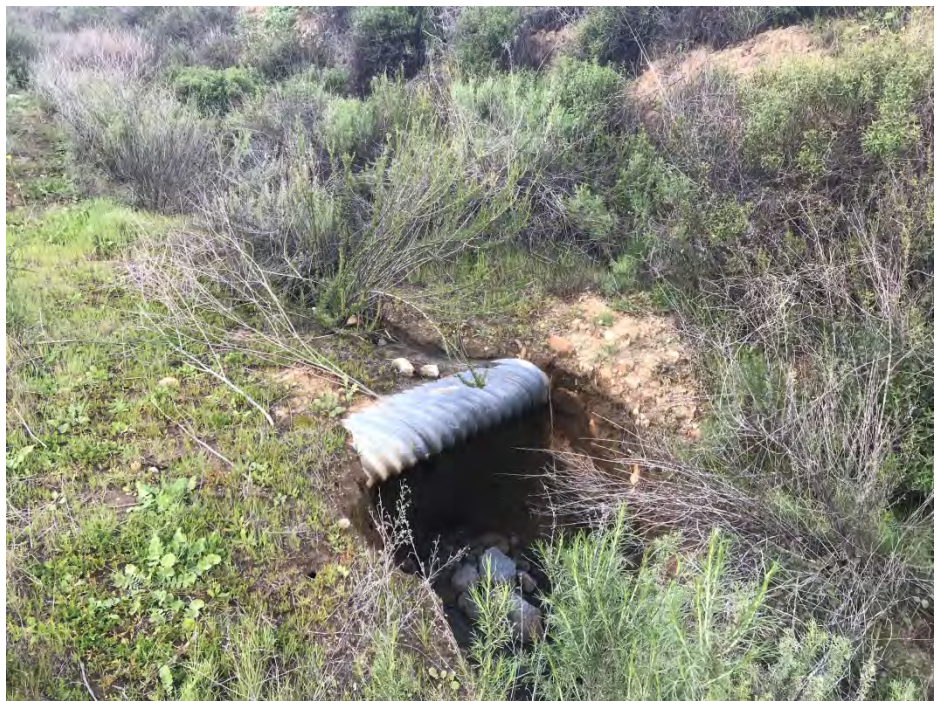
Photograph 4: View of erosion near drainage pipe along the abandoned maintenance trail in the eastern portion of Segment 3. Erosion measures up to 3 feet deep.

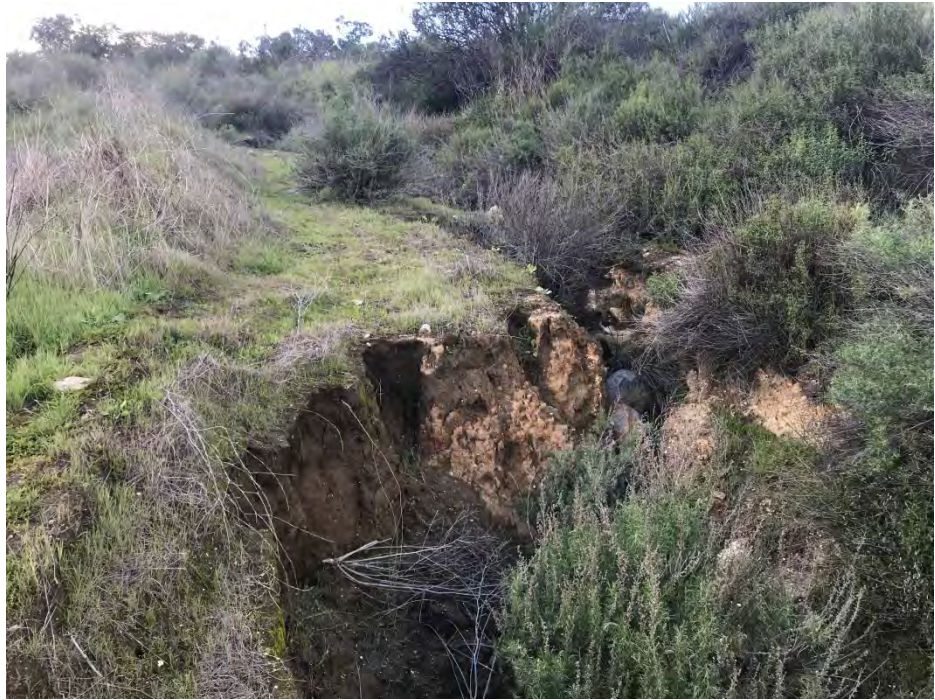
Photograph 5: View of erosion along the abandoned maintenance trail in the eastern portion of Segment 3. Erosion measures up to 3 feet deep.

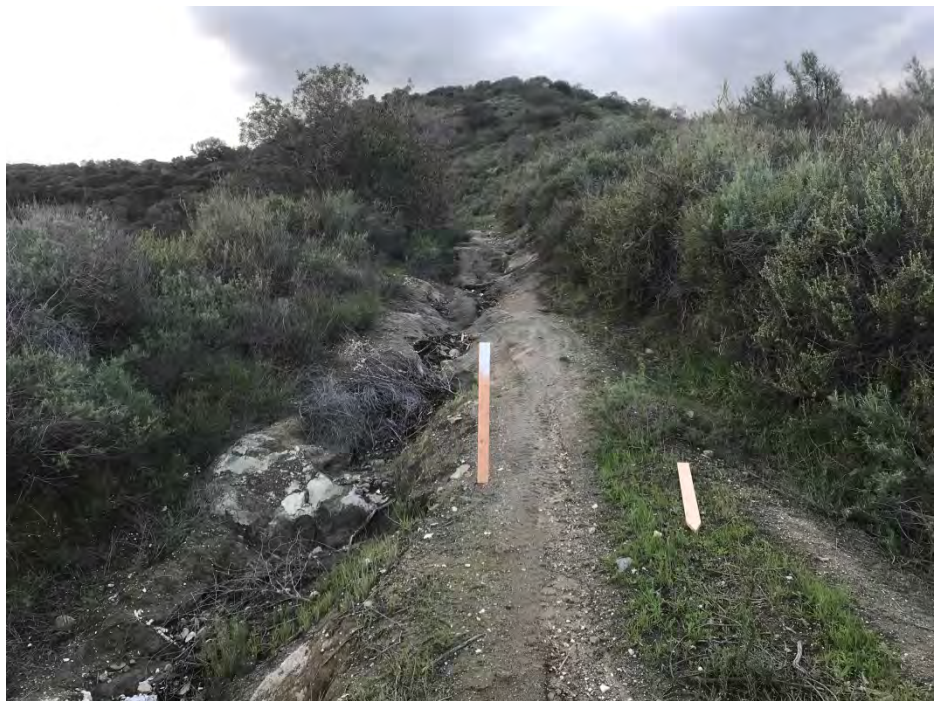
Photograph 6: View of erosion along the abandoned maintenance trail in the central portion of Segment 3.

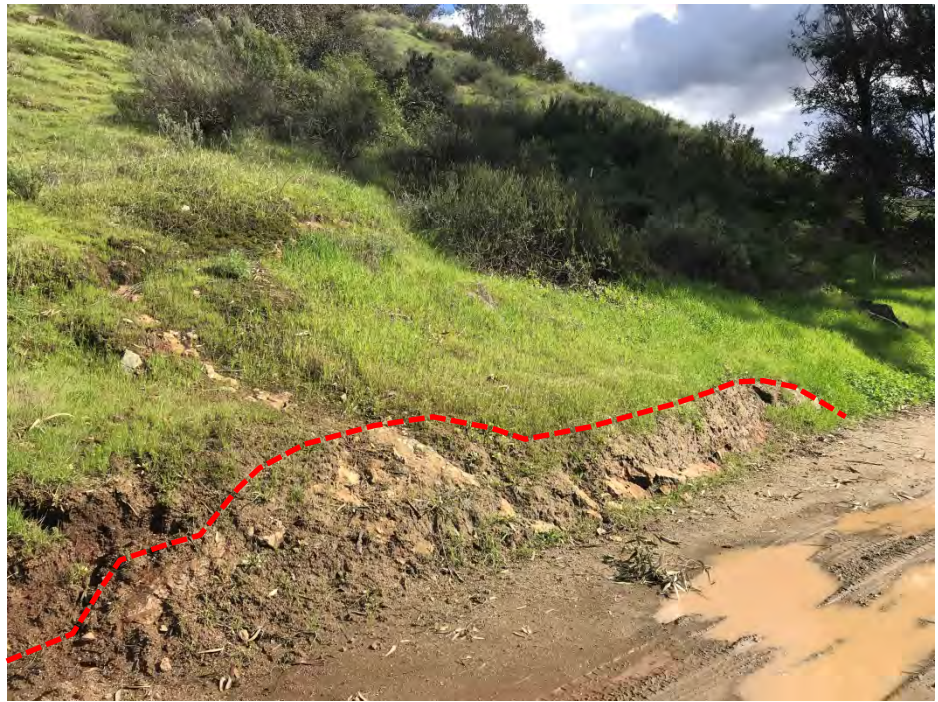
Photograph 7: View of granitic rock outcrops on the east side of the alignment on Segment 2. Contact with colluvium shown with dashed line.

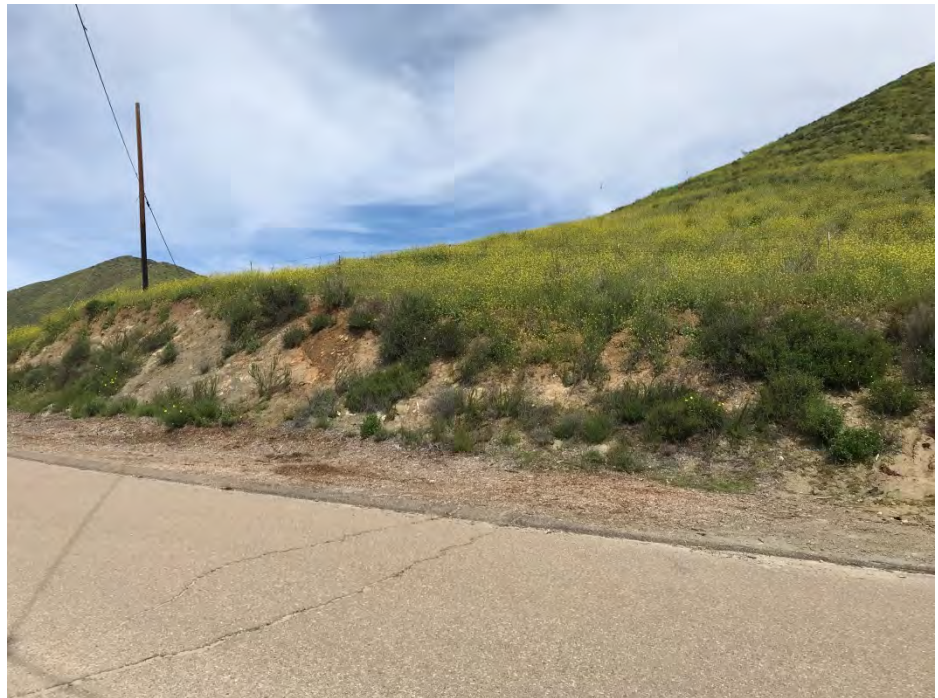
Photograph 8: View of granitic rock outcrops on the east side of the alignment on Segment 2 near the existing bridge.

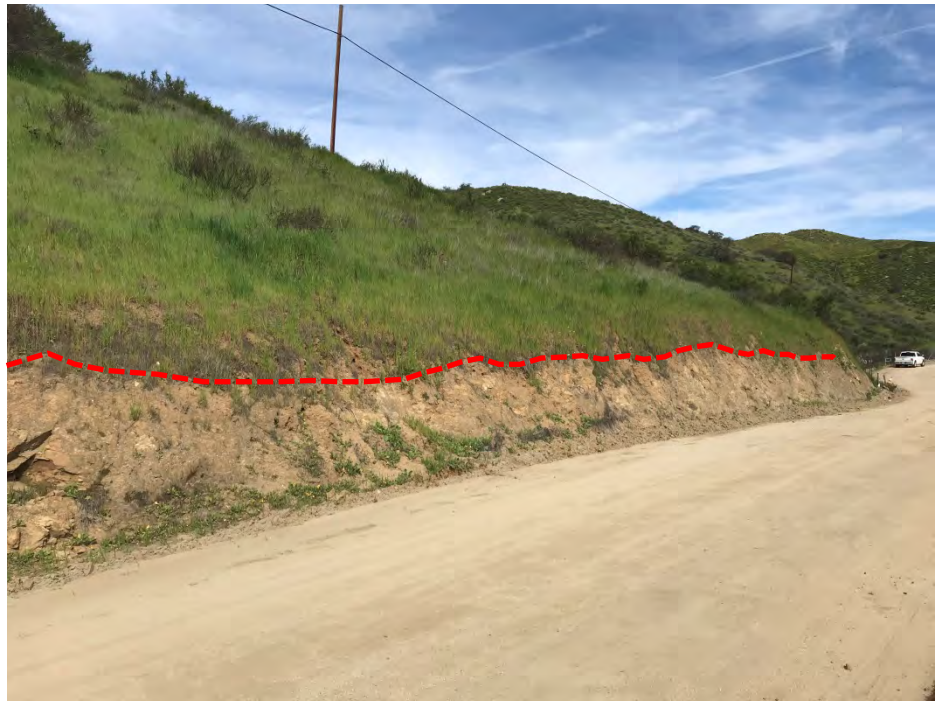
Photograph 9: View of granitic rock outcrops in the hillside on Segment 4. Contact with colluvium shown with dashed line.

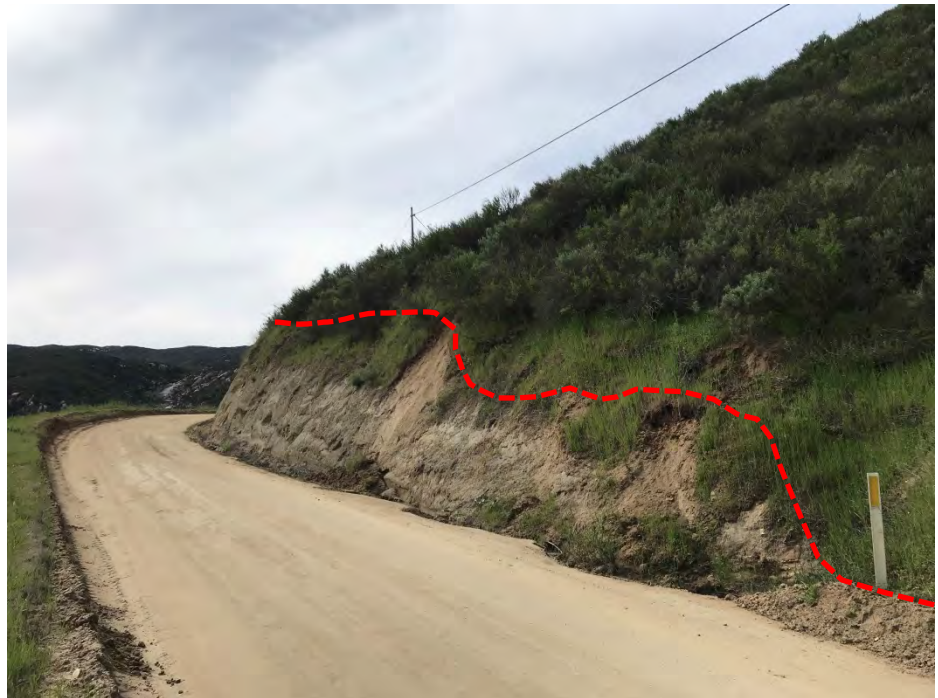
Photograph 10: View of granitic rock outcrops in the hillside on Segment 4. Contact with colluvium shown with dashed line.

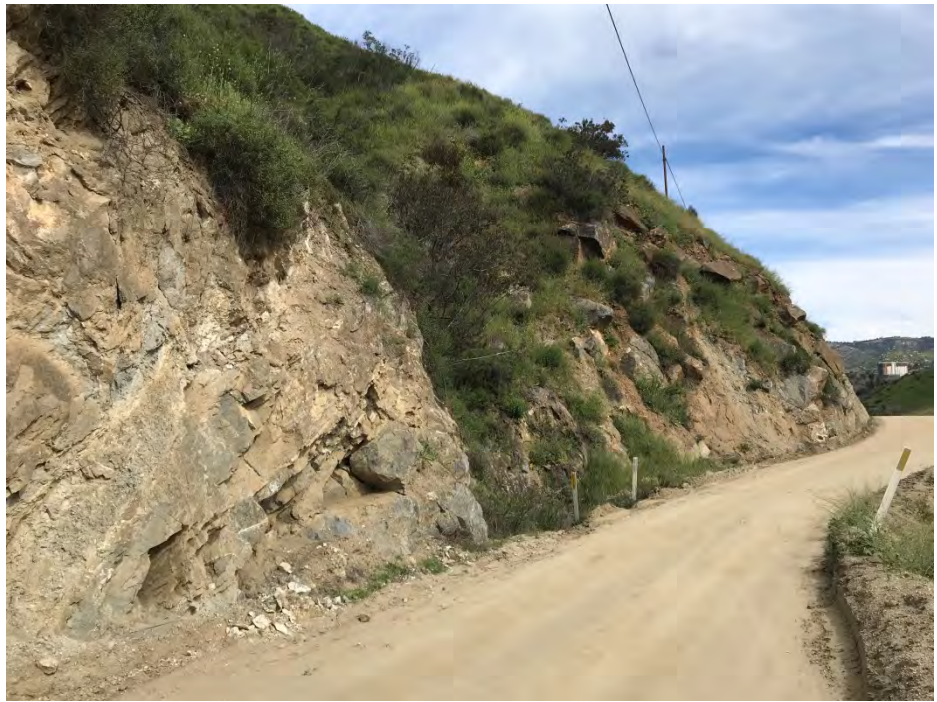
Photograph 11: View of granitic rock outcrops in the hillside on Segment 4.

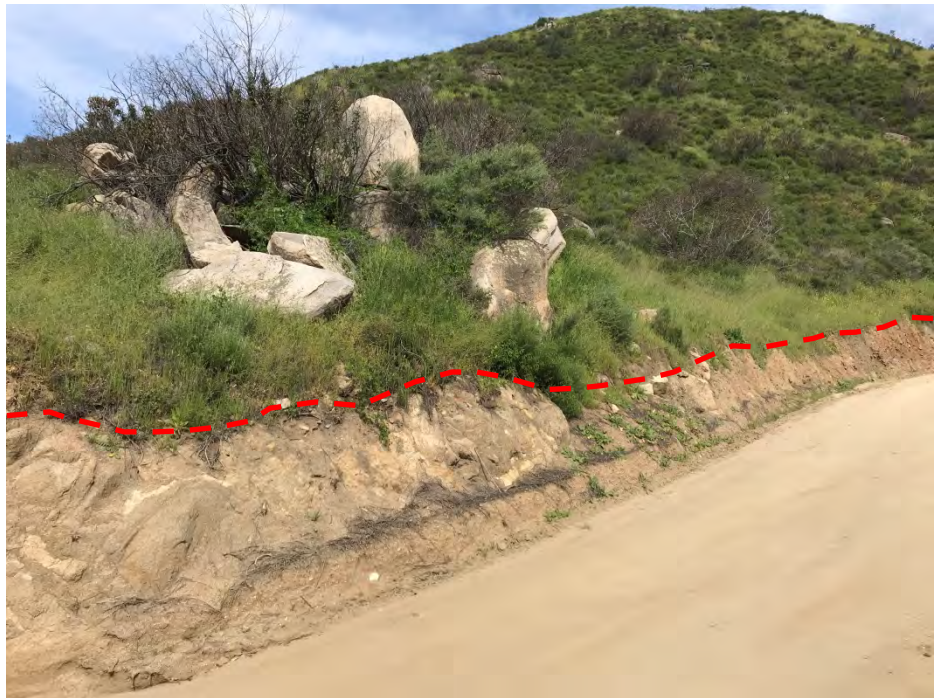
Photograph 12: View of granitic rock outcrops in the hillside on Segment 4. Contact with colluvium shown with dashed line.

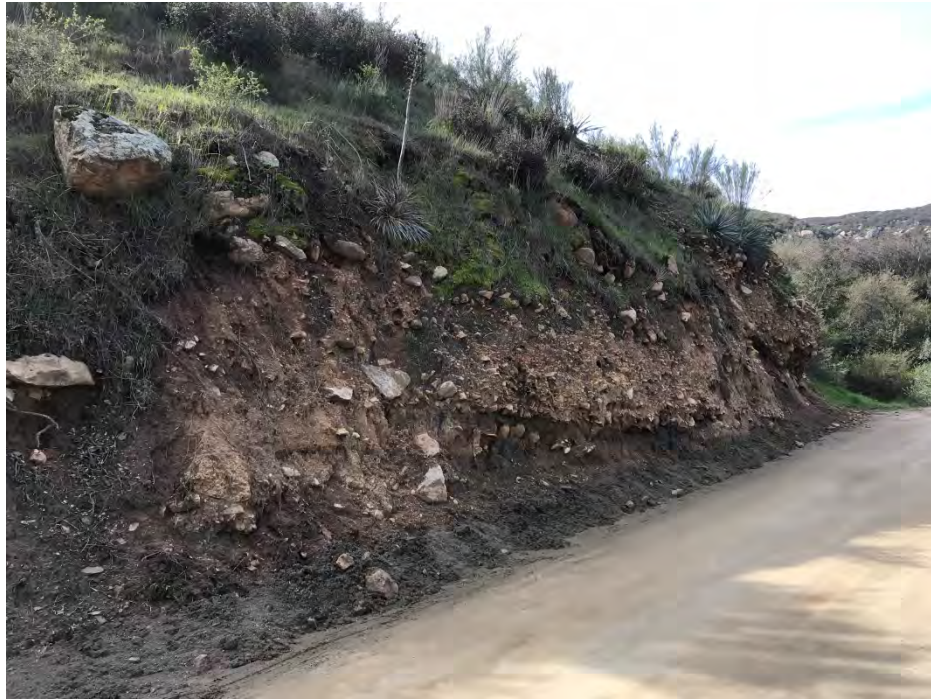
Photograph 13: View of cobble- and boulder-sized fragments of granitic rock in the colluvium deposits on the south side of the alignment of Segment 5.

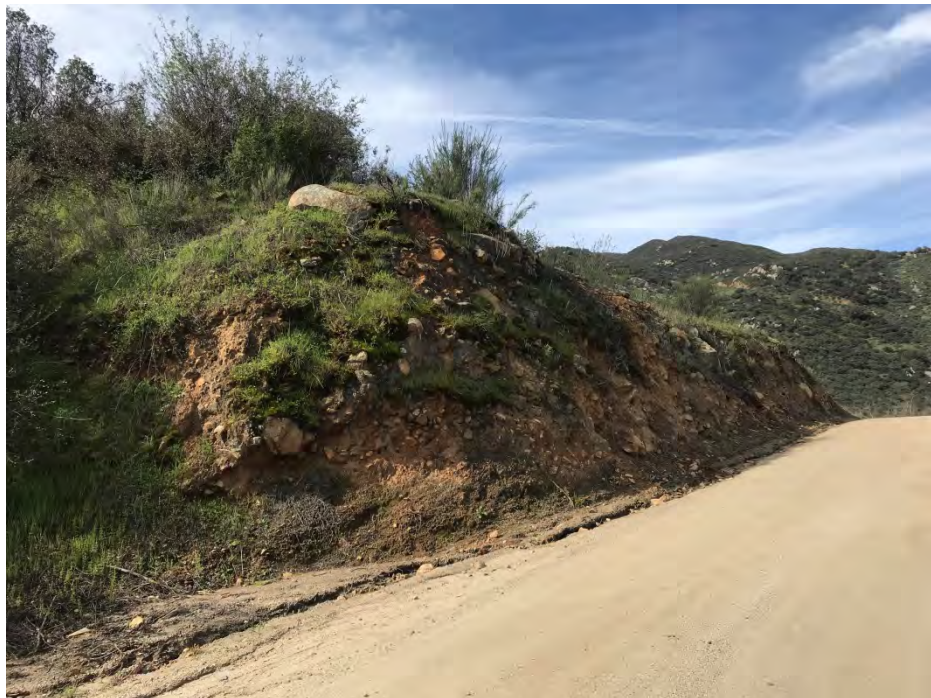
Photograph 14: View of cobble- and boulder-sized fragments of granitic rock in the colluvium deposits on the south side of the alignment of Segment 5.

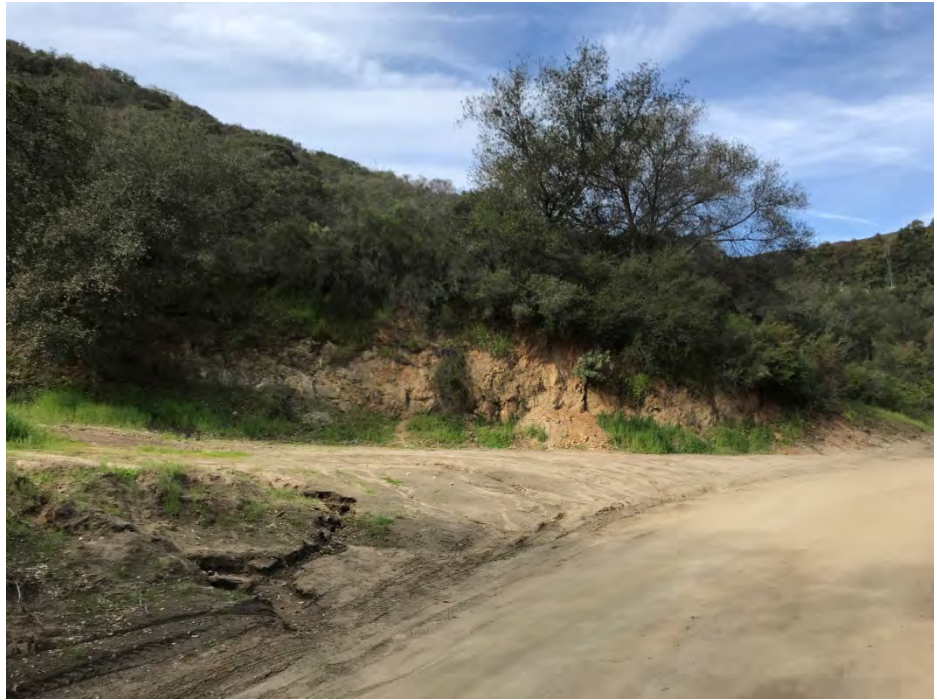
Photograph 15: View of granitic rock outcrops on the south side of the alignment on Segment 5 near the connection to Segment 4.

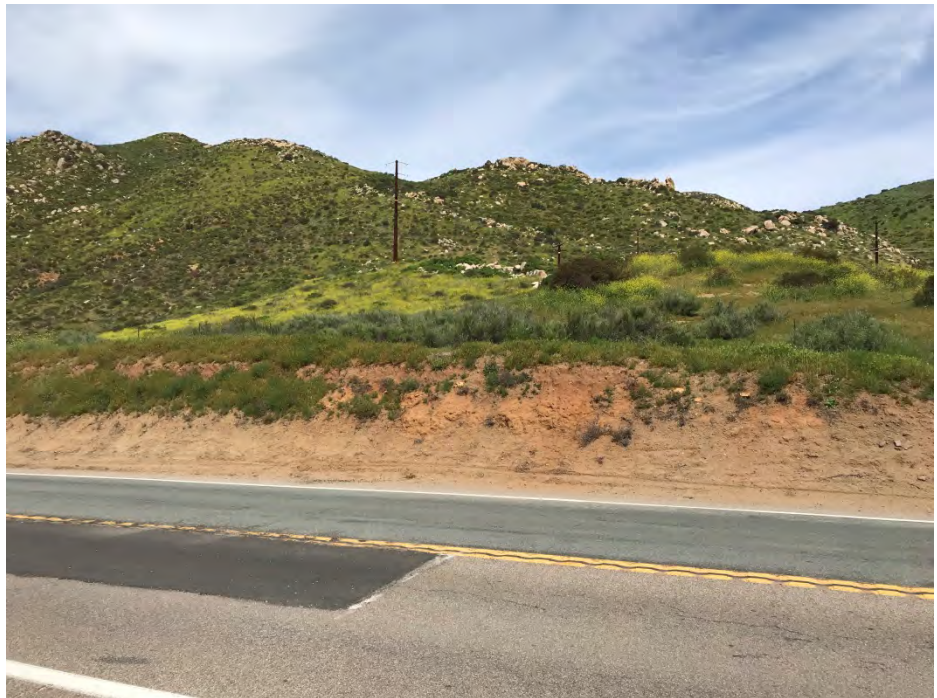
Granitic rock materials were encountered in borings located along Segments 2, 3, 5, and 6, and observed in rock outcrops along Segment 4. Where encountered, the materials generally consisted of various shades of brown and gray, dry, slightly weathered to decomposed, granitic rock. Outcrops of granitic rock and intact granitic materials were observed on the surface along the east side of the alignment of Segment 2 and along the alignment of Segment 4 (Figures 4 and 6; Photographs 7 through 12). Cobble and boulder sized fragments of granitic rock were observed in colluvial deposits on the south side of the alignment of Segment 5 (Photographs 13 through 15). Several outcrops of large granite boulders were observed on the surface along the northern alignment of Segment 6 (Figure 7; Photographs 16 through 20).

Photograph 16: View of weathered to decomposed granitic rock outcrops in the slope along the northern alignment of Segment 6.

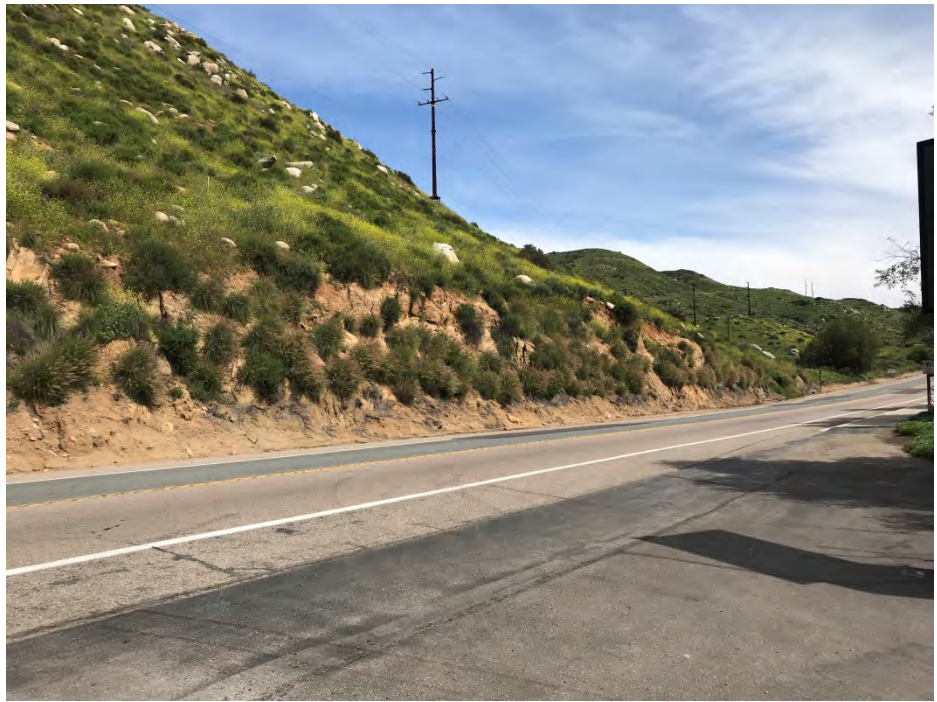
Photograph 17: View of granitic rock outcrops along the northern alignment of Segment 6.

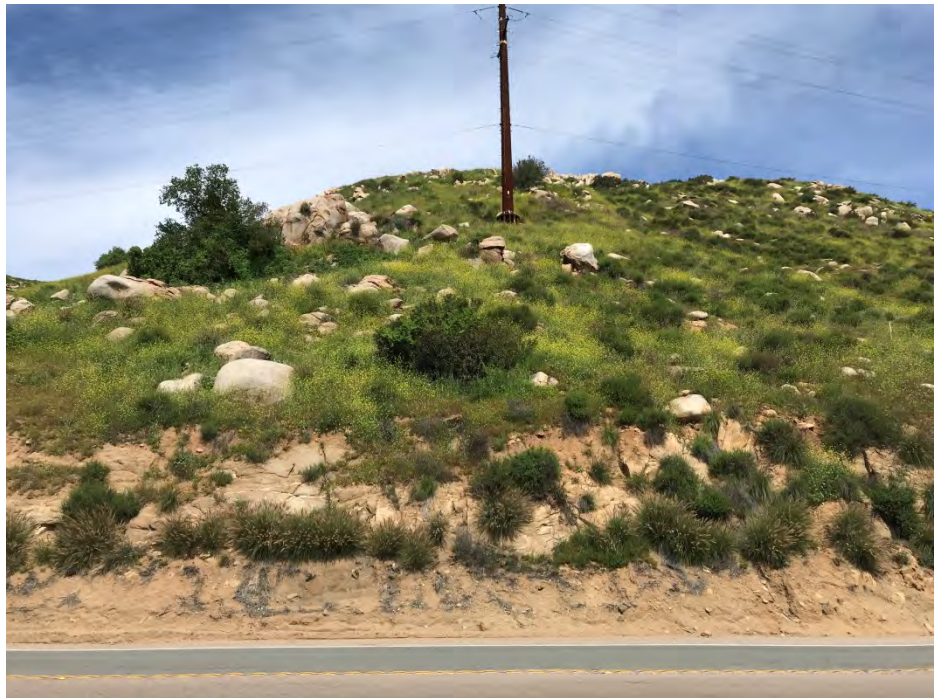
Photograph 18: View of granitic rock outcrops along the northern alignment of Segment 6.

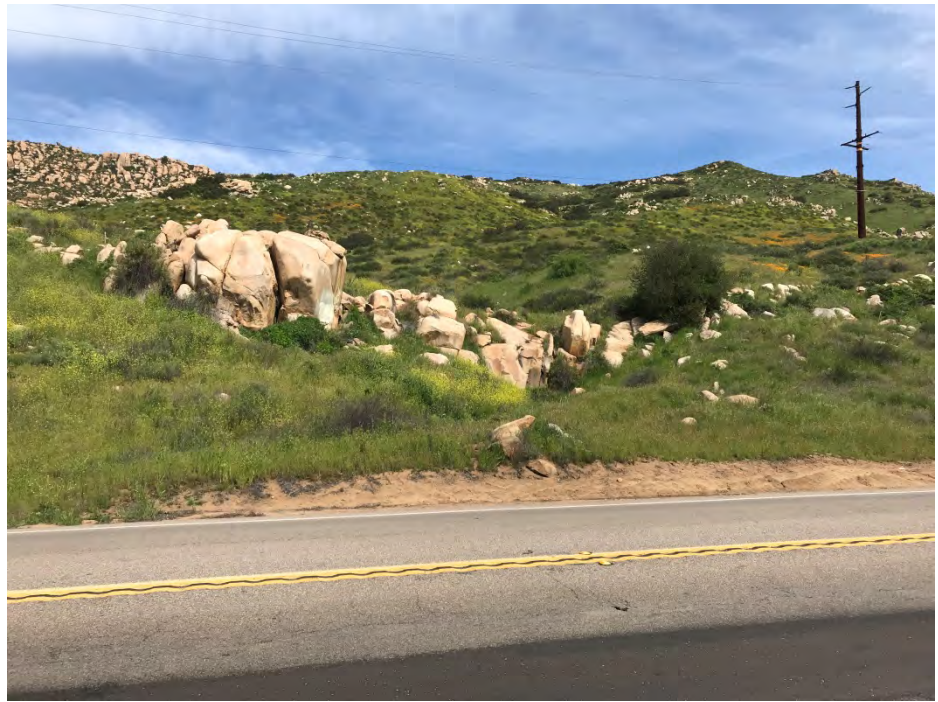
Photograph 19: View of granitic rock outcrops along the northern alignment of Segment 6.

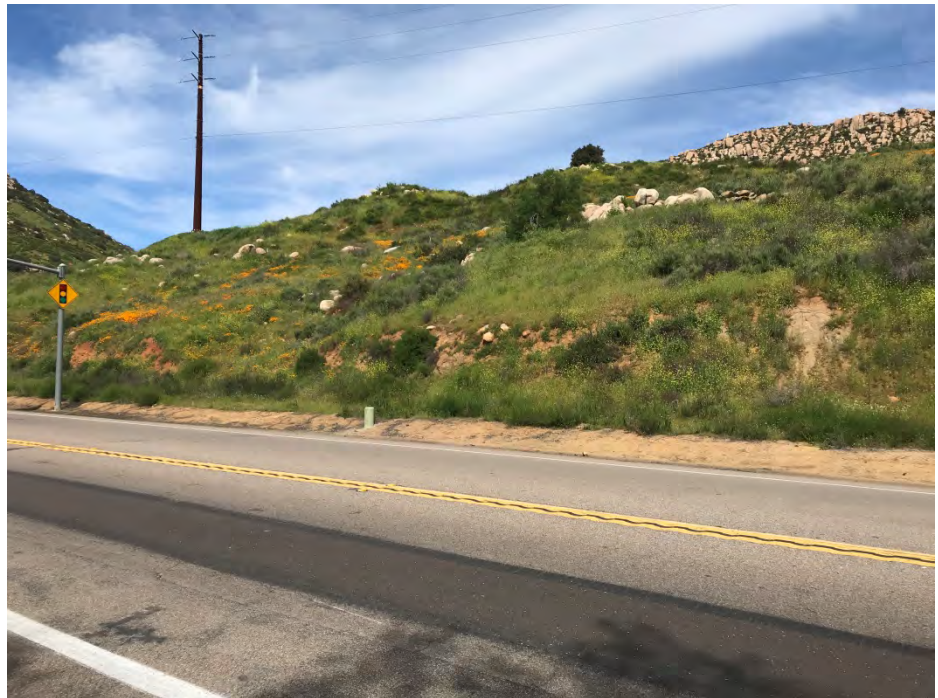
Photograph 20: View of granitic rock outcrops along the northern alignment of Segment 6.
