FAULT RUPTURE HAZARD STUDY

**WON MEDITATION CENTER
19993 GRAND AVENUE
LAKE ELSINORE, CALIFORNIA
APN # 382-140-002**

PROJECT NO. T2877-22-01

AUGUST 21, 2019

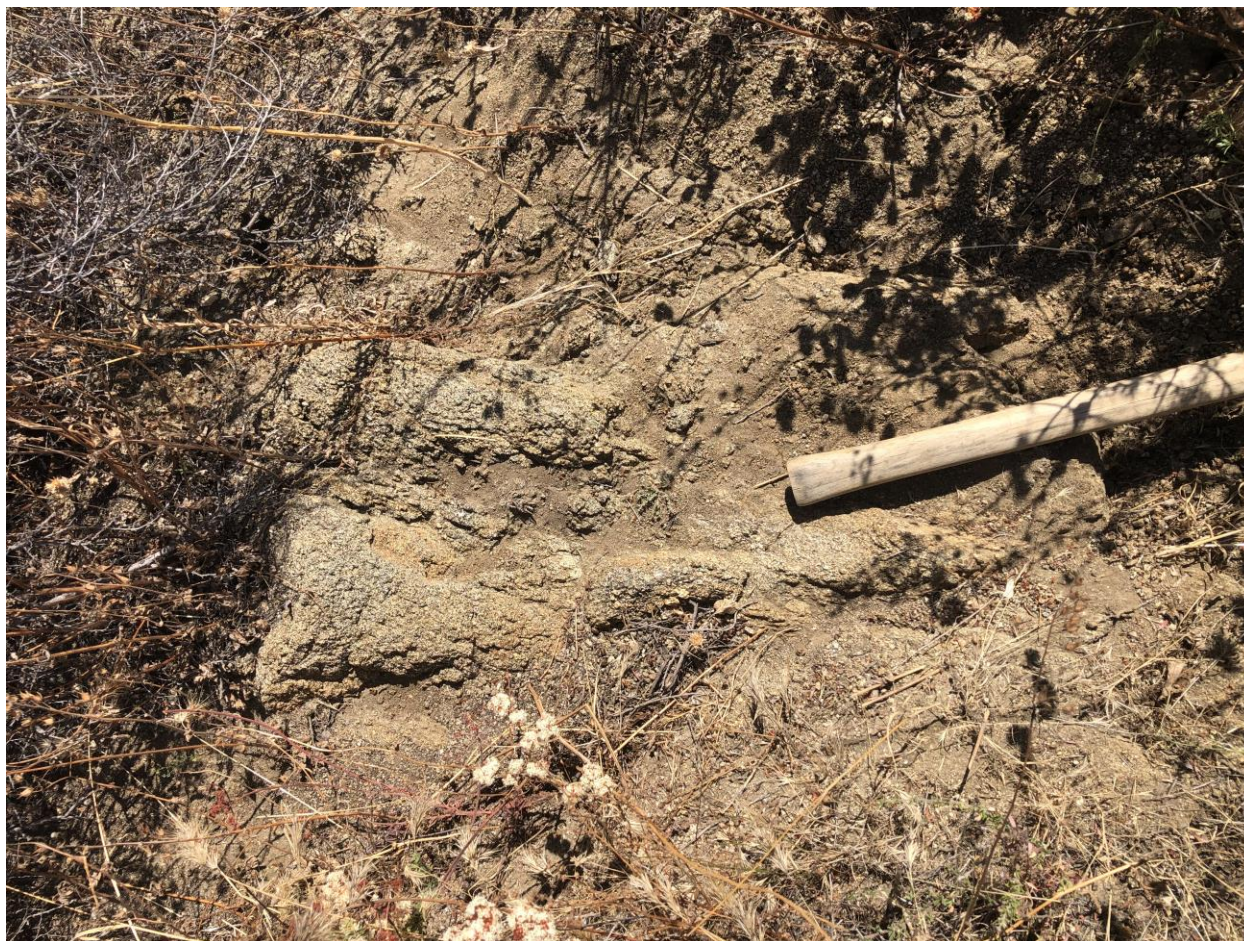
SITE PHOTOGRAHS		
WON MEDITAION CENTER 19993 GRAND AVENUE LAKE ELSINORE, CALIFORNIA APN # 382-140-002		
AUGUST 2019	PROJECT NO. T2877-22-01	Figure 9

Cretaceous-age Quartz Monzonite was observed in western and northern portion of the site and underlies the alluvium at depth. The roadcut exposed bedrock that is highly to moderately weathered. The rock is medium grained, gray, black, and white, and slightly jointed. Where weathered this granitic bedrock unit was hard and slightly friable. Joints were generally slightly open with some oxidation and more advanced weathering along the joint surface. Careful examination of the joints at location of mapped lineaments did not indicate evidence of faulting or fault related features (such as gauge, shear fabric, crushed bedrock), as shown on Figures 9 and 10, *Site Photographs*.

4. Lineaments observed in aerial photographs and regionally mapped by others are not the result of Holocene fault displacement.
5. Lineament identified during this investigation were identified in the field as jointing, not faulting. No faults or fault-related features were observed along the length of the mapped transect.

Figure 9. Jointing in granitic bedrock. Joint parallel to handle is coincident with mapped lineament 1 as shown on Figure 4.

Therefore, the potential for surface fault rupture at the site and within 50 feet of proposed structures depicted on *Figure 4* is considered low and no building setbacks are recommended at this time. If future development of habitable structures is planned in other locations at the site, further evaluation may be needed.

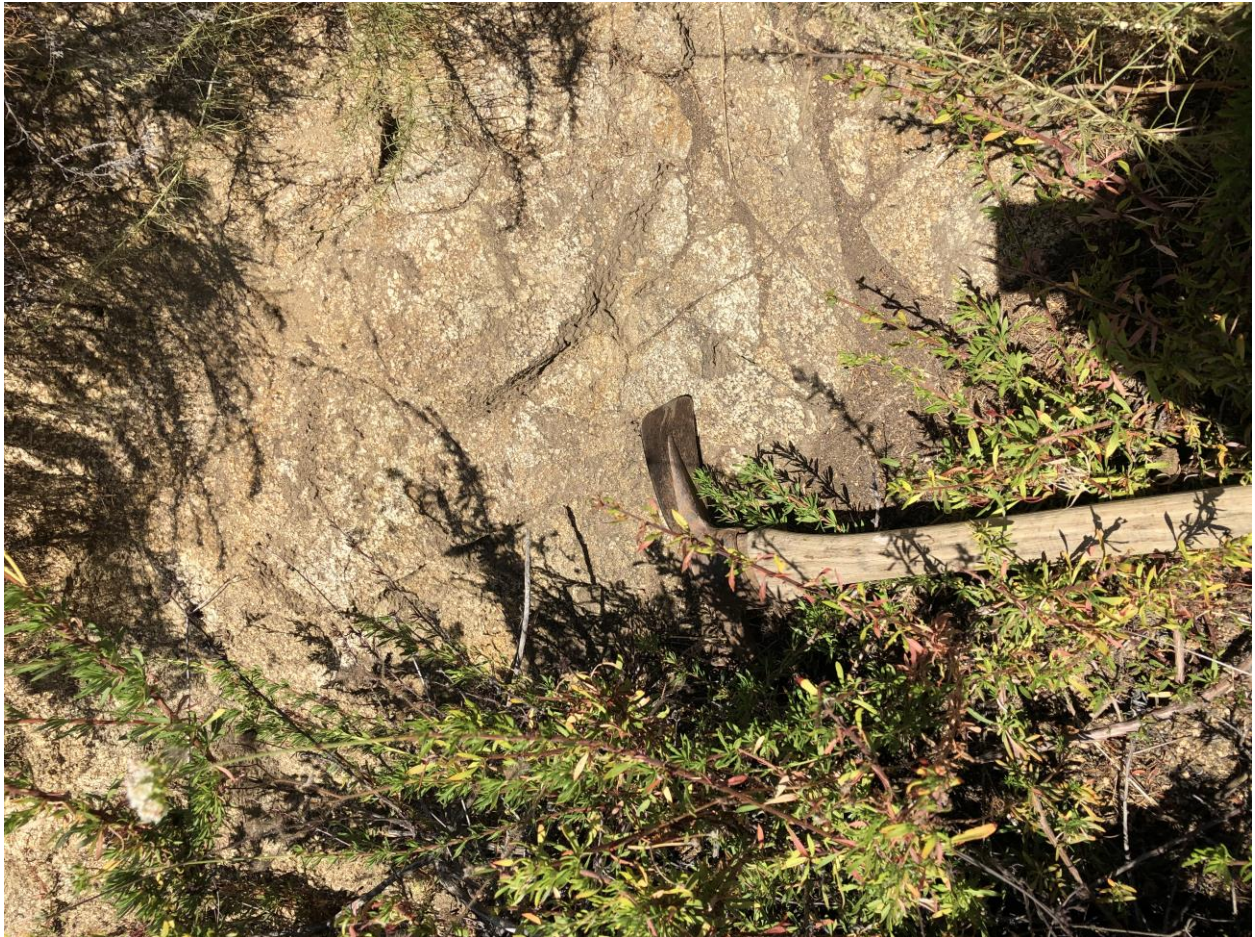
Figure 10

Figure 10. Jointing in granitic bedrock. Joint pick is pointing towards is coincident with mapped lineament 2 as shown on Figure 4.
