Arborist Report

PROTECTED TREE REPORT
for
the Meadows at Bailey Canyon Project
City of Sierra Madre, California

DUDEK

NOVEMBER 2020

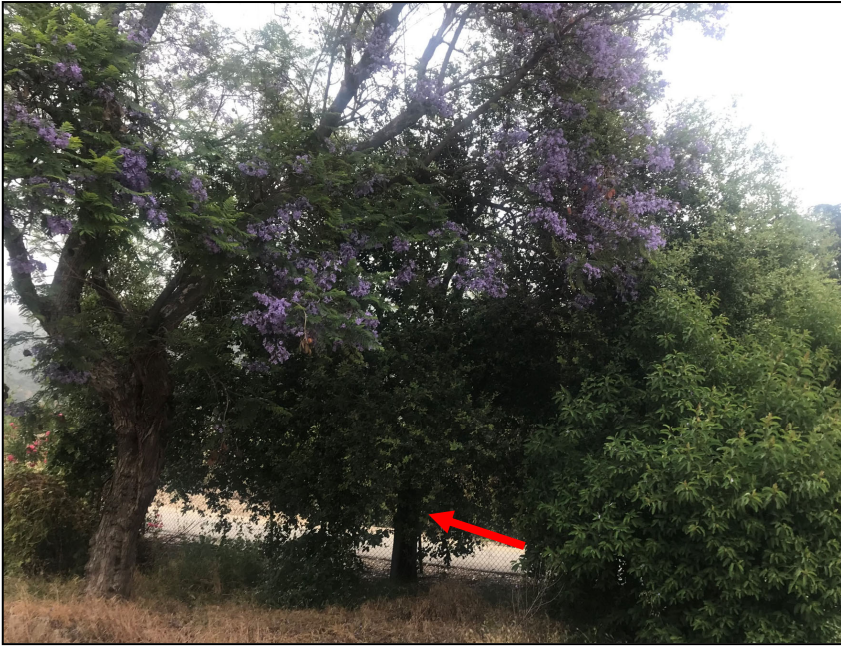
Photo 9. Photograph of protected coast live oak tree #15.

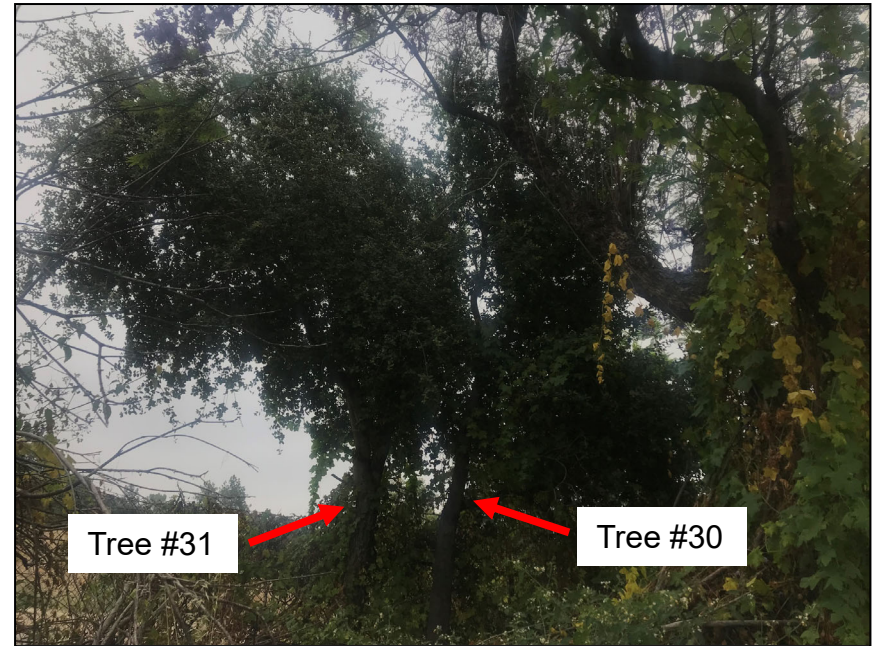
Photo 10. Photograph of protected coast live oak trees #30 and #31.

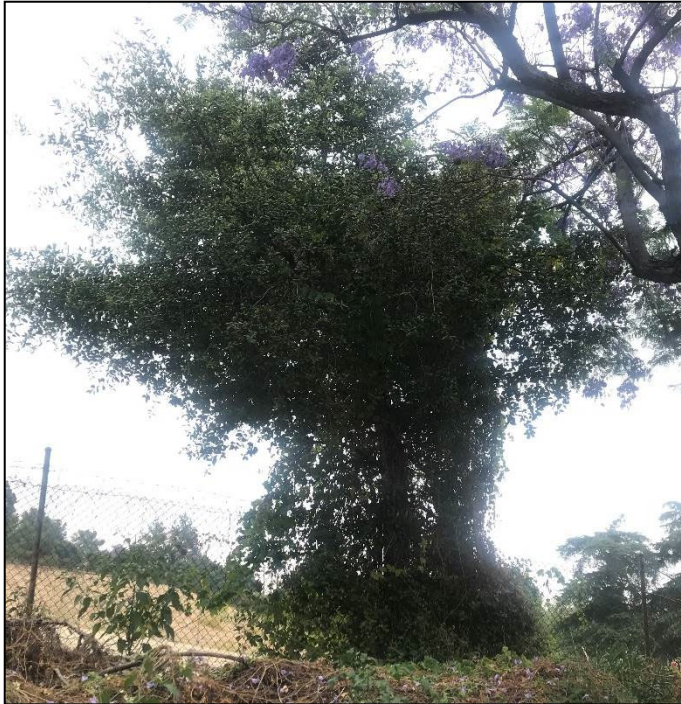
Photo 11. Photograph of protected coast live oak tree #33.
