SUBJECT: REPORT OF INFILTRATION TESTING

Proposed Arbor Carwash
9744 Arrow Route
Rancho Cucamonga, California
Project No. 1702-01

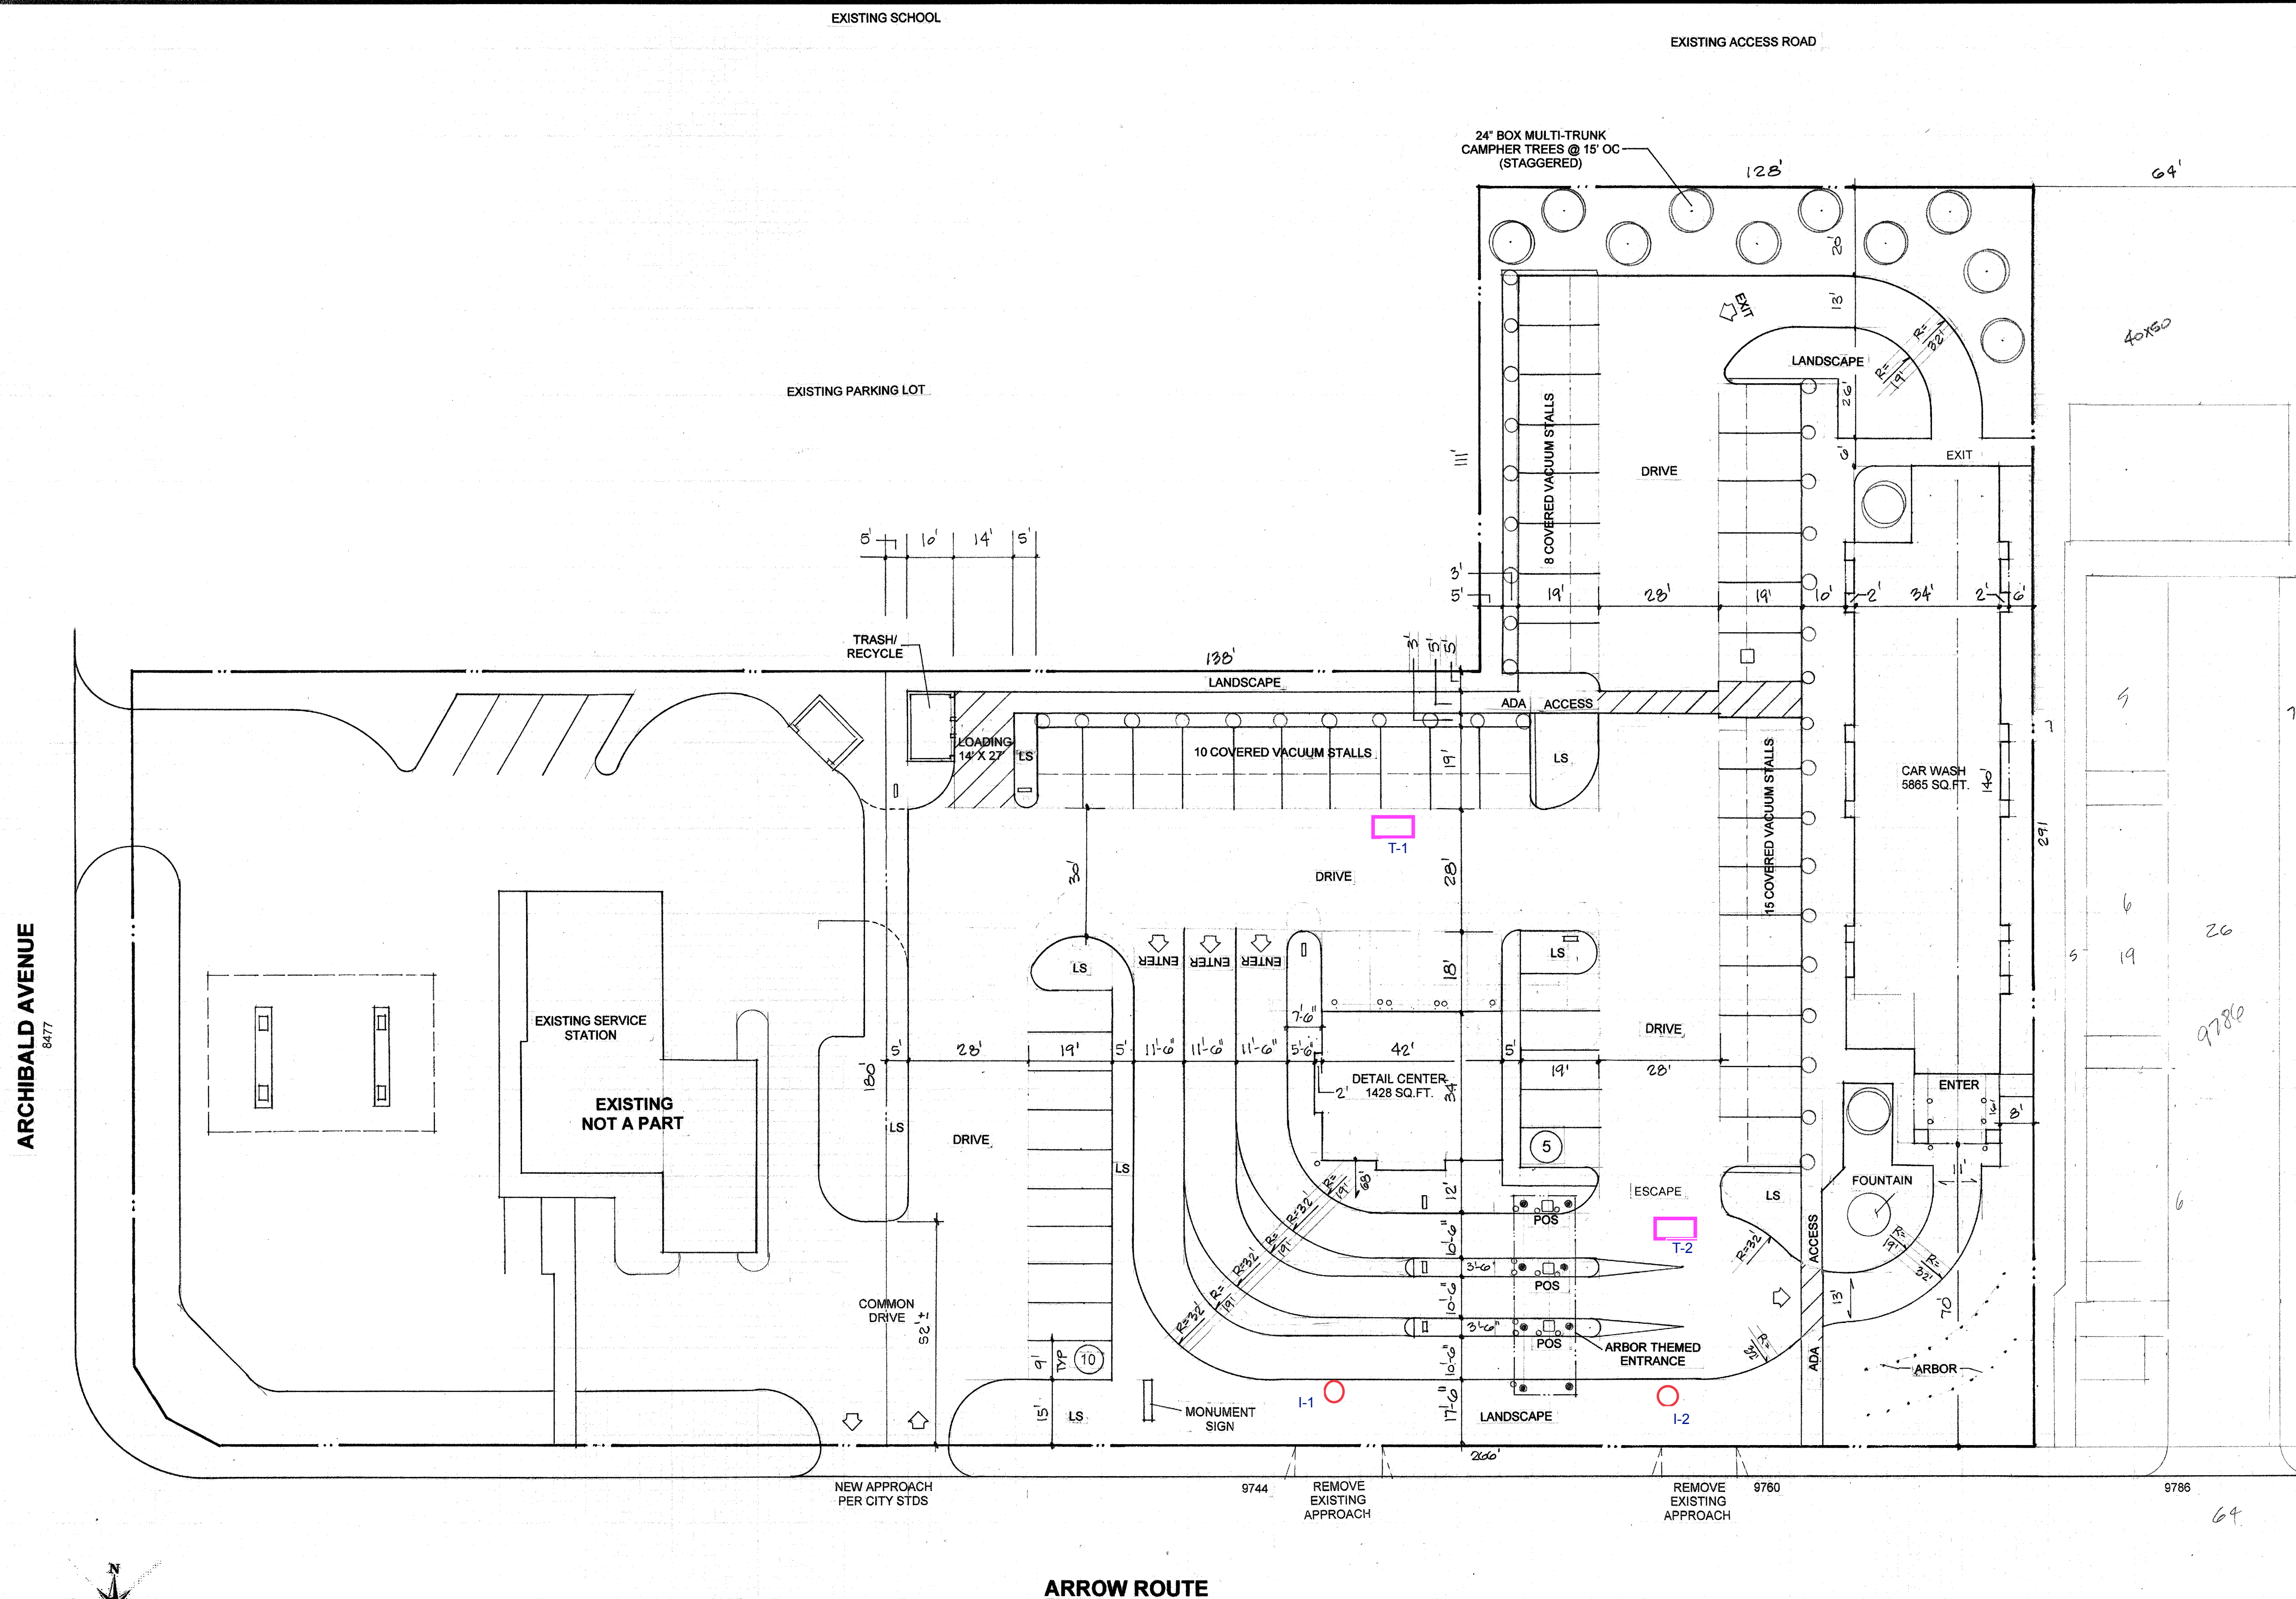
When 2 consecutive measurements indicated that 6 inches of water seeps into the soil in less than 25 minutes, the strata was classified as “sandy soil” and testing continued for an additional hour with measurements taken every 10 minutes. The drop that occurs during the final 10 minutes was used to calculate the field percolation rate. In non-sandy material at least twelve measurements were recorded over a period of at least six hours at approximately 30 minutes intervals. The final reading was used to calculate the field percolation rate. The test pits were backfilled immediately following field recordation for safety. At the completion of testing, a 3 feet long surveyor’s stake (lath), flagged with highly visible banner tape was placed in the location of the test indicating date, test hole number, and the company performing the test. The approximate location of each test pit is shown on our Infiltration Test Location Plan, Figure 2.

0 - Approximate Location of Infiltration Test

- Approximate Location of
T-2 Exploratory Trench
