Bill Pramuk, Consulting Arborist
Pramuk, Trees and Associates, LLC

January 31, 2020

Arborist Report

Re: Hotel Veranda, updated

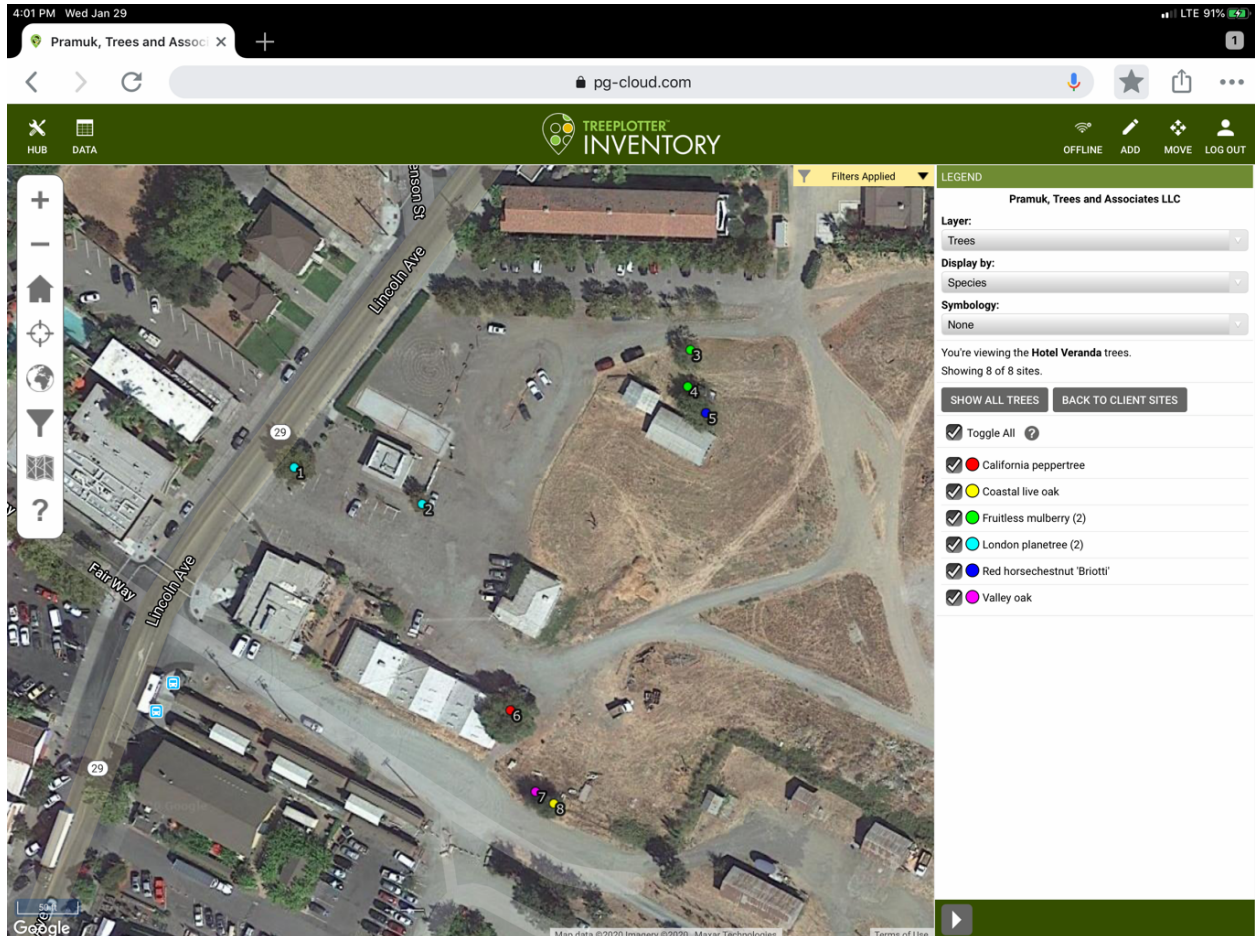
Tree Plotter Map

Subsequently, I met with you on January 29, when we walked the site. At that time, I plotted the existing trees on *Tree Plotter*¹. A copy of the resulting site image with the numbered trees is attached. The numbered trees correspond to those in my previous reports.

Judging by the *Tree Plotter* satellite photo compared with the plans you provided, it appears that all of the trees will need to be removed to accommodate the planned site improvements.

#1. 10” DBH² London plane (Platanus X hispanica) located 11 feet from the Lincoln Avenue curb, 169 feet southwest of the north corner of the property, and possibly on City right-of-way. This tree shows good vigor and structure.

#2. 5.2” DBH London plane, 117 feet from the Lincoln Avenue curb and 180 feet from the northeast boundary. This tree shows good vigor and structure.

#3. 11.7” DBH fruitless mulberry (Morus alba), 38 feet from the northeast boundary and 244 feet from the Lincoln Avenue curb. This tree shows good vigor and fair structure. Minor decay exists in the trunk at several old wounds, 5 1/2 - 6 feet above ground.

#4. 11” DBH fruitless mulberry, 38 feet south of tree #2. This tree shows good vigor and fair structure. Minor decay exists in the trunk at several old wounds.

#5. 10.7” (diameter at base horse) chestnut (Aesculus species), a low branching, multi stem tree located 17 feet south of tree #4. This tree shows fair vigor and structure. Minor decay exists in the central stem at an old wound.

#6. 20.3” DBH California pepper (Schinus molle) located approximately 50 feet from the southwest boundary and 287 feet from the Lincoln Avenue curb. This tree shows good vigor and poor structure. The base of the tree abuts the existing building and the trunk leans sharply away from the building.

#7. 2.6” + 2” caliper³ valley oak (Quercus lobata), two tightly adjoining trees, located approximately 4 feet outside the southwest fence line and 338 feet from the Lincoln Avenue curb. The larger tree shows good vigor and structure. The smaller one is suppressed and bent.

#8. 12” approximate DBH coast live oak (Quercus agrifolia), on the southwest fence line, 350 feet from the Lincoln Avenue curb. This tree shows good vigor. The structure is not visible because of very crowded low branches.”

Tree #3 now shows poor vigor. There are dead upper branches up to 2-inch diameter. **Tree #7**, outside of the west fence line: The 2.6" diameter trunk has grown to 4" and has been severely damaged, apparently by heavy equipment moving a large log in the area. The smaller trunk has been removed.

The other trees, #1,2, 4, 5, 6, and 8 are in about the same condition as before.

I recommend you have your project engineers overlay the satellite image, with the numbered trees, over the current *Existing Conditions and Demolition* and *Overall Site Plan* to verify my conclusion that all of the trees, #1 through 8, will need to be removed.
