TREE SURVEY REPORT

SANDRA-HAYNE STORMWATER IMPROVEMENT PROJECT HILLSBOROUGH, SAN MATEO COUNTY, CALIFORNIA

Date: August 2019

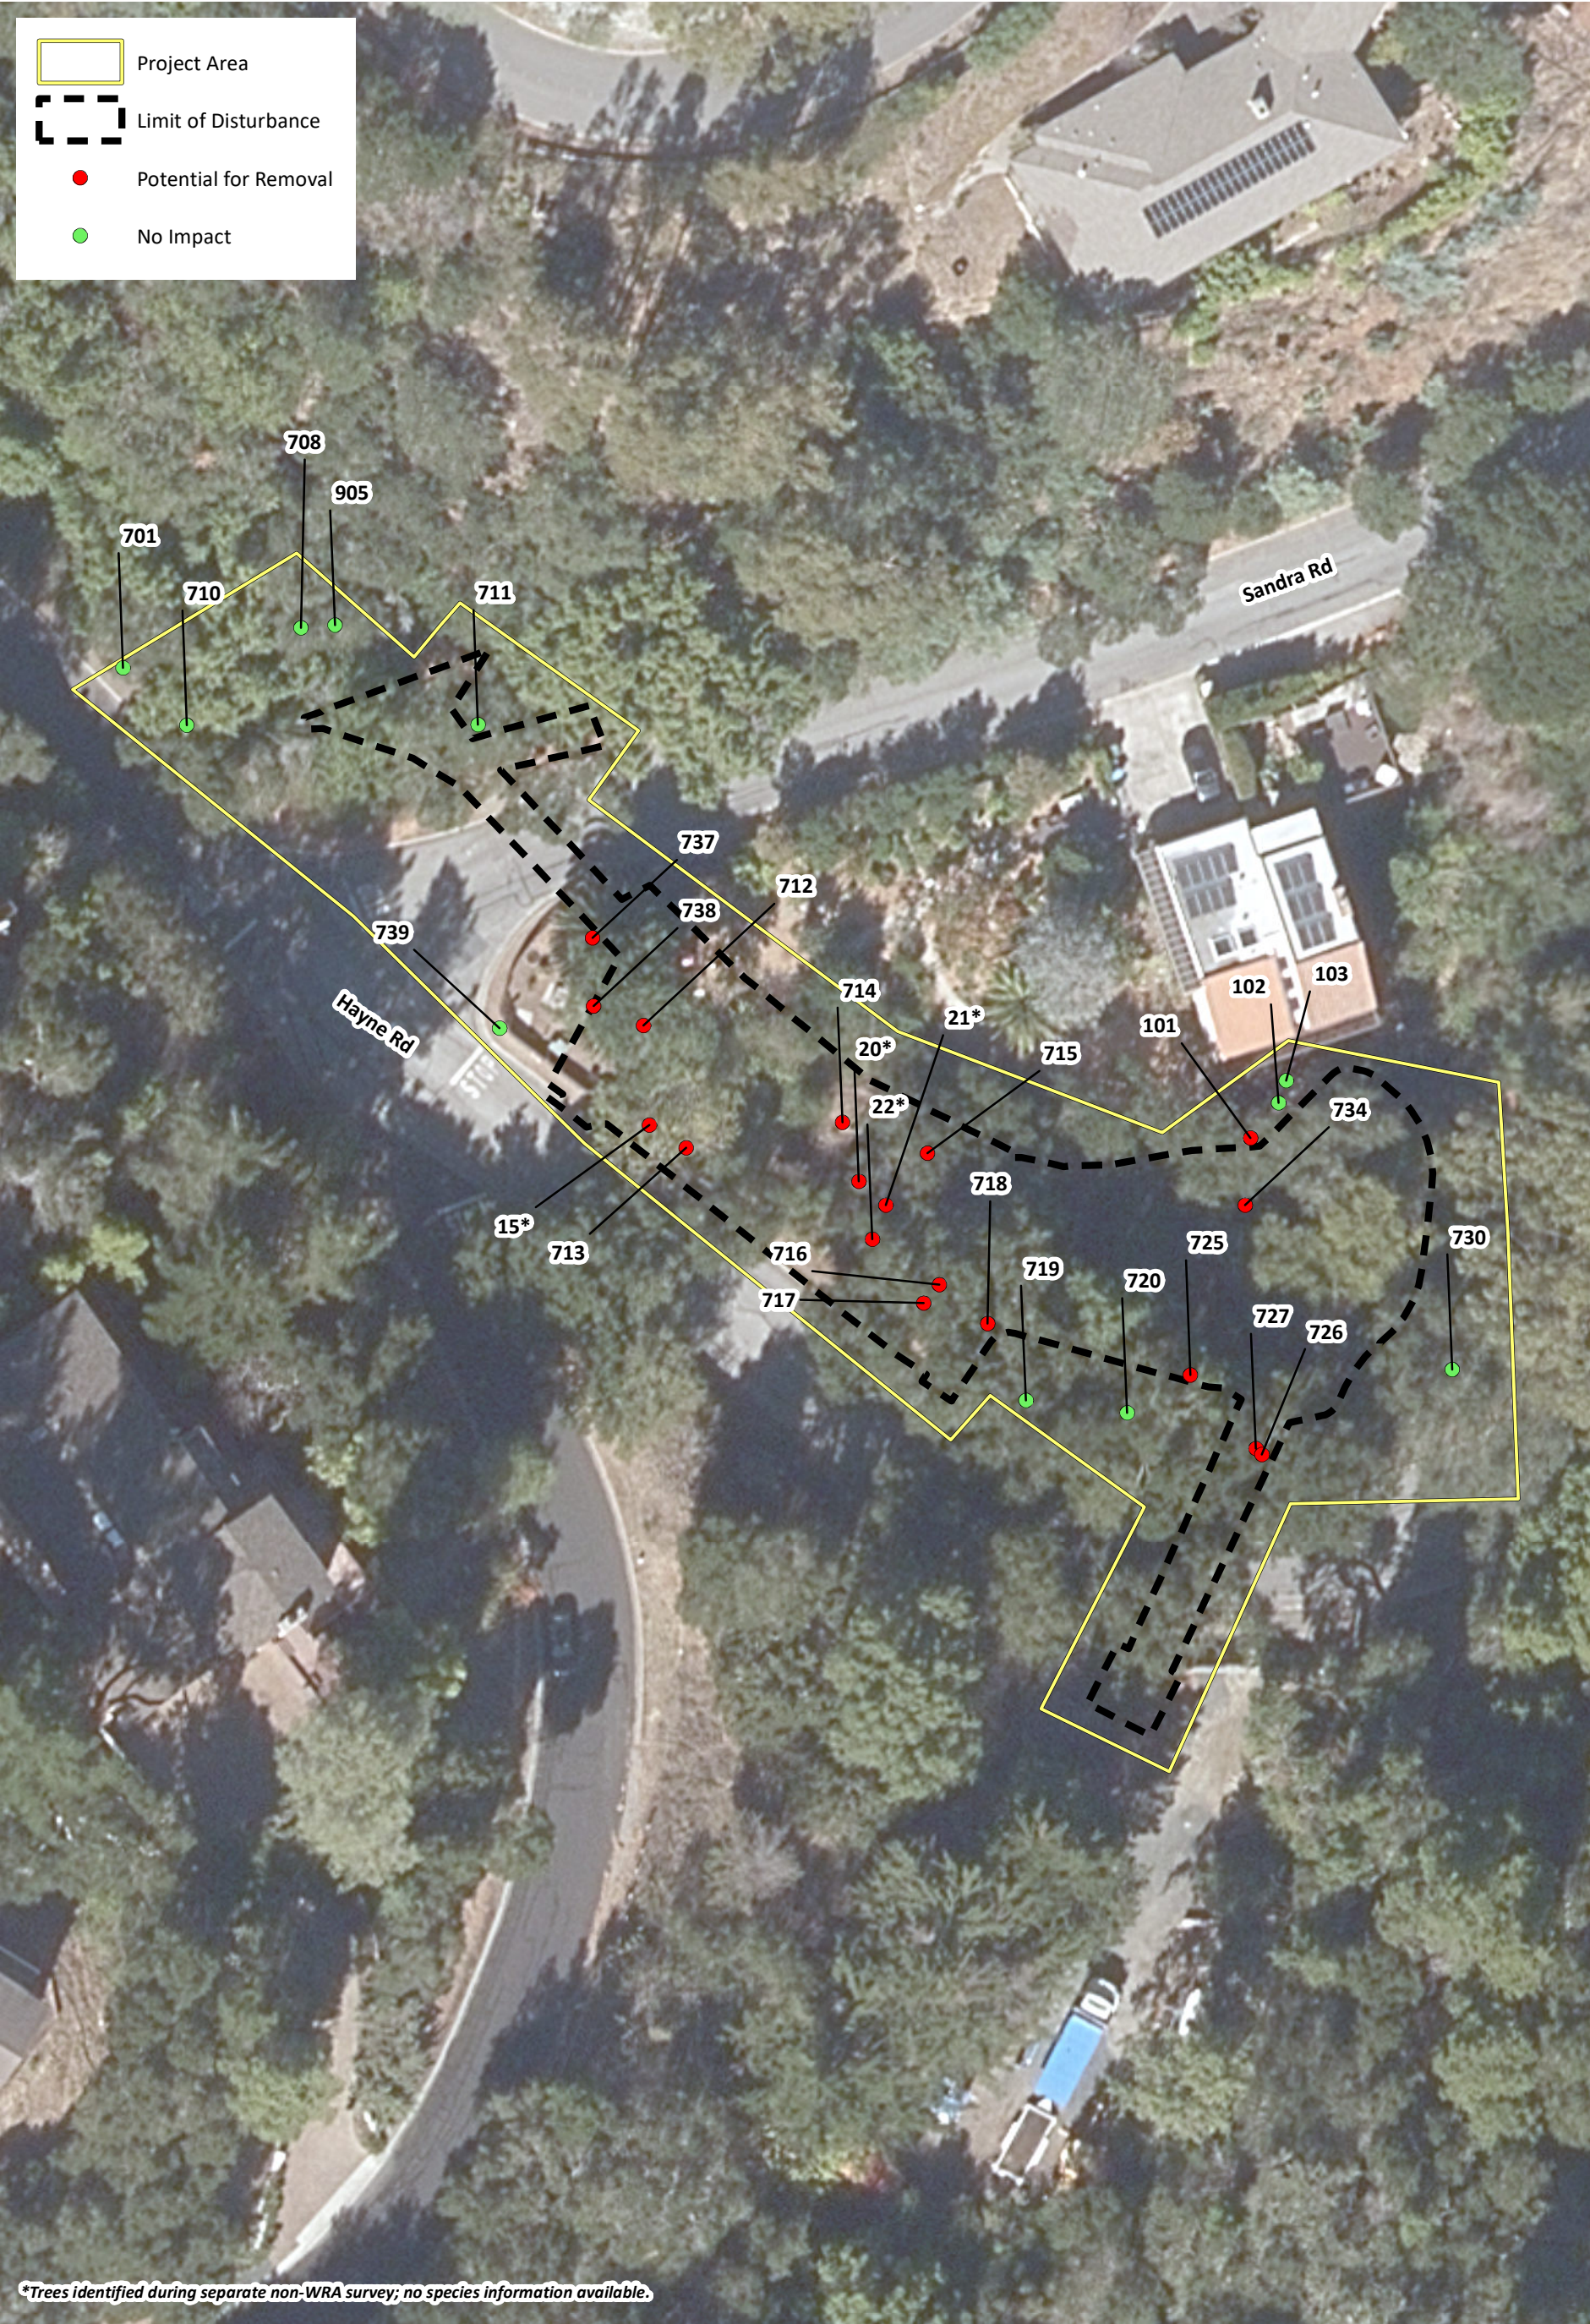
Tree Survey Map

A complete list of surveyed trees is included in Appendix A. The locations of surveyed trees are shown in Appendix B. Representative photographs of surveyed trees are included in Appendix C.

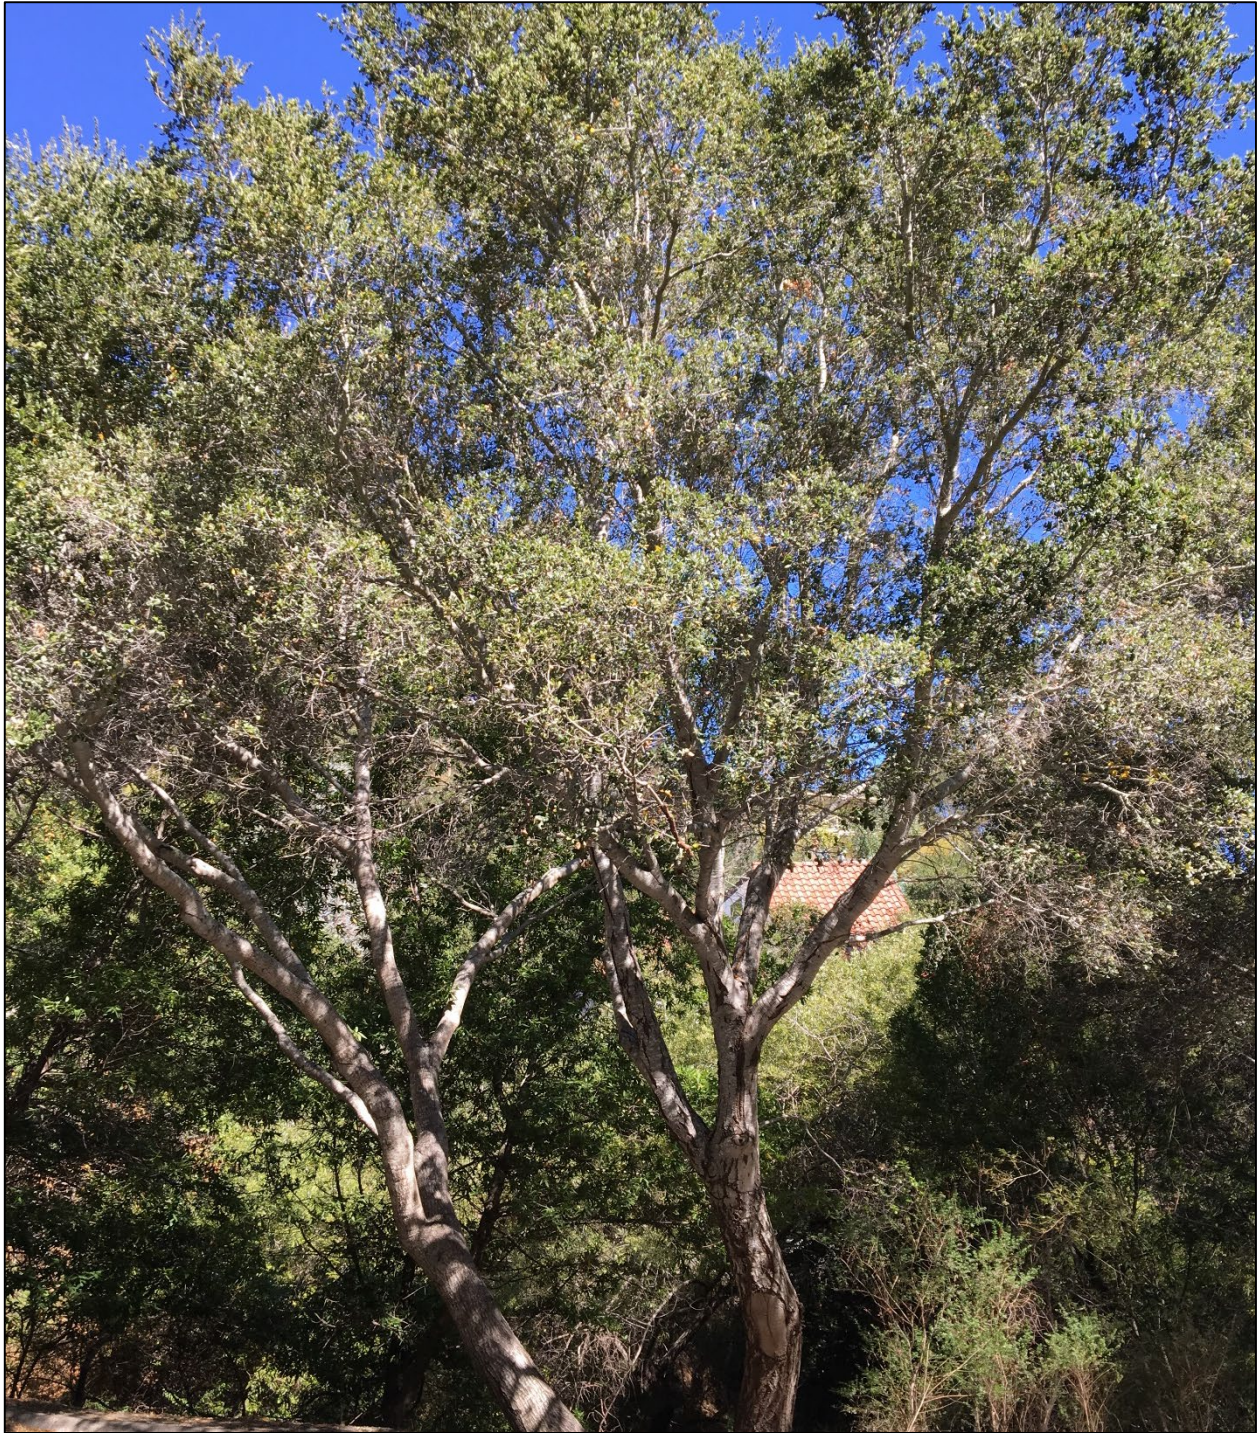
Photograph 1. Tree #726, 17.3" DBH coast live oak (*Quercus agrifolia*) and Tree #727, 18.7" DBH coast live oak (*Quercus agrifolia*) in the southern portion of the Project Area adjacent to Hayne road.

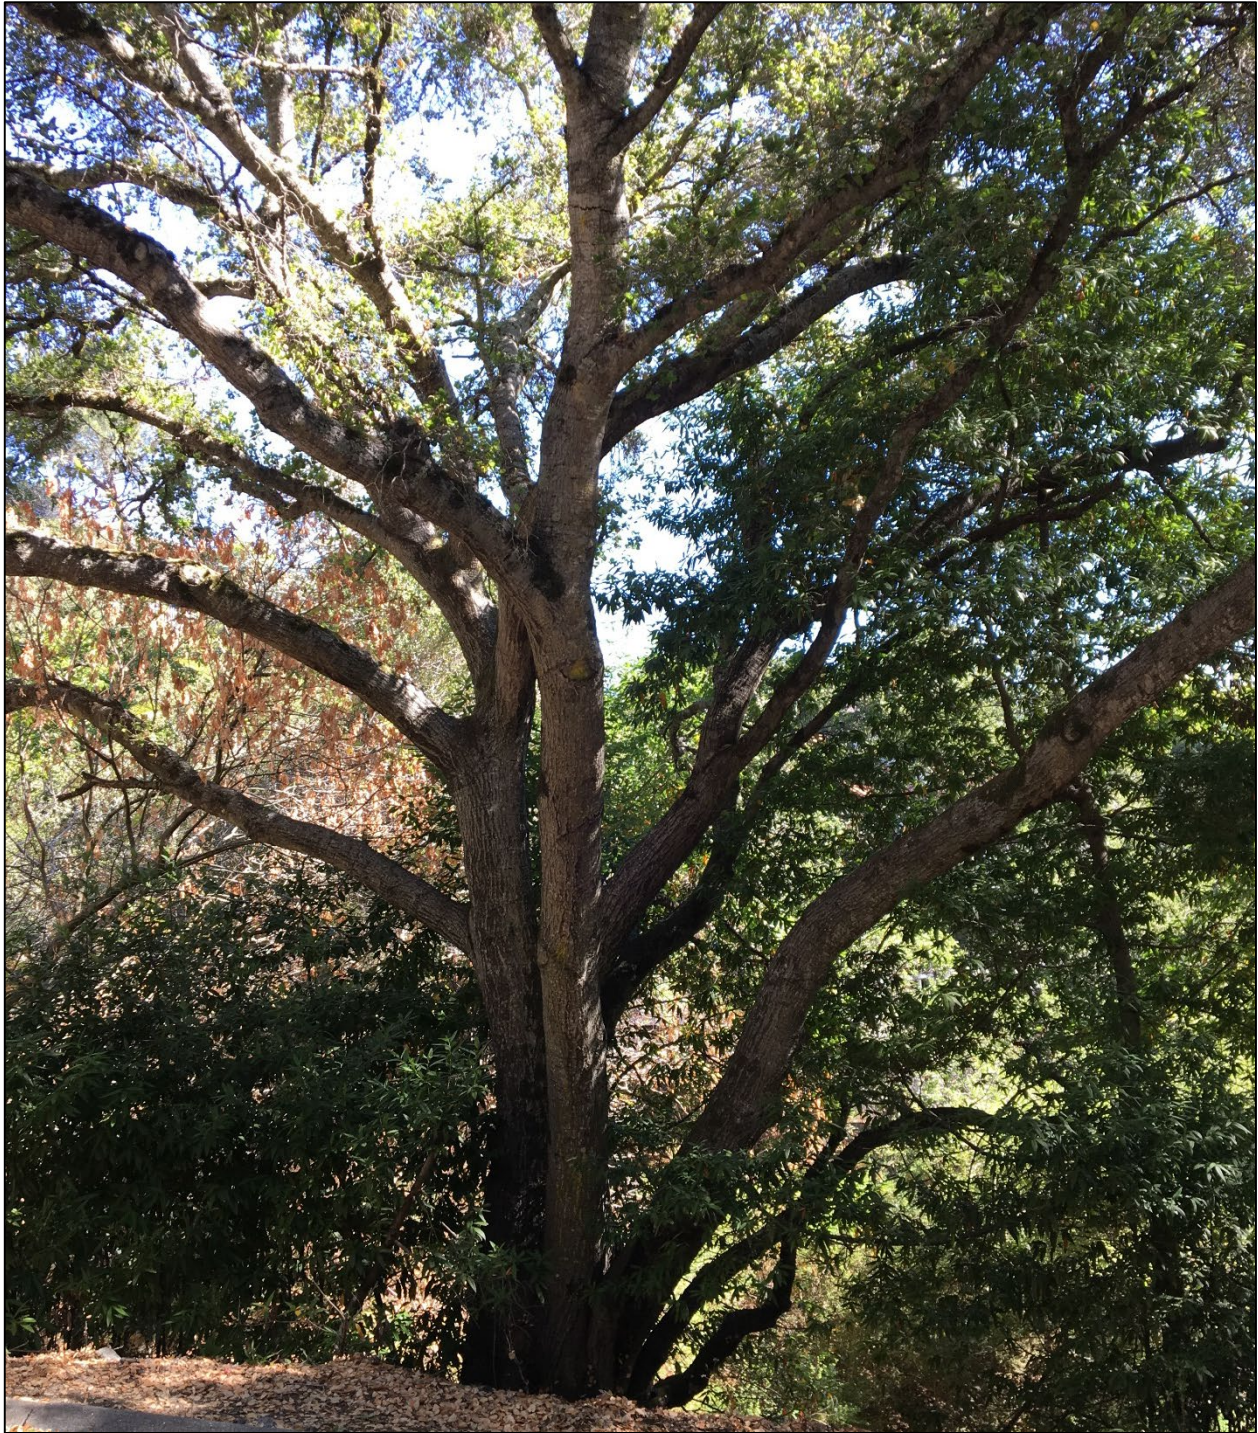
Photograph 2. Tree #717, 54.1" DBH coast live oak (*Quercus agrifolia*) in the southern portion of the Project Area adjacent to Hayne road.

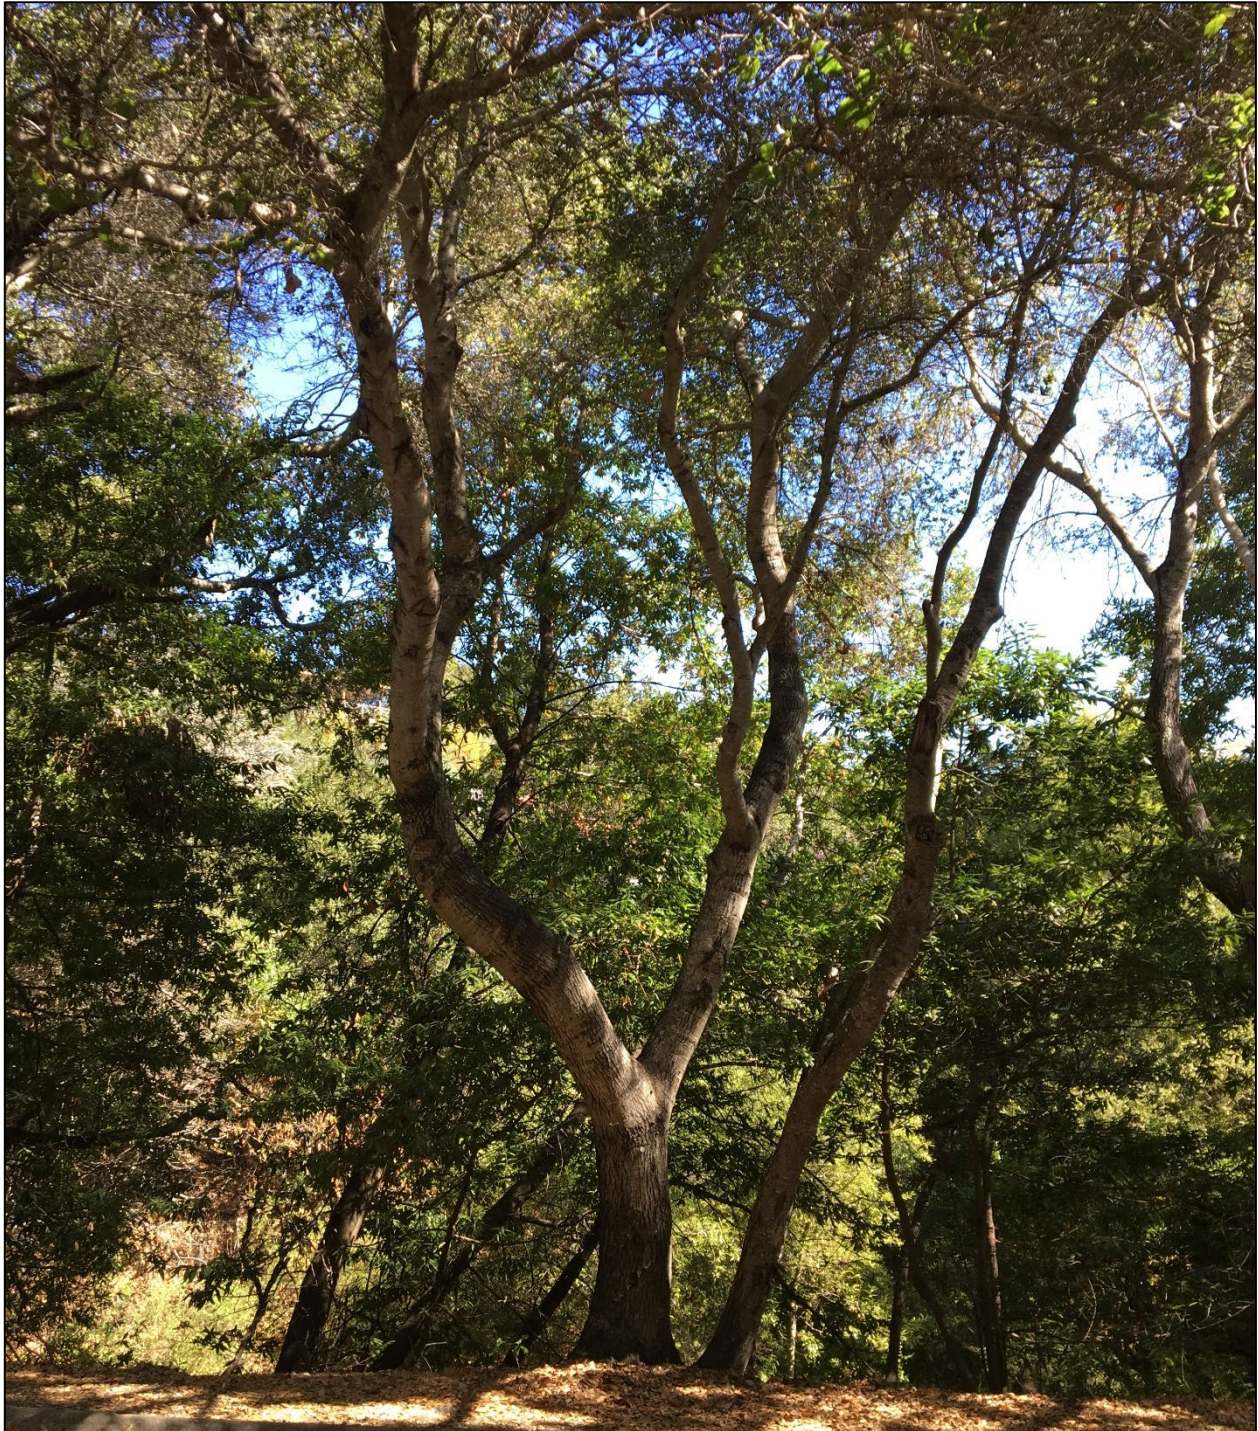
Photograph 3. Tree #719, 34" DBH coast live oak (*Quercus agrifolia*) in the southern portion of the Project Area adjacent to Hayne road.

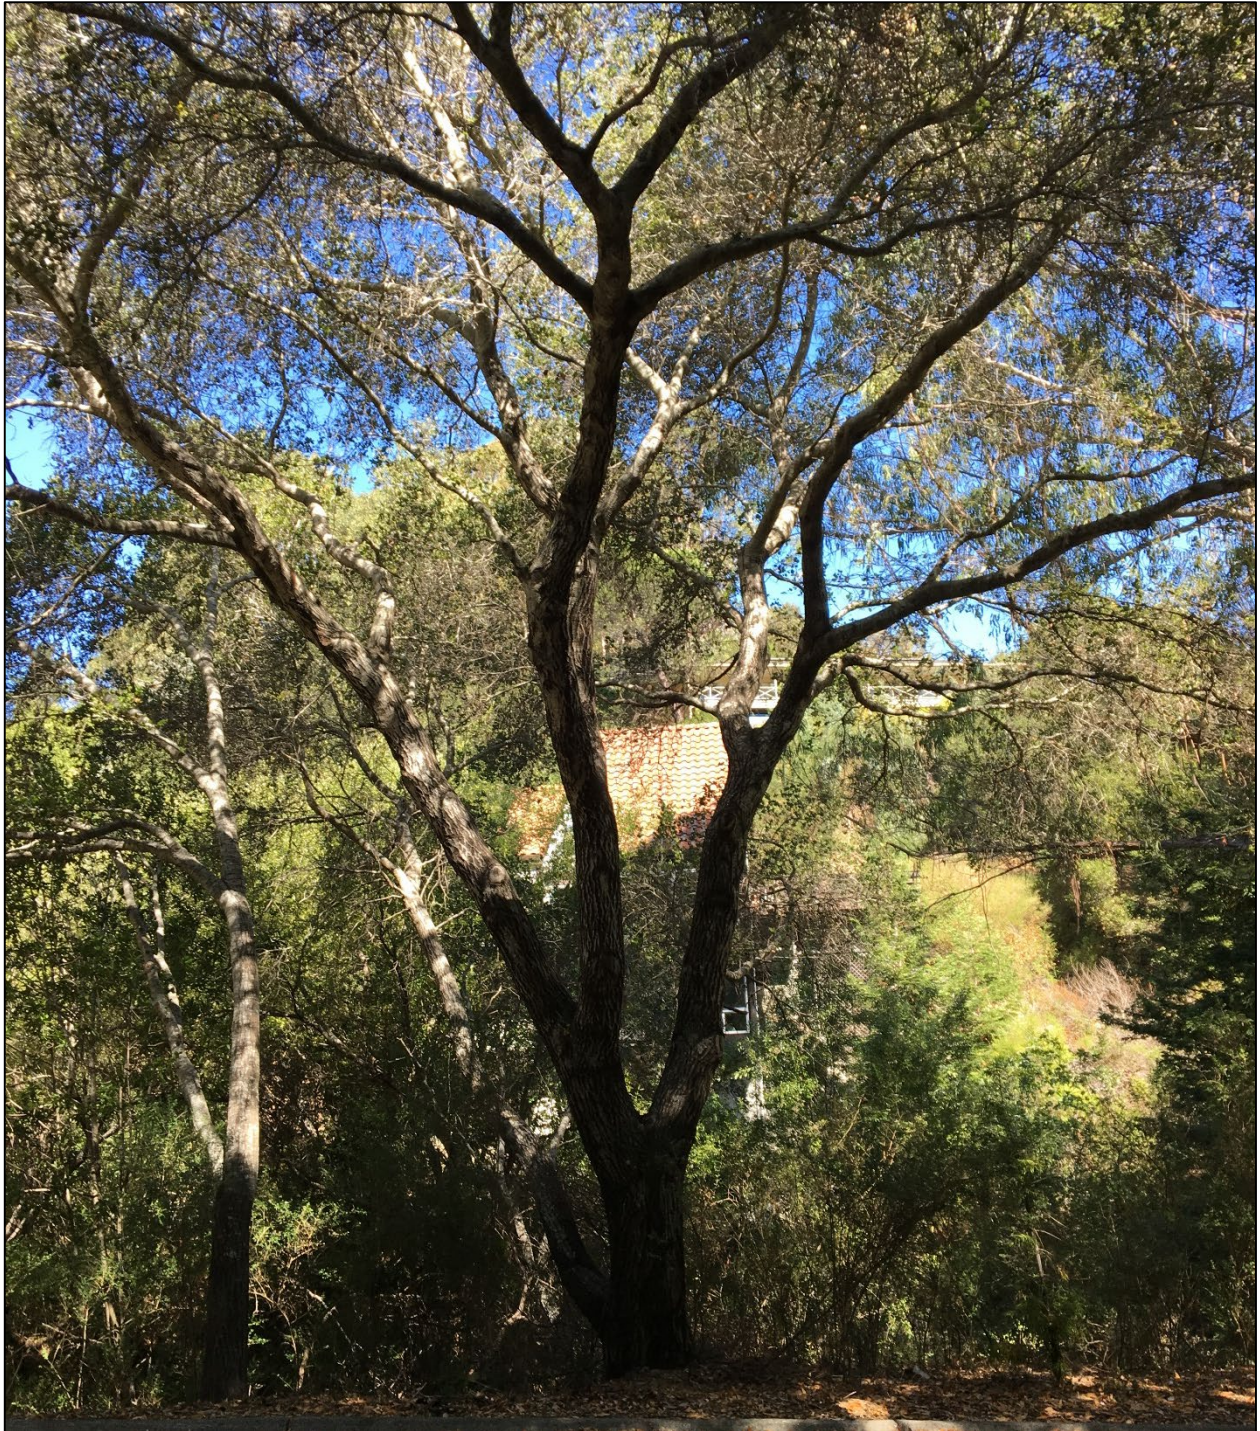
Photograph 4. Tree #730, 36.3" DBH coast live oak (*Quercus agrifolia*) in the southern portion of the Project Area adjacent to Hayne road.
