# 161-070-034BIOLOGICAL RESOURCES ASSESSMENT CHEVRON STATION-REDWOOD MARKET 9120 AND 9200 OLD REDWOOD HIGHWAY

(APNs: 161-070-034 and 161-070-035)

WINDSOR, CA

APPENDIX B.2: Updated Arborist Report

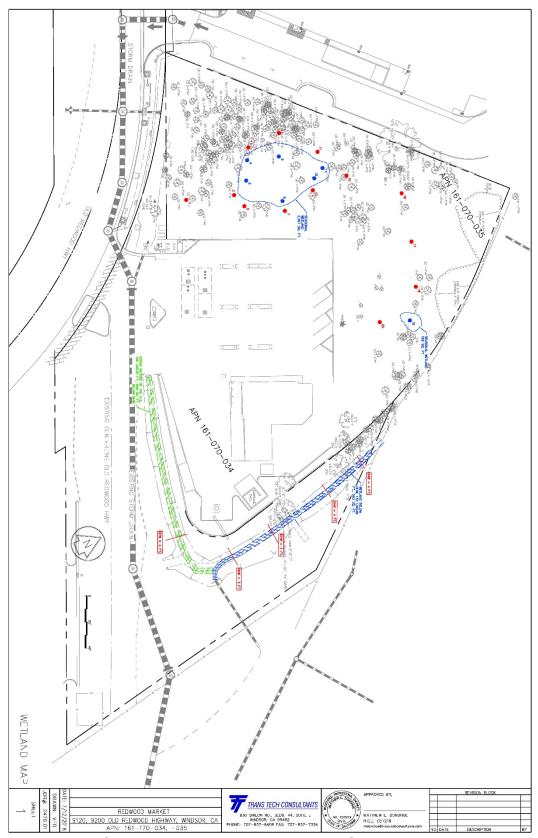
Figure 4. Location of seasonal wetlands at the Project Site.

The seasonal wetlands at the Project Site consist of shallow, slightly depressional areas north of the existing Chevron gas station, and do not provide suitable habitat for endangered plants found in seasonal wetland/vernal pool habitat on the Santa Rosa Plain. These wetland features likely pond from a few hours to a few days following rainfall events and do not provide the necessary longer-term wetland hydrology to support the endangered plants. The seasonal wetlands have been completely invaded by non-native annual grasses commonly found in disturbed and marginal seasonal wetlands in the region.

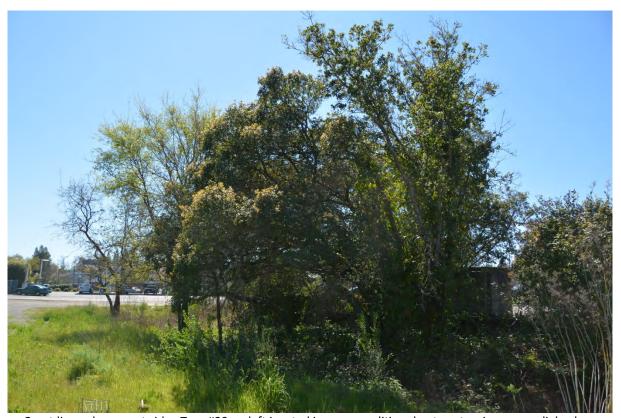
Coast live oaks on east side. Tree #39 on left is rated in poor condition due to extensive crown dieback.

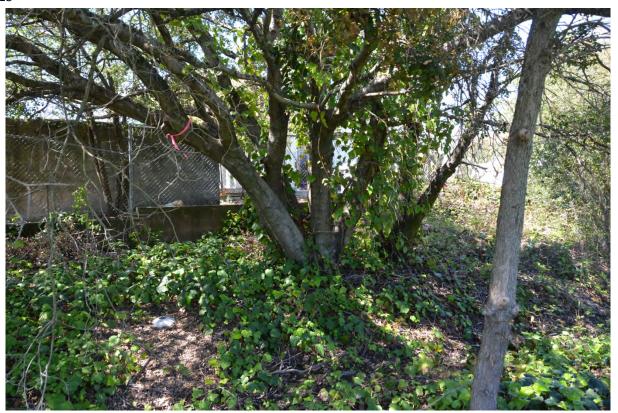
Base of coast live oak #40 with defective multiple trunk structure.

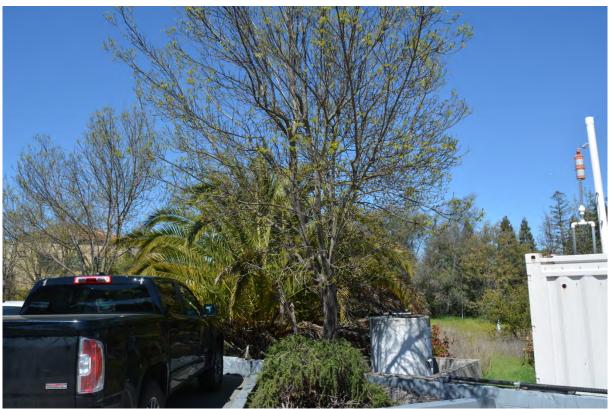
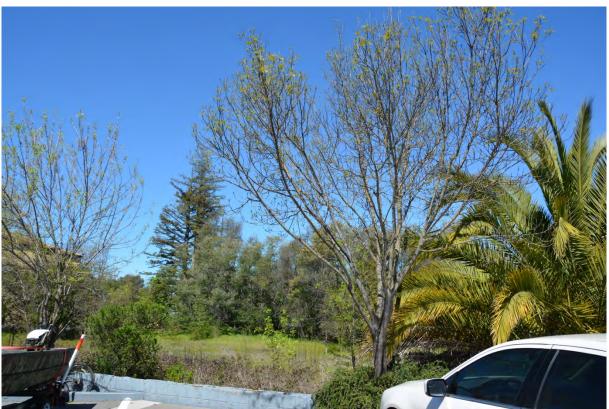
Smaller, drought stressed Raywood ash in planters on north side of parking area.

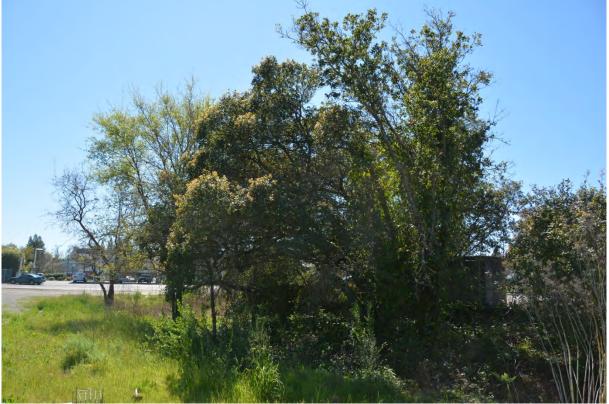
Coast live oaks on east side. Tree #39 on left is rated in poor condition due to extensive crown dieback.

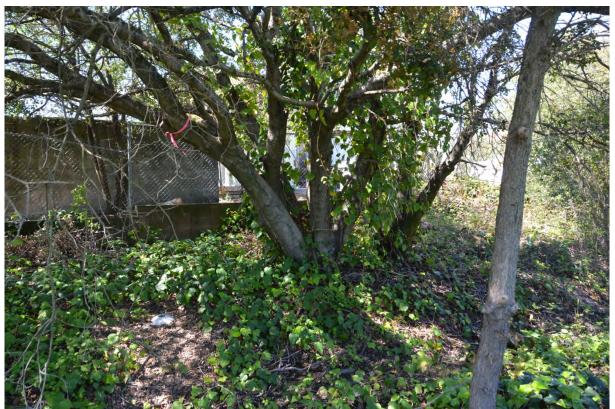
Base of coast live oak #40 with defective multiple trunk structure.

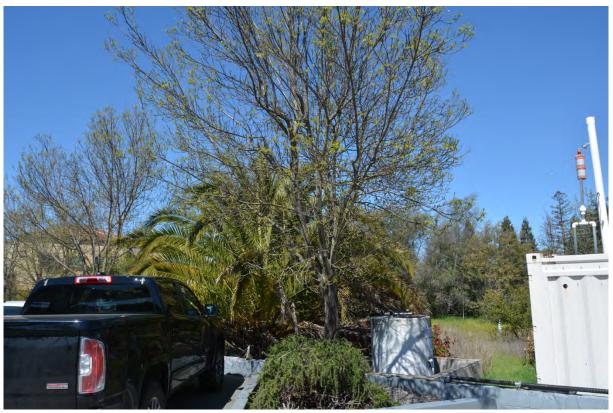
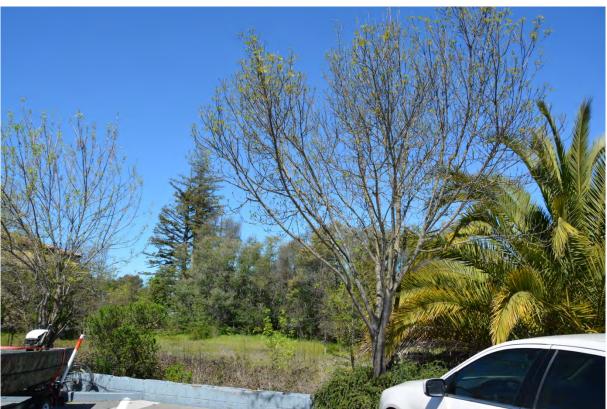
Smaller, drought stressed Raywood ash in planters on north side of parking area.
