**CITY OF LOS ANGELES TREE INVENTORY REPORT
2045 EAST VIOLET STREET
LOS ANGELES, CALIFORNIA 90021**

JULY 14, 2021

Re: Violet Street Tower, 2045 East Violet Street – Los Angeles City Tree Inventory Report

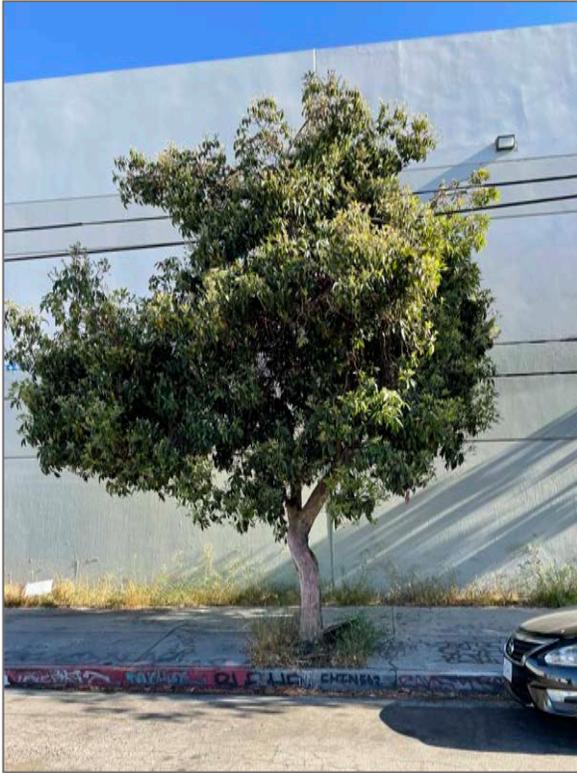
TREE #ST-1

ST-1	Brisbane box	<i>Lophostemon confertus</i>	11		26	06/08/07/14	A	B	ROW	To Be Removed

- The two small crape myrtles on Violet Street (ST4 and ST5) are in direct conflict with the driveway/drop-off and cannot be incorporated into the project design.
- The three Brisbane box trees on Violet Street (ST1, ST2, and ST3) are in various stages of health. Approximately 40% of the foliage on ST2 is dead, and the remaining two have no relationship to each other in terms of uniformity of size or form.

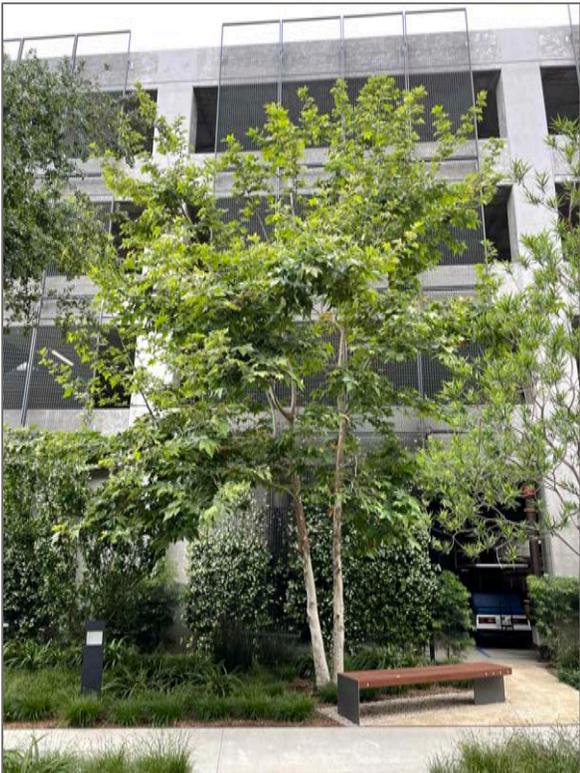
TREE #22

22	Western sycamore	<i>Platanus racemosa</i>	5.6, 5.7		40	10/12/12/06	A	A	Significant	Protected Species; not protected tree Tree was planted, not naturally occurring;

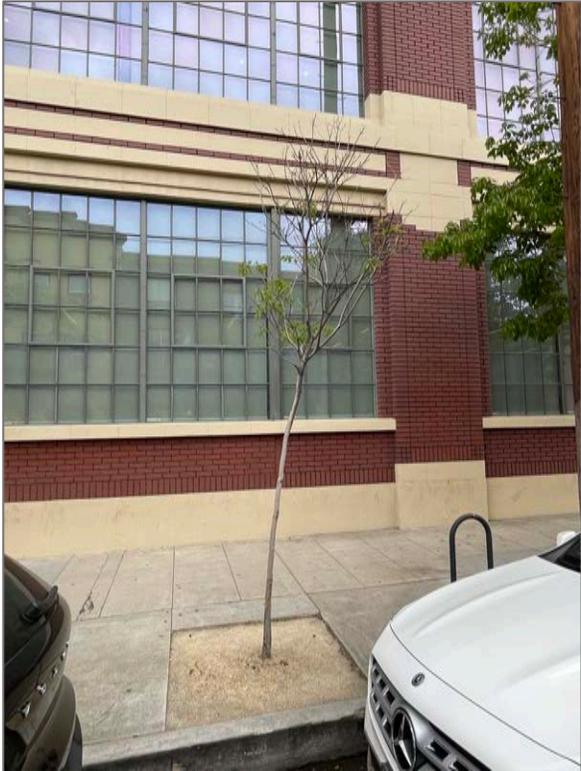
TREE #ST-13

ST-10	Pink trumpet tree	<i>Handroanthus impetiginosus</i>	5.5		24	07/07/08/06	B	B	ROW	
ST-11	Pink trumpet tree	<i>Handroanthus impetiginosus</i>	3.5		15	06/06/07/05	A	A	ROW	
ST-12	Pink trumpet tree	<i>Handroanthus impetiginosus</i>	3.3		17	10/06/11/07	B	B	ROW	
ST-13	Pink trumpet tree	<i>Handroanthus impetiginosus</i>	1.4		12	03/03/01/01	C	C	ROW
