Appendix E
Mission Canyon Stream Habitat
Restoration Project Jurisdictional
Delineation Report

MISSION CANYON STREAM HABITAT RESTORATION PROJECT

SOUTHERN CALIFORNIA EDISON, SANTA BARBARA COUNTY, CALIFORNIA

Delineation of State and Federal Jurisdictional Waters

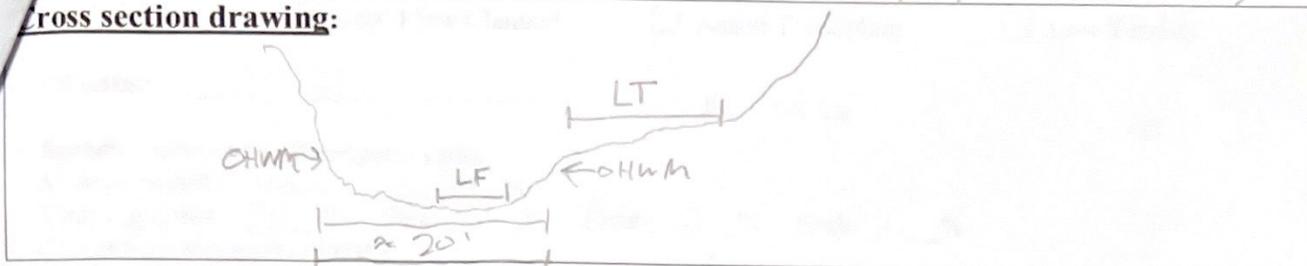
Project ID: Miss on Creek Cross section ID: Site/DS1 Date: 10/22/21 Time: 0933

Drift and debris noted deposited in low spots in channel, and above low flow. Clear bed and bank w/ low flow below a clear break in bank slope. Surface of bed defined by exposed rocks and cobbles and fine deposited sediments.

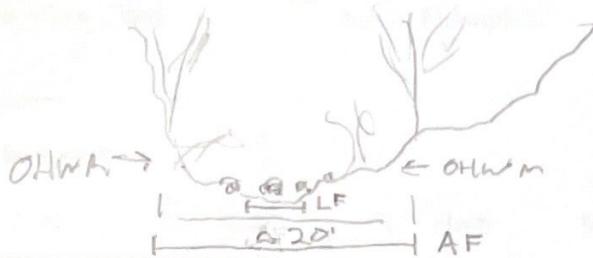
Project ID: Mission Creek Cross section ID: 5161/DS2 Date: 10/22/21 Time: 0954

presence of bed and bank w/ clear OHLWM. AF characterized by some drift / debris deposited overtop finer sediments than found in LF.

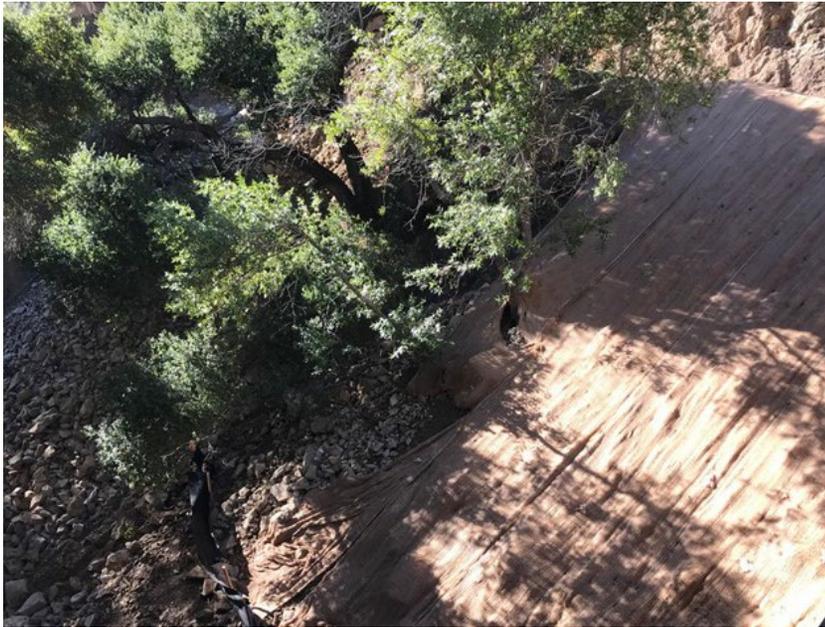
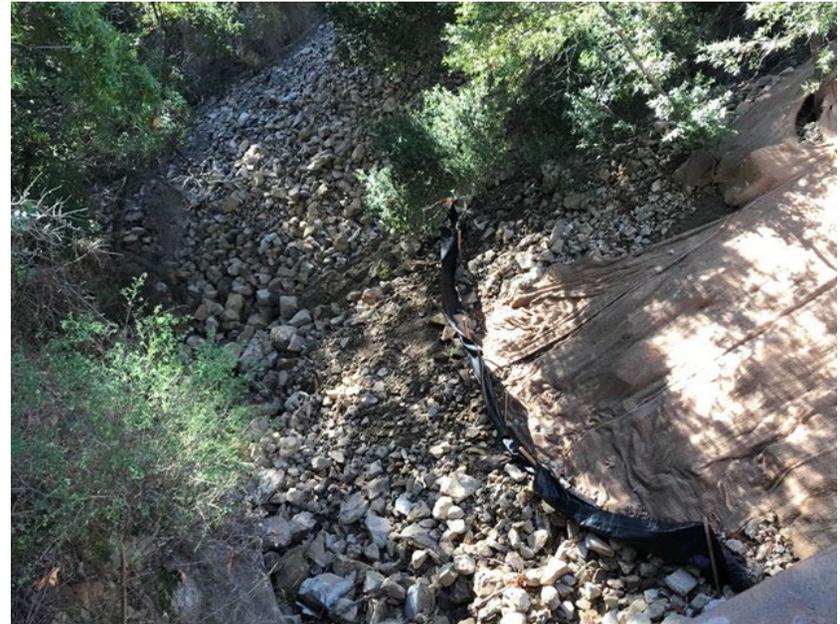
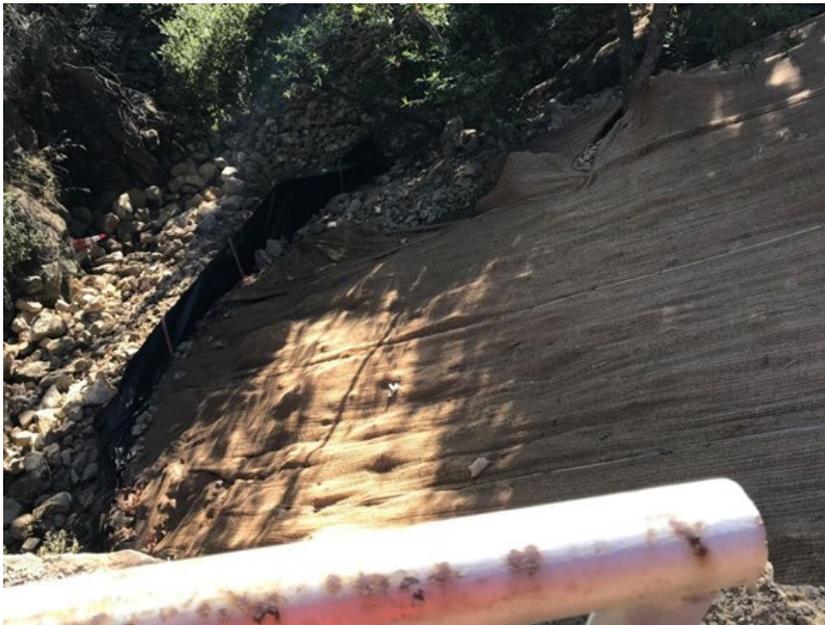
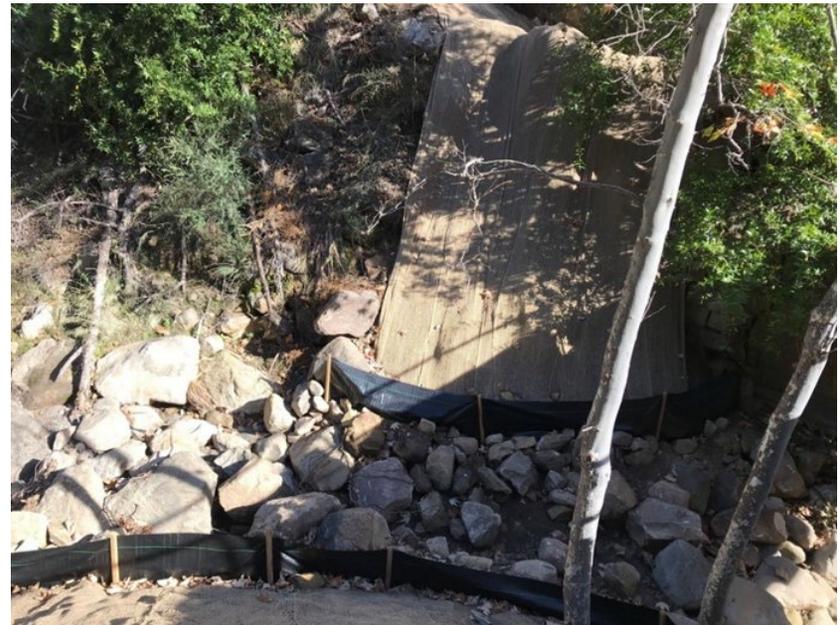
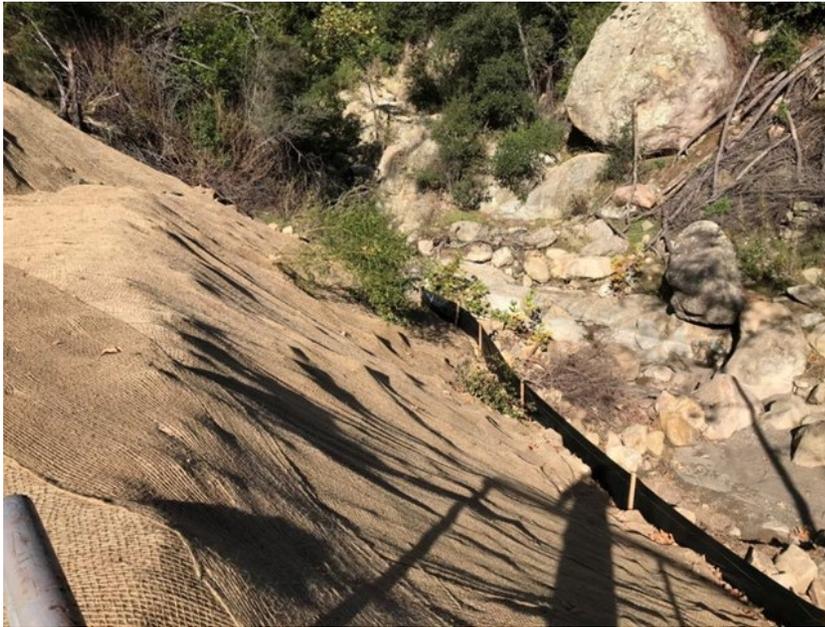
Photograph 1. Site 4 (Mission Creek) slope covered with jute netting and silt fencing installed at base of slope (January 3, 2020; aspect: south).

Photograph 2. Site 4 (Mission Creek) slope covered with jute netting and silt fencing installed at base of slope (January 3, 2020; aspect: south).

Photograph 3. Site 4 (Mission Creek) slope covered with jute netting and silt fencing installed at base of slope (January 3, 2020; aspect: south).

Photograph 4. Site 4 (Mission Creek) slopes covered with jute netting and silt fencing installed at base of slope (January 3, 2020; aspect east).

Photograph 5. Site 4 (Mission Creek) slope covered with jute netting and silt fencing installed at base of slope (January 3, 2020; aspect: north).

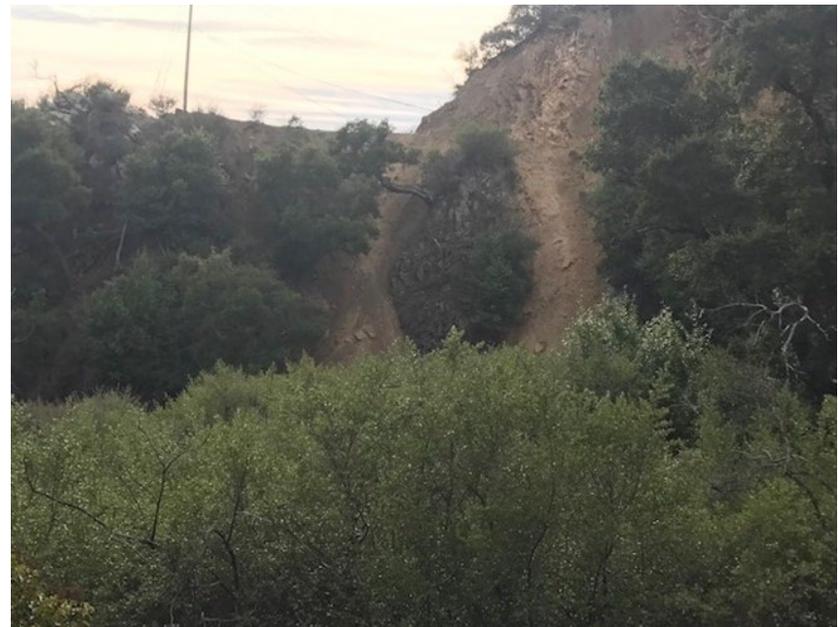
Photograph 6. Site 4 (Mission Creek). (January 3, 2020; aspect: west).

During the field surveys, portions of the Mission Creek drainage at Site 4 were observed to be filled with large rock and boulders from the debris spills generated by grading activities. Rock debris was also identified with drone imagery provided by Michael Baker International at Sites 2 and 5. In portions of the drainages that were not disturbed by excess debris, the drainages were generally unvegetated, with soil textures such as cobbles and boulders observed in the bed of the channel and rocky banks. The banks of the drainage were approximately 20 feet in height, and vegetation associated with the riparian corridor along the banks included mature trees species such as coast live oak (*Quercus agrifolia*), willow (*Salix* sp.), and California sycamore (*Platanus racemosa*). Shrub habitat outside the limits of jurisdictional areas was dominated by laurel sumac, bush mallow, and ceanothus. Similar conditions were observed at Sites 6 and 7, but no impacts occurred at these areas.

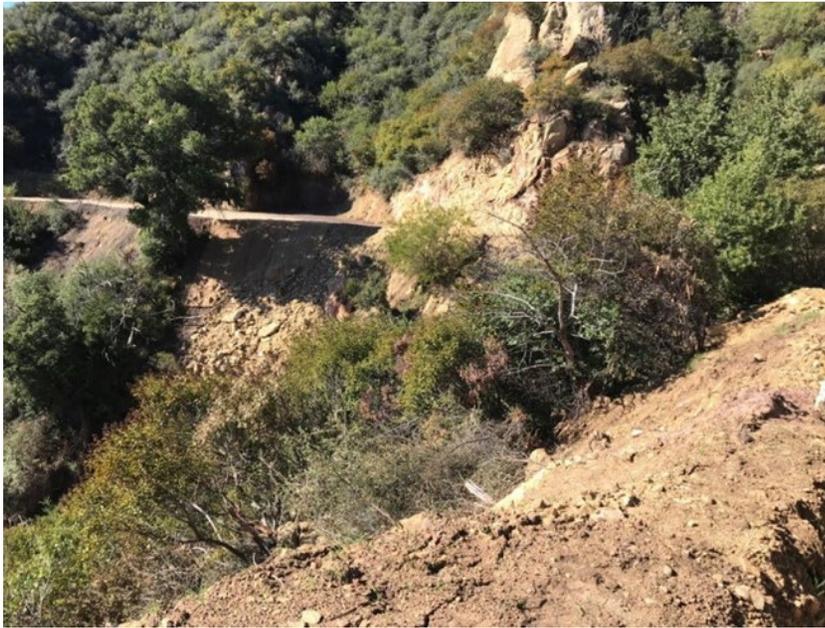
One area along another unnamed drainage, west of the Mission Creek mainstem, was identified where soil was observed spilling into potentially jurisdictional resources, specifically within CDFW/RWQCB jurisdiction. As depicted in Tables 3A and 3B, proposed temporary impacts to RWQCB/CDFW jurisdiction at Site 3 totals approximately 0.09 acre of sidecast removal (70.5 cubic yards) and 0.06 acre within the contingency disturbance buffer (225.0 cubic yards). The limits of the tributary were conservatively assumed to be equivalent to the jurisdictional stream and riparian habitat boundaries discussed below. No defined OWHM or channel was identified within the Study Area for this area, therefore no USACE jurisdiction was defined. Proposed impacts to Site 3 are depicted on Figure 4c.

Photograph 9. Site 3 showing side cast material off road, in foreground along Tunnel Trail. (January 3, 2020; aspect: west).

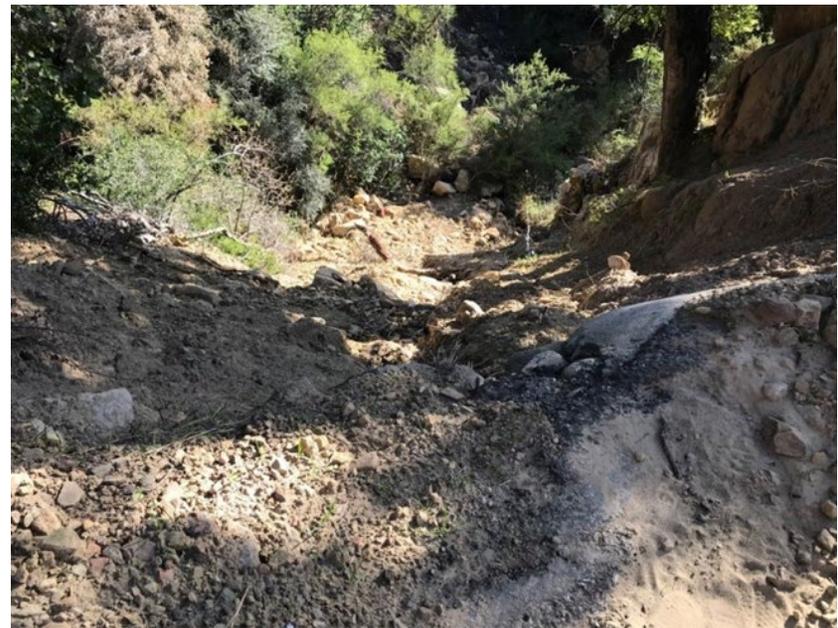
Photograph 10. Site 1, western bank (January 3, 2020; aspect: southeast).

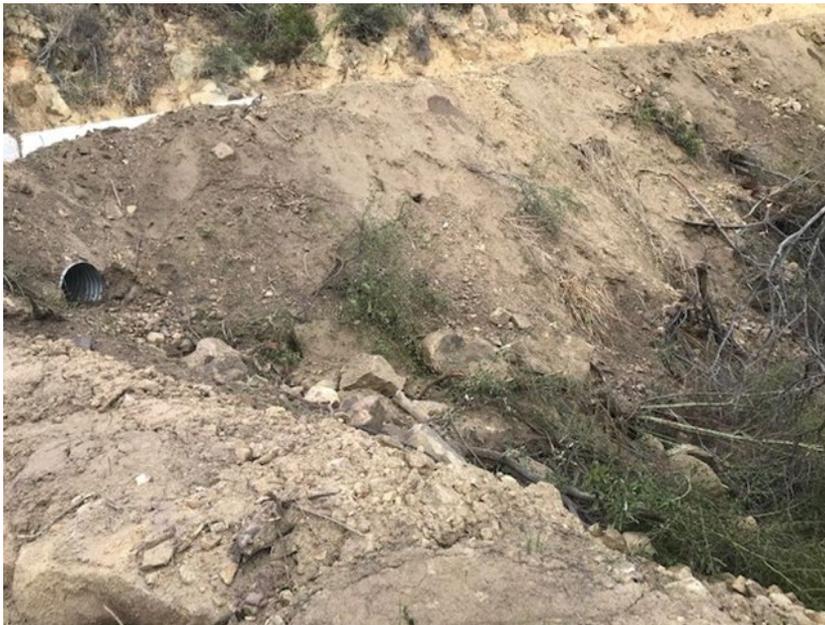
Photograph 11. Site 1. showing east and west bank, along Tunnel Trail (January 3, 2020; aspect: northeast).

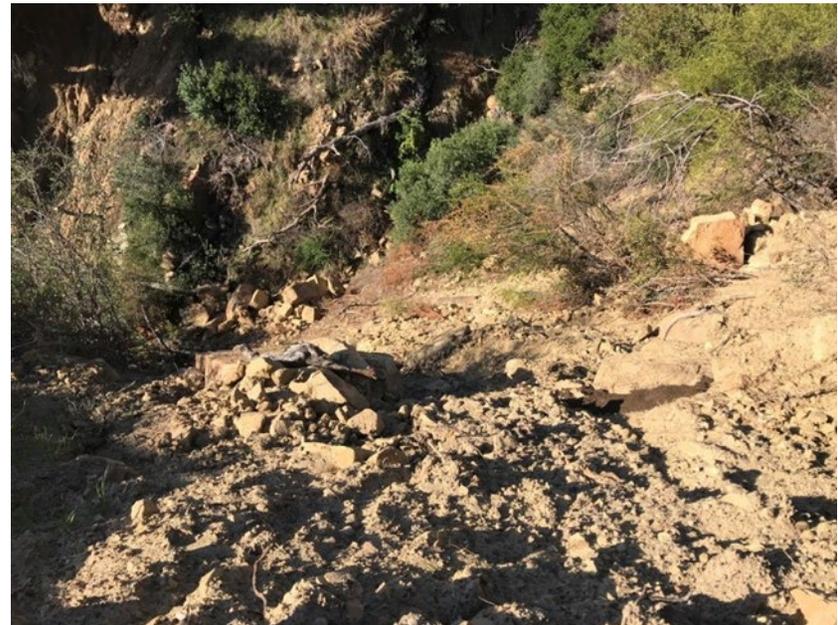
One area along an unnamed drainage, west of Mission Creek, was identified where soil was observed spilling into potentially jurisdictional resources. As depicted in Tables 3A and 3B, temporary impacts to USACE jurisdiction at Site 1 total to 0.002 acre of proposed sidecast removal and 0.01 acre within the contingency disturbance buffer (0.8 cubic yards). RWQCB/CDFW jurisdiction totals to 0.39 acre resulting from sidecast removal and 0.14 acre within the contingency disturbance buffer (184.9 cubic yards). Proposed impacts to Site 1 are depicted on Figure 4a.

Photograph 12. Site 1 (east bank) showing side cast material off road/trail, (January 3, 2020; aspect: west).

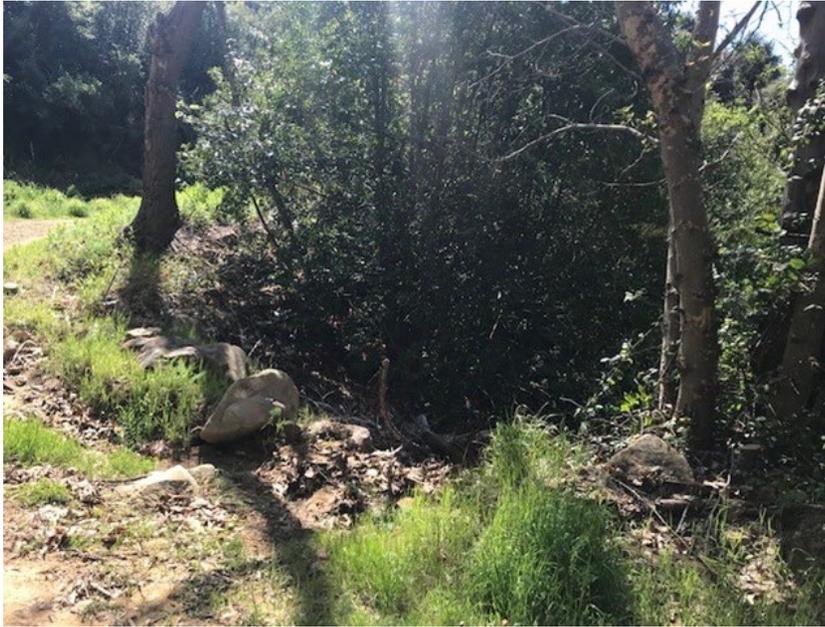
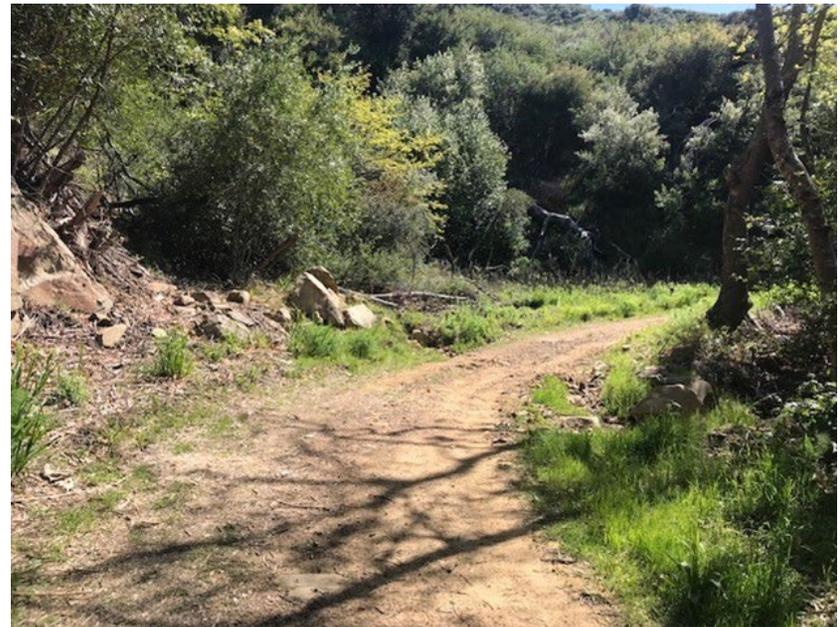
Photograph 13. Site 6, no impacts from road grading activities observed (March 27, 2020; aspect: south).

Photograph 14. Site 6, no impacts from road grading activities observed (March 27, 2020; aspect: east).

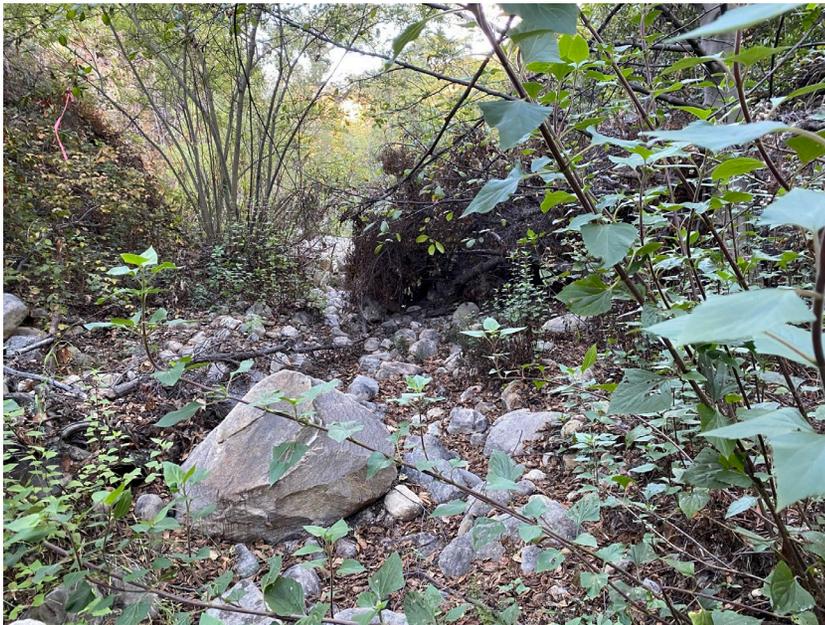
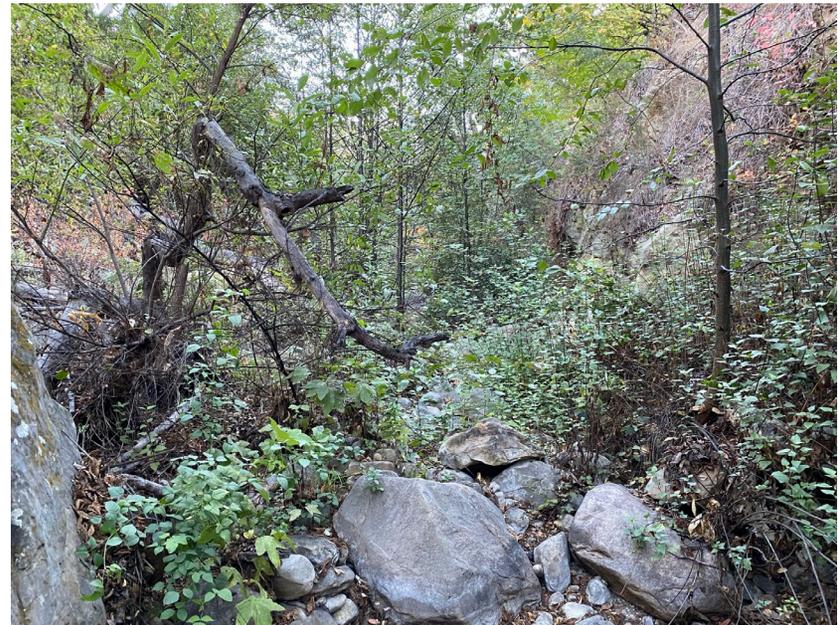
Photograph 19. Looking downstream in Mission Creek, immediately adjacent to Sidecast 3 Rock Outliers Area (October 22, 2021; aspect: southwest).

Photograph 20. Looking downstream in Mission Creek, immediately adjacent to Sidecast 3 Rock Outliers Area (October 22, 2021; aspect: northeast).

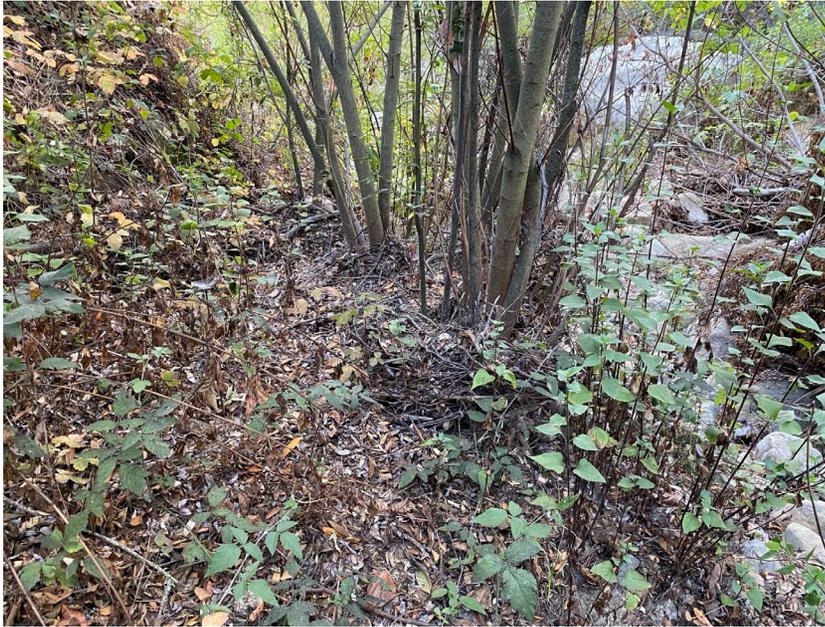
Photograph 21. Looking downstream in Mission Creek, adjacent to Sidecast 3 Rock Outliers Area. Photograph depicts wrack and debris along OHWM (October 22, 2021; aspect: southwest).

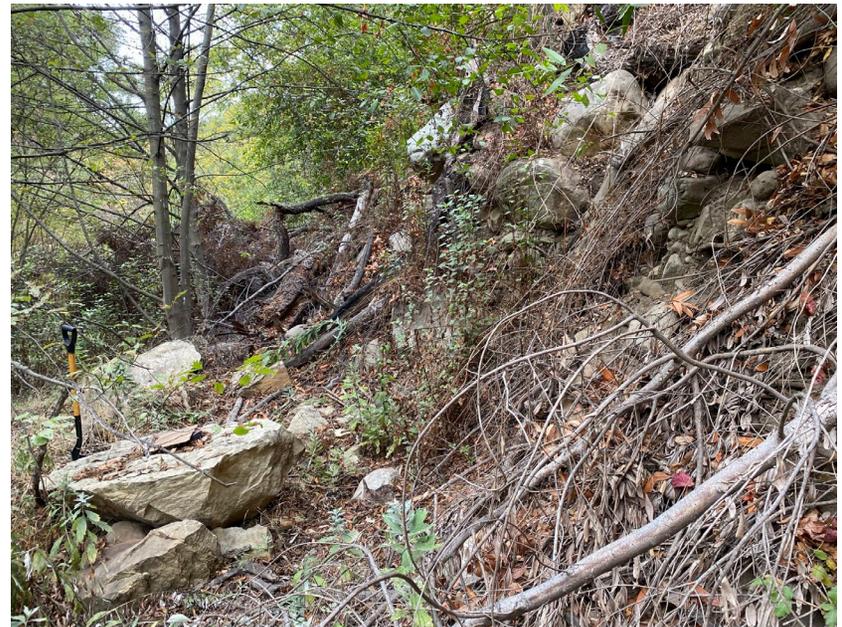
Photograph 22. Looking downstream in Sidecast 3 Rock Outliers Area, depicting rock outliers location (October 22, 2021; aspect: southwest).

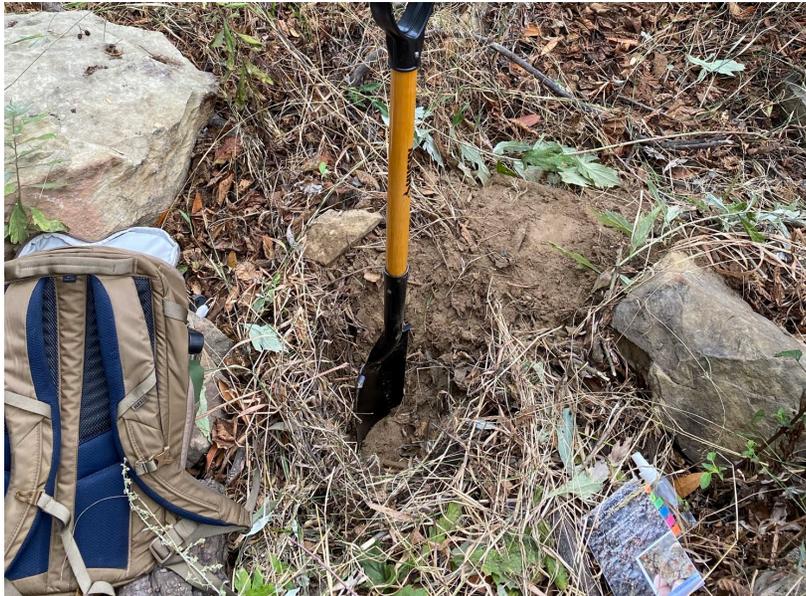
Remarks: No redox features or other hydric soils indicators observed. Consistent soil characteristics throughout profile. Soils appear to be well drained.

Photograph 27. Photograph depicts SP1, performed within USACE/RWQCB non-wetland woUS immediately adjacent to Sidecast 3 Rock Outliers area (October 22, 2021).
