MEMORANDUM

Subject: Golden Queen Mine Drainages

The purpose of this memo is to describe drainage features that were encountered during the delineation conducted by WRA on May 30 and 31st, 2018 within the proposed expanded permit boundary (Study Area; Appendix A, Figures 1-5). The delineation identified approximately 7.05 acres (55,188 linear feet) of ephemeral and intermittent drainages within the Study Area, similar to features originally reviewed by the California Department of Fish and Wildlife (CDFW) in 1996 when CDFW determined that a Streambed Alteration Agreement was not necessary for the project. The Study Area is adjacent to the current permit boundary which was previously analyzed in the EIR prepared by Kern County in 1997 and in the Supplemental EIR in 2010. Appendix B includes photos of a subset of drainages that were mapped throughout the Study Area in 2018.

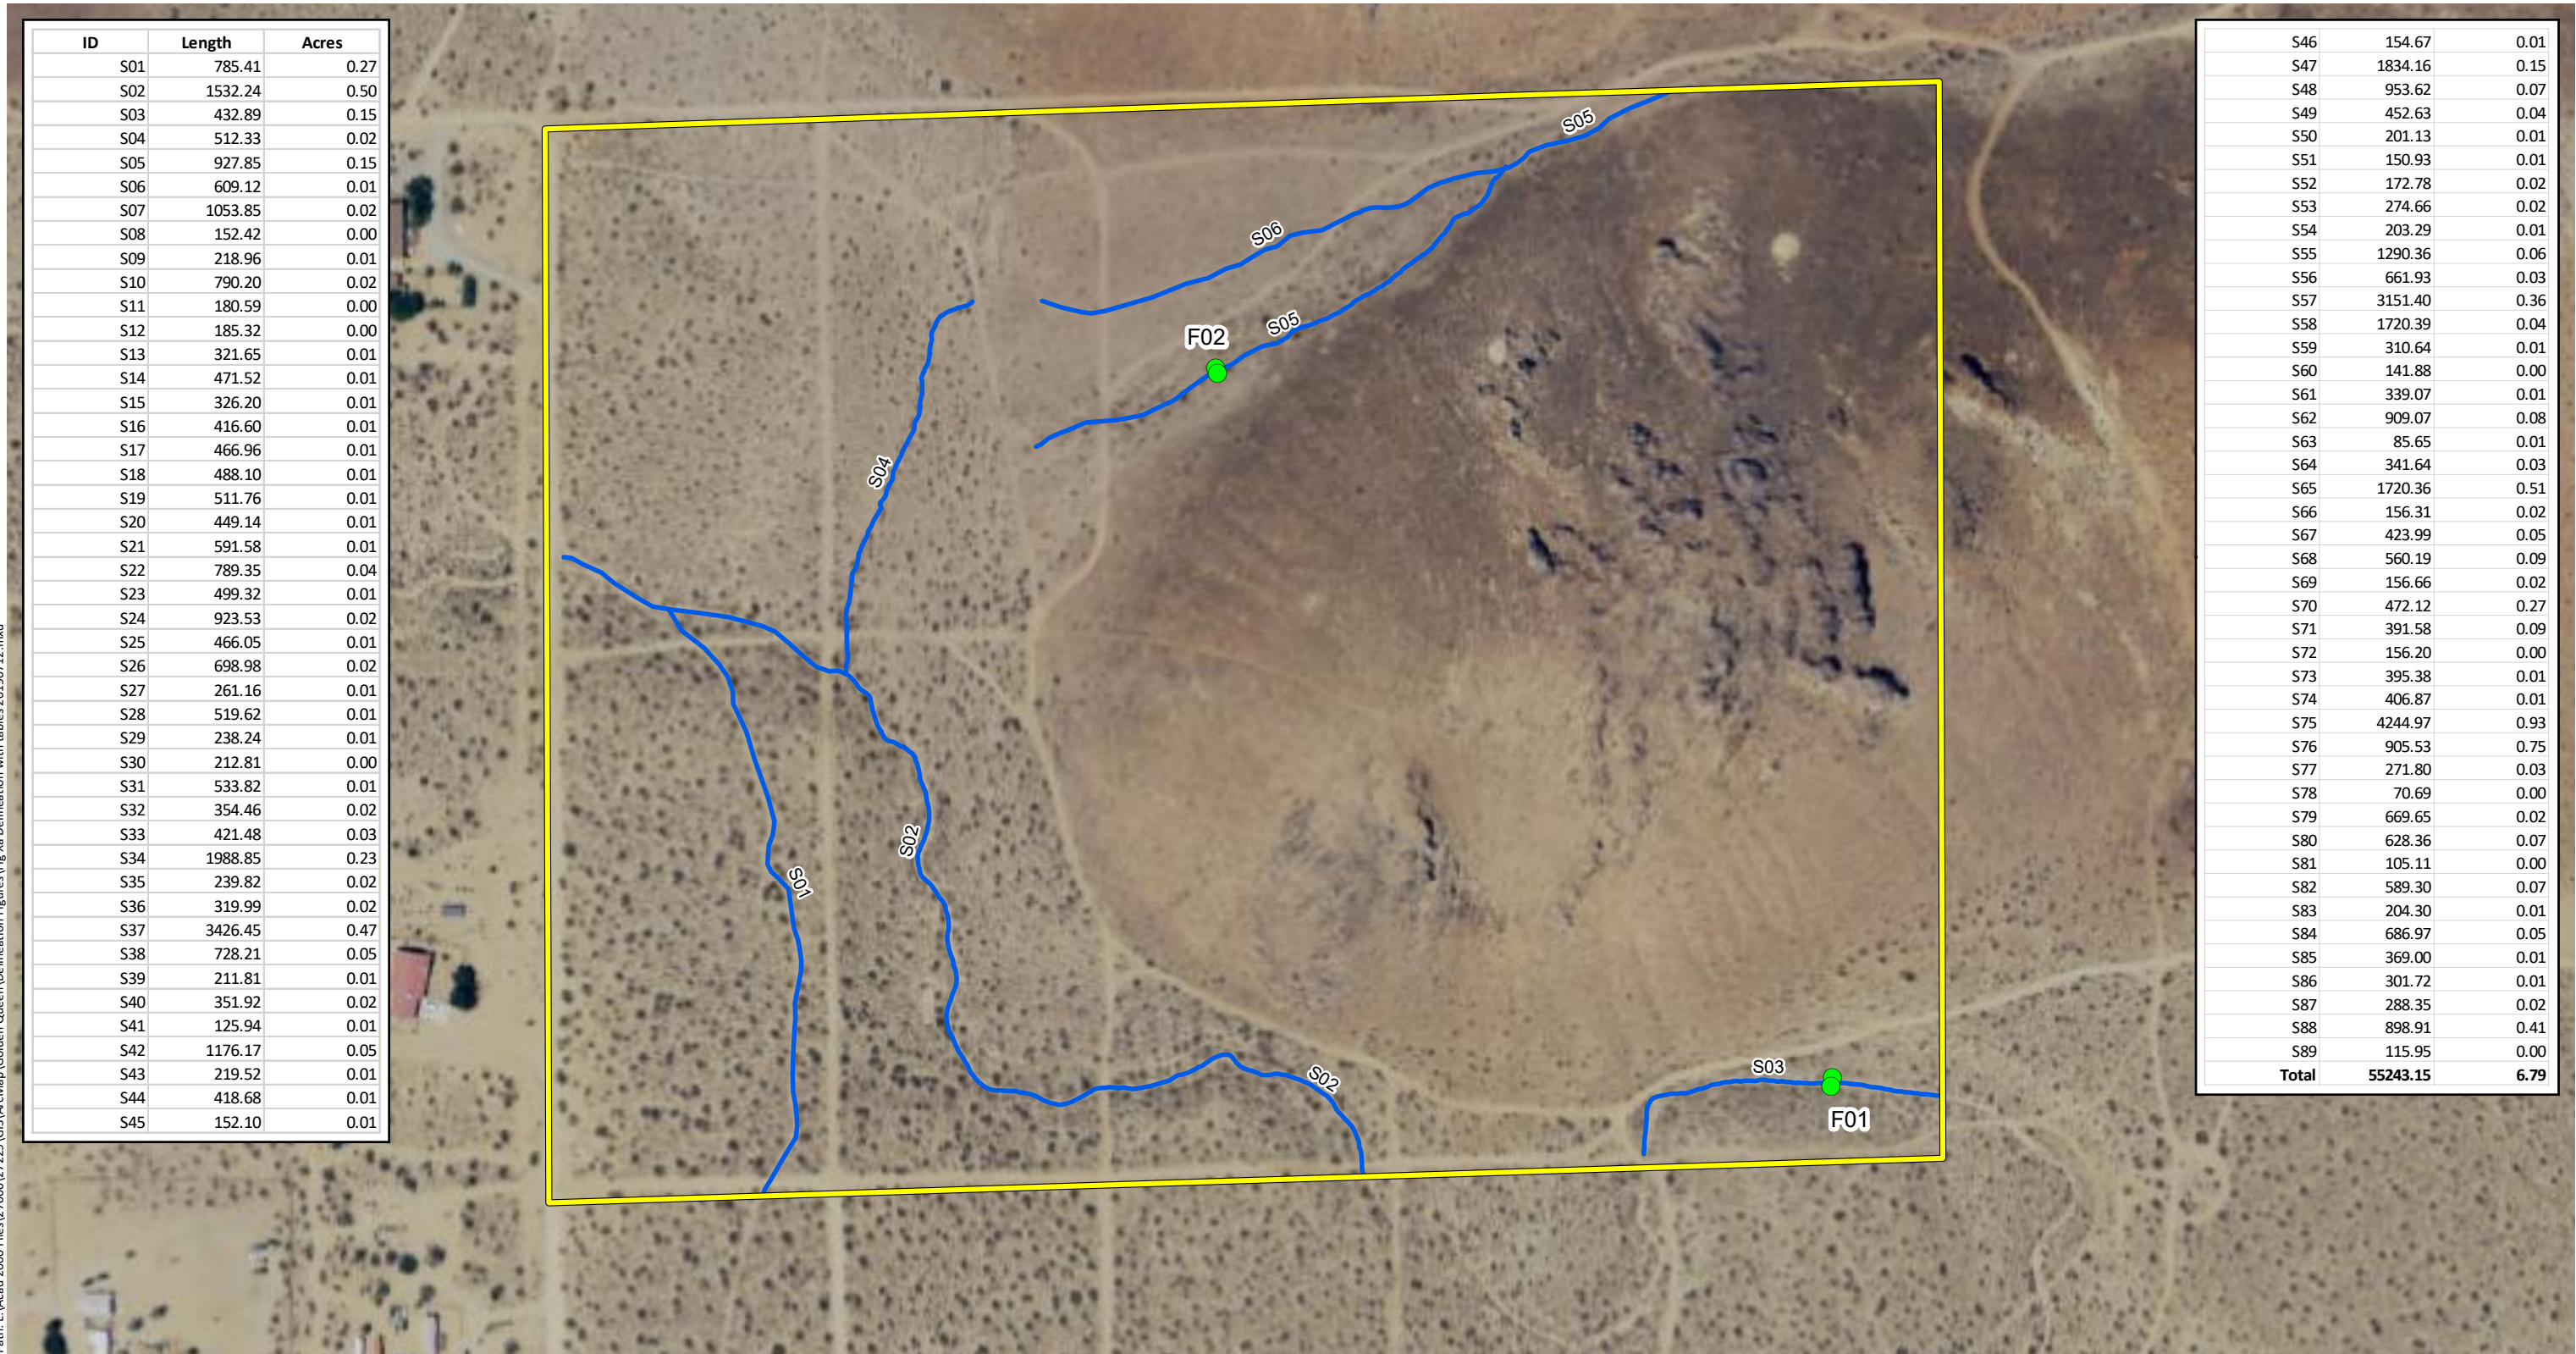
Figure 1. Potential Jurisdictional Waters

Golden Queen Mine
Kern County, California

Drainage Features Analyzed in 2018
-

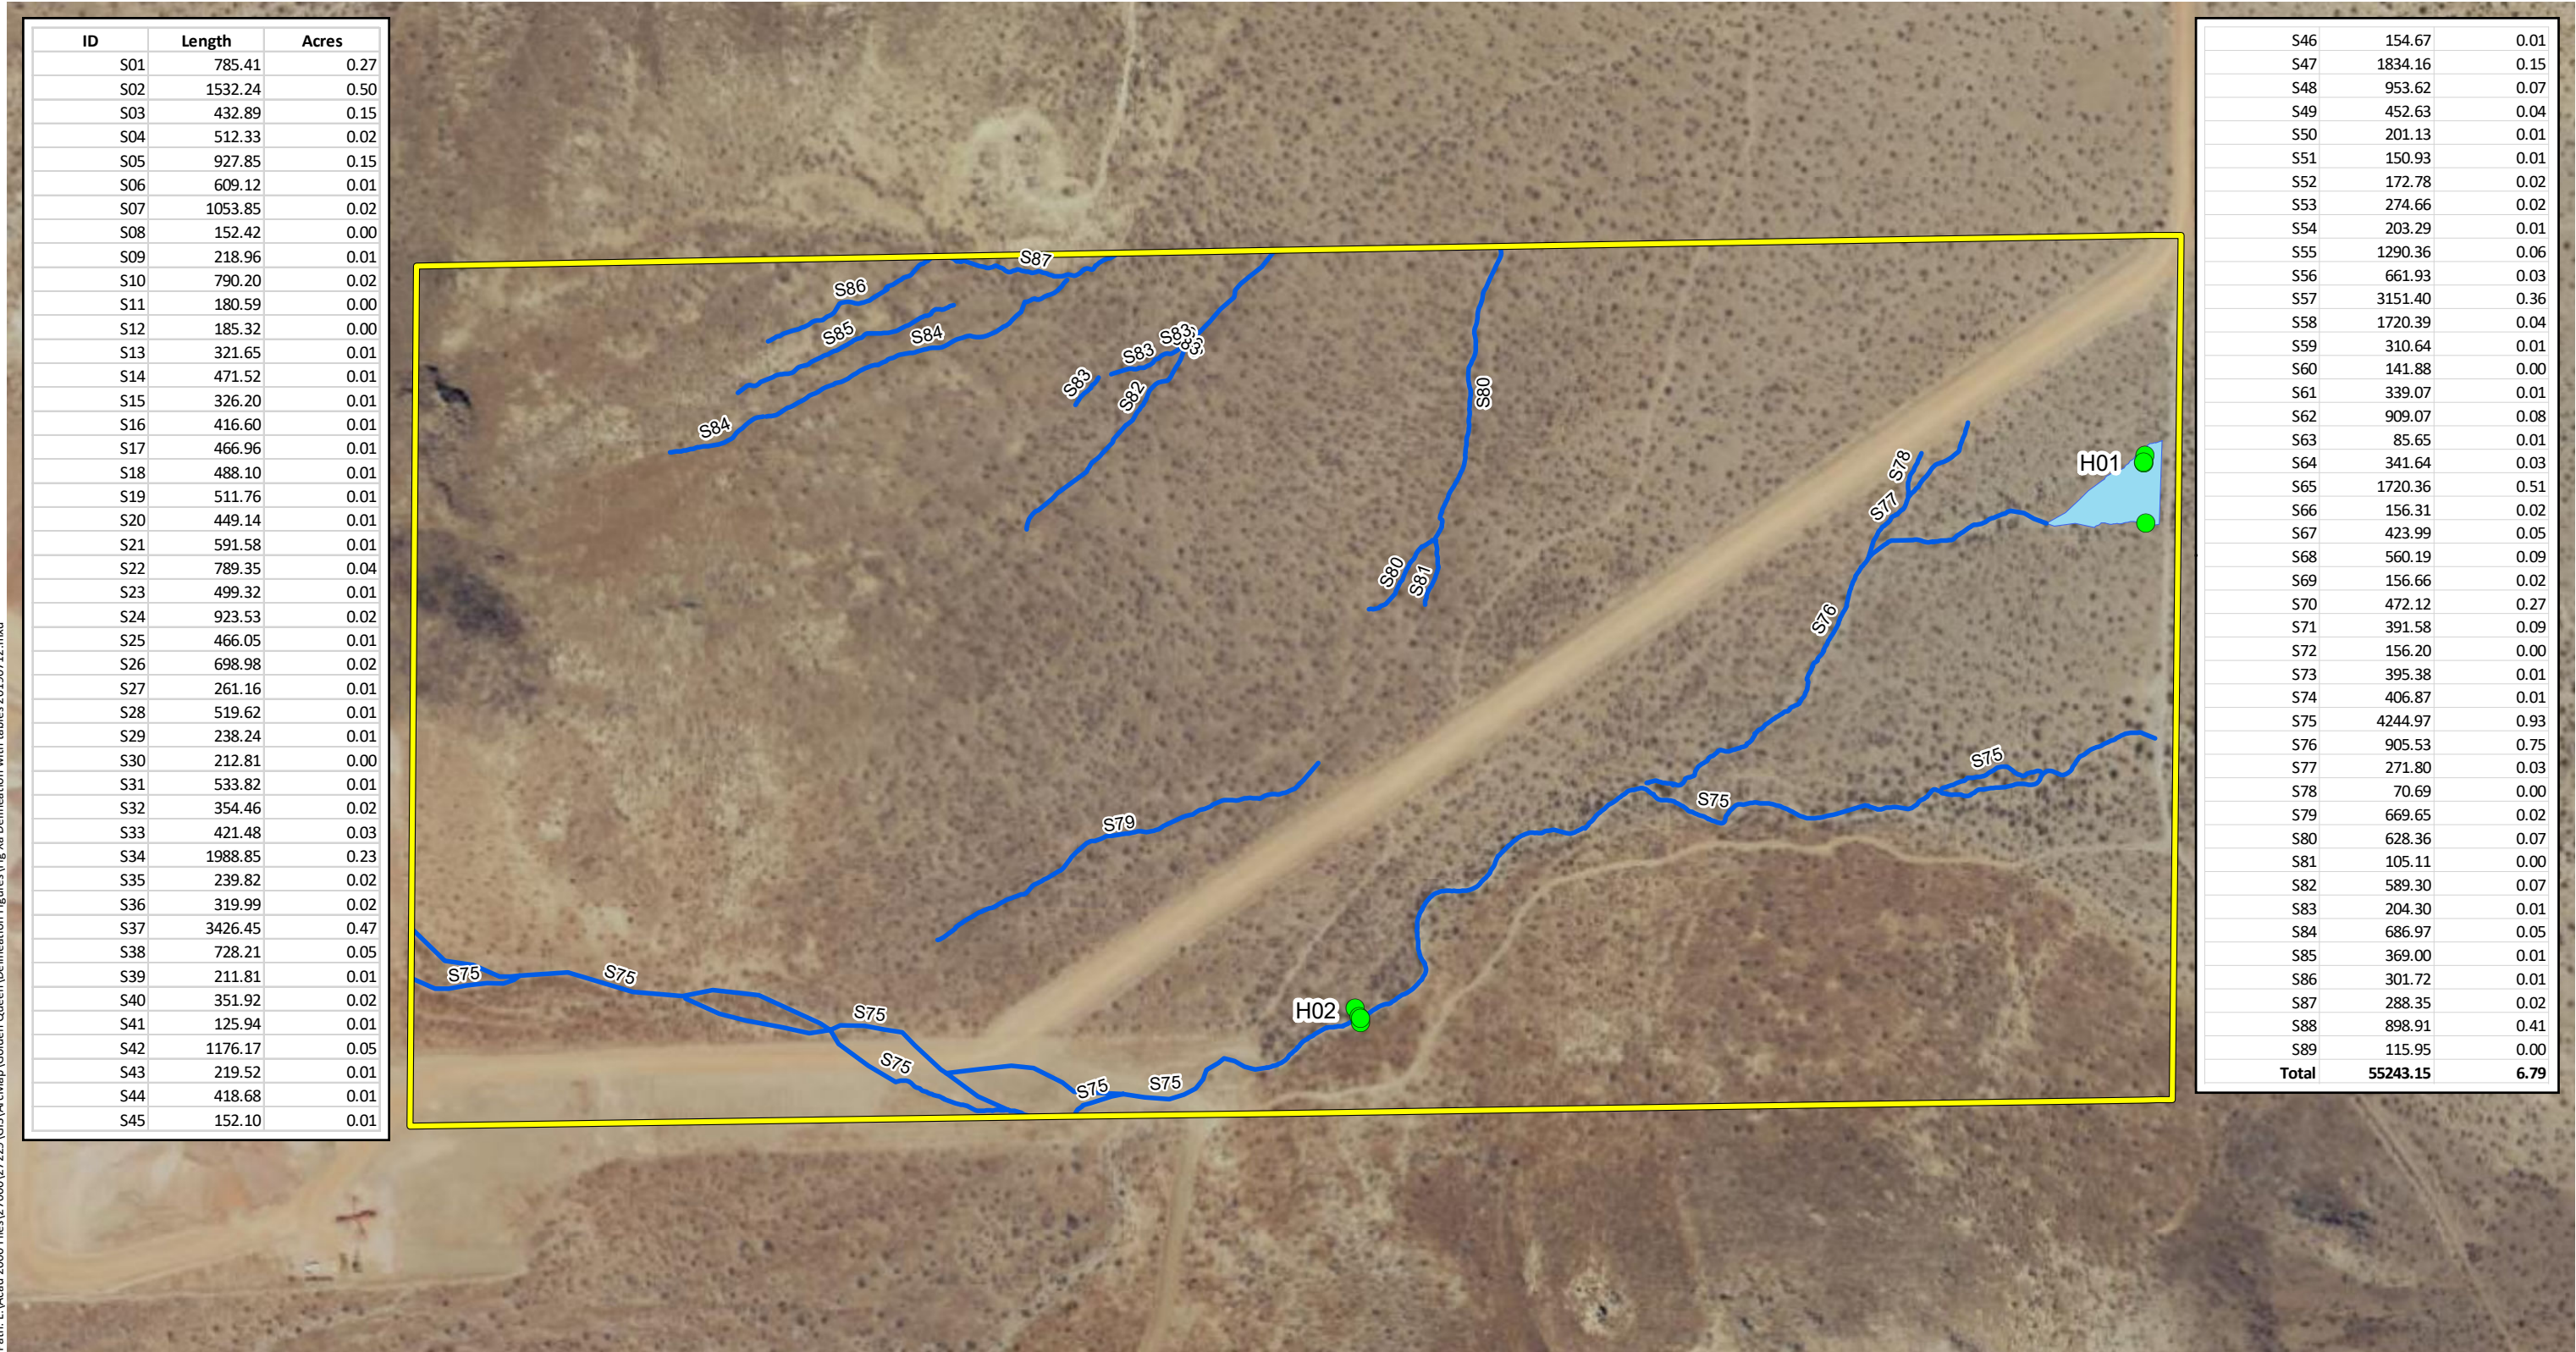
Figure 4. Potential Jurisdictional Waters

- Study Area
- Drainage Features Analyzed in 2018
- Drainage Features Analyzed in 2018
- Cross Section

vegetation growing within the drainage at higher elevations. Farther downstream, this drainage had a more well-developed bed and bank topography and well sorted bed material. Feature S75 originated from within the current permit boundary, and continued through the Study Area (Figure 4, Photographs 9-10). This feature exhibited similar characteristics along the length of the drainage and runs through both the current permit boundary and new study area. Similarly, feature S88 runs through both the current permit boundary and new Study Area and was the same along the length of the drainage (Figure 5, Photographs 7-8). Feature S85 is a steep, narrow, ephemeral drainage that extends through both the current permit boundary and Study Area (Figure 3, Photograph 18). The geomorphic characteristics of this channel are similar to those of other natural drainage areas that were mapped within the Study Area and were originally analyzed in the EIR for the current permit boundary.

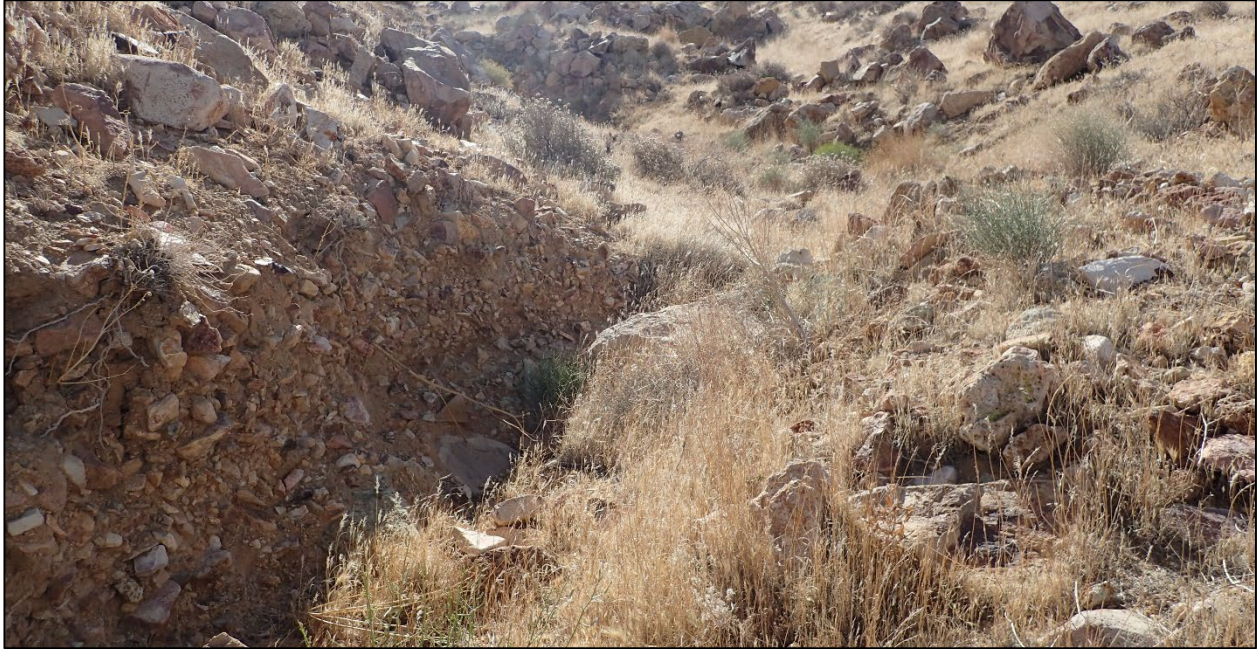
Photograph 1. Feature S52 along channel (northeast of Site E02) at the border of the new and current permit boundary, facing the current permit boundary Reference for Photograph 2 of the same channel in the Study Area. Photo taken May 31, 2018.

Natural drainage areas delineated in 1996 within the current permit boundary exhibited the same characteristics as those delineated in 2018 within the Study Area, and WRA observed many features that were continuous between the Study Area and the current permit boundary. Feature S52 originates from within the current permit boundary and extends into the Study Area (Figure 2, Photographs 1-2). This feature was steep-sided, with poorly sorted bed material, and

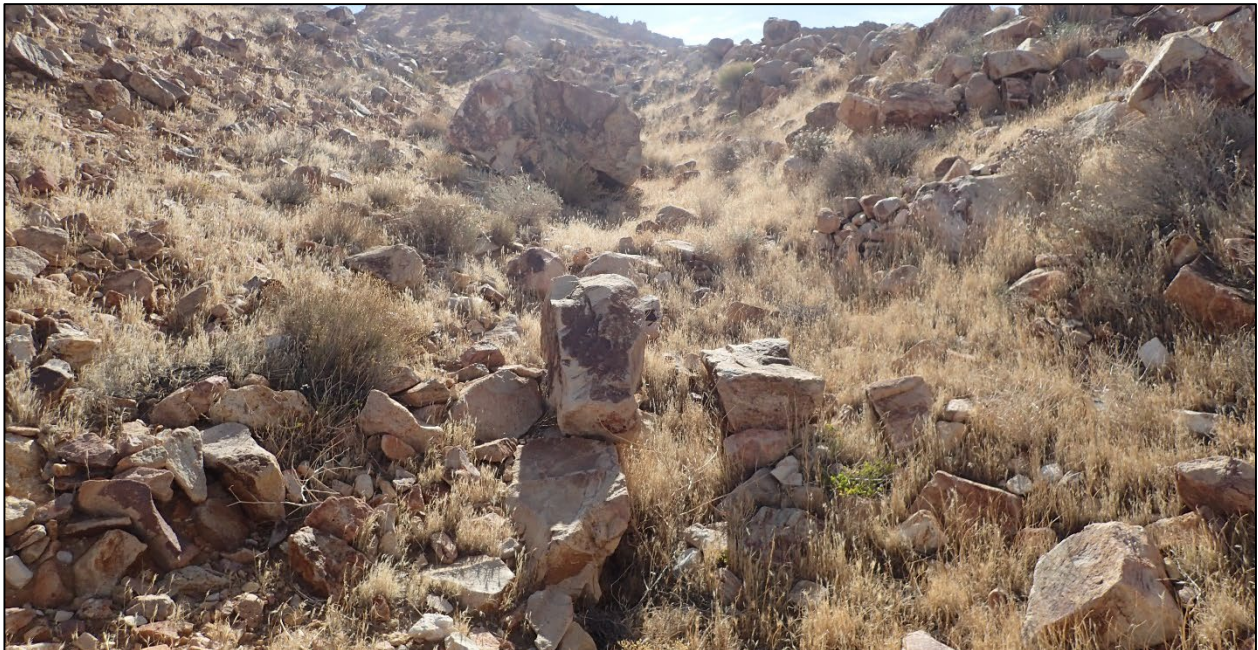
Photograph 2. Feature along channel (northeast of Site E02) in the Study Area, taken near Photograph 1. Photo taken May 31, 2018.

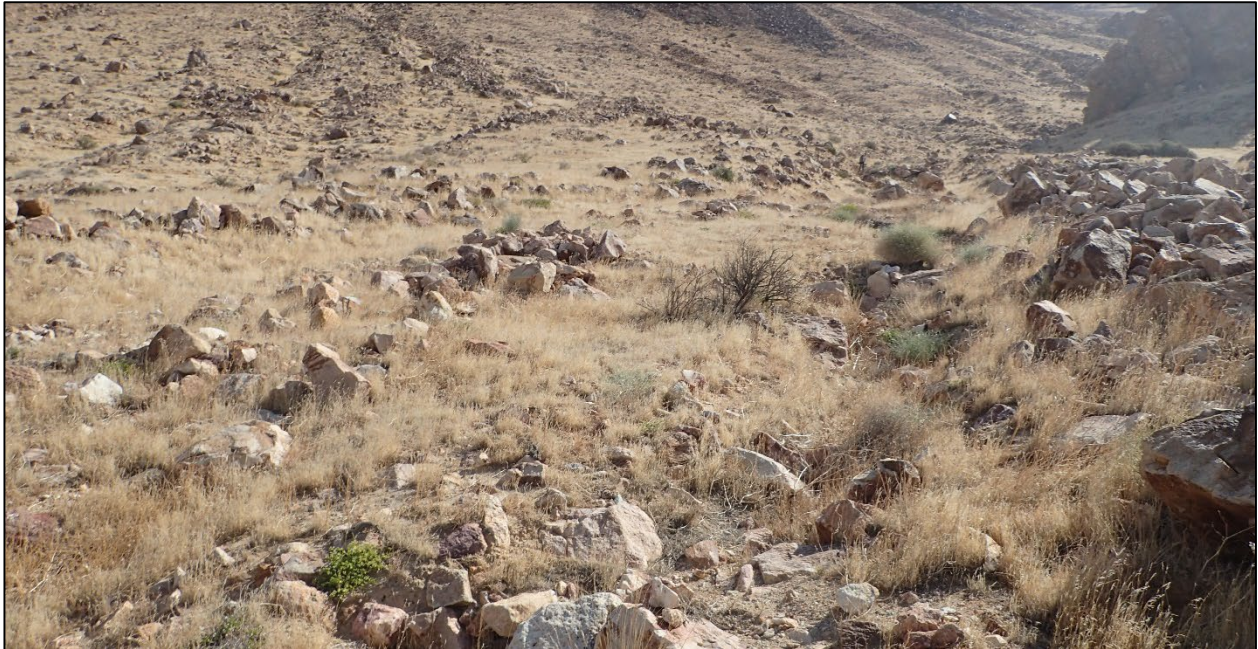
Photograph 3. Feature in current permit boundary (southeast of Site E02) at the border of the new and current permit boundary. Feature adjacent to Photograph 4 in the new project boundary. Photo taken May 31, 2018.

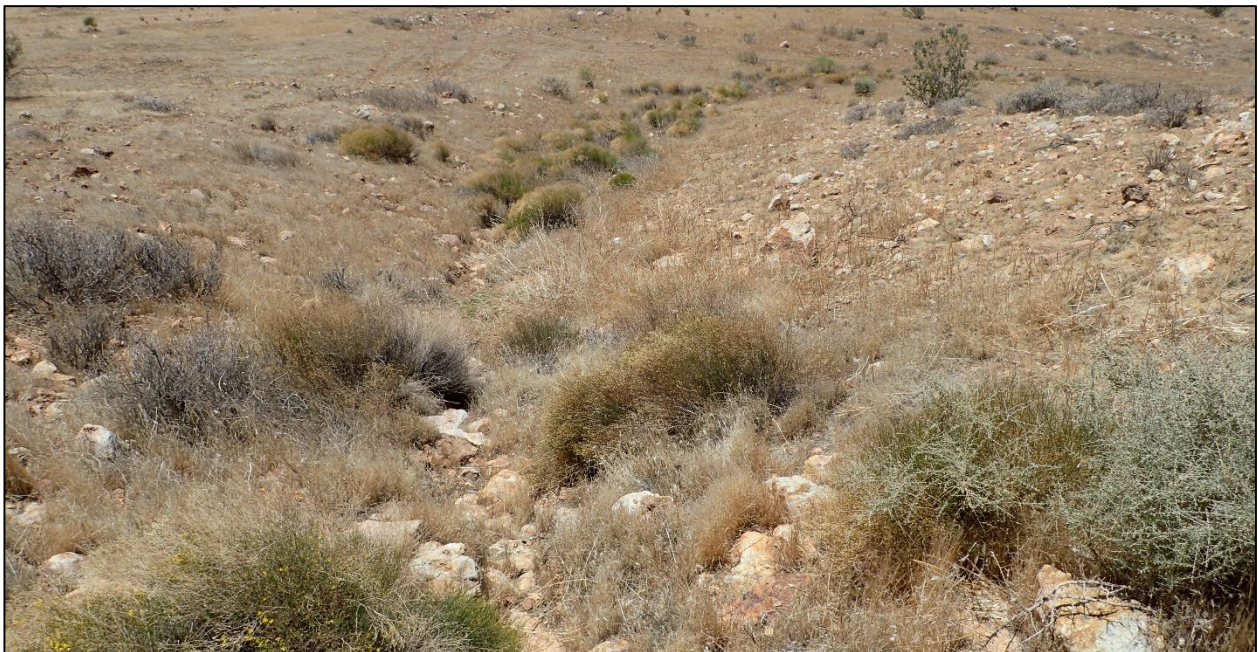
Photograph 4. Feature S44 in Study Area (southeast of Site E02) at the border of the new and current permit boundary. Photo taken May 31, 2008.

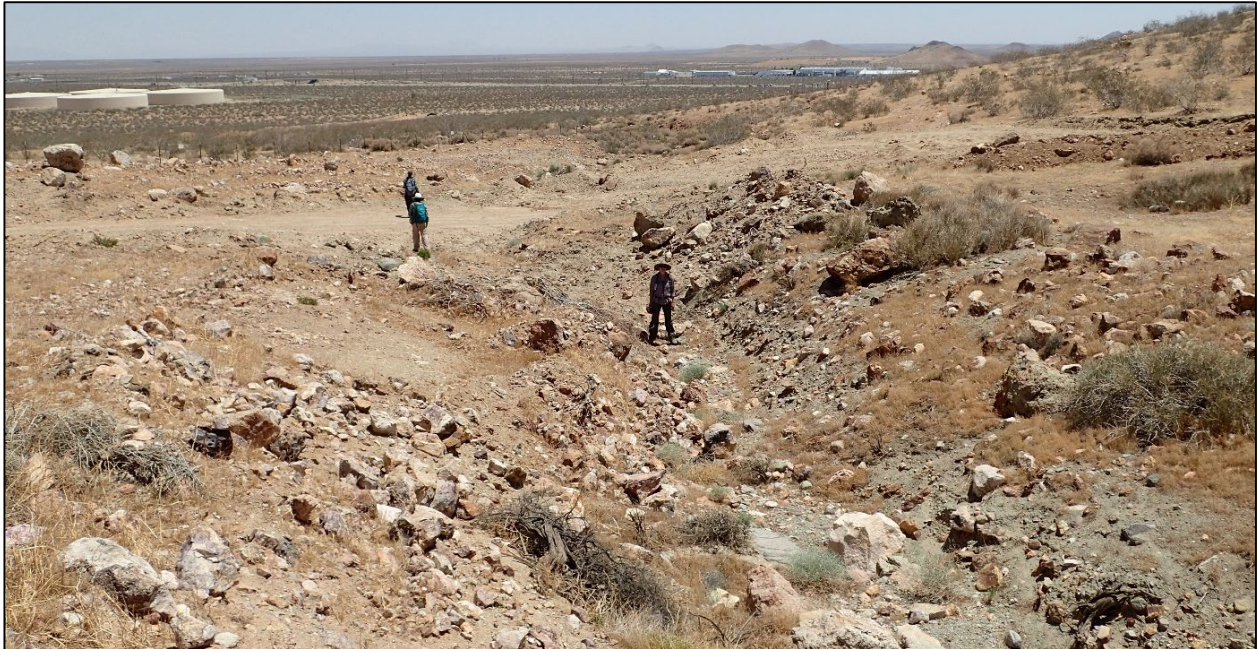
Photograph 5. Feature in current permit boundary at the border of the new and current permit boundary. Reference for Photograph 6, which was taken along the same channel northeast at Site H02. Photo taken May 30, 2018.

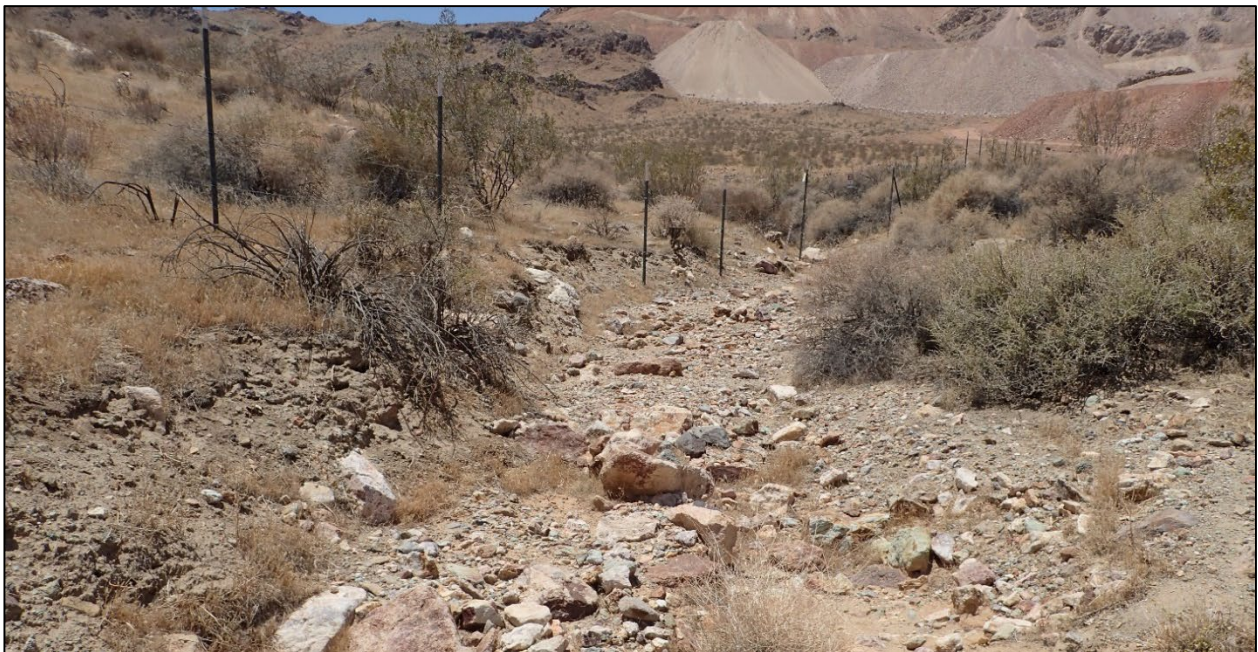
Photograph 6. Site H02 (upper fan of incised channel) in Study Area. Photo taken May 30, 2018.

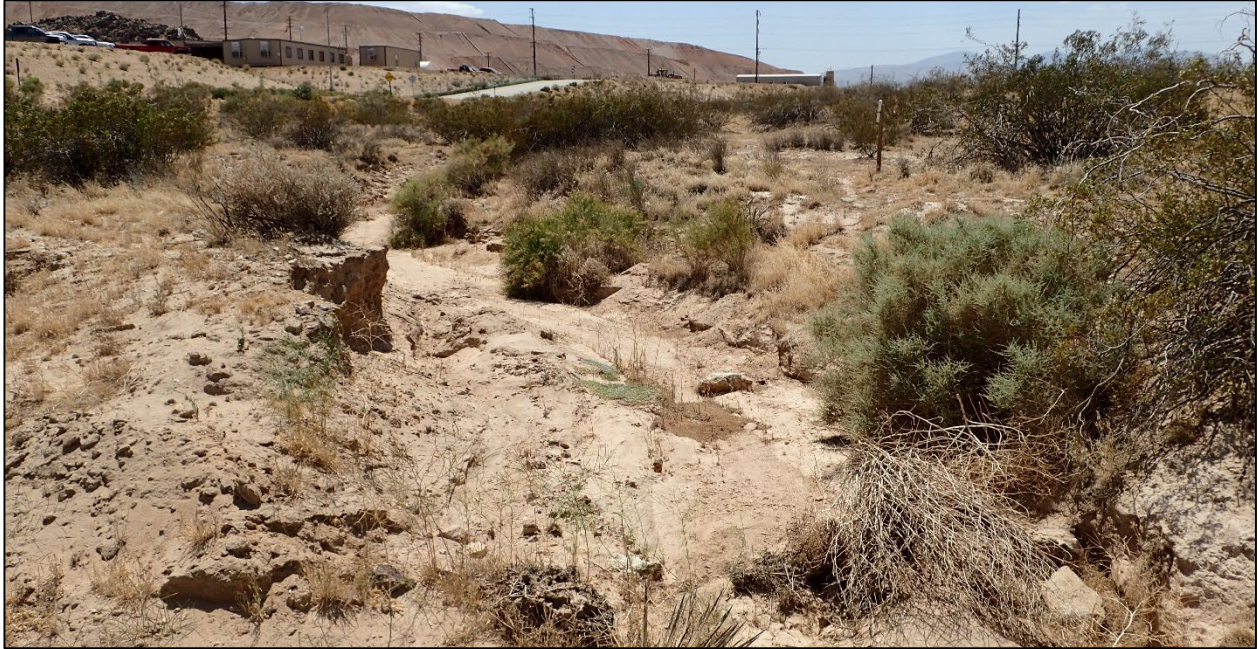
Photograph 7. South of Silver Queen Road roughly 0.1 miles east of Holt Street, within the current permit boundary. Feature continues in Photograph 8, which is the new project boundary. Photo taken May 30, 2018.

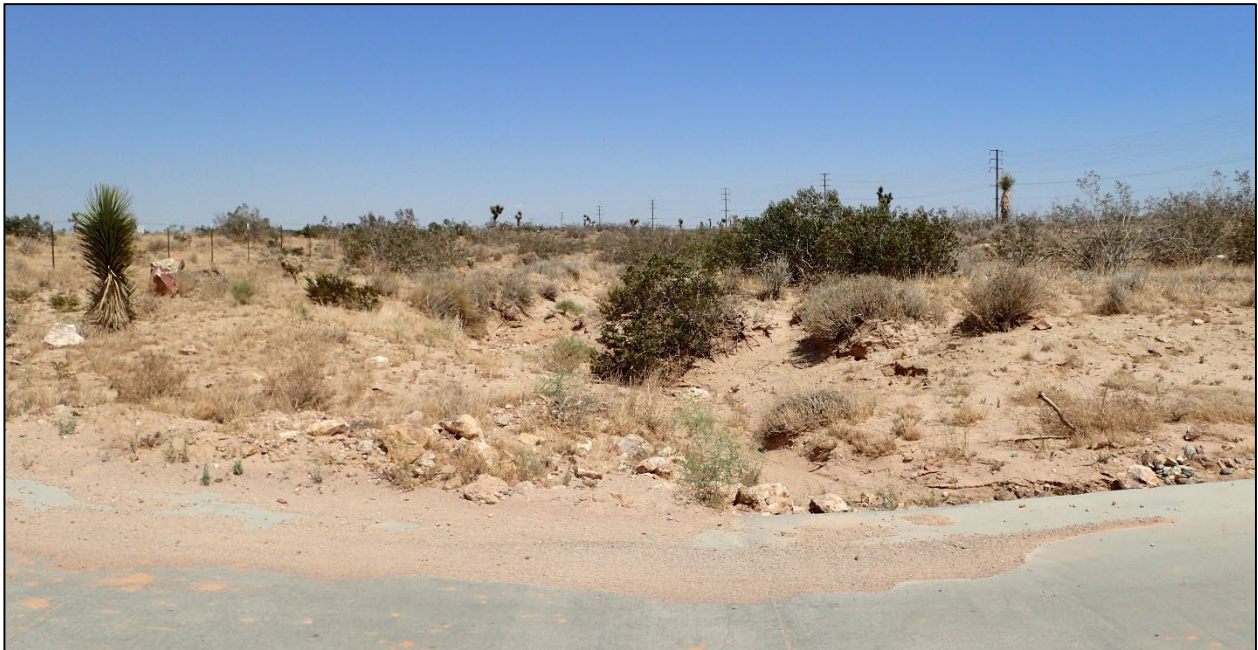
Photograph 8. Feature S88 and creosote scrub in Study Area. Photo taken May 30, 2018.

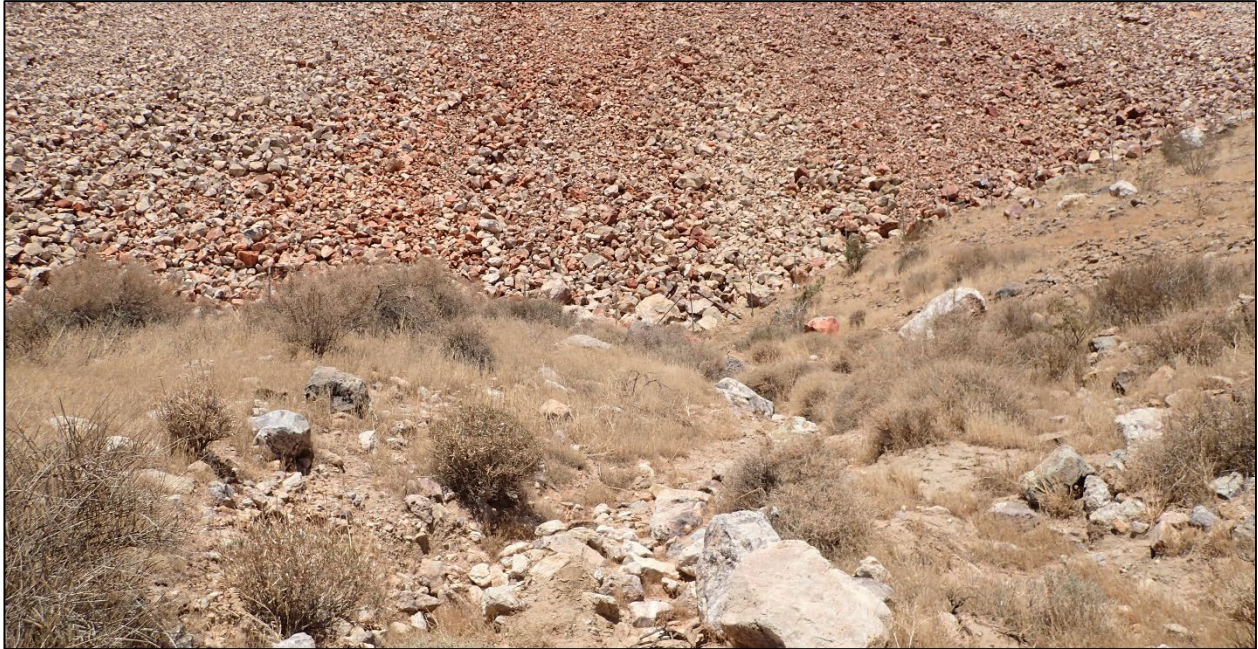
Photograph 9. Feature S75 that originates from within the existing permit boundary and continues downstream (below) into the eastern portion of the Study Area.

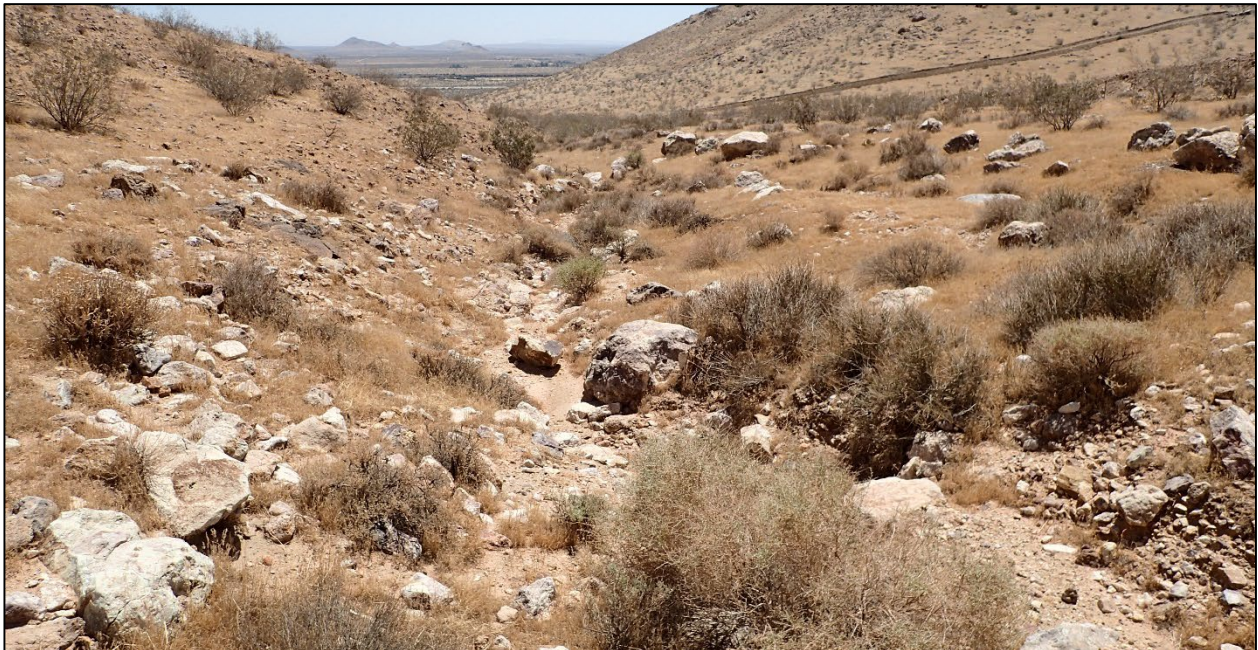
Photograph 10. Feature S75 located in the eastern portion of the Study Area.

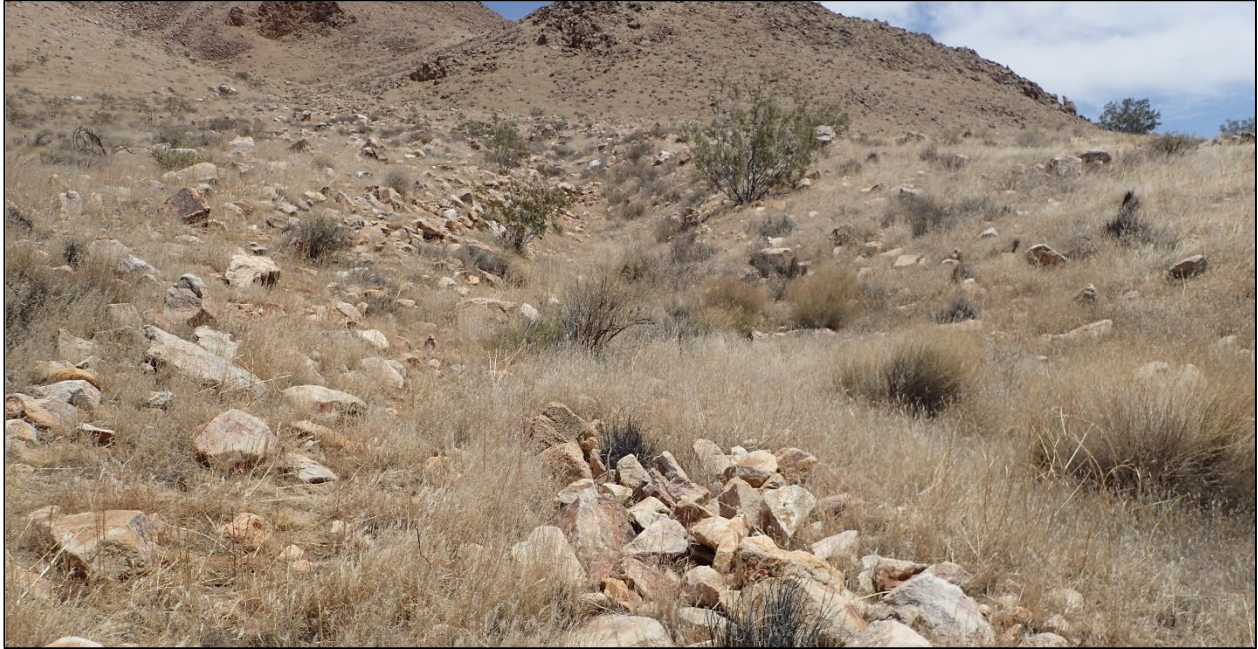
Photograph 11. Features S58 located on the southeastern edge of the Study Area. This feature originates from within the current permit boundary.

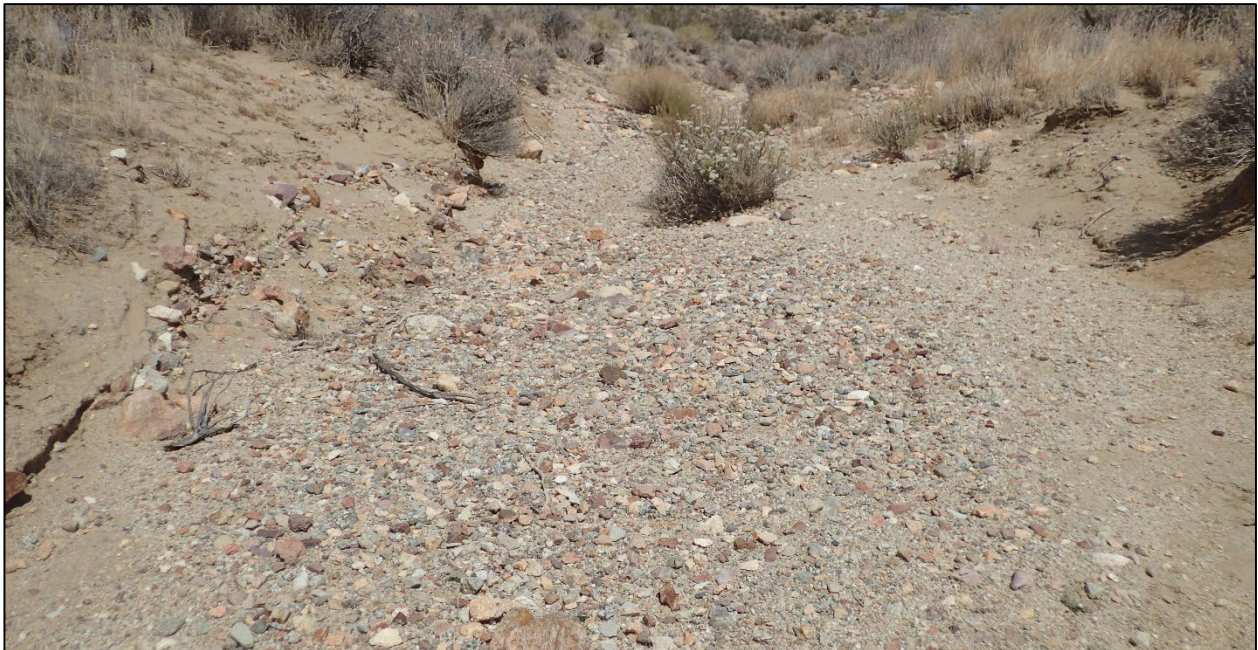
Photograph 12. Feature located in current permit boundary near 40th Street West and unnamed dirt road. Photo taken May 30, 2018.

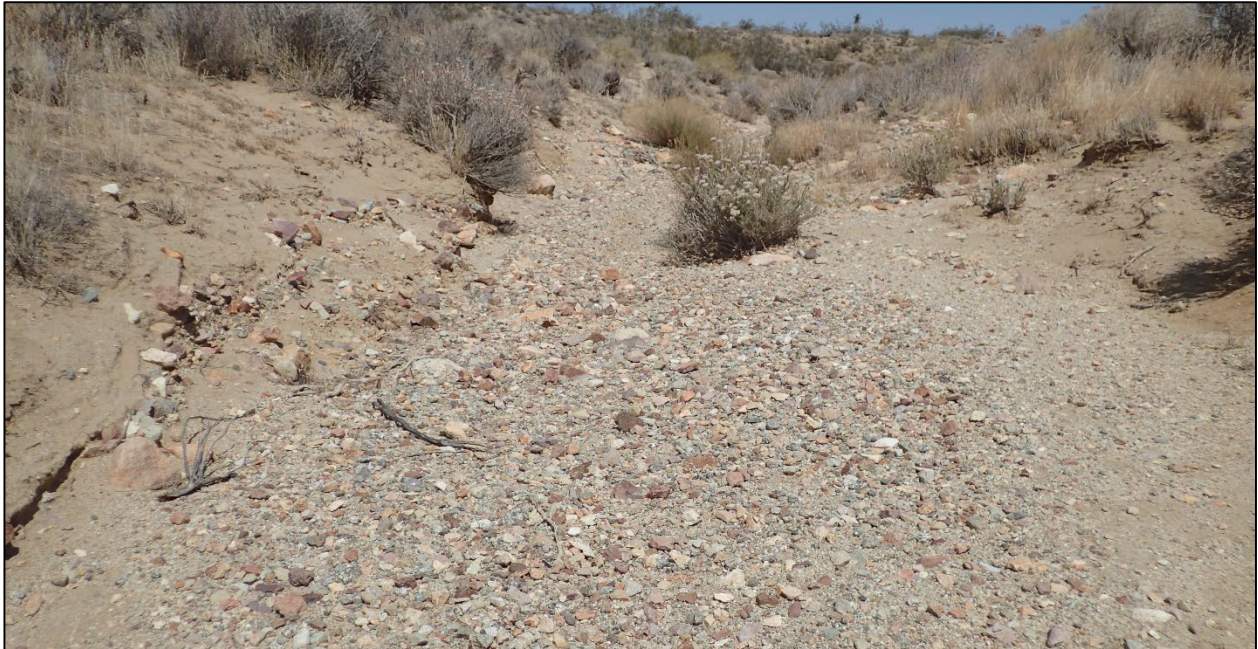
Photograph 13. Site F01 (dry wash in creosote/Joshua tree woodland). Photograph taken May 30, 2018.

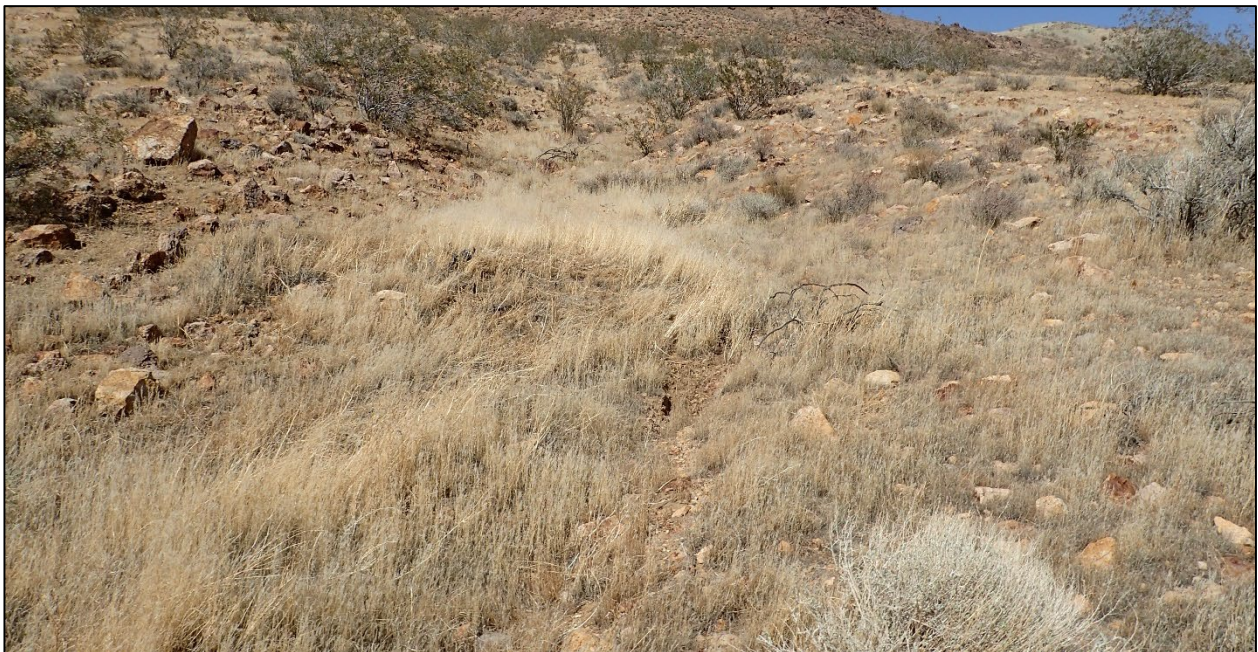
Photograph 14. Site F02 (creosote scrub with annuals, single thread runs parallel to base of hill), facing upstream. Photograph taken May 30, 2018.

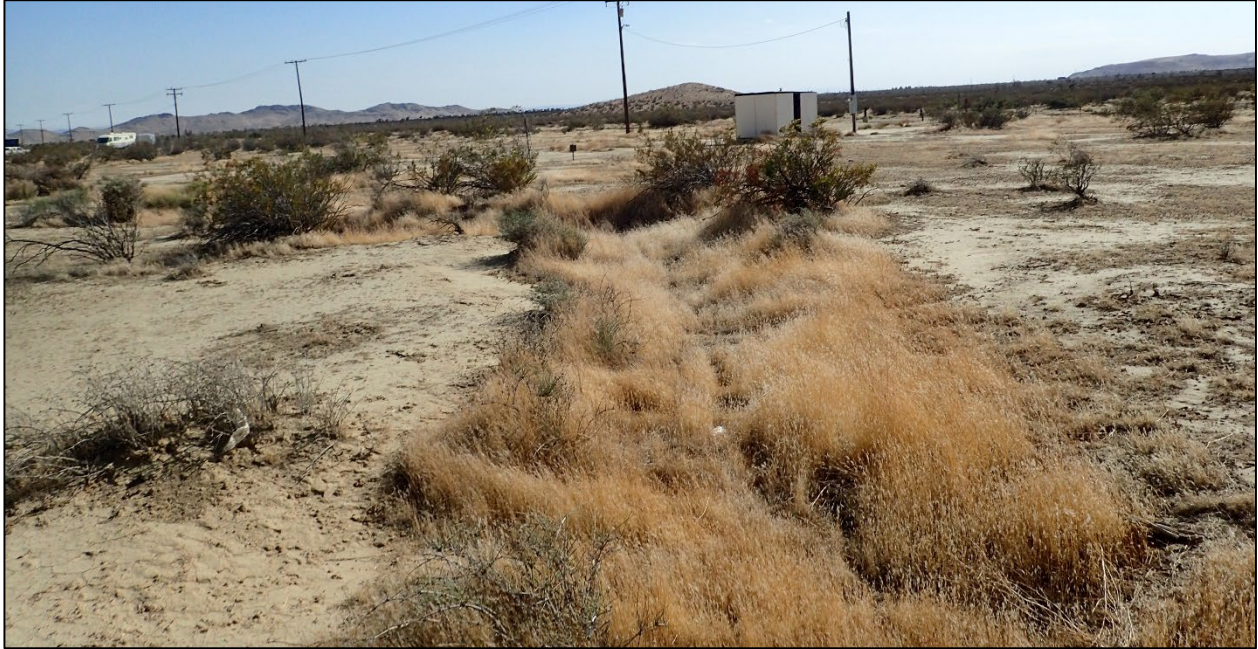
Photograph 15. Features S62 north of Site D01 (loamy-sandy, flat plain west of alluvial fan on west side of Soledad Mountain). Photograph taken May 30, 2018.

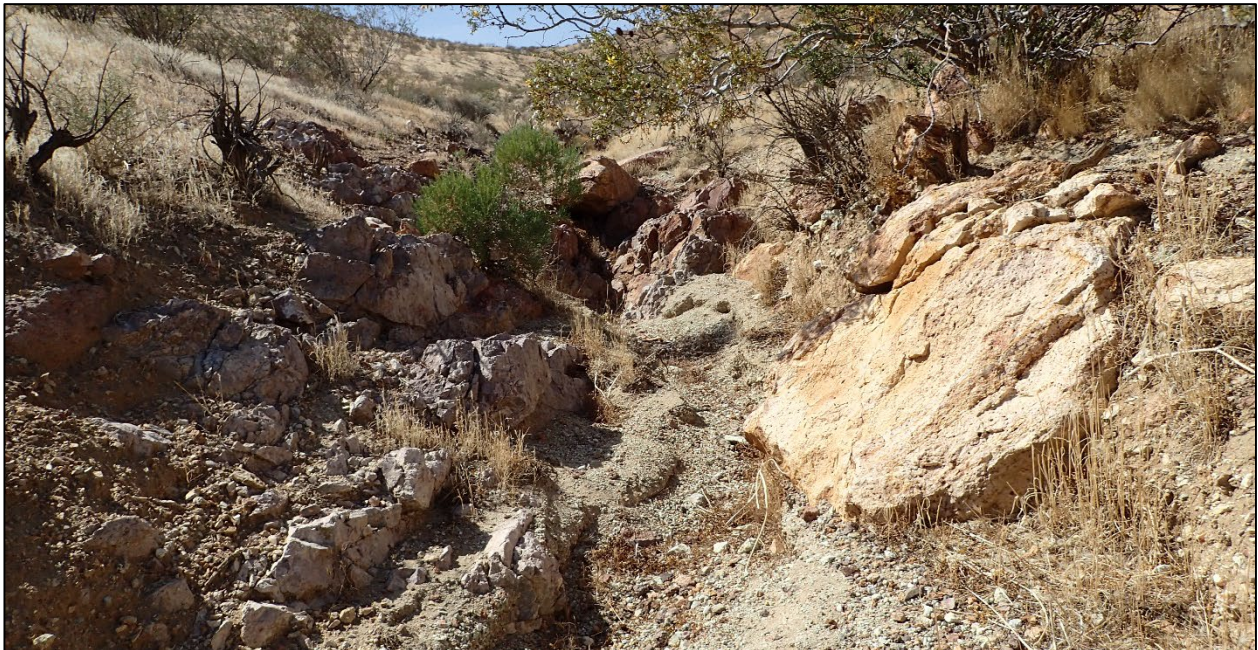
Photograph 16. Site E01 (single thread in creosote scrub) facing upstream. Photograph taken May 30, 2018.

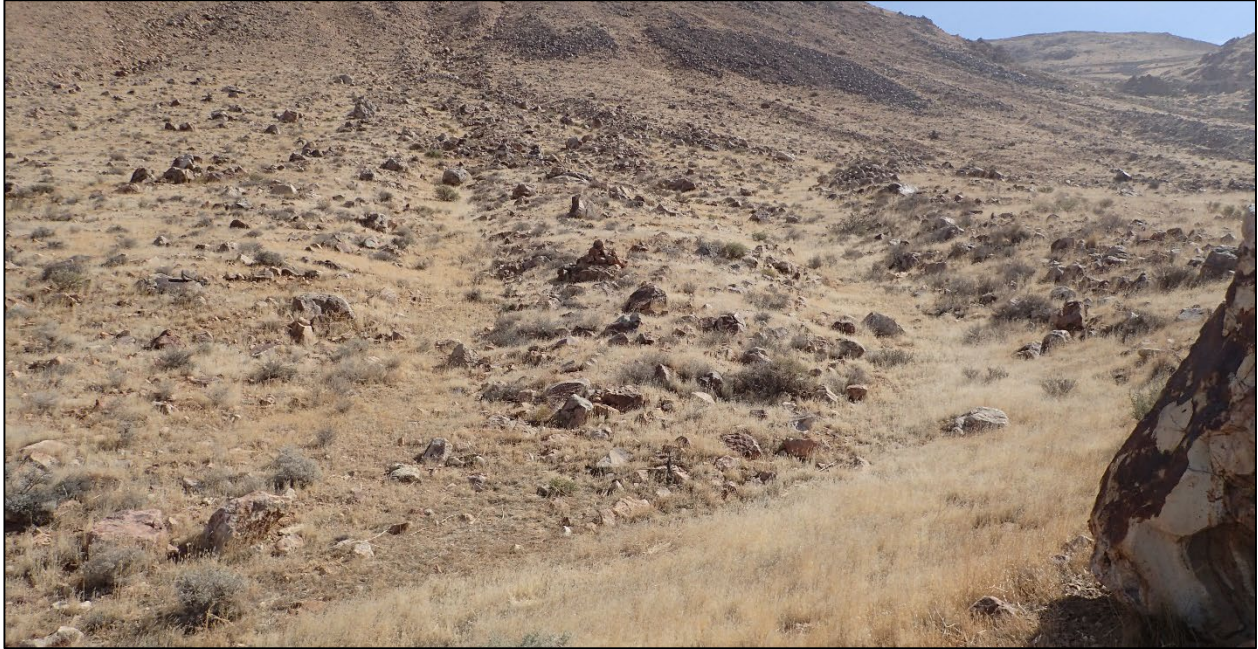
Photograph 17. Site E02 (dry wash in creosote scrubland). Photo taken May 30, 2018.

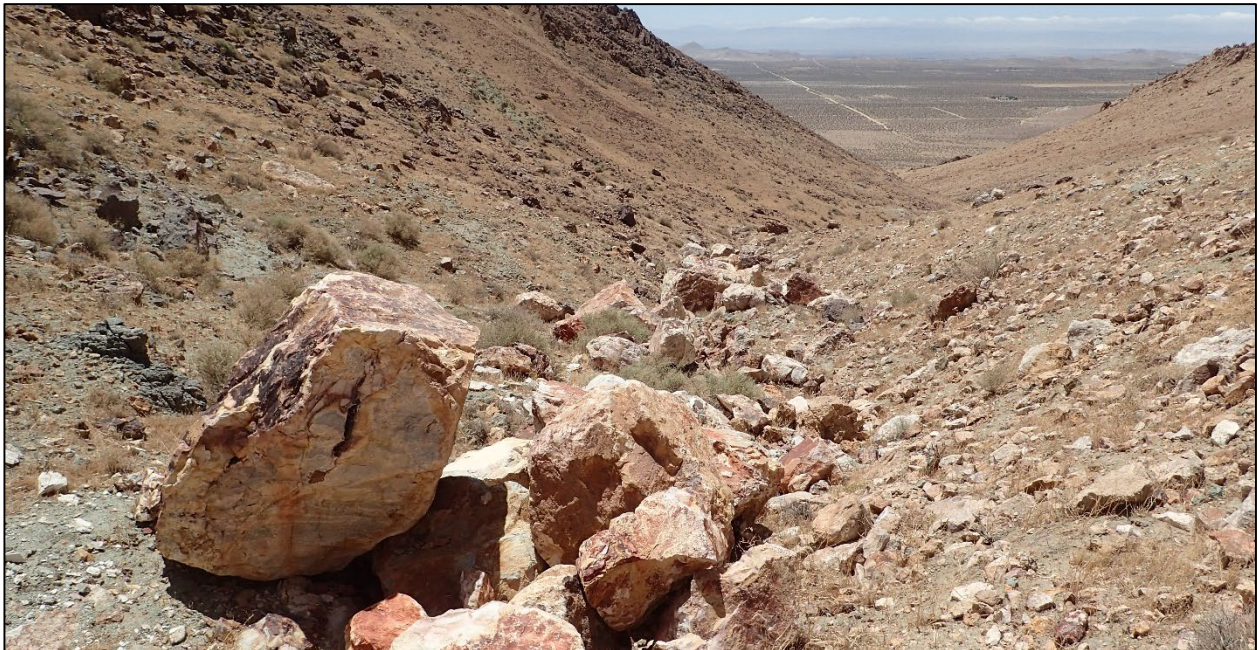
Photograph 18. Feature S85, steep, narrow, ephemeral channel described at cross-section J01, which is to the north. This feature extends through both the current permit boundary and Study Area. Photo taken May 31, 2018.
