MEMORANDUM

Subject: Golden Queen Mine Drainages

The purpose of this memo is to describe drainage features that were encountered during the delineation conducted by WRA on May 30 and 31st, 2018 within the proposed expanded permit boundary (Study Area; Appendix A, Figures 1-5). The delineation identified approximately 7.05 acres (55,188 linear feet) of ephemeral and intermittent drainages within the Study Area, similar to features originally reviewed by the California Department of Fish and Wildlife (CDFW) in 1996 when CDFW determined that a Streambed Alteration Agreement was not necessary for the project. The Study Area is adjacent to the current permit boundary which was previously analyzed in the EIR prepared by Kern County in 1997 and in the Supplemental EIR in 2010. Appendix B includes photos of a subset of drainages that were mapped throughout the Study Area in 2018.

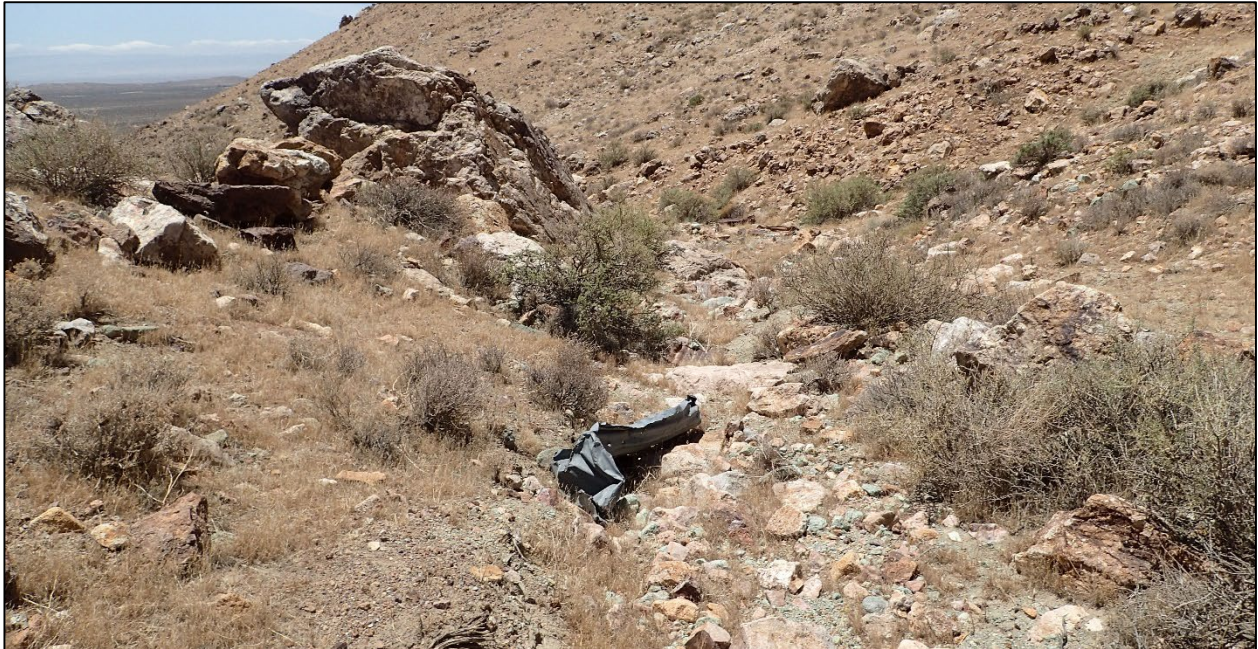
Photograph 19. Floodplain and secondary channel at Site J02, facing downstream. Photo taken May 31, 2018.

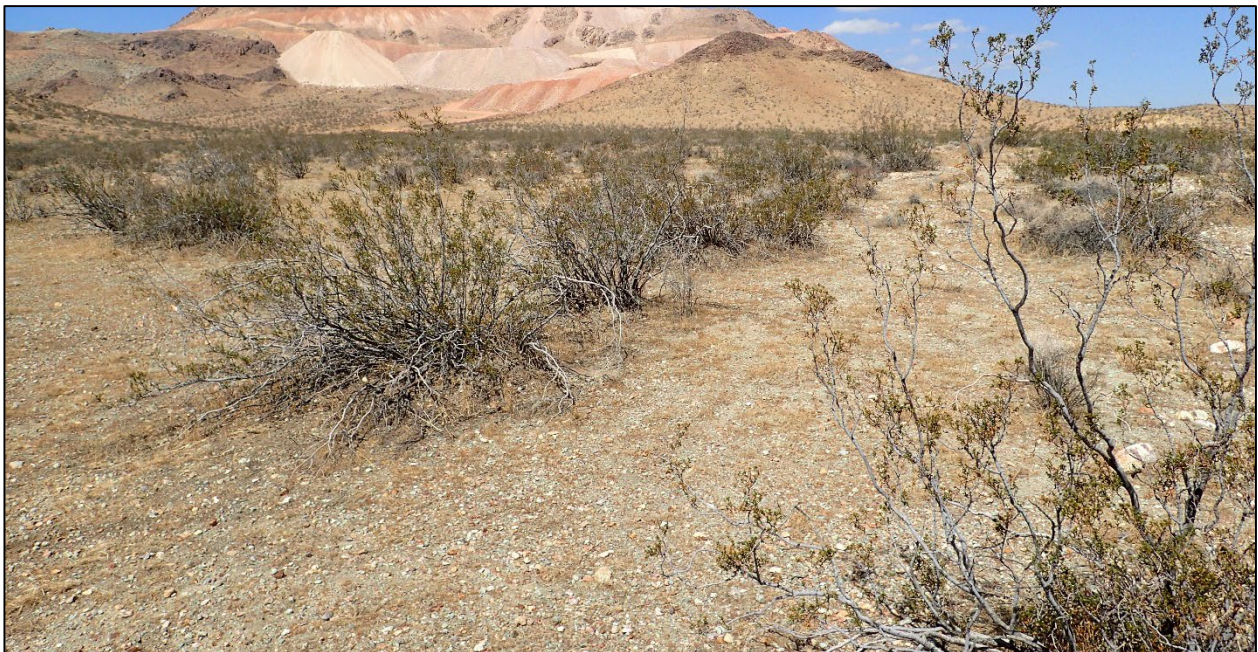
Photograph 20. Site H01 (gently sloping upper to mid alluvial fan creosote scrub), facing north. Photo taken May 30, 2018.
