Malibu Creek Ecosystem Restoration Project

Appendix J

Habitat Evaluation

U.S. Army Corps of Engineers
Los Angeles District

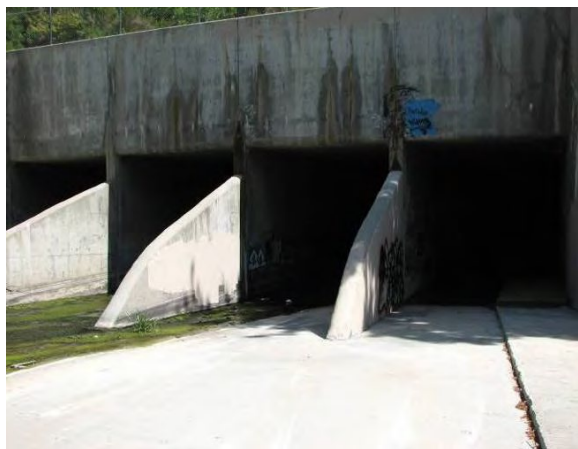
Upstream culvert entrance looking towards Lost Hills Rd

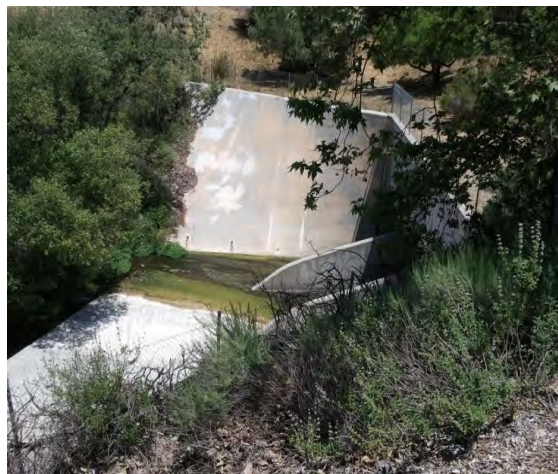
View upstream from Lost Hills Rd. showing wing walls.

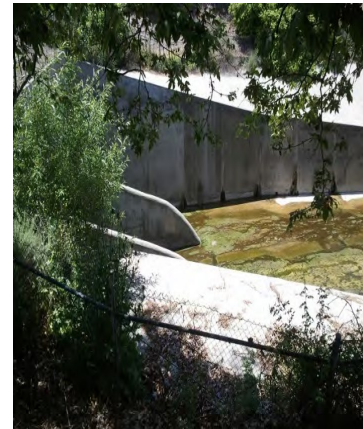
Entrance/intake upstream
