Malibu Creek Ecosystem Restoration Study
Los Angeles and Ventura Counties, California

Appendix D
Geotechnical Engineering

U.S. Army Corps of Engineers
Los Angeles District

August 2020

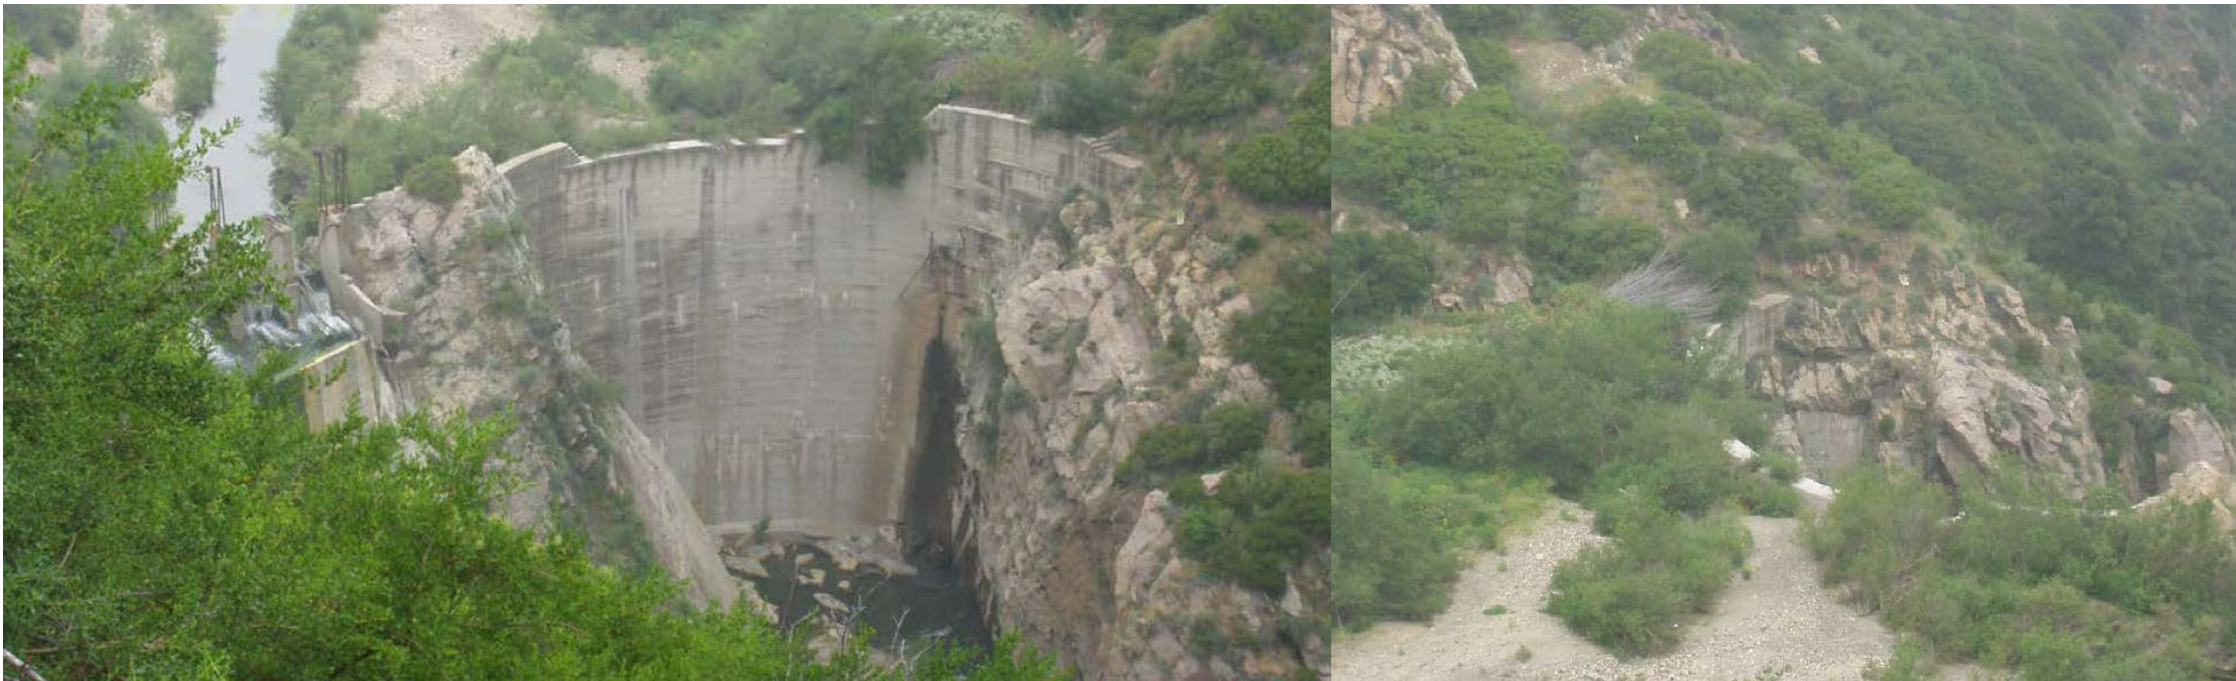
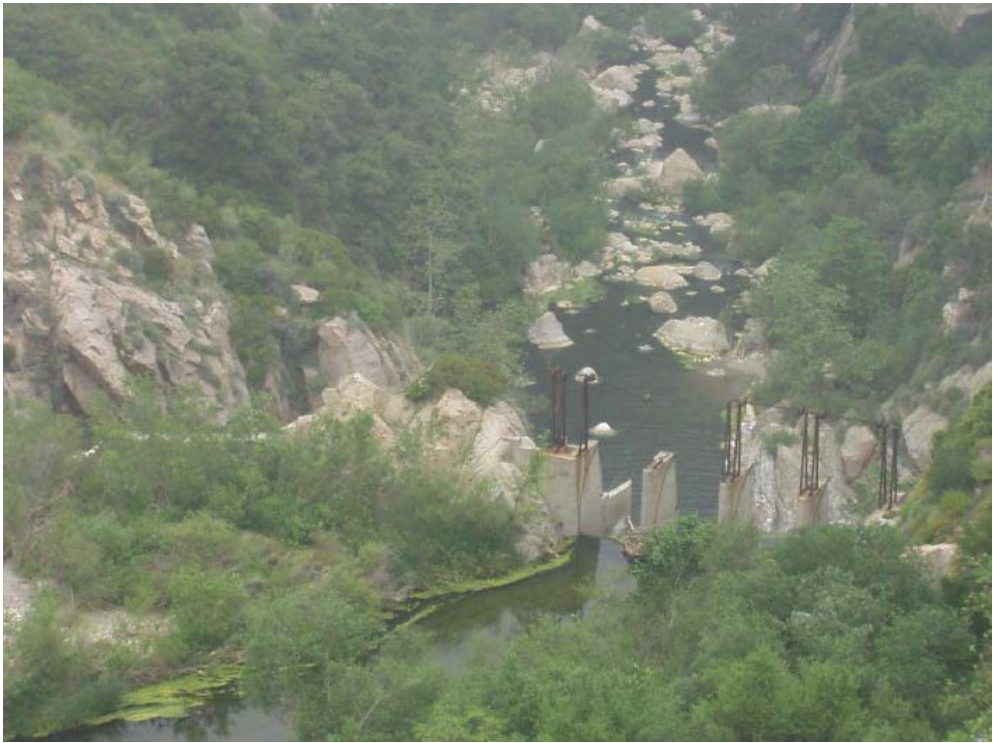
Clockwise from left: View of the downstream face of the dam, left and right abutments, and spillway. View of the upstream face and crest of the dam. Sediment has deposited on the upstream face almost to the top. View of the upstream side of the spillway.

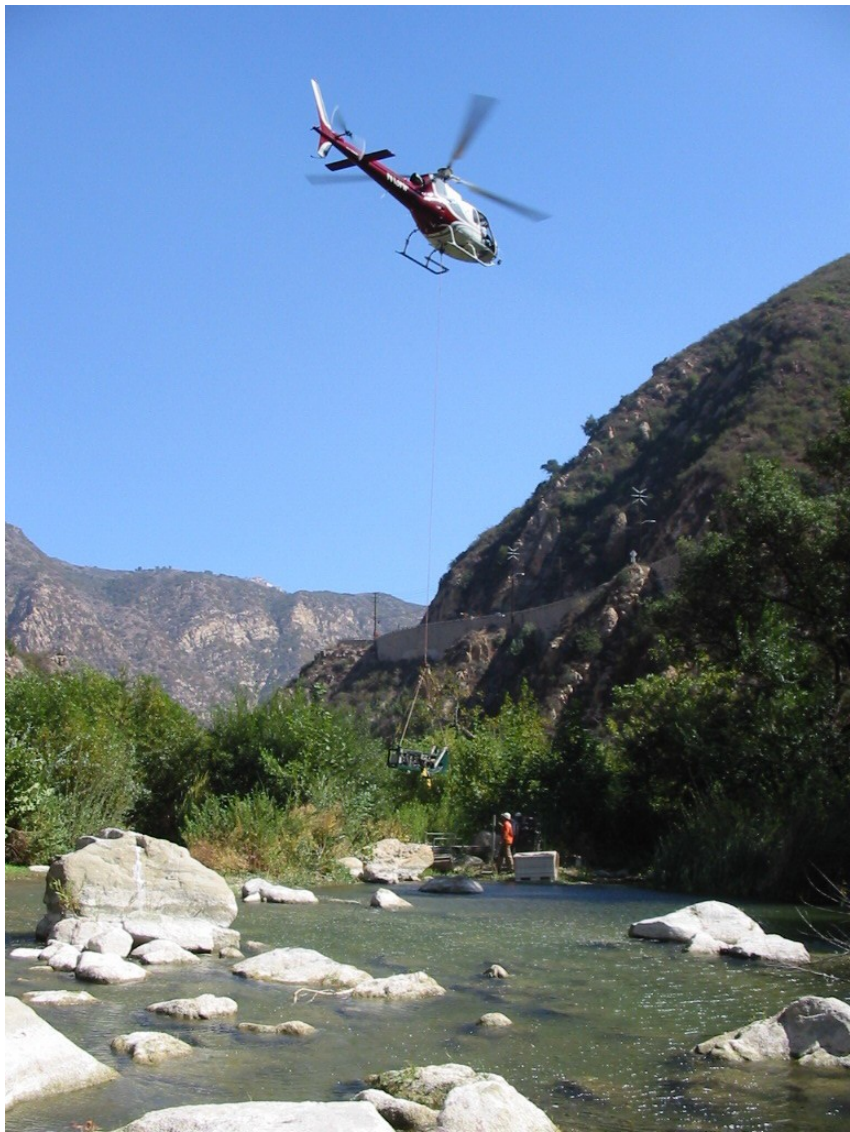
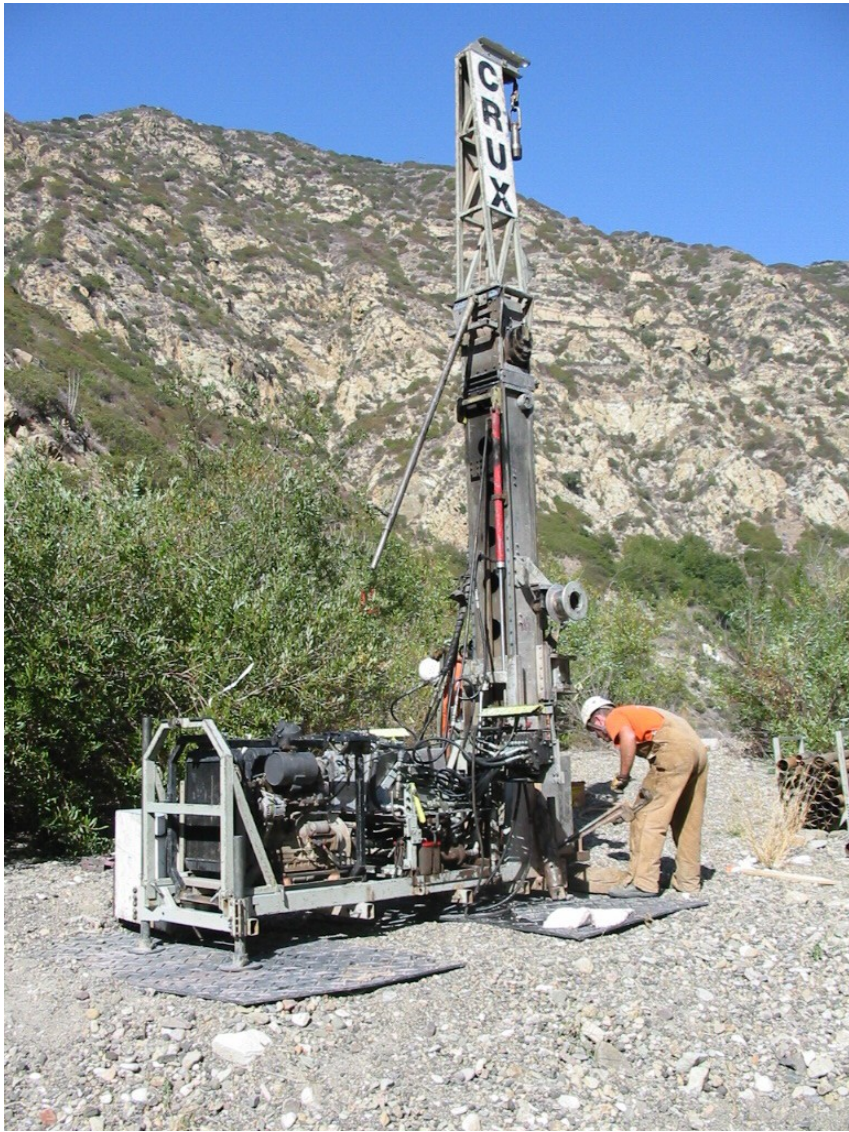
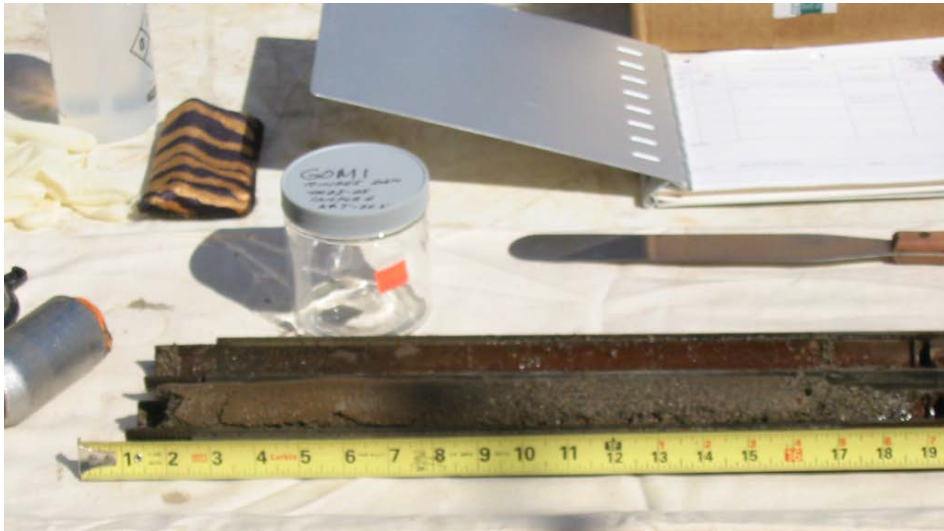
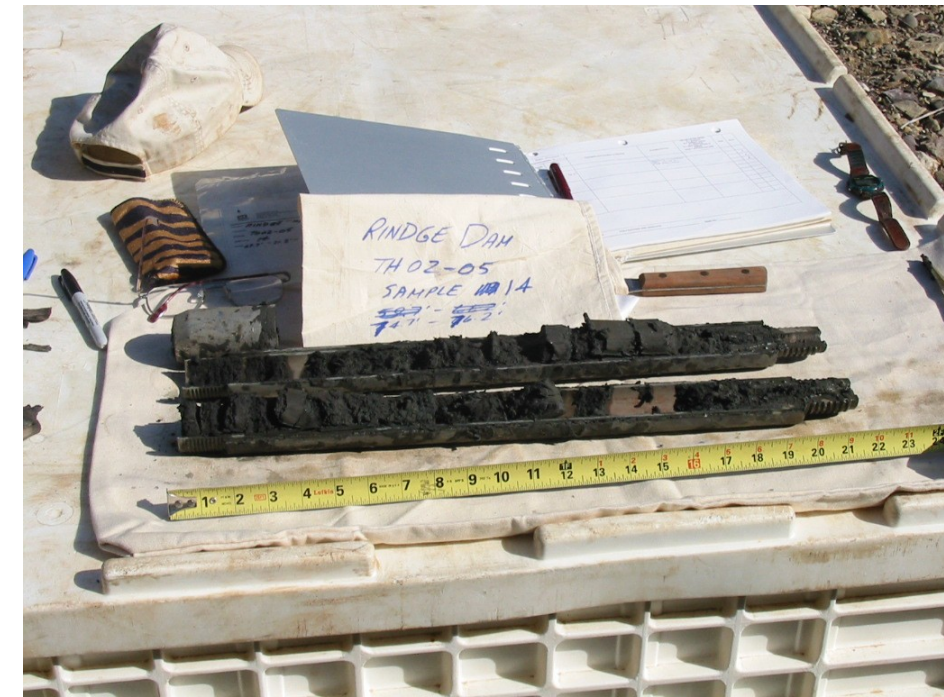
USACE subsurface exploration program.

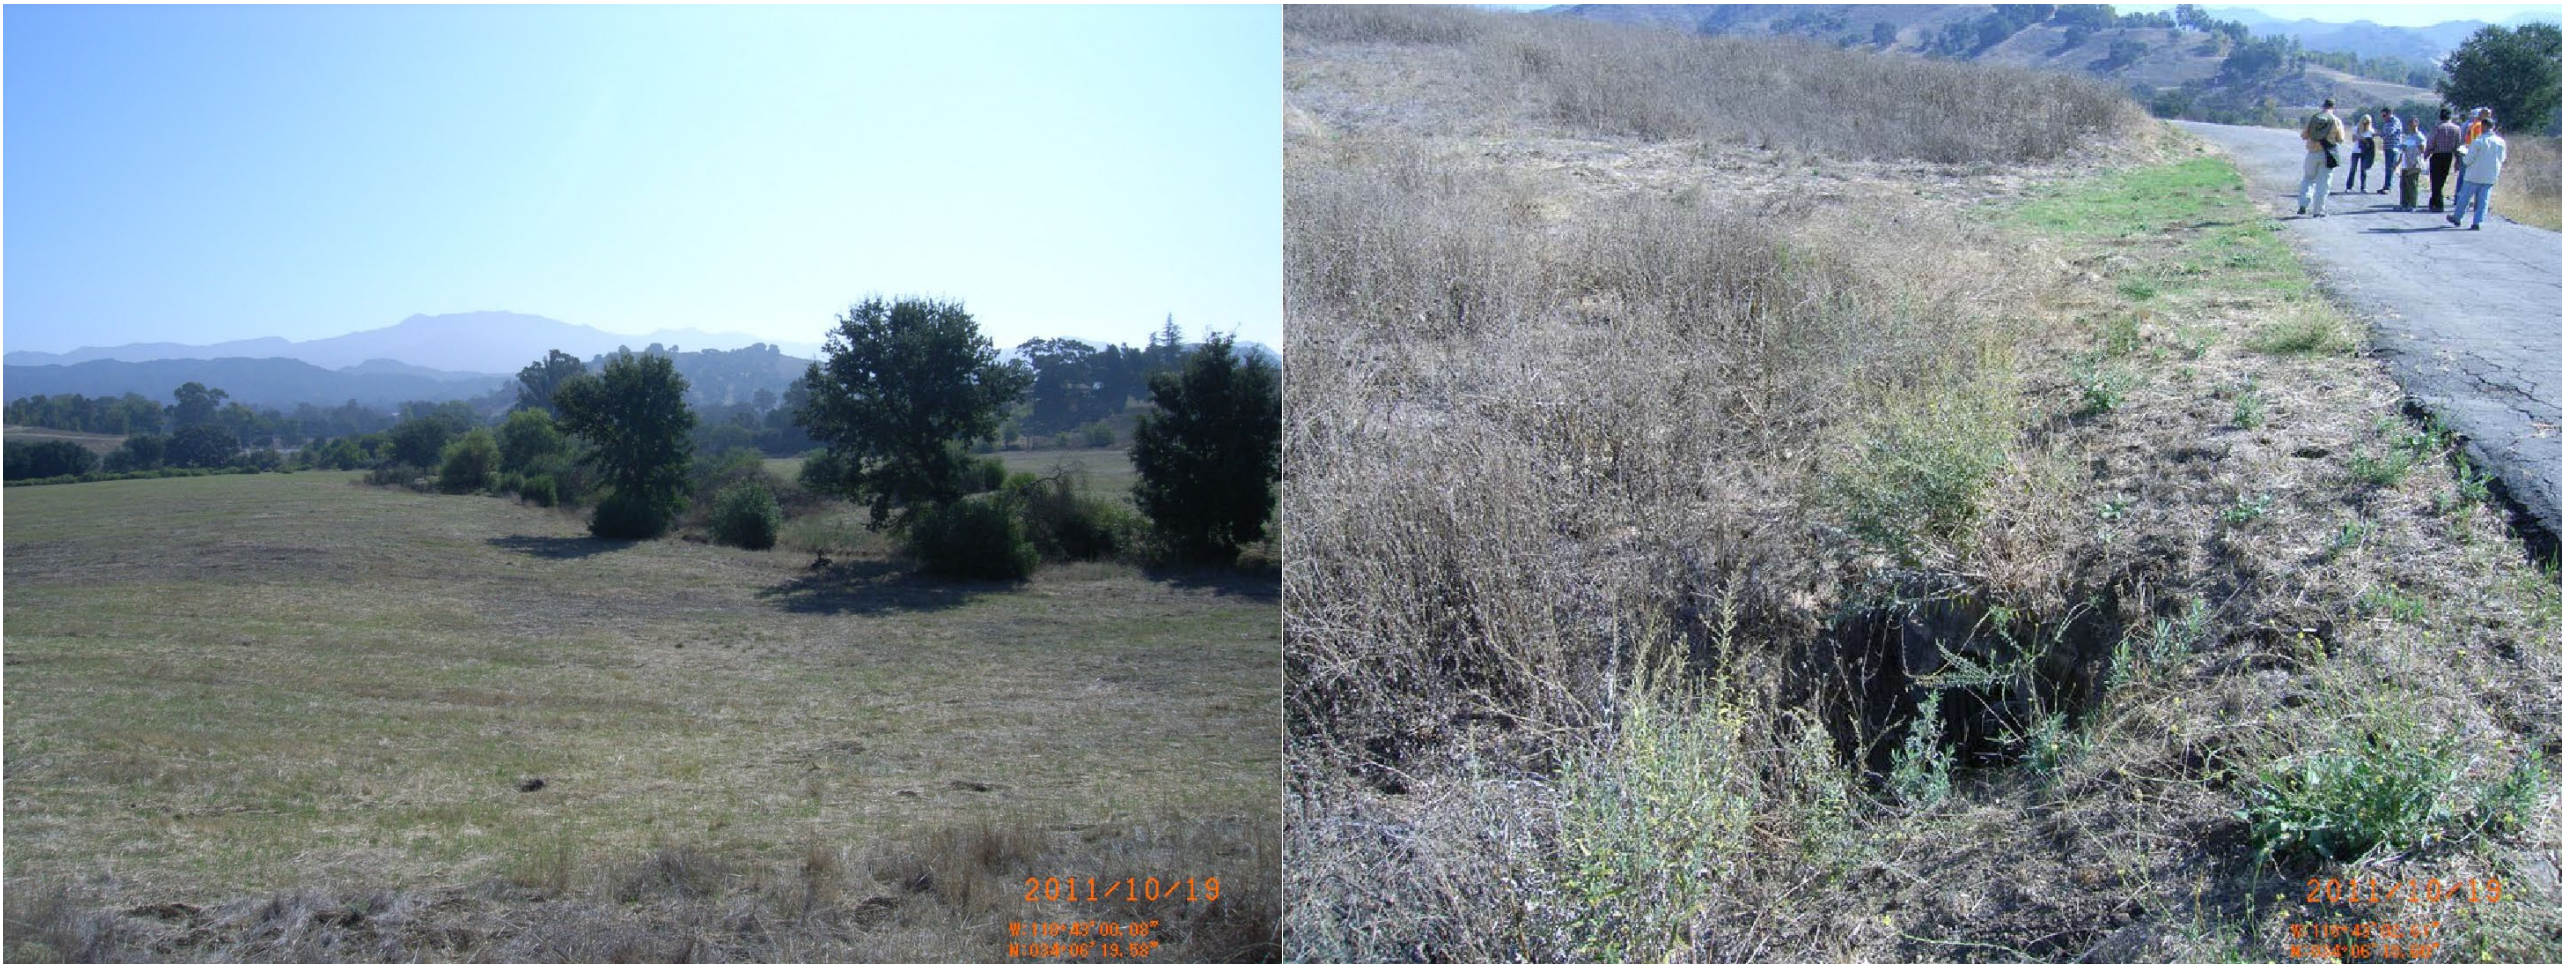
Proposed storage Site F.

In particular, a geotechnical assessment of the foundation of Site F must be undertaken prior to its use for this purpose, as it is the only such site that appears likely to be carried forward as an alternative. The assessment must consist of the site foundation being drilled, logged, and sampled to verify subsurface and soils properties conditions prior to the onset of construction, something beyond the budgets available for this feasibility study. Site F is the only site currently under consideration as a temporary storage site. No permanent, in-canyon, upland disposal sites are under consideration, currently, other than a commercial landfill, which will not require additional study.
