Malibu Creek Ecosystem Restoration Study

Appendix C

Civil Design & Structural

U.S. Army Corps of Engineers
Los Angeles District

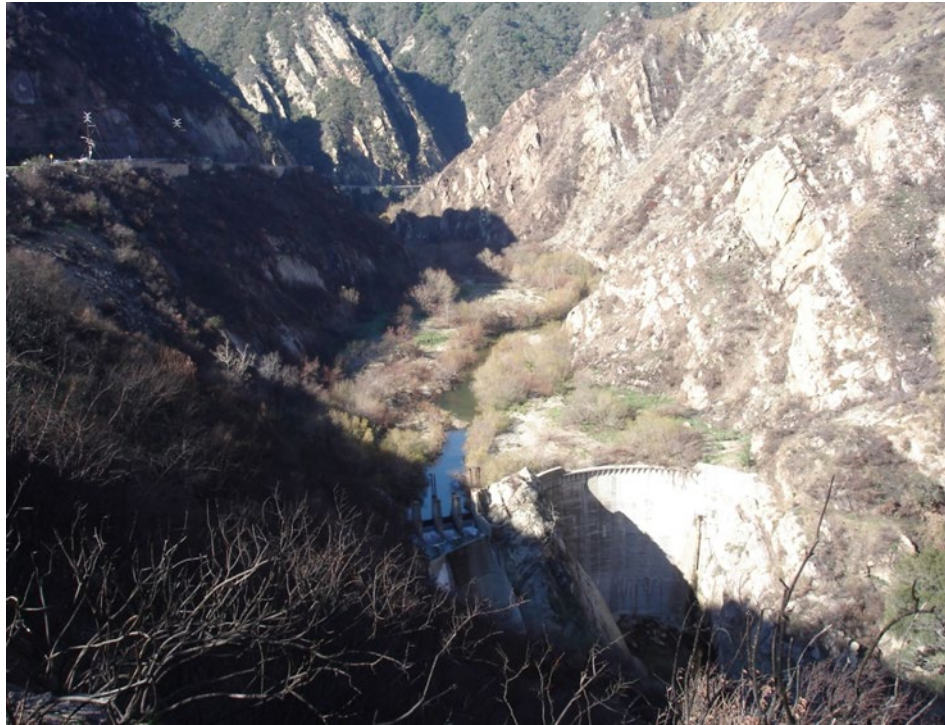
Figure 3.0-1 Rindge Dam

Built between April 1924 to January 1925, Rindge Dam is a 100-ft-high thin-arch concrete dam with a detached spillway cut into bedrock. The dam became State of California jurisdictional for safety following passage of legislation in August 1929. It was certified for safety operation on October 17, 1935. On May 2, 1967, the dam was declared nonjurisdictional when it was found to store less than 15 acre-feet of water which is the threshold storage the State defines for a dam. **Figure 3.0-1** – Rindge Dam shows the dam viewed from above and looking upstream from Malibu Canyon Road.

The length of the dam at the crest is 175 ft and 95 ft at its base. The thickness of concrete at the base of the dam is 11.5 ft and tapers to a width of 2 ft at the top. The dam foundation extended 15 ft to below the original streambed to bedrock. Based on as-built drawings, the dam was reinforced with 30-foot long steel railroad rails weighing sixty lbs/yd. The rails were placed vertically near the abutments at the crest and at the base at the center of the arch on the upstream face.

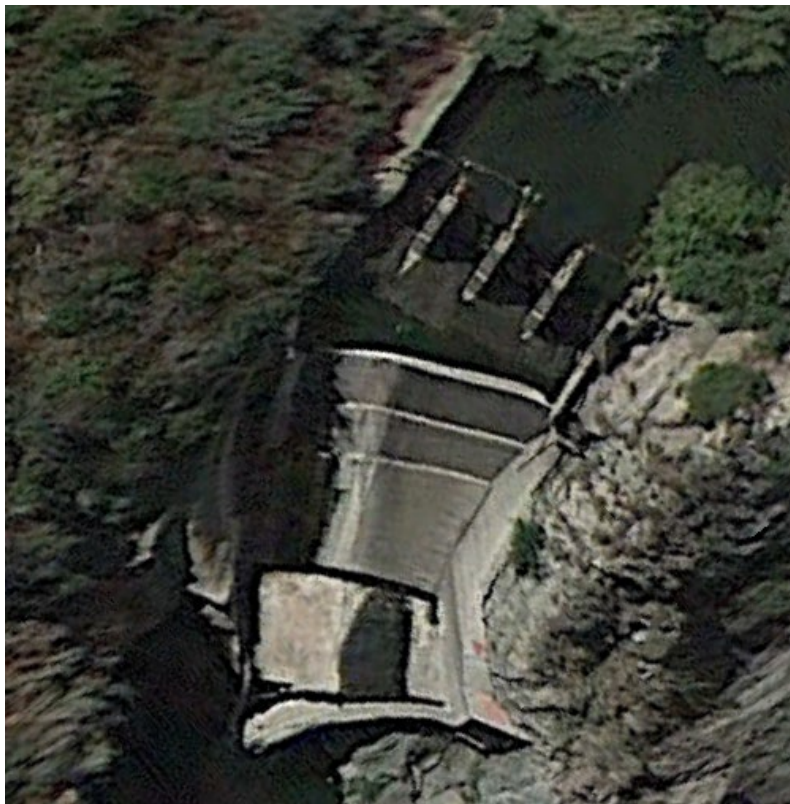
Figure 3.0-2 Rindge Dam Spillway

The spillway has five concrete buttresses with four 8 ft wide by 11 ft high flow ways. The dam foundation extended 15 ft to below the original streambed to bedrock. A plan view of the spillway, taken from Google Earth, can be seen in **Figure 3.0-2**. The spillway would be removed with the dam.

The concrete spillway would be demolished by first pre-splitting the concrete from the rock substratum than drilling and micro-blasting the surface to fracture the concrete and then manually breaking the concrete.

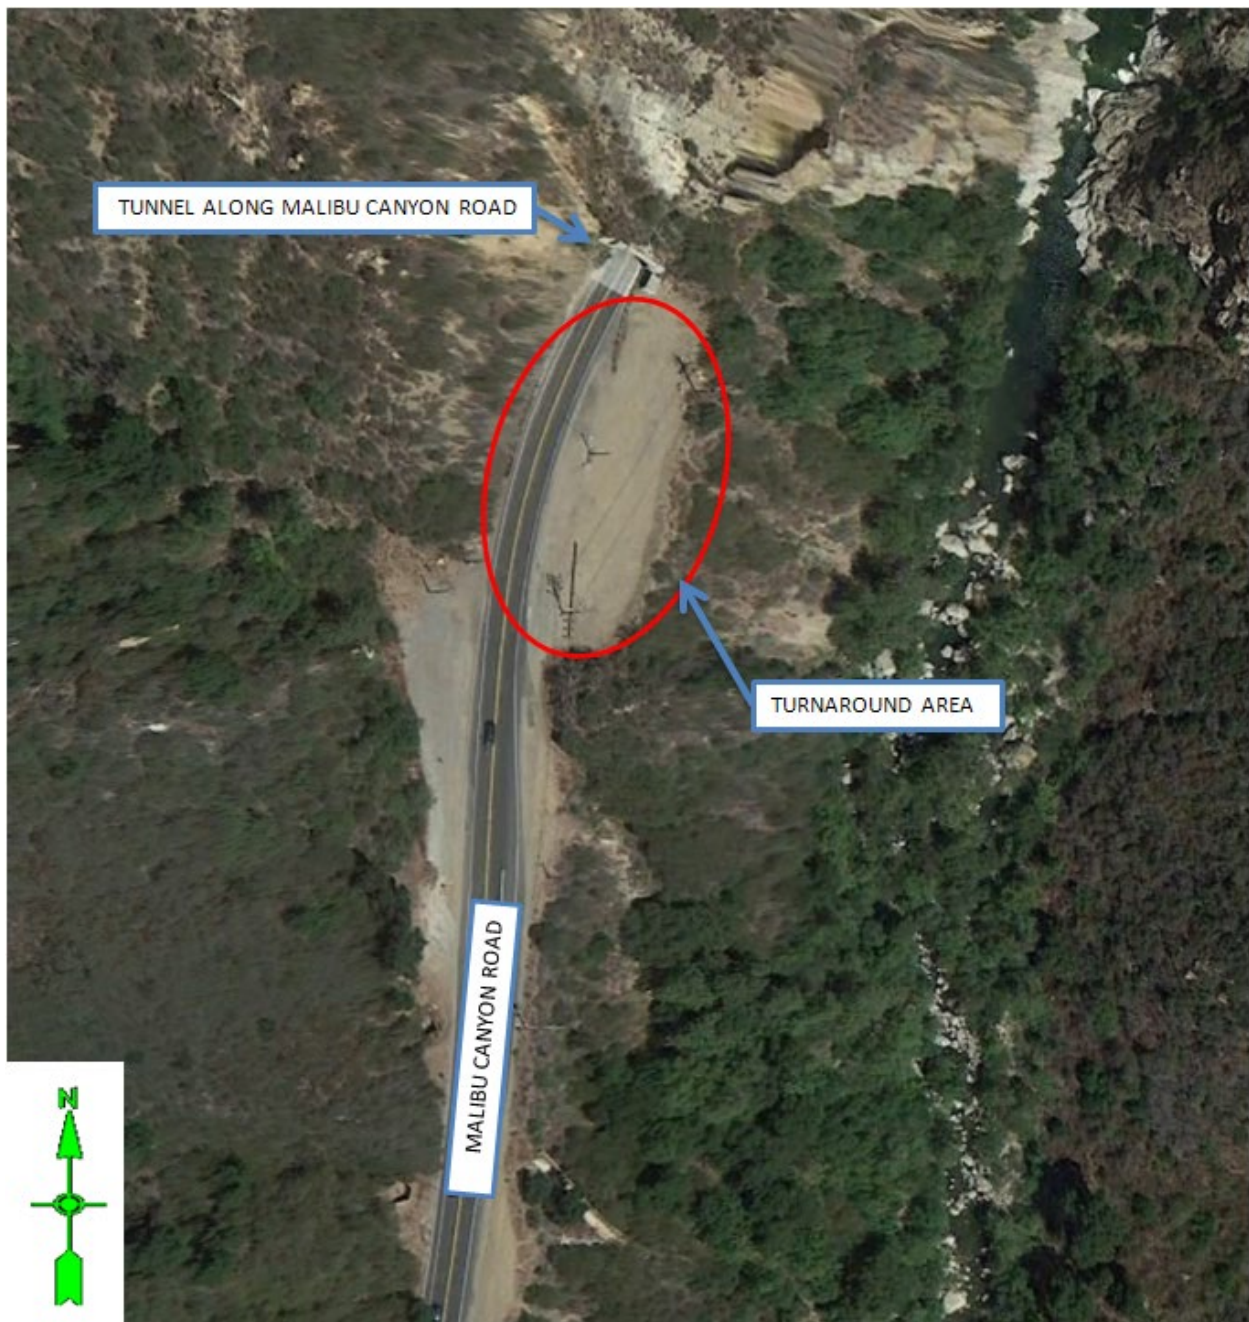
Figure 4.2-4 Turnaround Area 1

Area 1 is located about 0.30 mi north of the Northbound Ramp intersection with Malibu Canyon Road. This area was eliminated because both lanes of traffic would be blocked while the truck makes the turn from the northbound lane to the southbound lane. This would heavily impact traffic during construction hours, as outlined in the analysis of the **Figure 4.1-1** access ramp. There is also a safety concern due to the limited visibility of southbound traffic passing through the nearby tunnel.

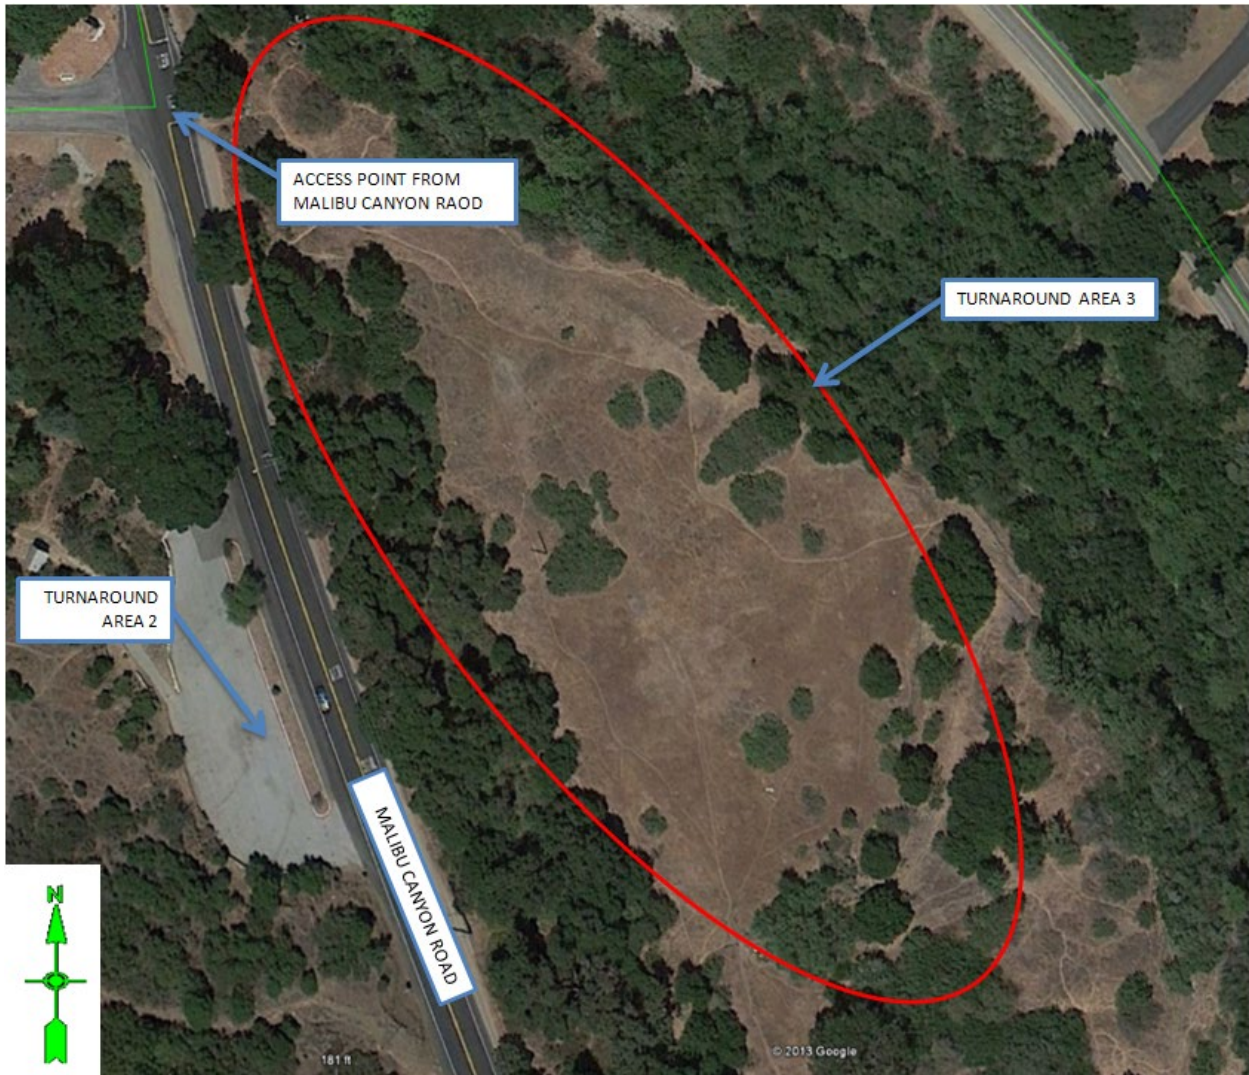
Figure 4.2-6 Turnaround Area 3

The entrance to Area 3 is located 275 ft north of the entrance to Area 2, and approximately 1.05 mi north of the Northbound Ramp intersection with Malibu Canyon Road. There is an existing intersection at the northern end of the site that can be modified to allow trucks to turn into the site and exit the site. There is plenty of room for multiple trucks to turn around at the same time and allow staging to get back onto Malibu Canyon Road. According to Google Maps this area is part of the Santa Monica Mountains National Recreation Area but the exact owner of the land is unknown at this time. This area was eliminated because it adds 2.1 mi to the haul route for material going south.

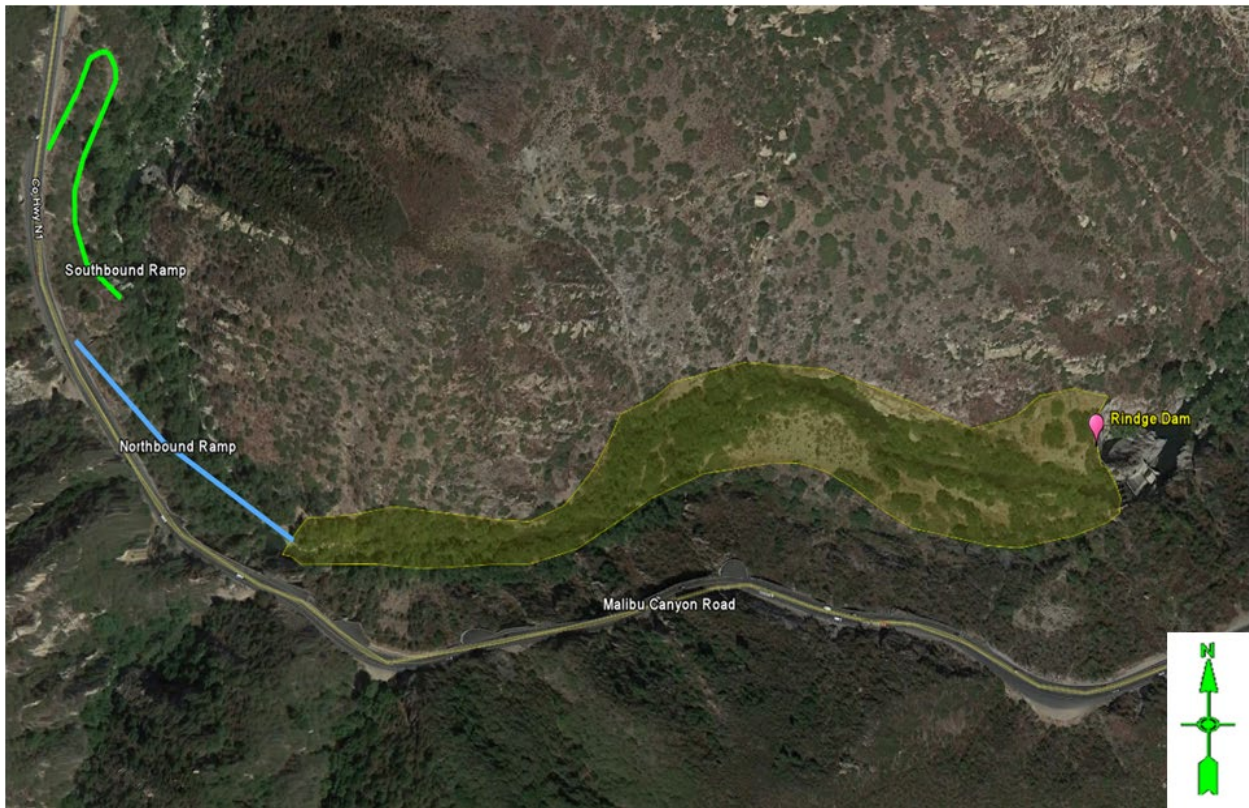
Figure 5.1-1 Sediment Impound Area

The sediment area to be removed is confined to the narrow canyon along the creek bed from the dam to about 2,400 ft upstream of the dam. The top of the sediment is roughly 250 ft wide near the dam and maintains this width consistently to about 1,400 ft upstream of the dam, at which point it narrows to about 100 ft for the remainder 1,000 ft upstream. The approximate impounded sediment area is shown in yellow in **Figure 5.1-1**. **Figure 5.1-1** also depicts the Northbound Ramp in blue and the Southbound Ramp in green.

The proposed excavation would remove most of the sediment and restore the approximate gradient of the original channel invert. Some of the larger rocks in the creek would be utilized to stabilize the final invert. Excavation depth ranges from approximately 100 ft at the dam tapering to zero feet at the upstream end of the sediment area. Excavation of the sediment would expose rock canyon side-slopes. The width of the channel bottom upon final excavation would closely match the pre-dam conditions and be approximately 40 to 60 ft.

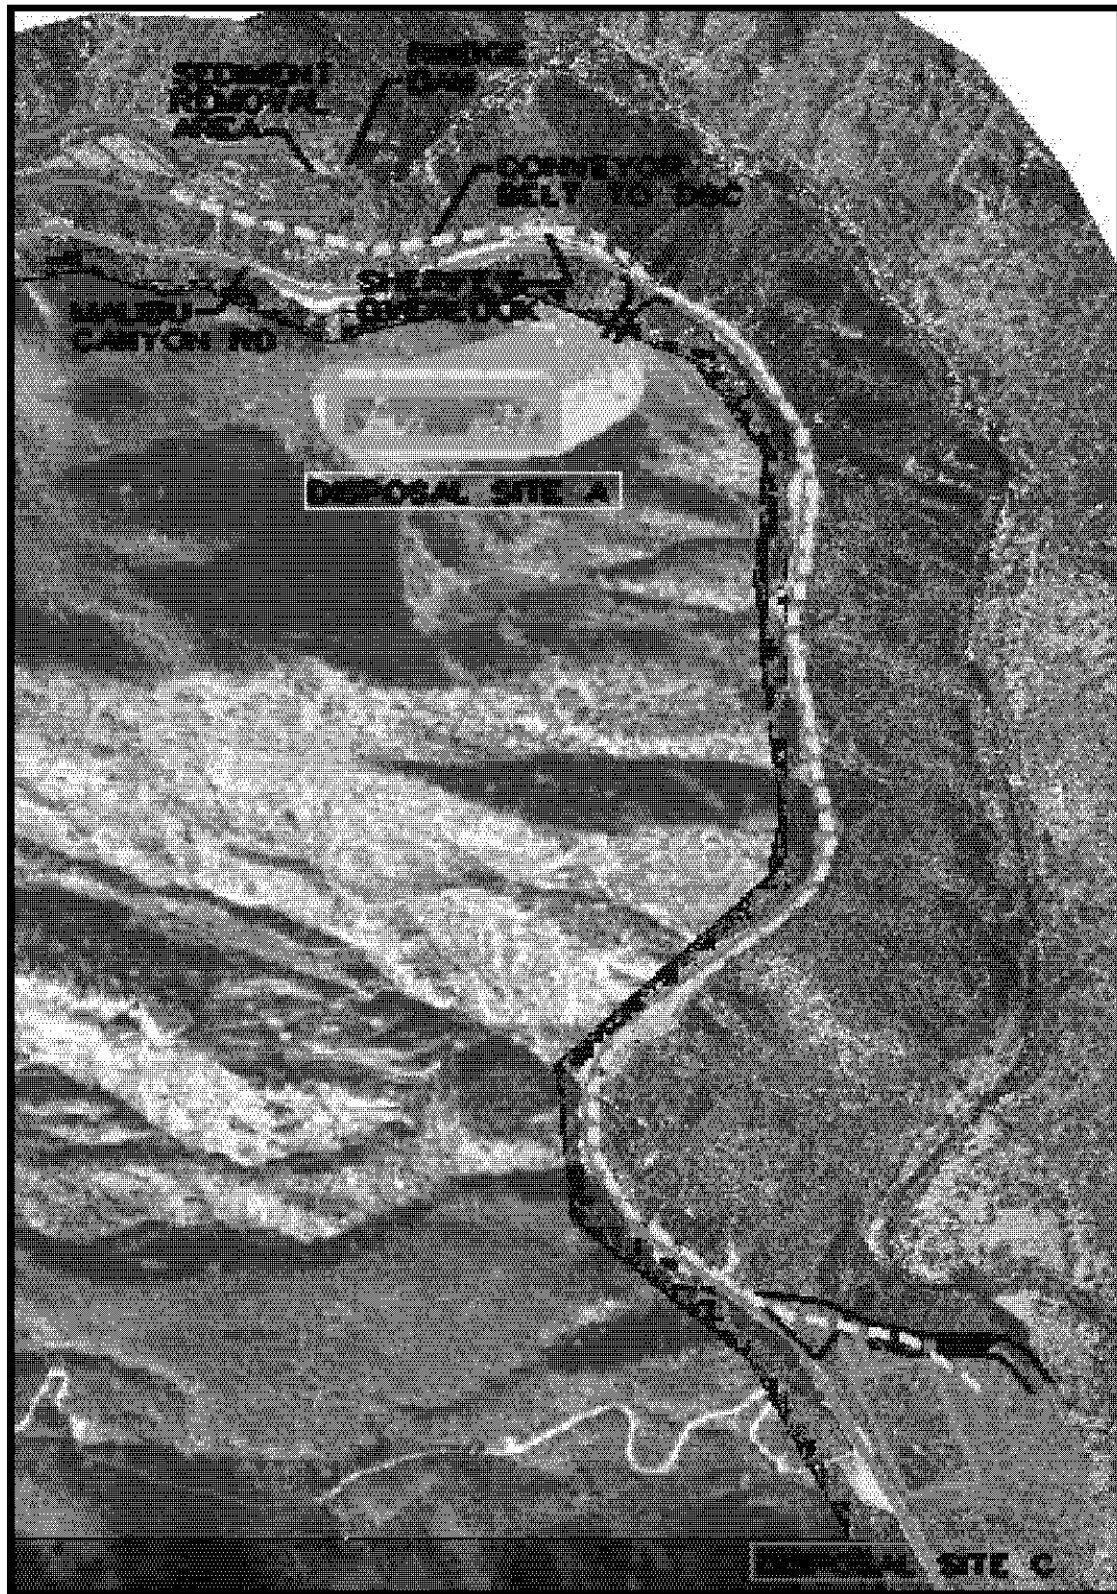
Figure 5.3-3 Conveyor Belt Alignment to Disposal Site C

The conveyor alignment would run up to Sheriff's Overlook. If further separation of sediment is necessary, a portable screening plant can be installed at Sheriff's Overlook if space is limited in the SRA. A portable screening plant capable of separating sand from silt can be installed here if additional sand is desired from the Unit 3 region of the SRA. From this location beach compatible sand would be hauled through Malibu Canyon and non beach material disposed of at DSA by conveyor. Sheriff's Overlook would have to be cleared and grubbed. This area is about ½ acre in size. It would have to be regraded and the cut material be relocated to DSA. There are power poles along Malibu Canyon Road at this site. These power poles would be protected in place. The conveyor crossing Malibu Canyon Road would have to be a 20 ft minimum clearance from the surface of the road. If DSA is not available as a disposal site, the conveyor alignment would run along the east side of Malibu Canyon Road way to either DSB or DSC. Preliminary belt alignment to Disposal Sites A, B, and C are shown in **Figure 5.3-1** through **Figure 5.3-3**. Further analysis is necessary to determine the conveyor belt alignment. Bends in the conveyor alignment can be achieved by special sections of belt and/or the use of hoppers to redirect the conveyor alignment. Avoiding the power-poles along Malibu Canyon Road would be difficult. The road would probably have to be restriped and would require a reduction in traffic speed along Malibu Canyon Road for the duration of the construction.

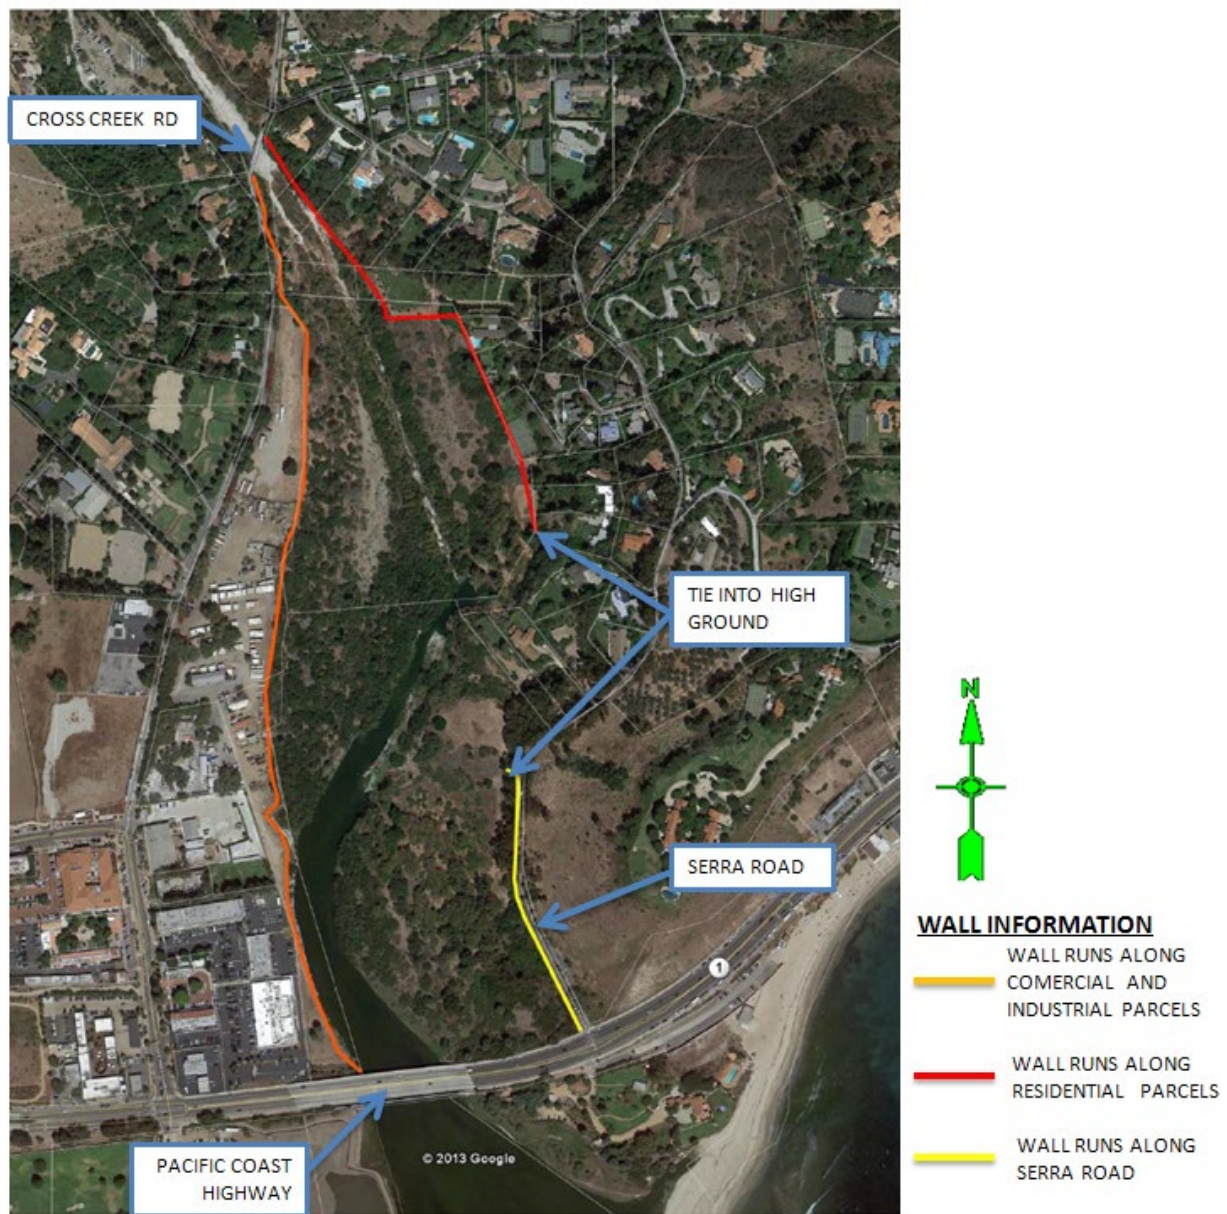
Figure 8.1-2 Downstream Flood Mitigation Alignment

Alternatives 3a, 3b, 4a and 4b would use anticipated natural sediment transport to remove the impounded sediment from behind the dam. It is estimated that Alternatives 4a and 4b would release between 15,000 and 55,000 cy of sediment a year over 5 years while Alternatives 3a and 3b would use natural transport to remove all the sediment from behind the dam over 50 years. The sediment released from behind the dam would be deposited along the downstream portions of Malibu Canyon and eventually increase the flood risk for properties between Cross Creek Road and Pacific Coast Highway by increasing the water surface elevation of the floods. To mitigate for this flood risk, approximate 3,100 ft of flood wall would have to be built along the west bank and approximately 2,700 ft along the east banks of Malibu Creek for a total of approximately 5,800 ft of flood wall. **Figure 8.1-2** illustrates a preliminary alignment for the flood walls.

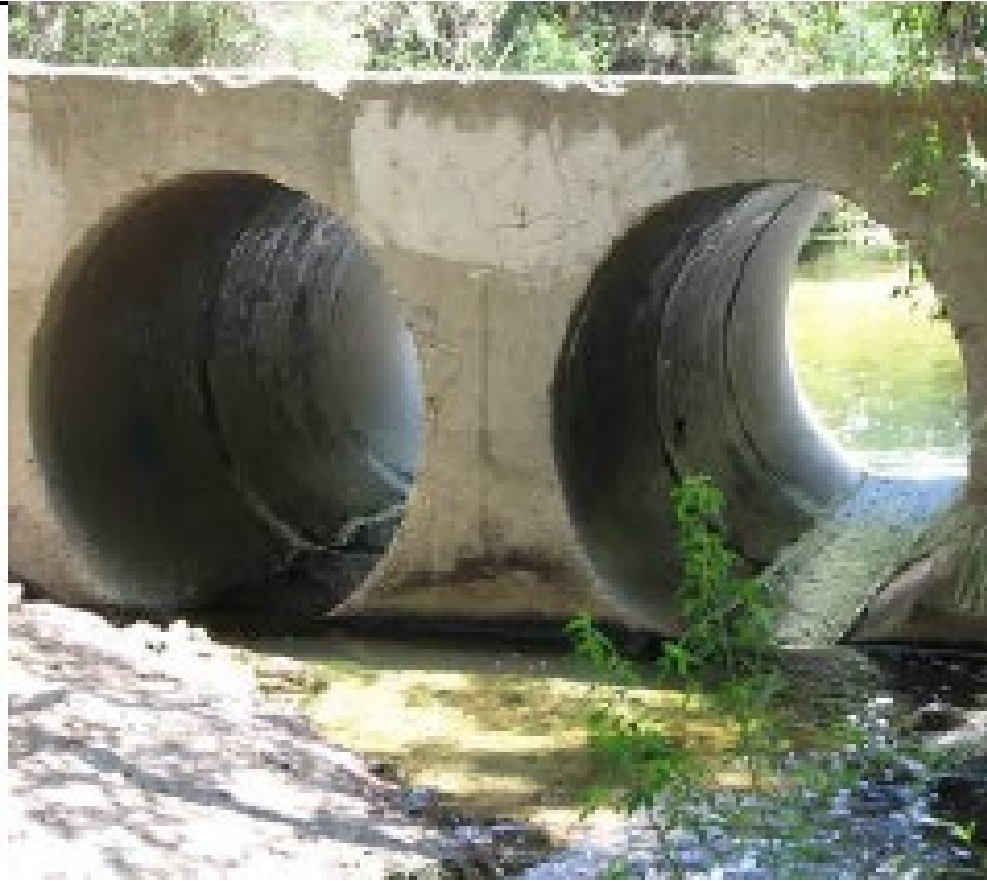
Figure 3.1-2 LV1, Craggs Road Culvert (Picture taken while looking upstream toward the outlet of the culvert)

LV1, Craggs Road Culvert is a 6 ft diameter concrete, double barrel culvert located on Malibu State Parks land along Las Virgenes Creek. It currently serves as a crossing for maintenance vehicles for Malibu State Park and fire trucks.

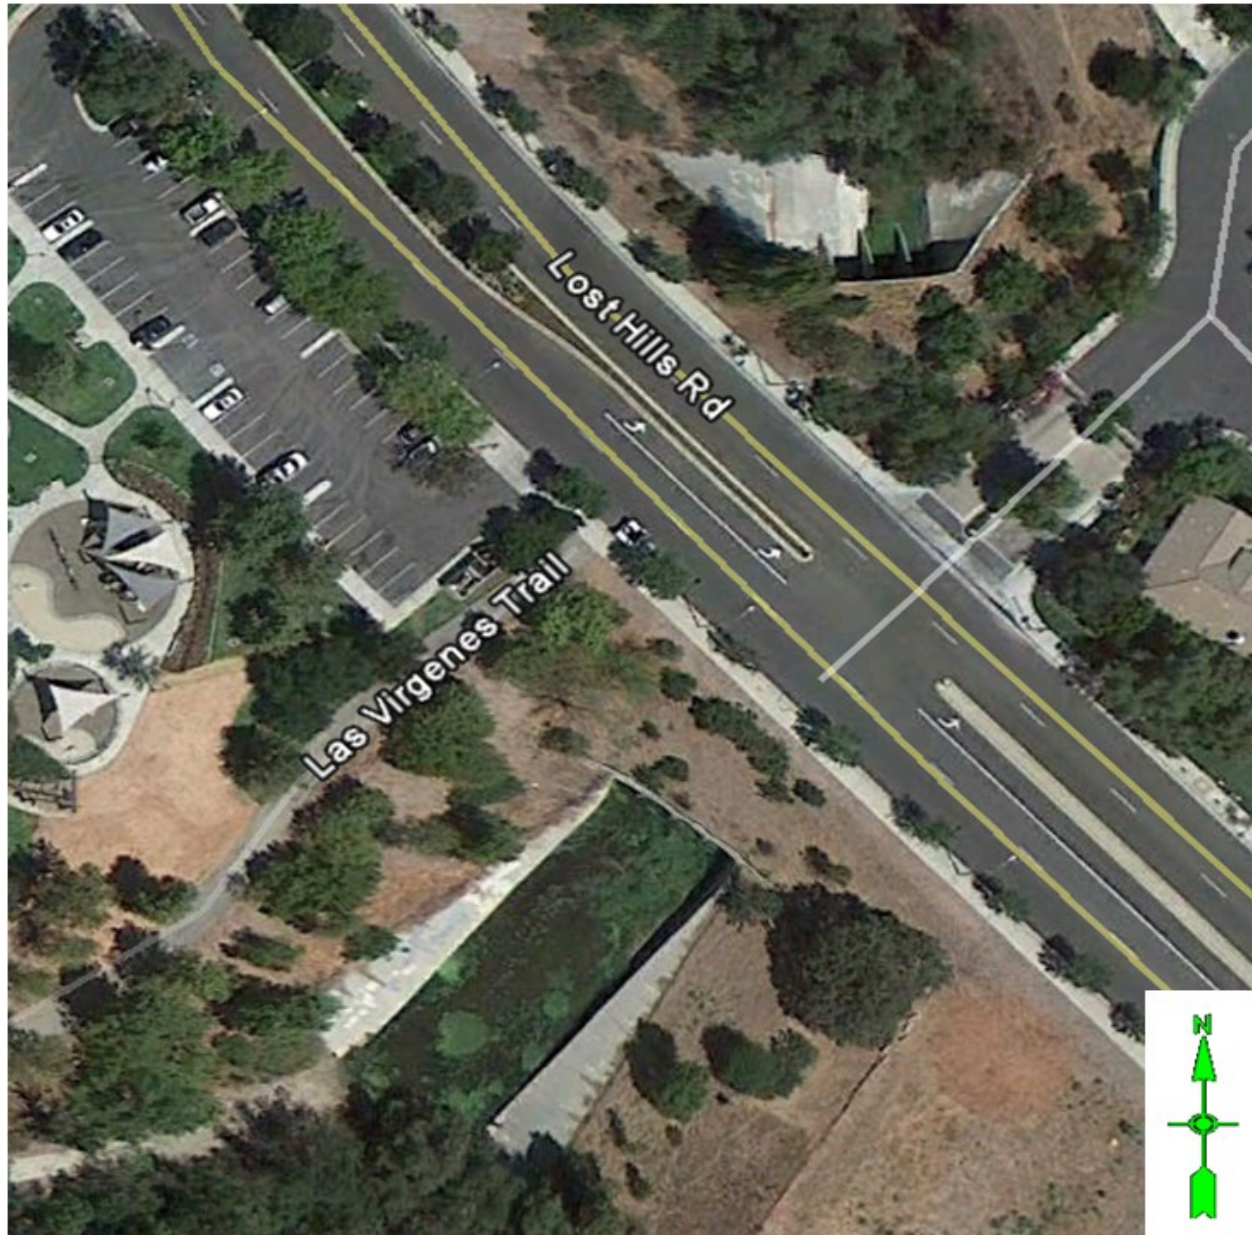
Figure 3.3-2 LV3, Lost Hills Road Culvert (Aerial View)

LV3, Los Hills Road Culvert is a 61 ft wide, 241 ft long, concrete box culvert with four 14 ft x 14 ft openings. The culvert follows a curve in the creek. Los Hills Road is a four lane road that passes over the culvert and through a densely developed residential area. There are concrete aprons that extend 100 ft upstream of the inlet and 100 ft downstream of the outlet of the culvert. LV 4,

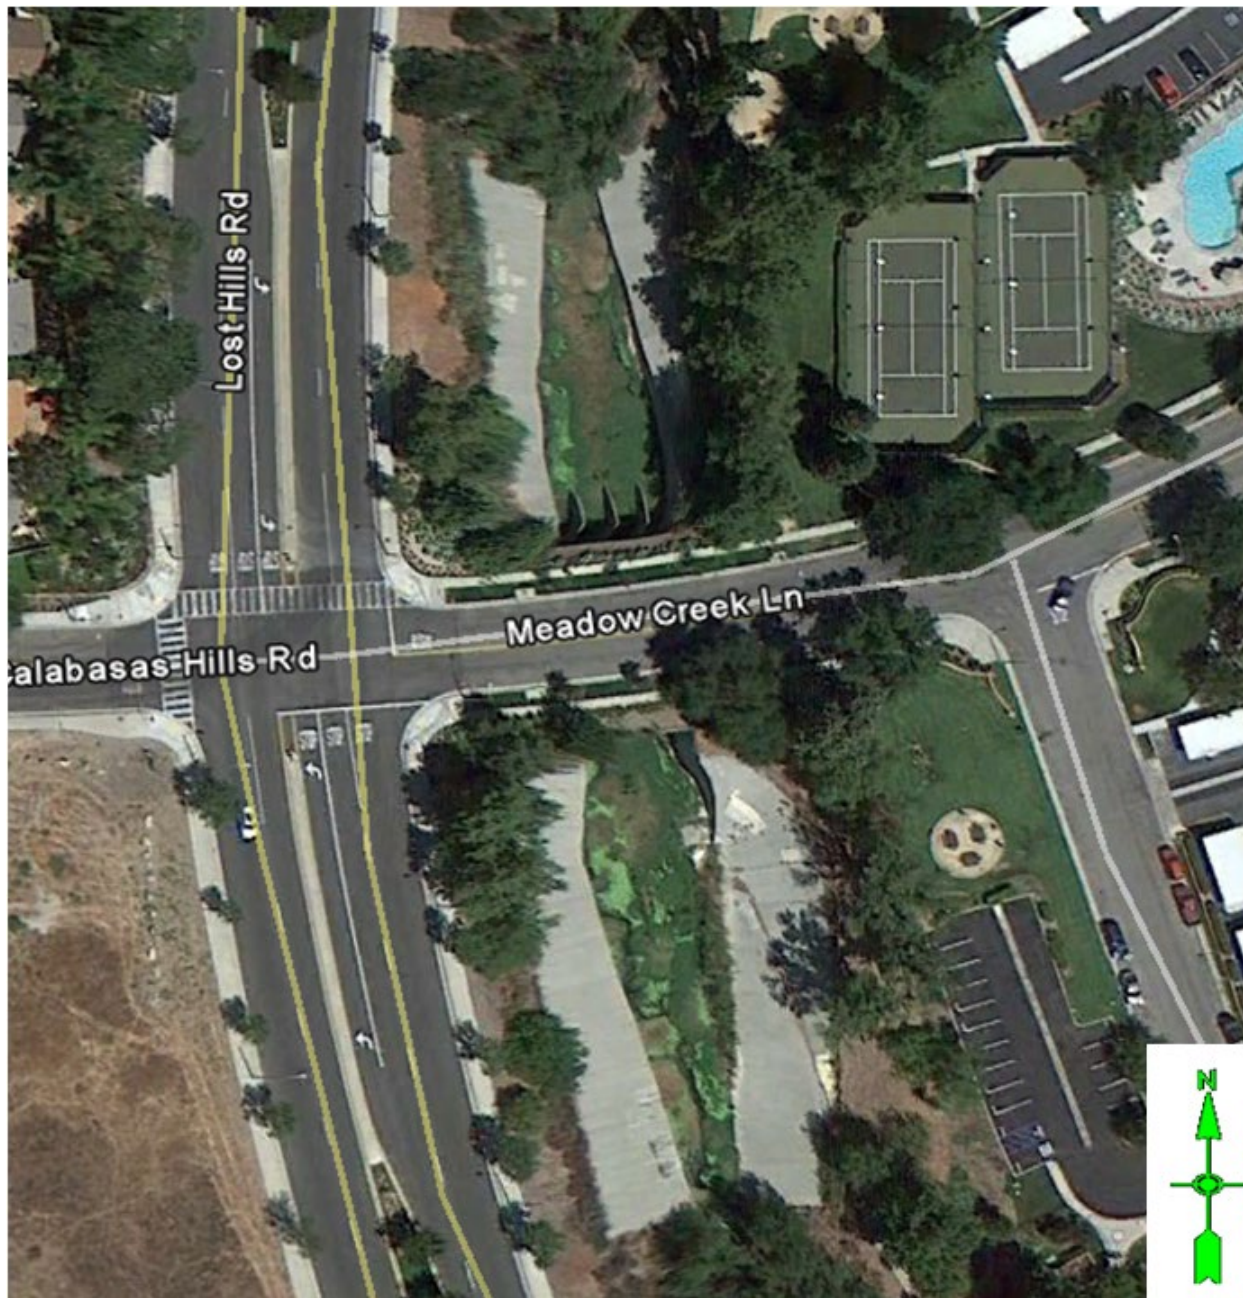
Figure 3.3-4 LV4, Meadow Creek Crossing (Aerial View)

Meadow Creek Lane Crossing, is 930 ft upstream of LV3 and consists of a 61 ft wide, 82 ft long concrete box culvert with four 14 ft x 14 ft openings. There are concrete aprons that extend 170 ft upstream of the inlet and 170 ft downstream of the outlet of the structure. Meadow Creek Lane is a two lane road that passes over the culvert and it serves as one of two points of entry into a densely developed residential neighborhood. Both structures are located on Las Virgenes Creek.

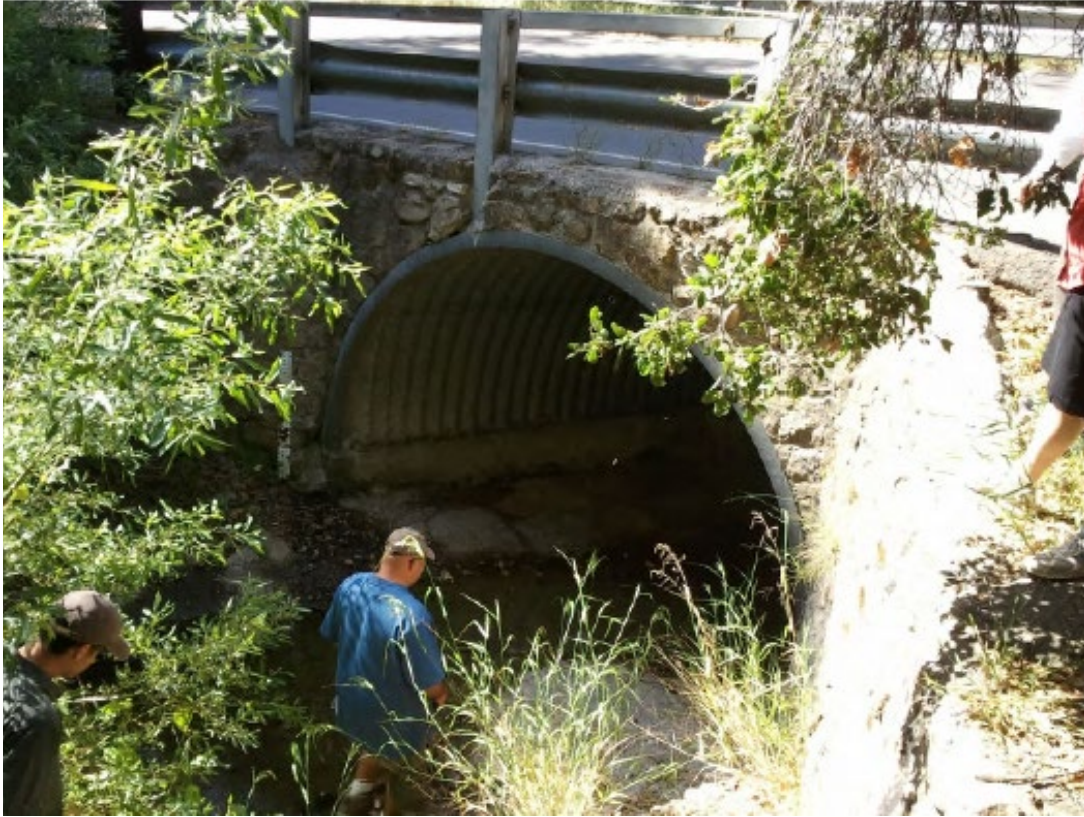
Figure 3.4-2 CC1, Piuma Culvert (Picture taken looking upstream)

CC1, Piuma Culvert is a 12 ft long, 46 ft wide corrugated metal pipe (CMP) arch culvert with a concrete invert. The downstream end of the concrete invert ends abruptly and there is a two foot drop from the top of the concrete invert to the creek bed. Piuma road is a two lane rural road that passes over the structure and provides access to homes throughout the hills. CC1 is located along a curve in Piuma Road. There is a 90 degree bend in Cold Creek approximately 50 feet downstream of the culvert where bed rock is exposed.

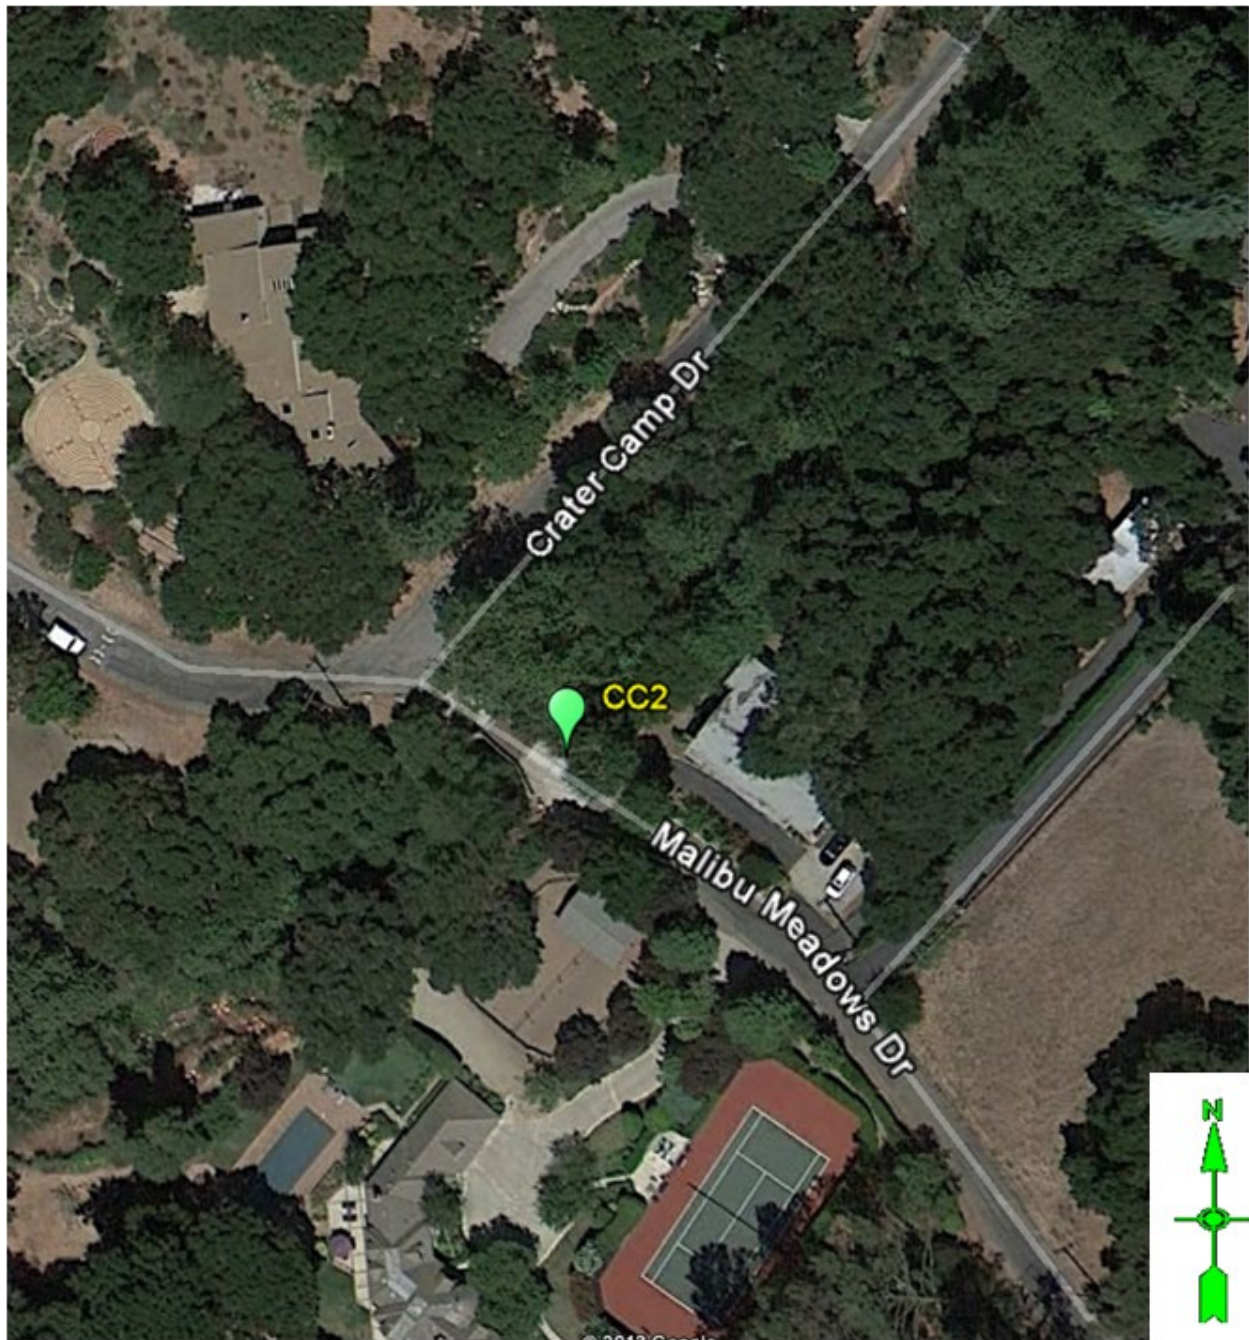
Figure 3.5-1 CC2, Malibu Meadows Road (Aerial Image)

CC2, Malibu Meadows Road Crossing, is a 28 ft wide, 40 ft long steel beam bridge with a wood deck. A concrete slab that is at least 18 inches thick passes under the bridge and ends abruptly just downstream of the structure. There is a two foot to three foot drop from the top of the concrete slab to the creek invert. The bridge is part of Malibu Meadows Road which is a narrow two lane road that serves homes throughout the hills.

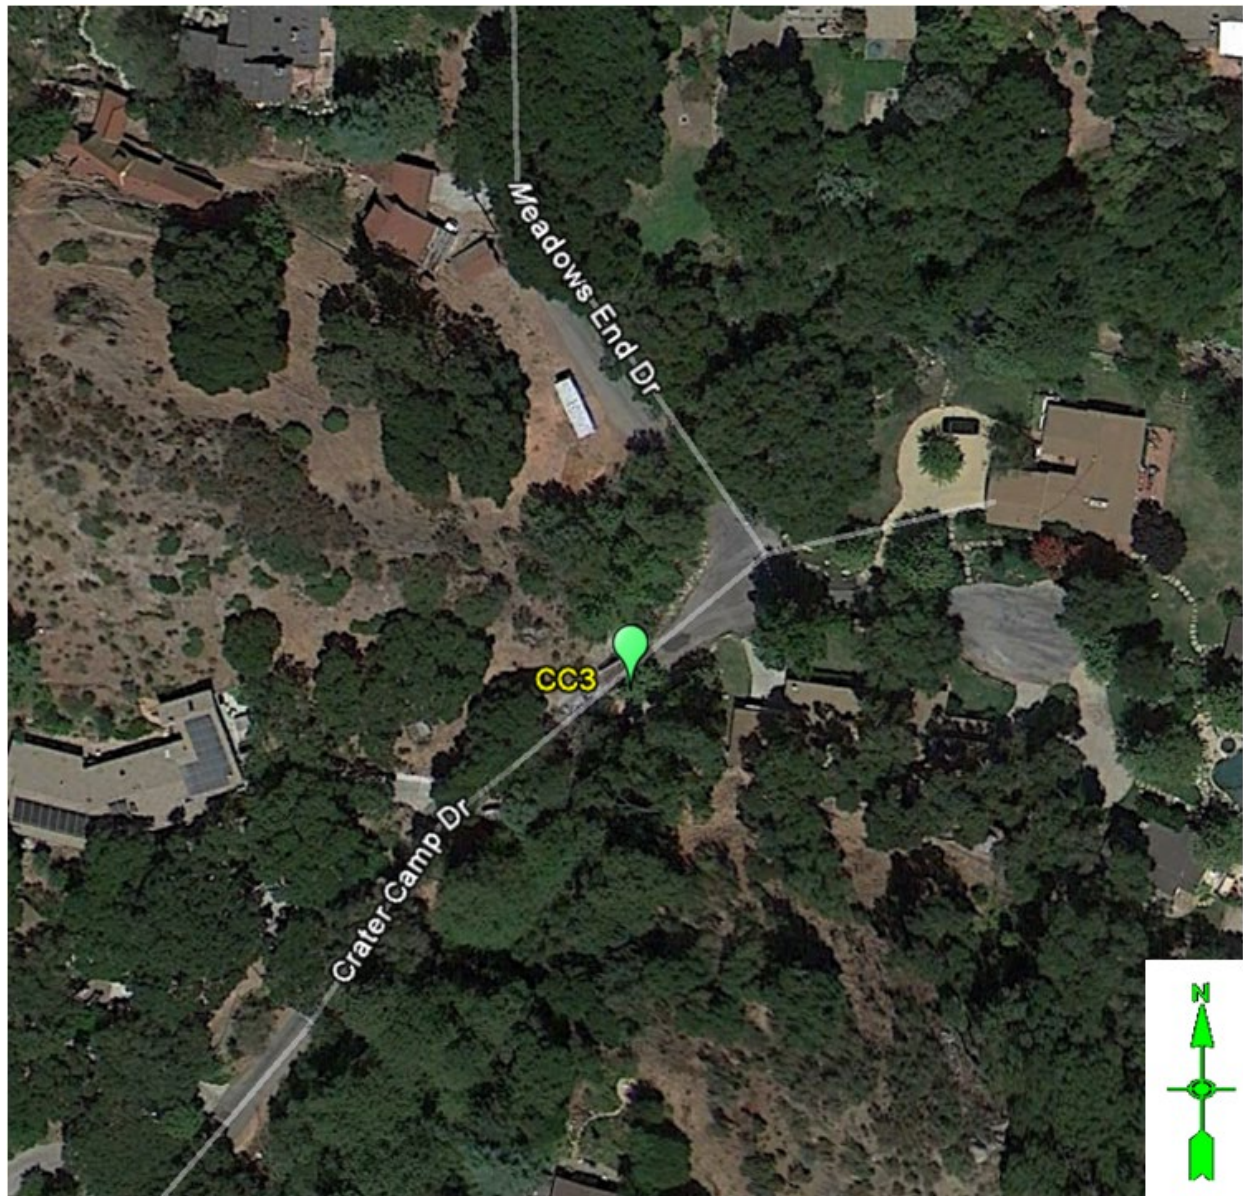
Figure 3.6-1 CC3, Crater Camp Road Crossing (Aerial Image)

CC3, Crater Camp Road Crossing, is 11 ft wide, 46 ft long steel beam bridge with a wood deck. A concrete slab that is at least 18 inches thick passes under the bridge and ends abruptly just downstream of the structure. There is a three foot drop from the top of the concrete slab to the top of the creek invert. The bridge is part of Crater Camp Road which is a narrow road that serves homes throughout the hills.

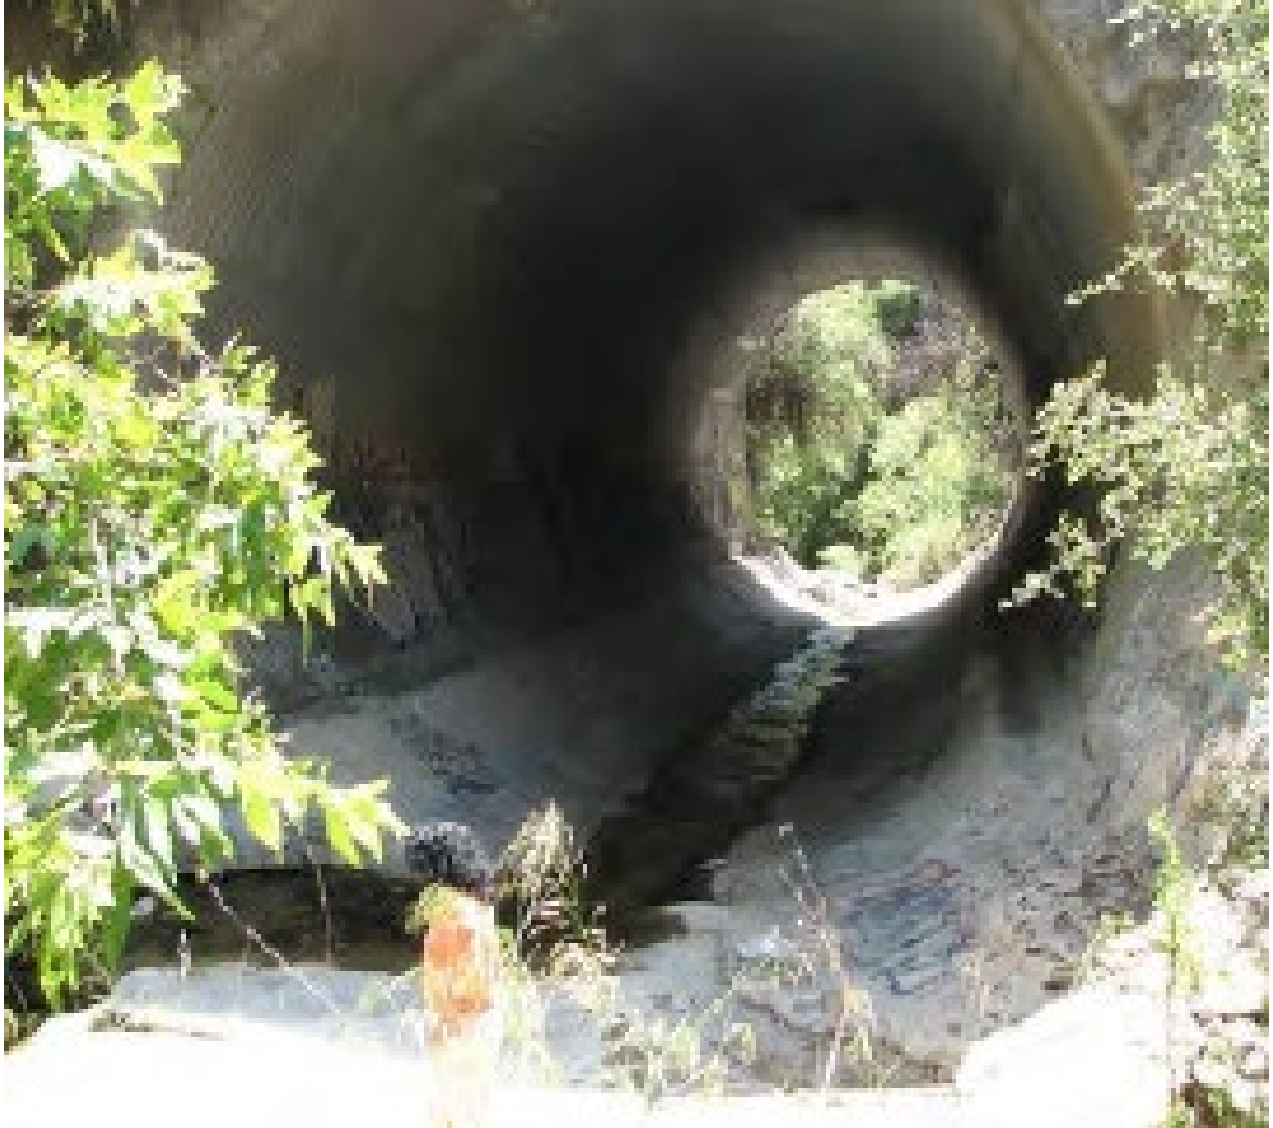
Figure 3.8-2 CC5, Cold Canyon Road Culvert (Picture taken looking upstream)

CC5, Cold Canyon Road Culvert is a 25 ft diameter concrete culvert along Cold Creek. Cold Canyon Road is a two lane rural road that serves homes in the mountains.

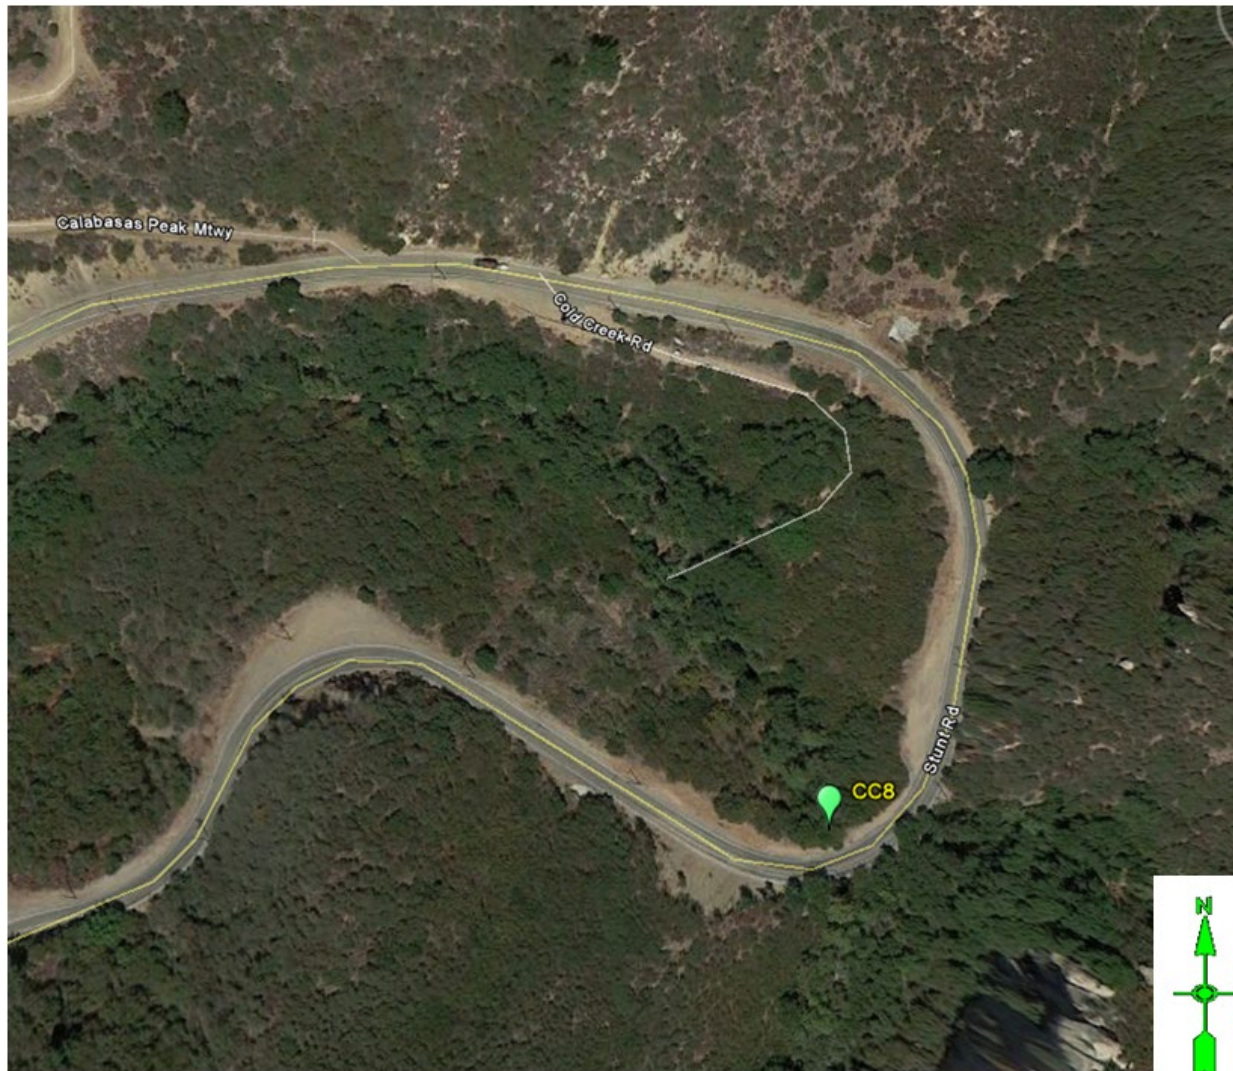
Figure 3.9-1 CC8, Stunt Road Crossing (Aerial)

CC8, Stunt Road Crossing is a six foot diameter CMP culvert that runs along the creek for 104 ft. The structure is covered with at least 20 ft of soil and has a stone headwall at the outlet that also acts as a retaining wall for the embankment of Stunt Road. Stunt Road is a two lane rural road that serves traffic passing through the mountains. The culvert is located along a curve in Stunt Road on Cold Creek.
