HISTORIC RESOURCE ASSESSMENT REPORT

Scholle Farm

APN 157-0-020-210

**Terminus of Ponderosa Drive at Springville Drive
Camarillo, Ventura County, CA**

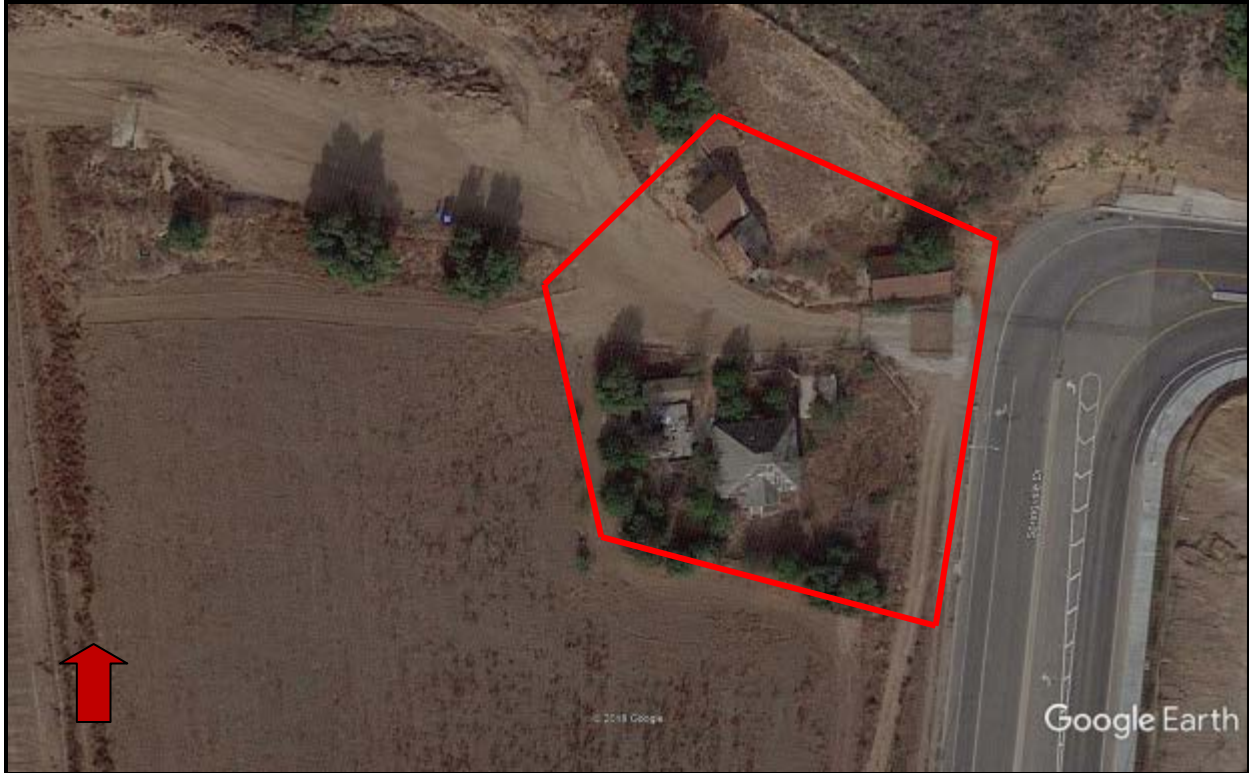
Figure 3: Aerial view of the remaining built-environment resources (except for well-head) of Scholle Farm.
(Source: Google Earth 2017)

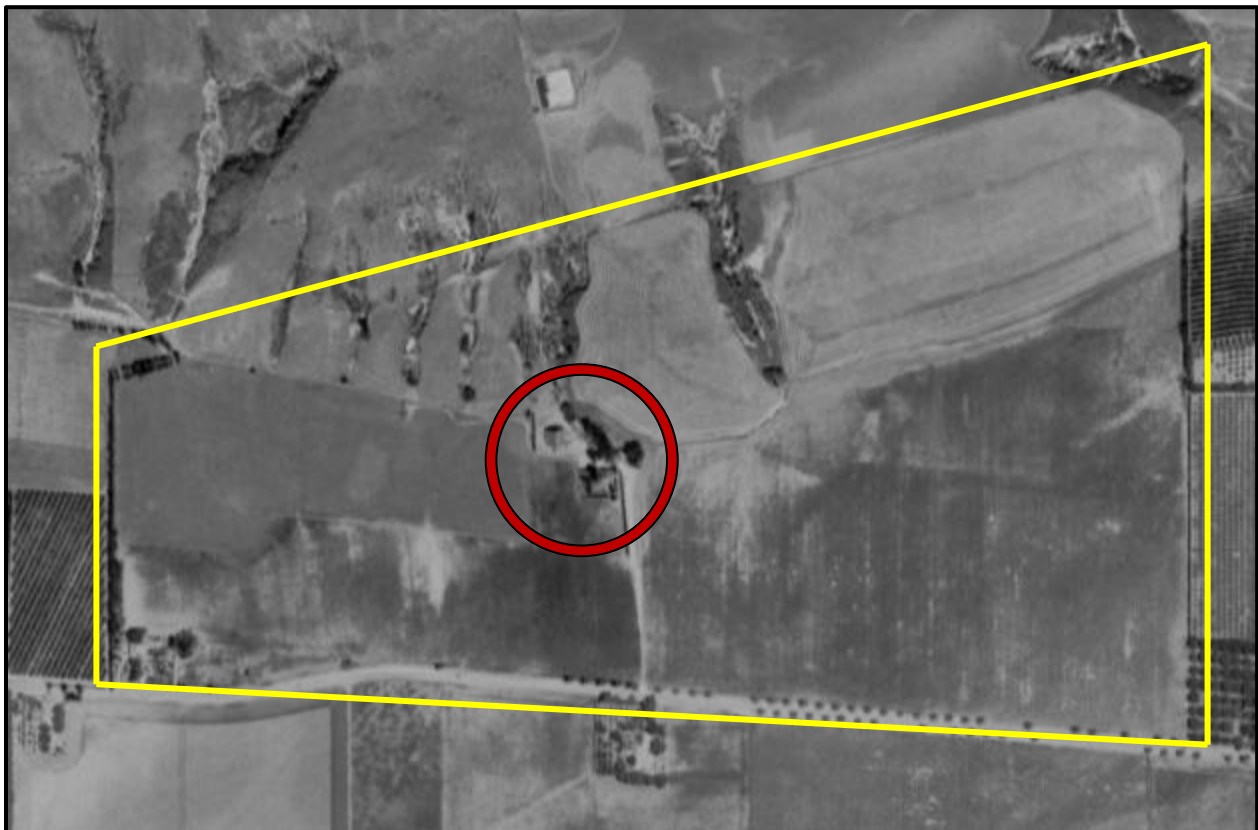
Figure 5: Aerial photograph of the C. M. Simmons parcels under the ownership of Edward Scholle Jr. in 1947. The highlighted boundary line was placed just outside of the boundary of the parcels for viewing the intentional physical boundaries that existed between neighboring parcels. The Scholle Farm house and barns are within the circle.

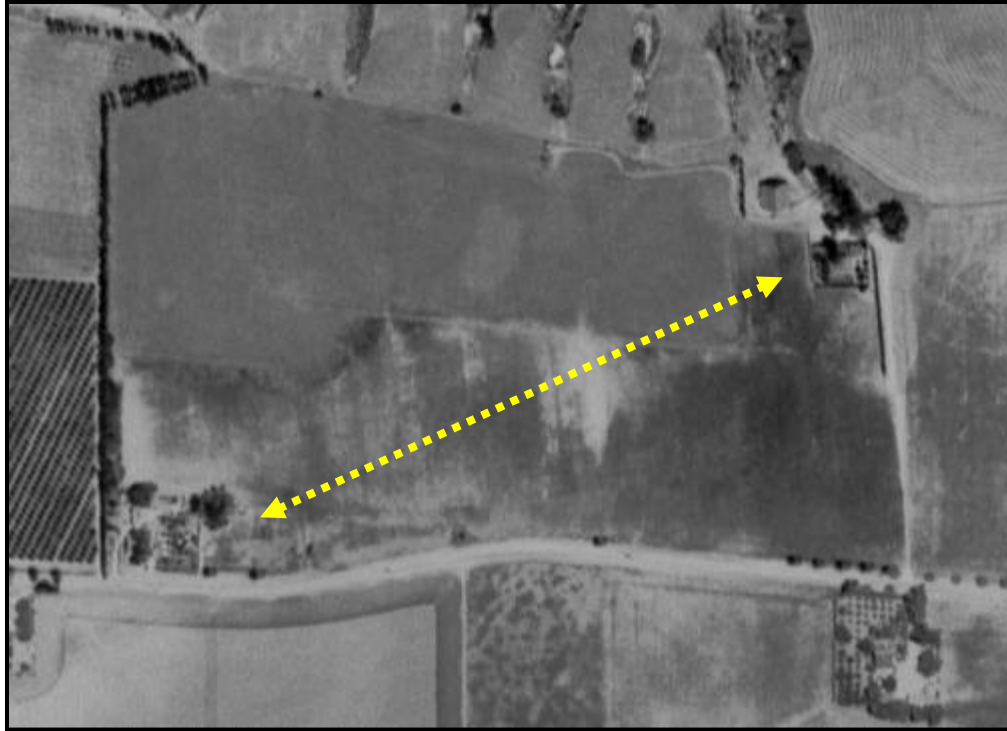
Figure 6: Aerial view of Scholle Farm buildings in 1947. It is entirely possible that the Scholle buildings had been moved from what appears to be an empty lot, along the road.

The extended family is so tightly integrated into the Springville community, that for the Census of 1900, Sheet 29 of the Hueneme Township enumeration has the John Scholle family, Ignatz Scholle family, Caspar Wucherpfennig family, Moritz Reiman family, and Joseph Reiman family, all living on adjoining properties in the same small area. Edward Scholle would come to purchase most of the old Simmons' patent lands from Moritz Reiman, and establish a farmstead there in 1895 (Figure 5). Christian Borchard passed away in 1903, and as the other immigrants grew older, many of the families moved away from agriculture, and from the Pleasant Valley region. As farms changed hands, and farms were consolidated, some of the buildings and structures may have been moved to a new home at the Scholle Farm (Figure 6).

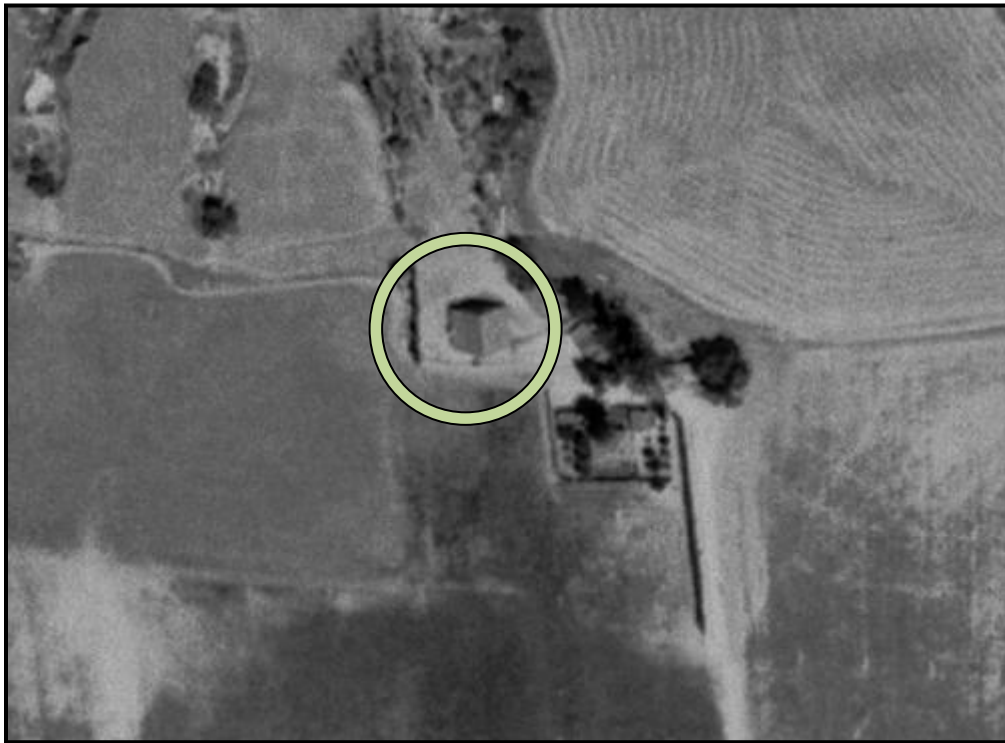
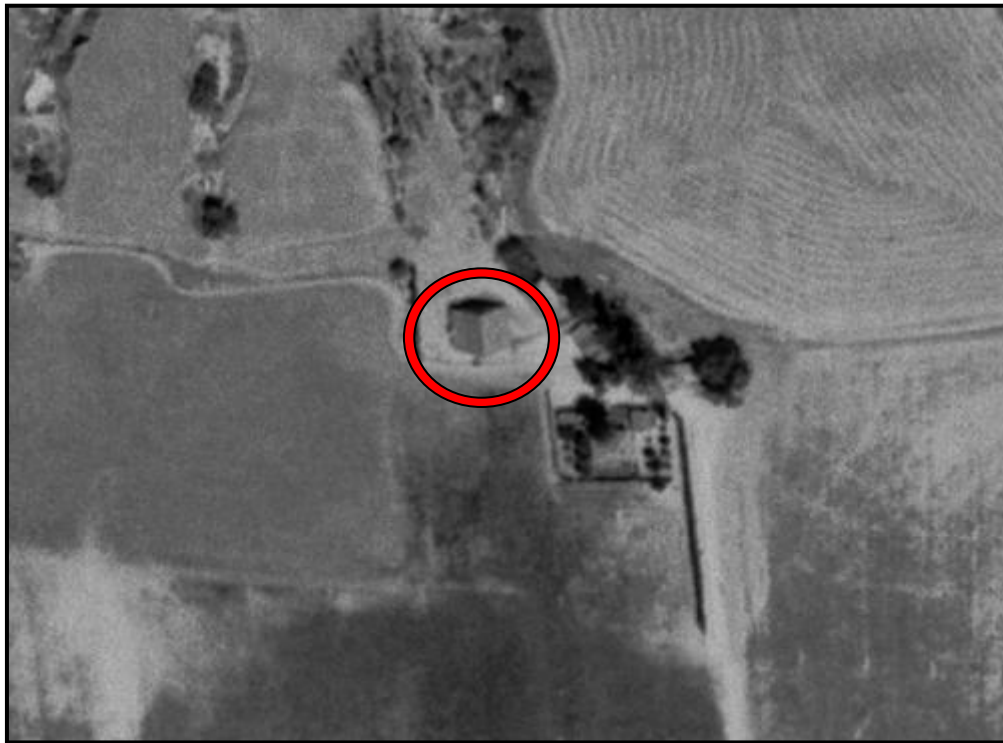
all the activity on the farm from the time it was constructed contemporaneously with the Scholle house being moved onto the property. In the early 1900s, up to the end of World War I, horses, mules, and occasionally oxen, provided the power for all the transportation, farm equipment, hauling, and heavy lifting needs on the farm. The barn would have housed valuable animals, and kept expensive machinery dry. For whatever reason, the main barn was removed before 1967, and was not replaced.

Figure 7: The original “farm” barn on the property in 1947. It was removed from the farm by 1967.
(Source: NETR Historic Aerials)

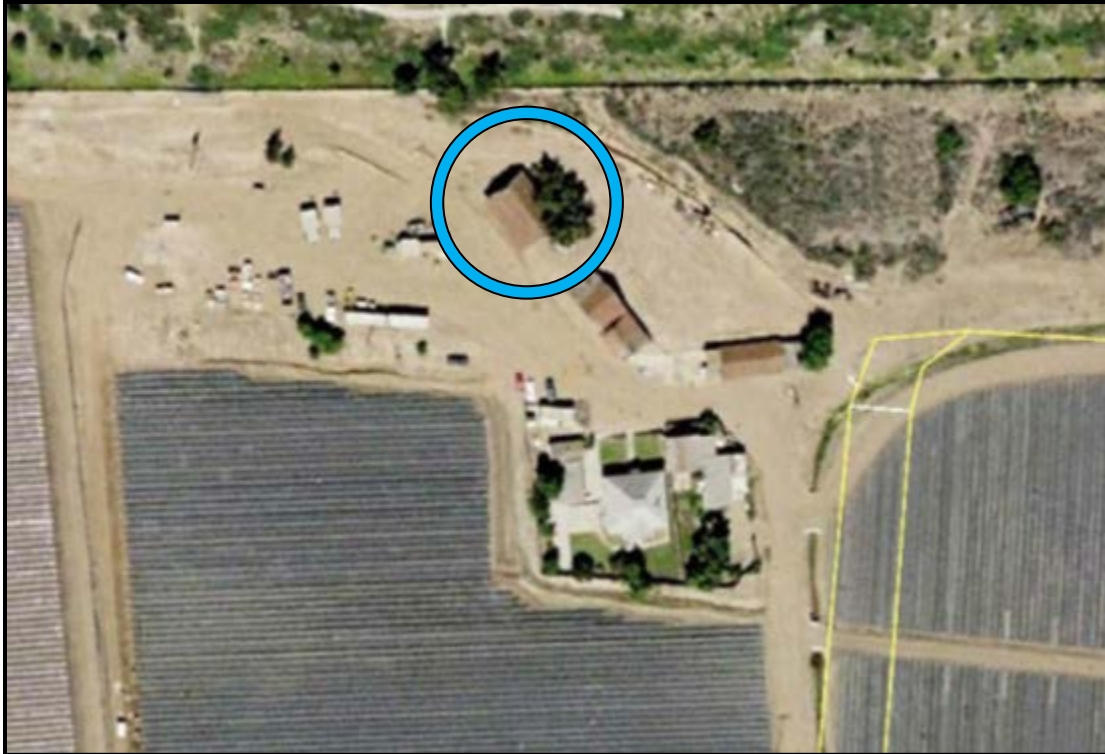
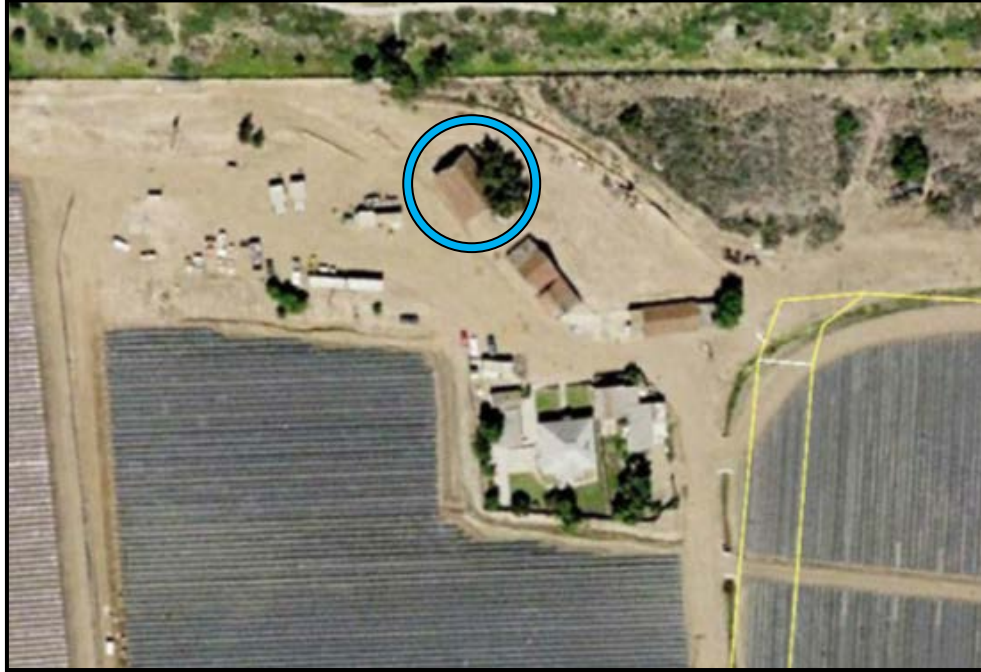
The other important building that is no longer on the farmstead is the packing shed. Based upon Gregory’s description that this building actually had a dirt floor, and from a photograph that shows the building with a steep-pitched gable roof, it is possible that the packing shed pre-dated the Scholle settlement on the property (Figure 8). Unfortunately, the packing shed was demolished in 2008. [Note: We were informed by the City of Camarillo that the packing shed was heavily damaged during a strong Santa Ana wind event. The building materials were subsequently cleared away by the property owners.]

Figure 8: Aerial view of the property in 2007 before the packing shed (in blue circle) was demolished.
(Source: Google Earth, imaged captured in 2007)

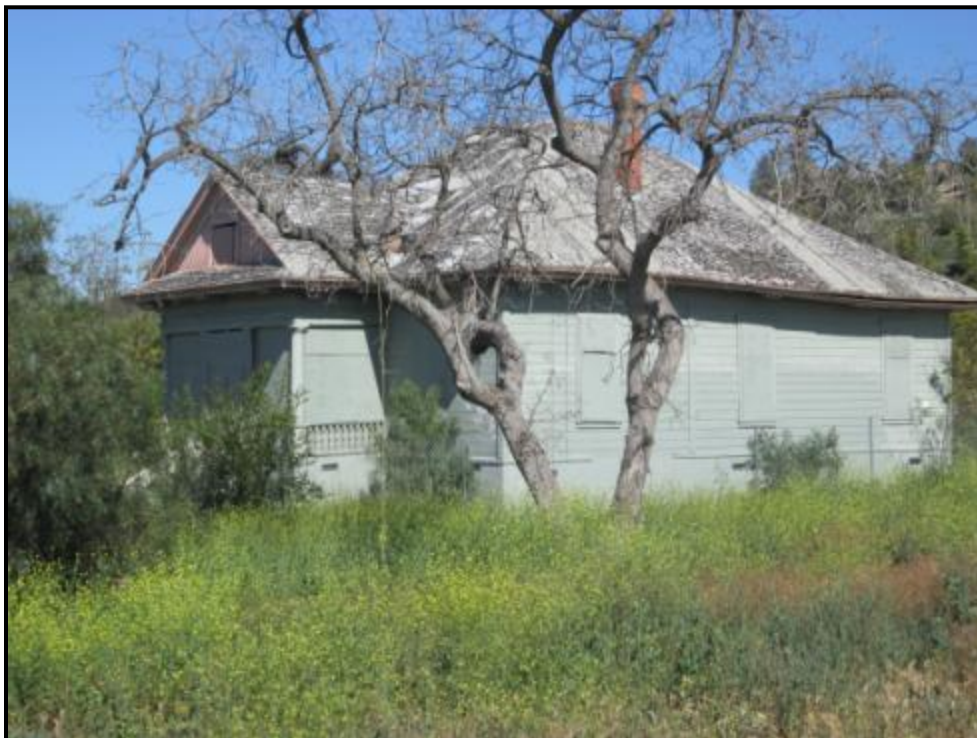
Resource #1 (McKenna #8): Main Residence/Farm House (constructed circa 1870)

Figure 9: Scholle Farm House. View looking northwest.

The main residence of the Scholle Farm is a one-story, rectangular-massed single-family abode that measures approximately 42 feet long by 45 feet wide, for 1,890 square feet of living space (Figure 9.) The building is clad in tongue-in-groove wood siding, and the corners are finished with plain, 4-inch wide corner boards. A medium-pitched hip roof covers the main body of the building, and a red brick chimney with a corbelled top rises from the east roof slope.⁴² Severely deteriorated asphalt shingles and roofing paper barely cover the roof surface. The roof has overhanging eaves, with box gutters along the eaves above the cornice, and shallow decorative brackets extend from under the eaves. The house sits on what appears to be a foundation wall made of poured concrete, concrete-masonry units, or other sturdy framing, and then clad with a thin cementitious parging. The crawl space vents are not of a type usually found on houses of this age.

The Scholle Farm House should be protected from any direct adverse physical changes to the buildings (demolition or substantial alterations), or indirect adverse changes (such as continued deterioration of the buildings caused by deferred maintenance. It is highly recommended that the roof be inspected and repaired, if only temporarily.)

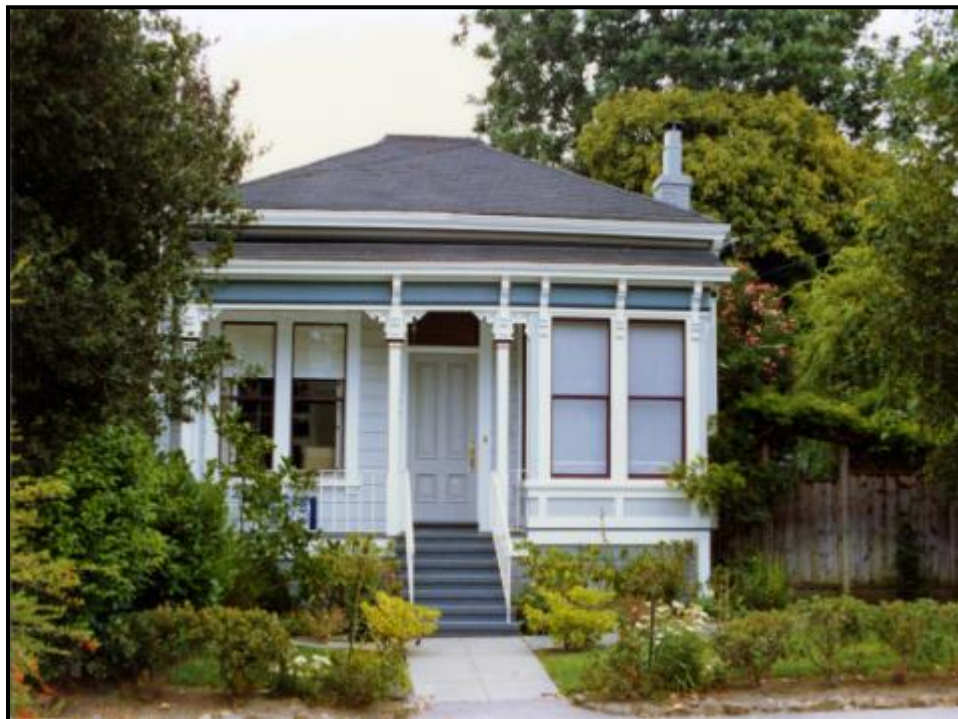
Figure 10: example of Italianate cottage.

designed as an Italianate style cottage (Figures 10 and 11). The character-defining features of the Italianate style are hip roofs, rectangular or squared massing, paired or single narrow 1/1 wood sash windows set symmetrically on the building, and overhanging boxed eaves with ornamental brackets. The buildings are usually sided with horizontal tongue-in-groove board, but as with many Victorian era buildings, there are very elaborate interpretations of the Italianate style residences, as well as modest versions found usually in urban settings.

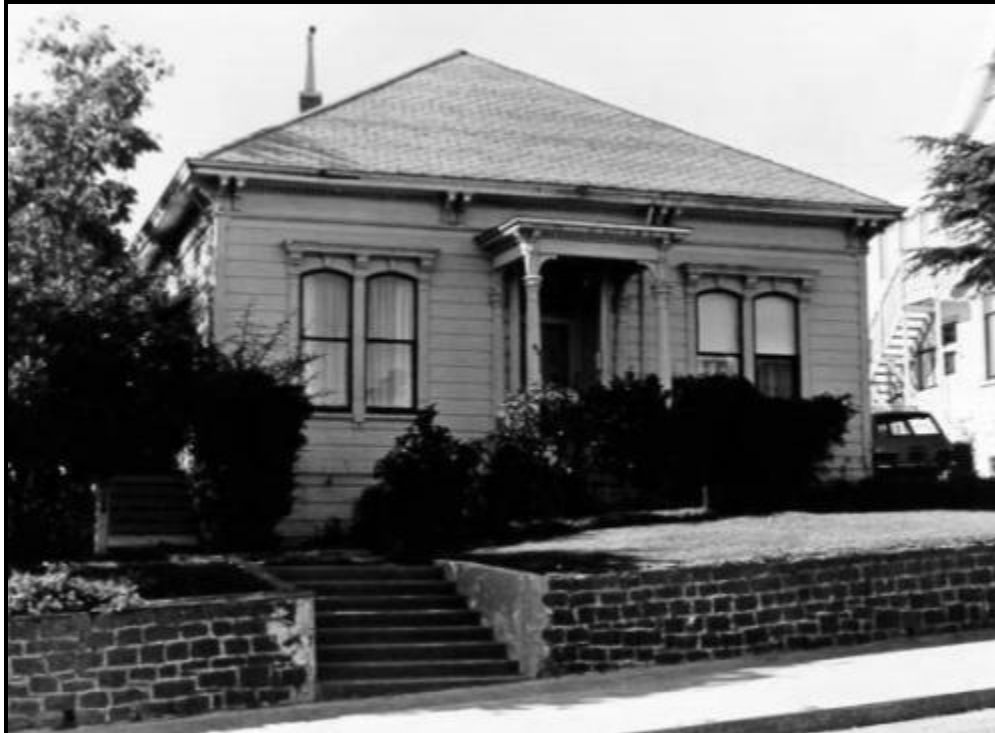
Figure 11: Italianate cottage, 1895.
(Source: Sonoma County Library, Historic Photograph Collection)

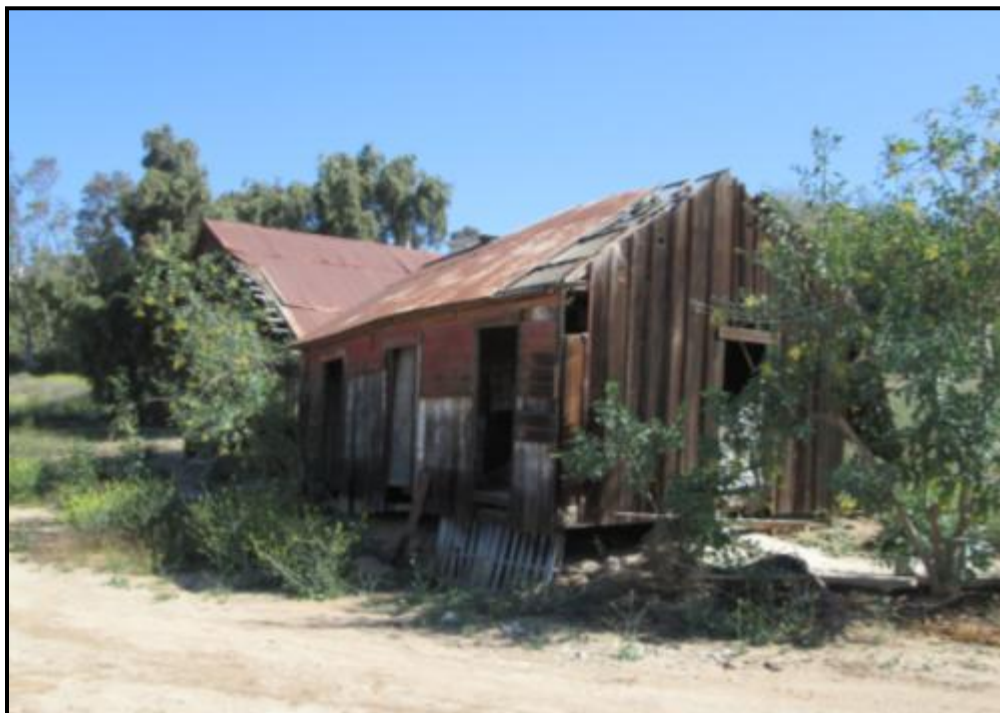
Resource #2 (McKenna #14): Small residence (constructed circa 1870)

Figure 12: Small residence, front (west) and south elevations. View looking north.

Gregory described the small residential unit as a “cabin”, which raises the image of a small building situated in a wild, forested or secluded area (Figure 12). Upon our investigation, and experience with similar architecture, we believe that the residence may have once served as a small, local, railroad depot building before it was considered no longer useful, and was moved and repurposed by the Scholle family on their land (Figure 13). The building could have originally been a supporting structure for the Bakersfield and Ventura Railway (circa 1885-1927) that ran from Port Hueneme to Bakersfield, by way of Santa Paula, that later became enveloped into the Southern Pacific Railroad line.⁴⁴

The original building measures approximately 22 feet long by 16 feet wide, and has a gable roof with wood shingles set on a northwest-southeast axis. The building was built on short wood posts, and concrete forms were used to create a shored foundation pad for the structure.

The northeast roof slope of the old depot building was extended with the addition of a shed roof used to cover an additional room built along the north facing façade. Due to its extremely deteriorated condition, it's likely that this building could have been used as a lodging house for workers or boarders, or it may have just been used for storage. It does not appear to have been ever rehabilitated to a level above sub-standard living conditions.

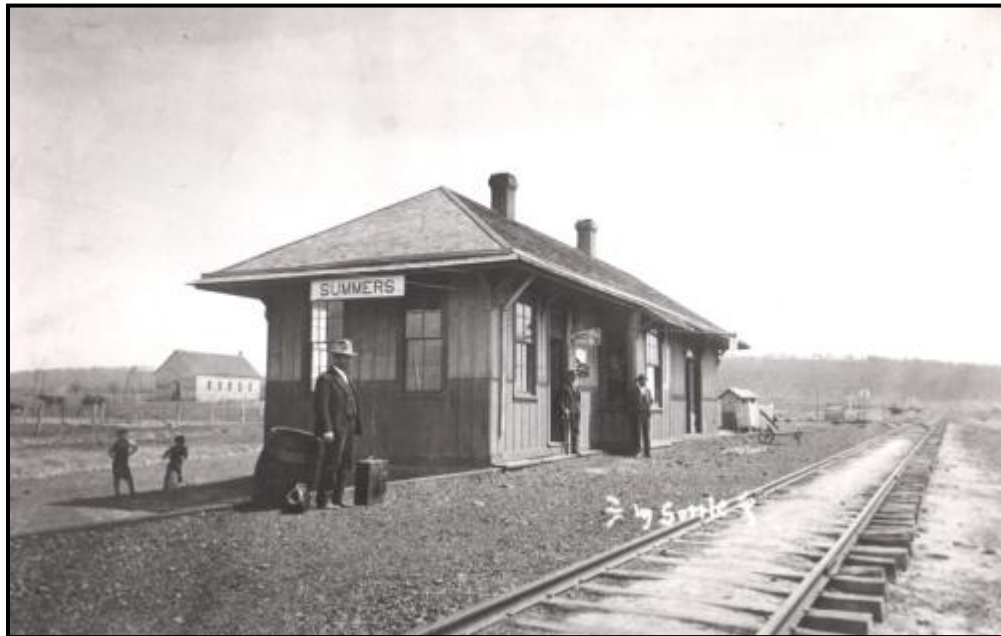
Figure 13: Example of a small railroad depot located in Summers, Arkansas, Frisco Central Division Stations. Note the board and batten siding. <https://condrenrails.com/Frisco%20Catalog/Frisco-Central-Division-Stations.htm>

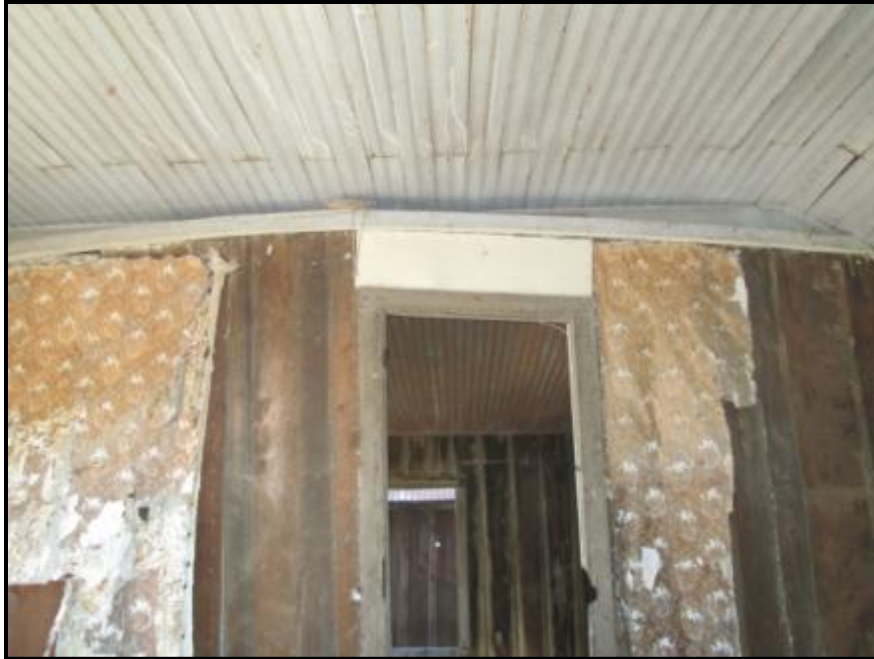
Early railroad buildings were designed with wood-paneled ceilings and walls as they could withstand the vibrations from frequent activity of the passing steam engines and their haulage. Finished plaster walls were expensive to install and maintain, whereas the wood paneling could be sent out by the railroad company to the depot, and a local carpenter could easily install new panels, or replaced damaged panels with little fuss. As shown in the following photographs, a distinctive characteristic of a small depot building is its canted ceiling (Figures 14 and 15).

Figure 14: Interior walls and ceilings of the small residence. Note that both the walls and ceiling are clad with either flat boards (walls) or narrow tongue-in-groove panels covering the ceiling. Also note that the ceiling is canted downwards where it meets the side walls of the room, and the top of the interior wall (with the scraps of remaining wall paper) is framed as an arch instead of meeting the ceiling. View looking from south room to the north.

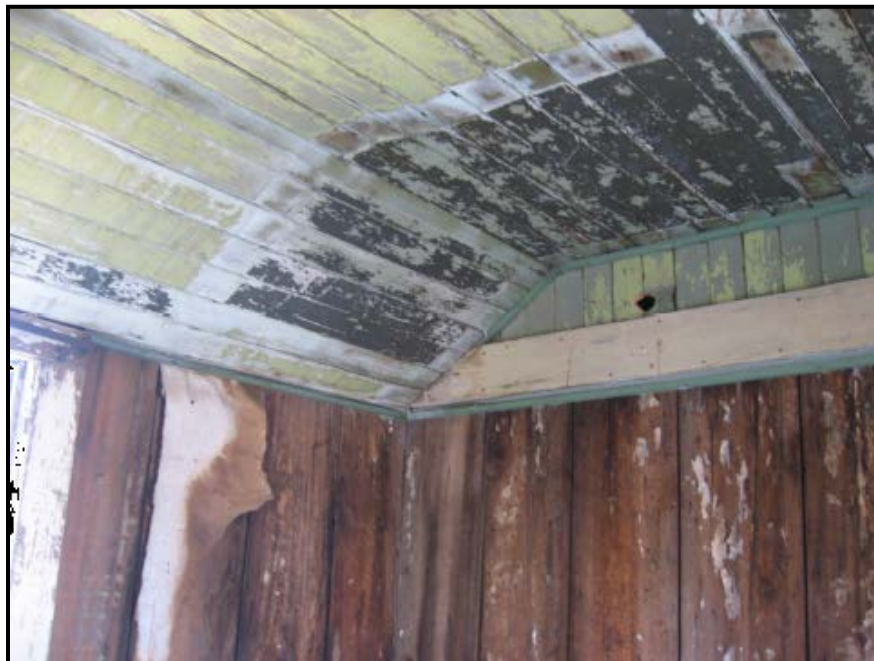
Figure 15: Photograph of the ceiling of "Percy's Place", Hudson Family Ranch, Taft, Kern County, California. This is a photograph of the interior of the small house that had been constructed with an abandoned railroad depot building. The Hudson family had moved the old depot building with teams of horses up into the hills where the ranch had been located since 1898. It has the same ceiling treatment of a wood paneled ceiling with canted corners where the ceiling meets the wood paneled walls. (Source: Daly, Pamela. *Final Historic Evaluation Report of Percy's Place and Associated Resources, Bitter Creek National Wildlife Refuge, Kern County, California.*, June 2010.)

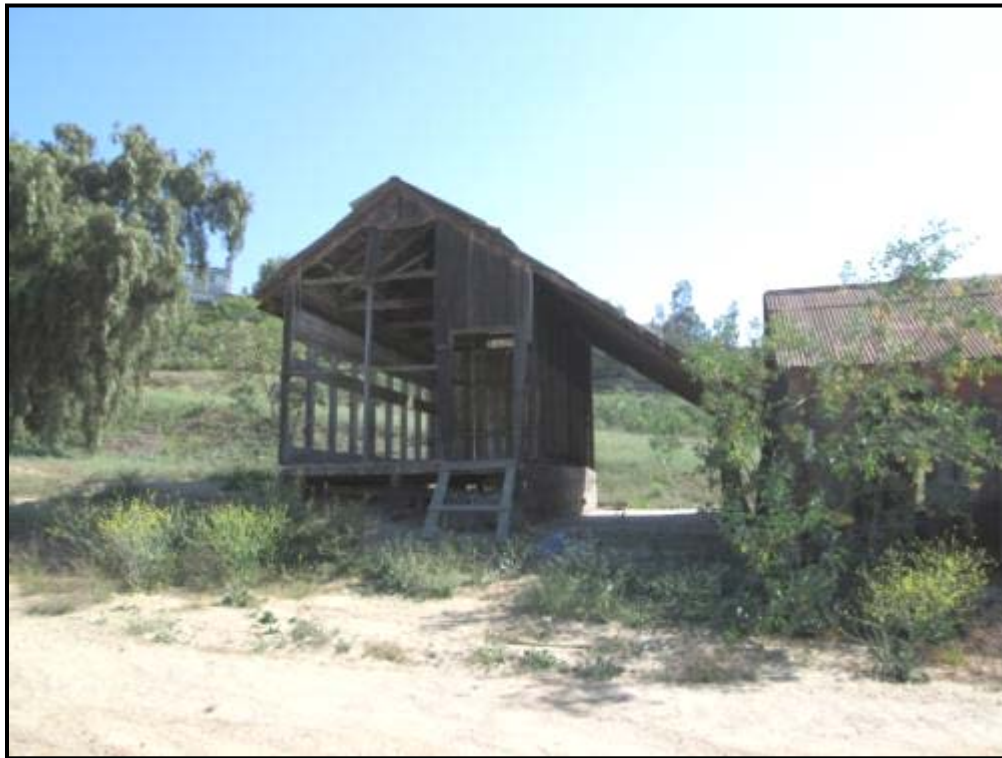
Resource #2a (McKenna #13): small barn (constructed circa 1870)

Figure 16: Small barn with side bay to cover wagons/trucks. View looking east.

This one-story, wood-frame structure, with a medium-pitch gable roof set on an east-west axis, measures approximately 35 feet long by 20 feet wide (Figure 16). When the structure was moved to the property, it was constructed on an elevated foundation of posts and poured concrete walls, so that an extension of the south facing roof slope could become a cover for a vehicle parked underneath on a concrete pad. The exposed wood members have kerf marks from both large circular saws used by lumber mills, and by band saws that were used to resaw large timbers into boards. Much of the original siding is missing, so this structure may have been used for utilitarian purposes to store hay or alfalfa.

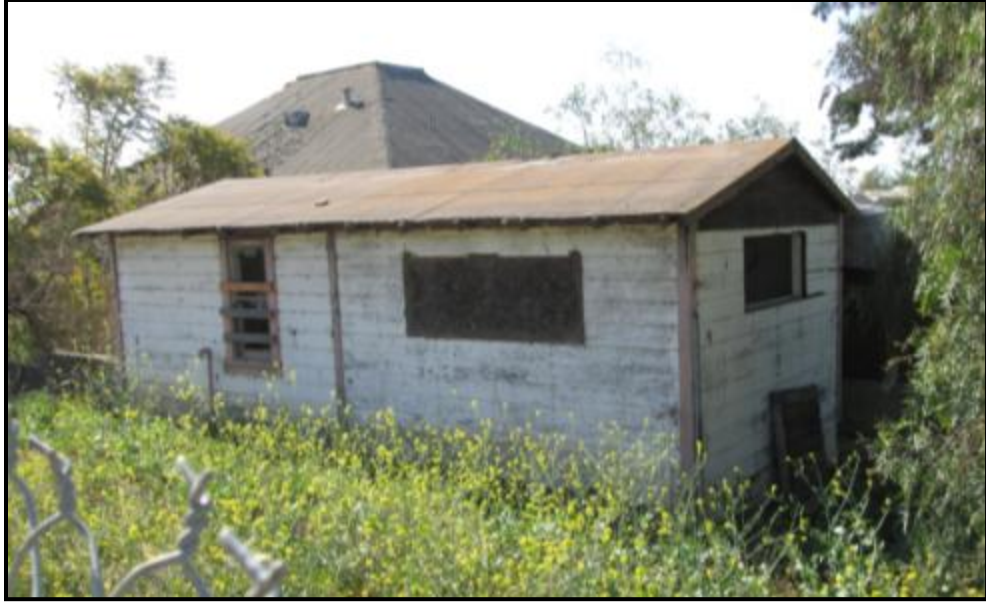
Resource #4 (McKenna #9 and #11): Rental or lodger house, day-laborer facilities

This building is a one-story, narrow rectangular-massed, wood-frame structure that may have served as a small homestead home, before being moved to its current location and altered for another purpose, which is unknown (Figure 18). The building measures approximately 24 feet long by 12 feet wide, and has a medium pitch gable roof set on an east-west axis, with narrow rafter tails extending from under the eaves. The building is clad in tightly butted tongue-in-groove siding with plain, flat corner boards. The building currently sits on a poured concrete foundation. The visible fenestration is comprised of 1/1 wood frame, double hung, eared, sash windows that have flat surrounds, sill and apron. The building does not appear in historic aerial photographs of the farmstead until after 1967.

McKenna described the shed/kitchen/dining building as being contained within a “relatively large shed” with a shed roof that sits on a poured concrete foundation pad. It appears the building was used to serve as a cooking and dining area for workers, and was outfitted with plumbing for kitchen and bathroom facilities. The outdoor dining facility appears in the 1947 aerial photograph of the property.

Figure 18: Guest house/bunkhouse situated to the immediate northeast of the main house. View looking southeast. One of the original Victorian-era windows is on the left hand side of the north elevation, while one of the new, unfinished openings is visible in the upper façade of the west elevation.

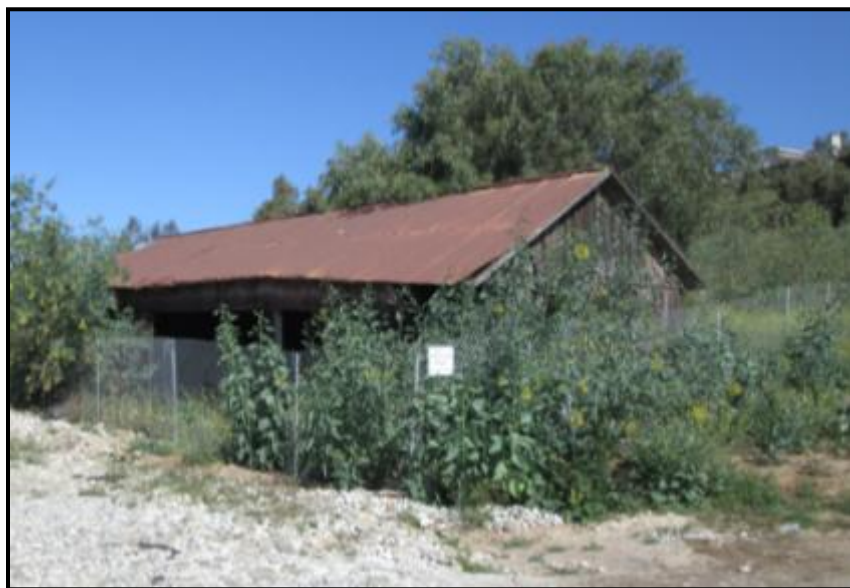
Resource #5 (McKenna 12): Garage/Workshop (constructed circa 1920)

The one-story, utilitarian, wood-framed building measures approximately 36 feet long by 22 feet wide, and has a low pitch gable roof set on an east-west axis (Figure 19). Based upon the raised, poured concrete foundation created to foot the building, the board and batten siding on the west and east elevations, and the presumed date of the installation of the building on the farmstead in 1924, this may be an additional building that was abandoned by the local railroad and rehabilitated for use on the Scholle Farm.

Figure 19: Workshop/garage building. View looking northwest.

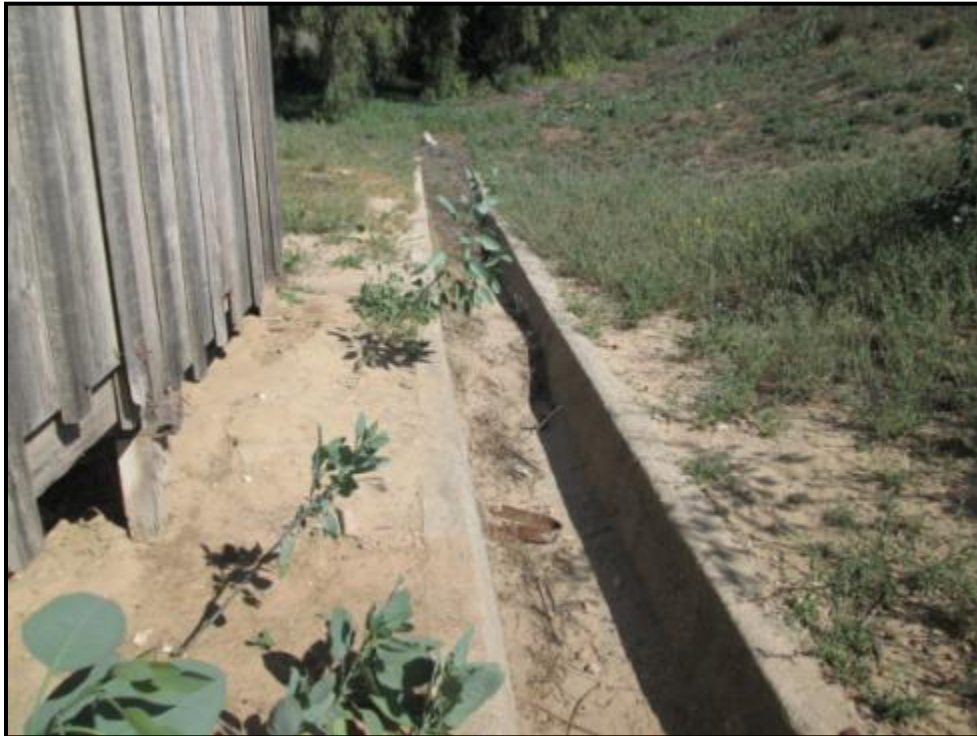
Resource #13: Segment of concrete-lined diversion ditch (constructed circa 1900)

Based upon review of the aerial photographs of the Scholle Farm property and its surrounding topography in 1947, one can see how the Scholles would have used the natural topography of the entire hillside to the north, to provide its cultivated acreage with runoff from the hills. It also appears that at some point in time, diversion ditches were constructed across the base of the hillside to move the runoff across all of the acreage. We believe that the relatively narrow, and shallow, concrete-lined diversion ditch that runs along the east sides of the old barn and the small residence was created to keep water away from the main activity area of the farmstead; not as a main irrigation conduit (Figure 20).

Figure 20: Diversion ditch to the immediate east of the old barn. View looking north.

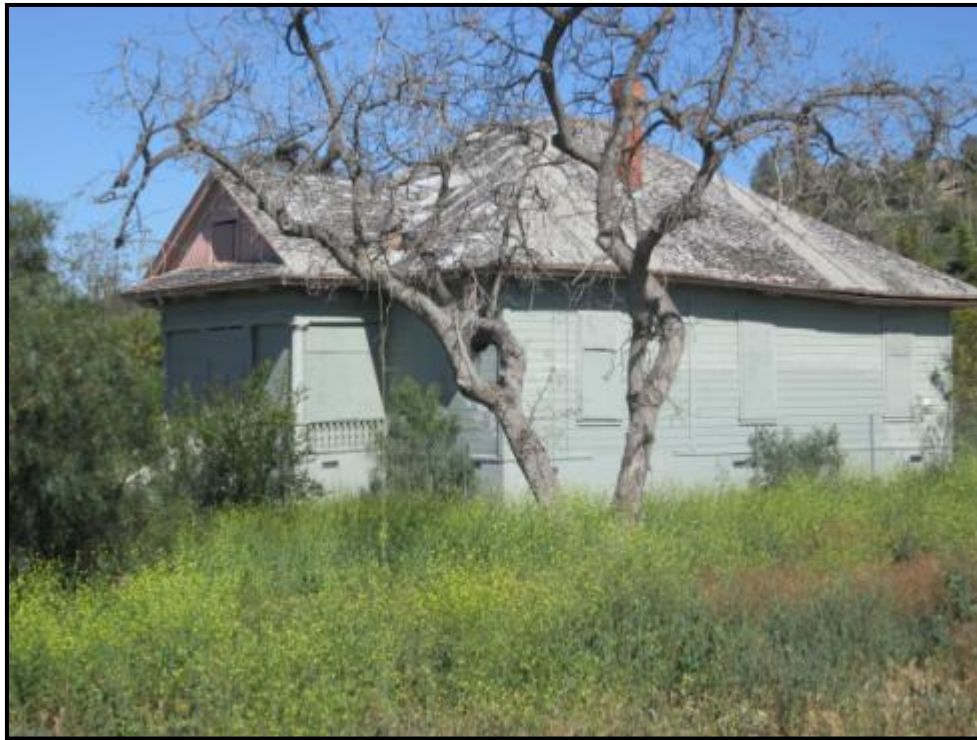
The main residence of the Scholle Farm is a one-story, rectangular-massed single-family abode that measures approximately 42 feet long by 45 feet wide, for 1,890 square feet of living space (Figure 9.) The building is clad in tongue-in-groove wood siding, and the corners are finished with plain, 4-inch wide corner boards. A medium-pitched hip roof covers the main body of the building, and a red brick chimney with a corbelled top rises from the east roof slope. Severely deteriorated asphalt shingles and roofing paper barely cover the roof surface. The roof has overhanging eaves, with box gutters along the eaves above the cornice, and shallow decorative brackets extend from under the eaves. The house sits on what appears to be a foundation wall made of poured concrete, concrete-masonry units, or other sturdy framing, and then clad with a thin cementitious parging. The crawl space vents are not of a type usually found on houses of this age.

Figure 9: Scholle Farm House. View looking northwest.

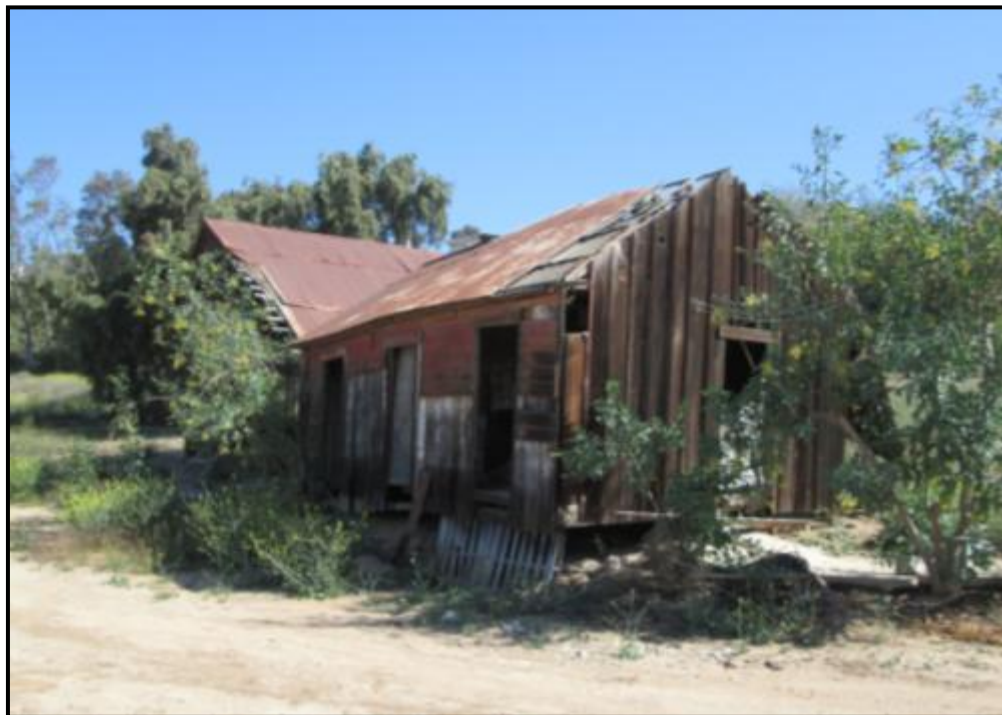
Gregory described the small residential unit as a “cabin”, which raises the image of a small building situated in a wild, forested or secluded area. Upon our investigation, and experience with similar architecture, we believe that the residence may have once served as a small, local, railroad depot building before it was considered no longer useful, and was moved and repurposed by the Scholle family on their land. The building could have originally been a supporting structure for the Bakersfield and Ventura Railway (circa 1885-1927) that ran from Port Hueneme to Bakersfield, by way of Santa Paula, that later became enveloped into the Southern Pacific Railroad line.

Small residence, front (west) and south elevations. View looking north.

The original building measures approximately 22 feet long by 16 feet wide, and has a gable roof with wood shingles set on a northwest-southeast axis. The building was built on short wood posts, and concrete forms were used to create a shored foundation pad for the structure.

The northeast roof slope of the old depot building was extended with the addition of a shed roof used to cover an additional room built along the north facing façade. Due to its extremely deteriorated condition, it's likely that this building could have been used as a lodging house for workers or boarders, or it may have just been used for storage. It does not appear to have been ever rehabilitated to a level above sub-standard living conditions. (See Continuation sheets for additional text.)

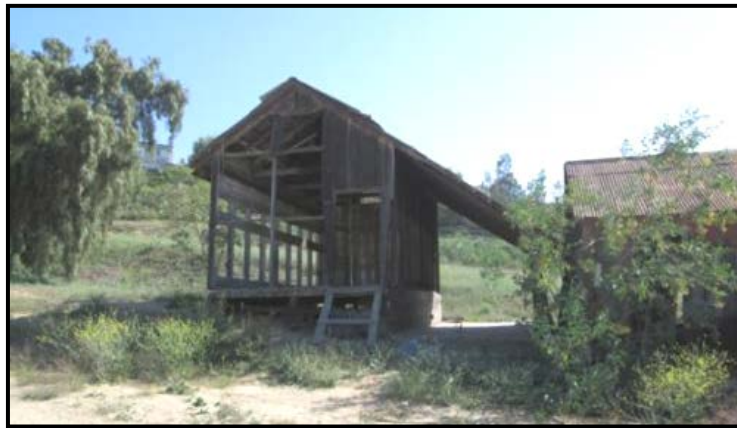
This one-story, wood-frame structure, with a medium-pitch gable roof set on an east-west axis, measures approximately 35 feet long by 20 feet wide. When the structure was moved to the property, it was constructed on an elevated foundation of posts and poured concrete walls, so that an extension of the south facing roof slope could become a cover for a vehicle parked underneath on a concrete pad. The exposed wood members have kerf marks from both large circular saws used by lumber mills, and by band saws that were used to resaw large timbers into boards. Much of the original siding is missing, so this structure may have been used for utilitarian purposes to store hay or alfalfa.

Small barn with side bay to cover wagons/trucks. View looking east.

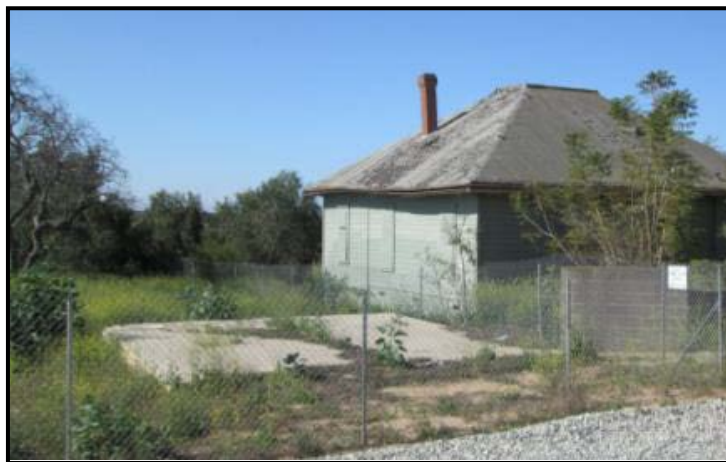
Resource #3 (McKenna #10): Concrete pad

All that remains of what may have been a separate living unit in this location (according to Gregory) is the concrete pad. According to aerial photographs of the site available from Google Earth, the house was demolished between April 2011 and August 2012.

Concrete pad. View looking south.

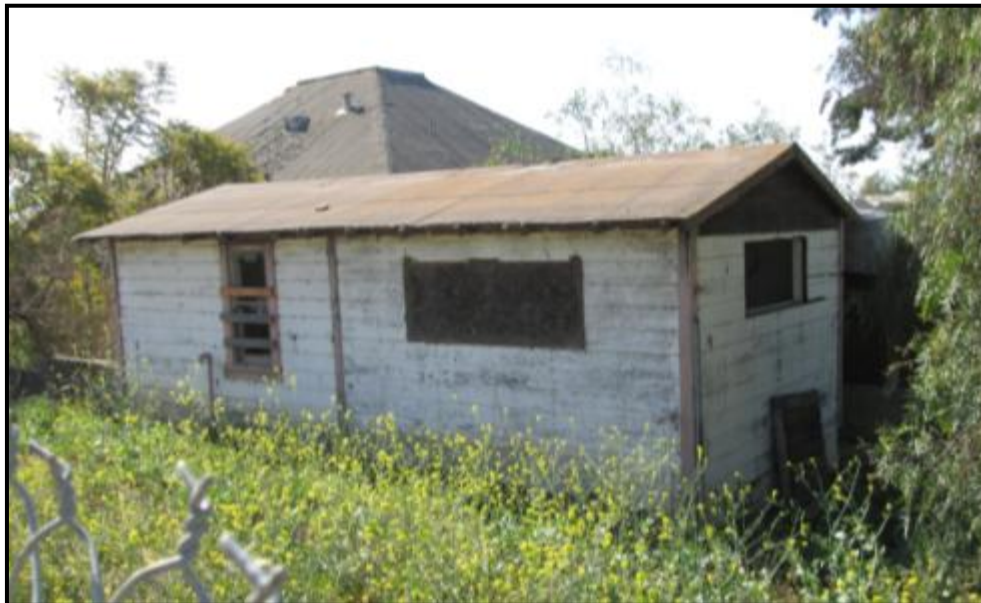
This building is a one-story, narrow rectangular-massed, wood-frame structure that may have served as a small homestead home, before being moved to its current location and altered for another purpose, which is unknown. The building measures approximately 24 feet long by 12 feet wide, and has a medium pitch gable roof set on an east-west axis, with narrow rafter tails extending from under the eaves. The building is clad in tightly butted tongue-in-groove siding with plain, flat corner boards. The building currently sits on a poured concrete foundation. The visible fenestration is comprised of 1/1 wood frame, double hung, eared, sash windows that have flat surrounds, sill and apron. The building does not appear in historic aerial photographs of the farmstead until after 1967.

McKenna described the shed/kitchen/dining building as being contained within a “relatively large shed” with a shed roof that sits on a poured concrete foundation pad. It appears the building was used to serve as a cooking and dining area for workers, and was outfitted with plumbing for kitchen and bathroom facilities. The outdoor dining facility appears in the 1947 aerial photograph of the property.

Guest house/bunkhouse situated to the immediate northeast of the main house. View looking southeast. One of the original Victorian-era windows is on the left hand side of the north elevation, while one of the new, unfinished openings is visible in the upper façade of the west elevation.

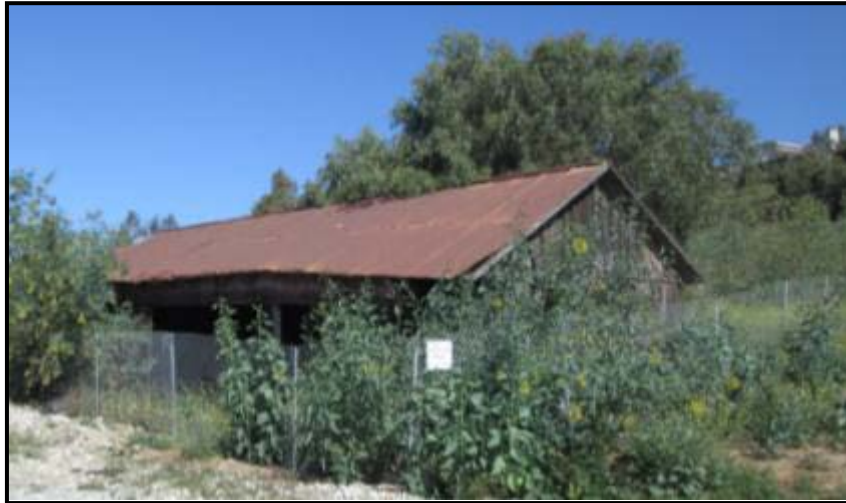
The one-story, utilitarian, wood-framed building measures approximately 36 feet long by 22 feet wide, and has a low pitch gable roof set on an east-west axis. Based upon the raised, poured concrete foundation created to foot the building, the board and batten siding on the west and east elevations, and the presumed date of the installation of the building on the farmstead in 1924, this may be an additional building that was abandoned by the local railroad and rehabilitated for use on the Scholle Farm.

Workshop/garage building. View looking northwest.

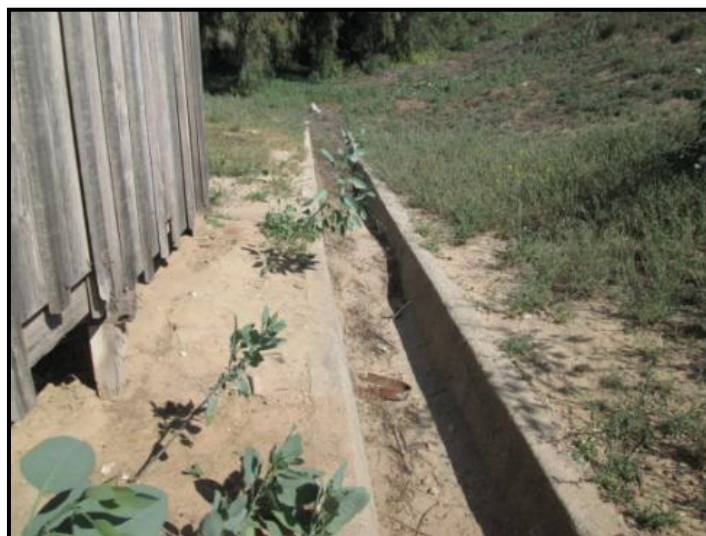
Resource #13: Segment of concrete-lined diversion ditch (constructed circa 1900)

Based upon review of the aerial photographs of the Scholle Farm property and its surrounding topography in 1947, one can see how the Scholles would have used the natural topography of the entire hillside to the north, to provide its cultivated acreage with runoff from the hills. It also appears that at some point in time, diversion ditches were constructed across the base of the hillside to move the runoff across all of the acreage. We believe that the relatively narrow, and shallow, concrete-lined diversion ditch that runs along the east sides of the old barn and the small residence was created to keep water away from the main activity area of the farmstead; not as a main irrigation conduit.

Diversion ditch to the immediate east of the old barn. View looking north.
