California High-Speed Rail Authority

Bakersfield to Palmdale Project Section

Section 3.10 Hazards and Hazardous
Wastes

Appendix 3.10-A
Sites of Potential Environmental
Concern

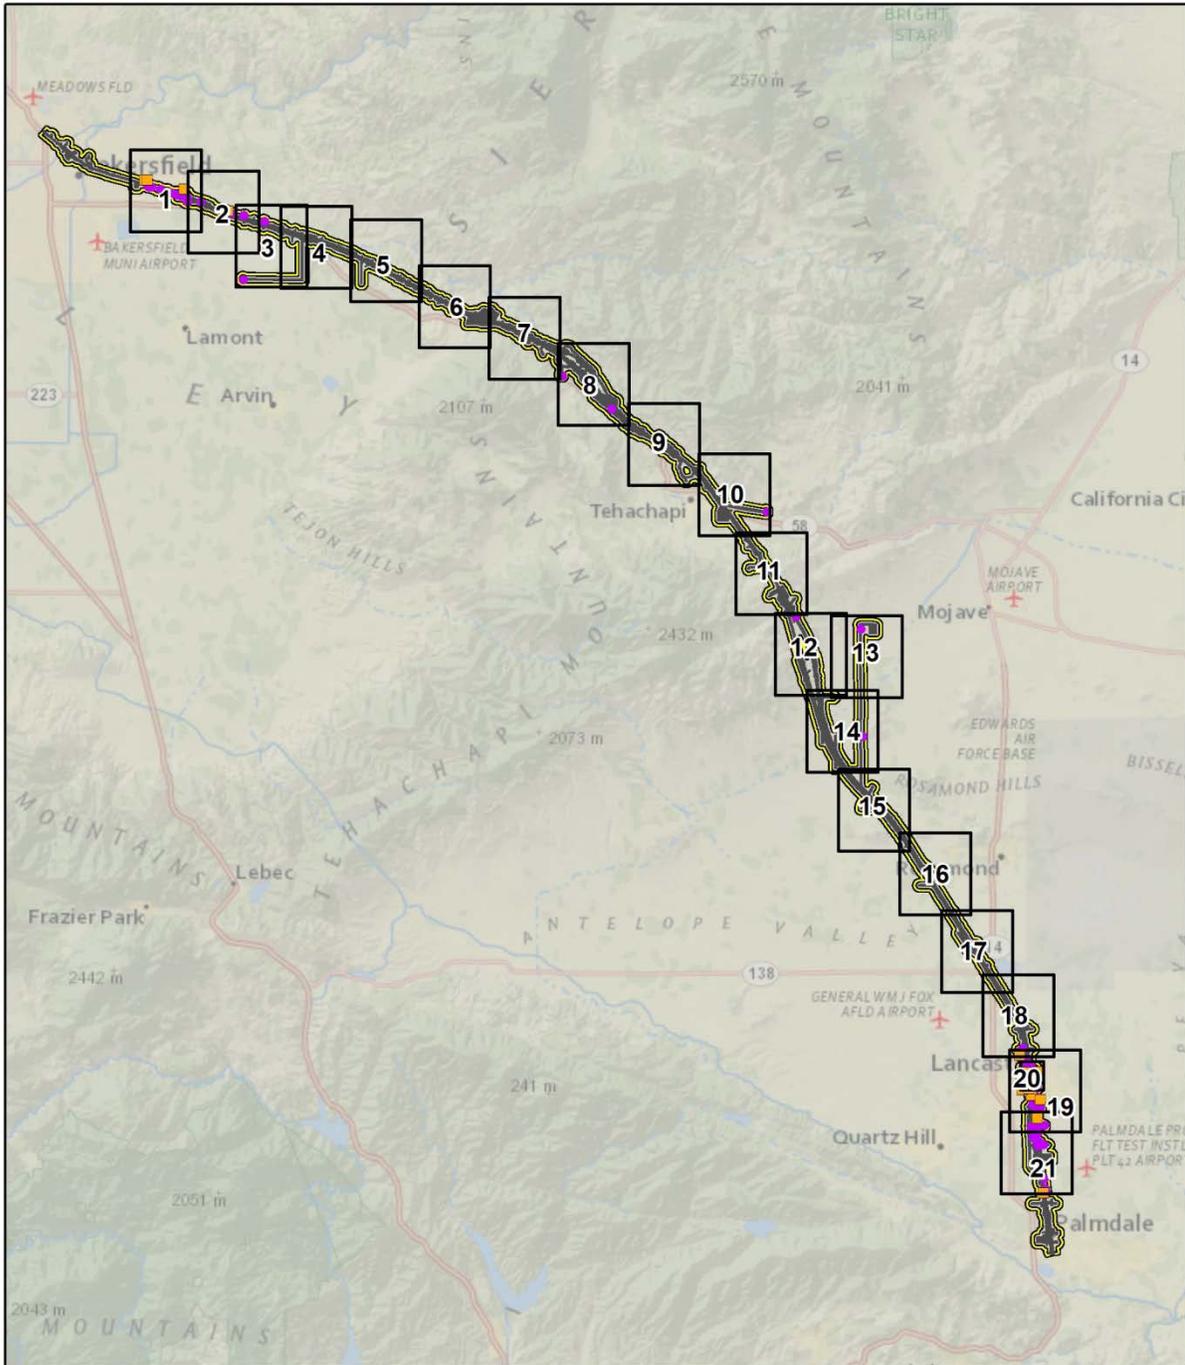
Figure 3.10-A-1 PEC Sites in the RSA - Overview

Sites labeled S# are from the Sanborn maps.
 Sites with E# are from the EDR database (Authority 2016: 6-14 to 6-47).

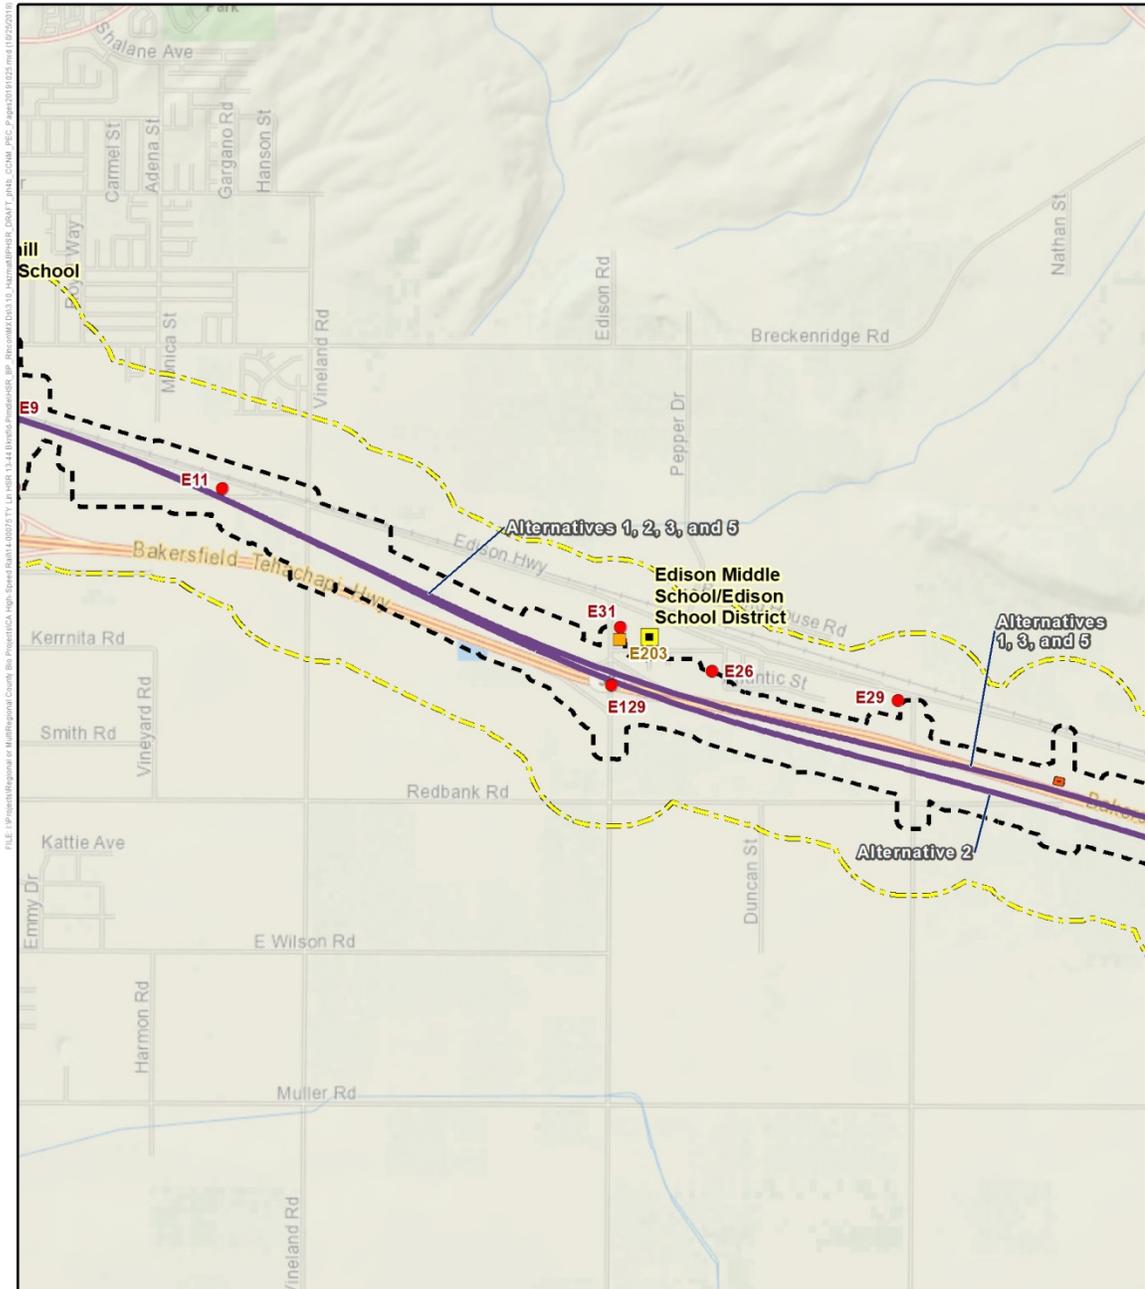
Figure 3.10-A-1 PEC Sites in the RSA (Sheet 2)

Sites labeled S# are from the Sanborn maps.
 Sites with E# are from the EDR database (Authority 2016: 6-14 to 6-47).

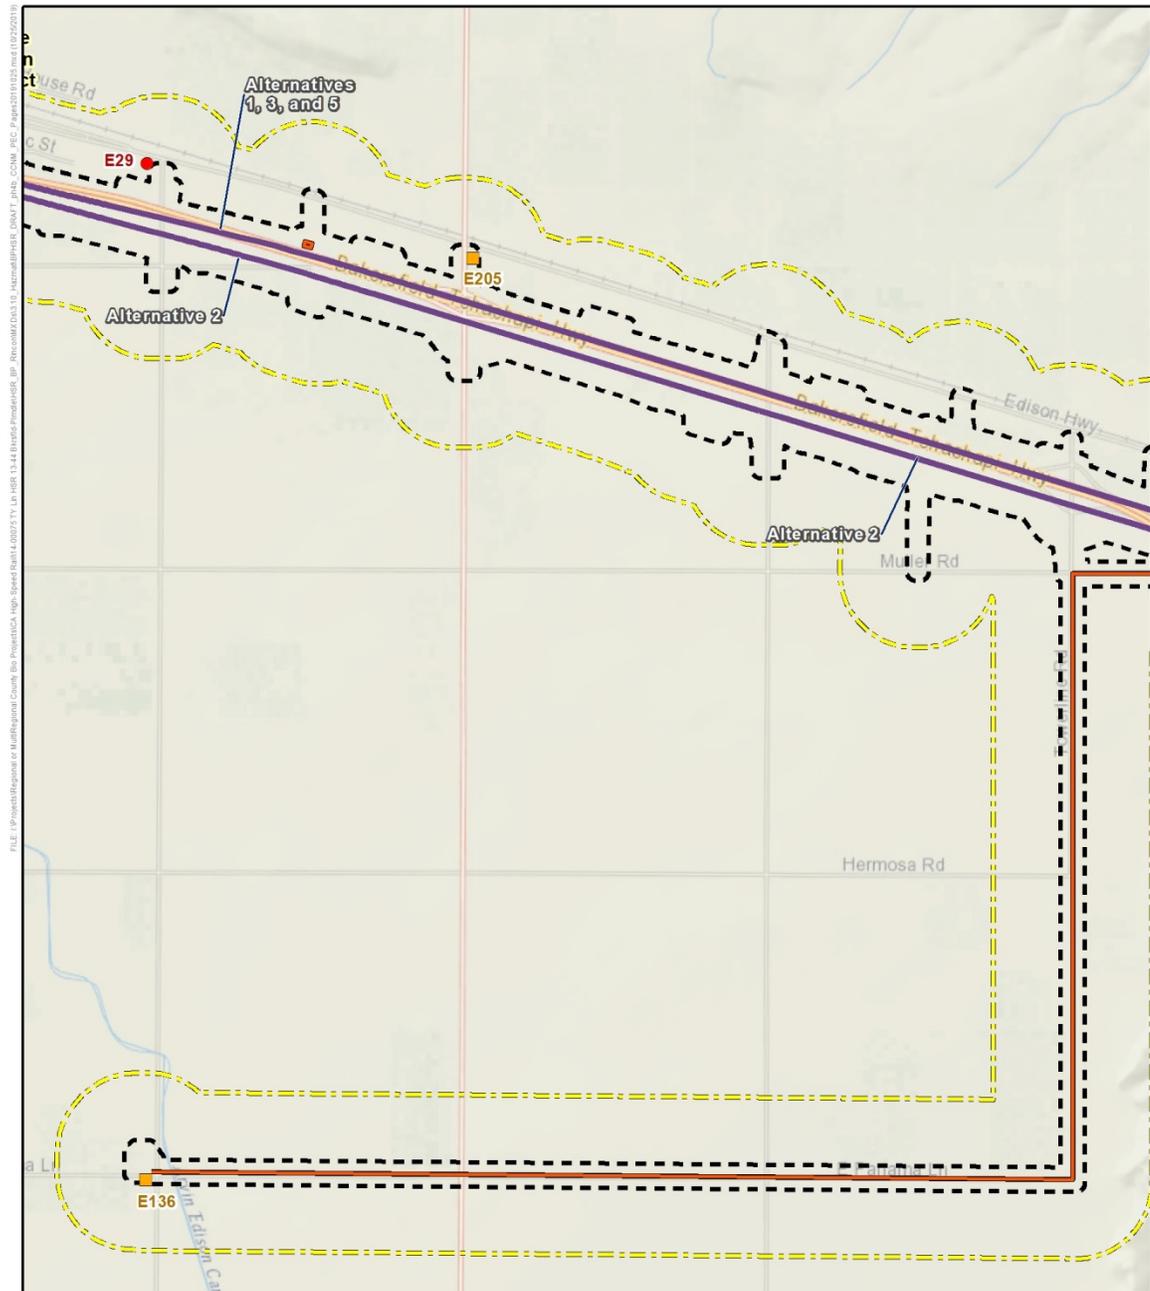
Figure 3.10-A-1 PEC Sites in the RSA (Sheet 3)

Sites labeled S# are from the Sanborn maps.
 Sites with E# are from the EDR database (Authority 2016: 6-14 to 6-47).

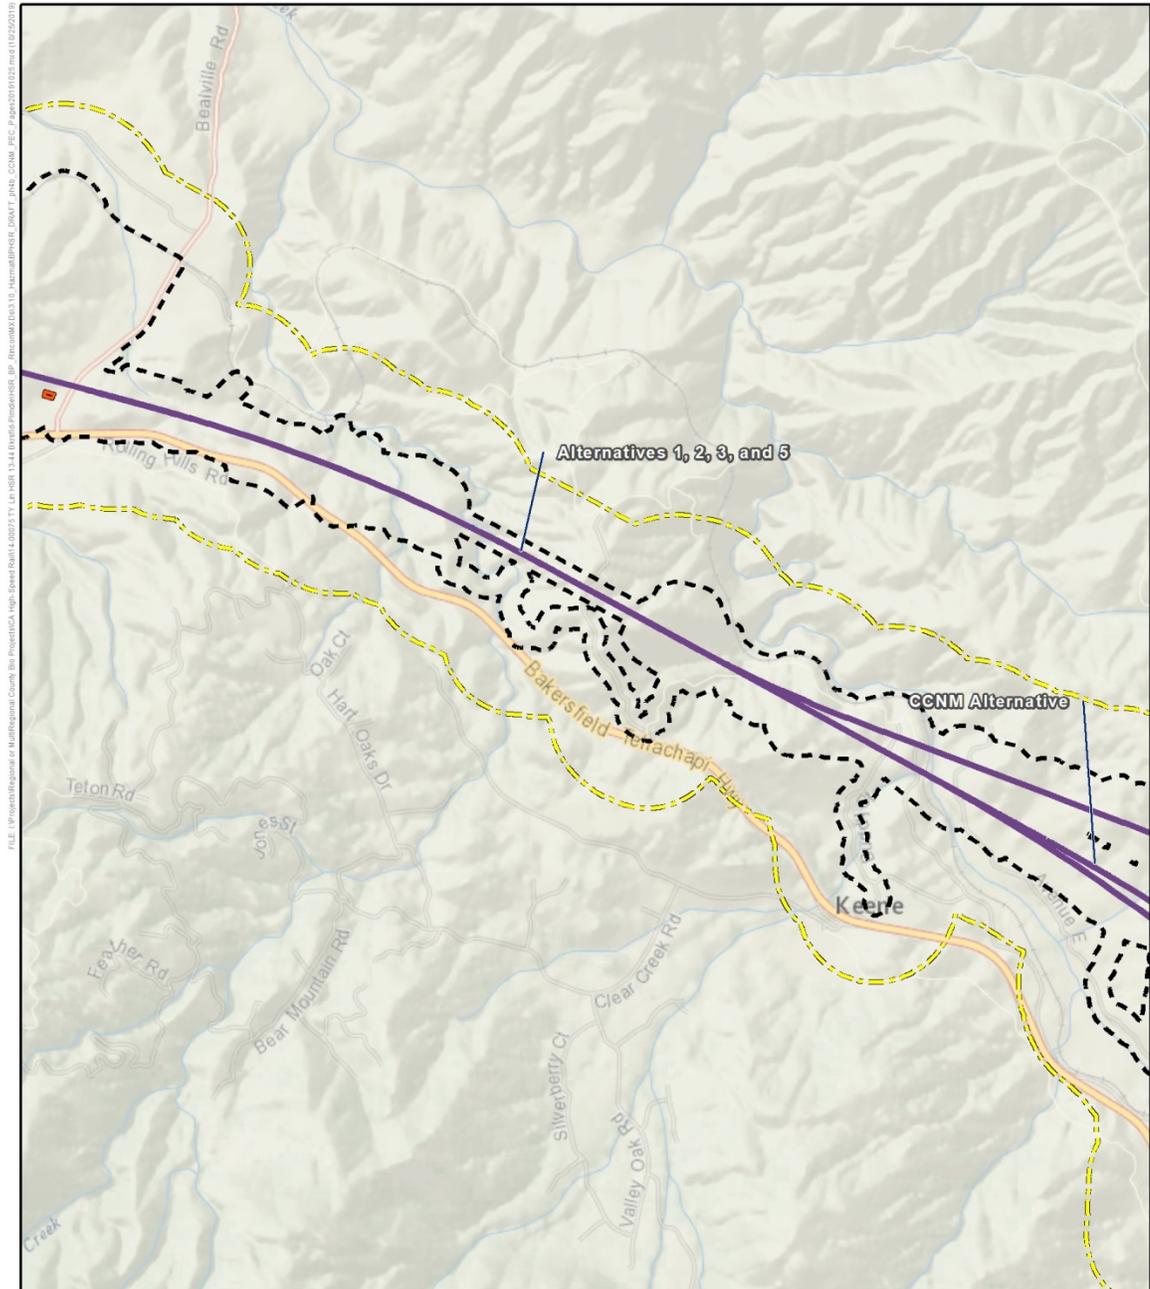
Figure 3.10-A-1 PEC Sites in the RSA (Sheet 7)

Sites labeled S# are from the Sanborn maps.
 Sites with E# are from the EDR database (Authority 2016: 6-14 to 6-47).

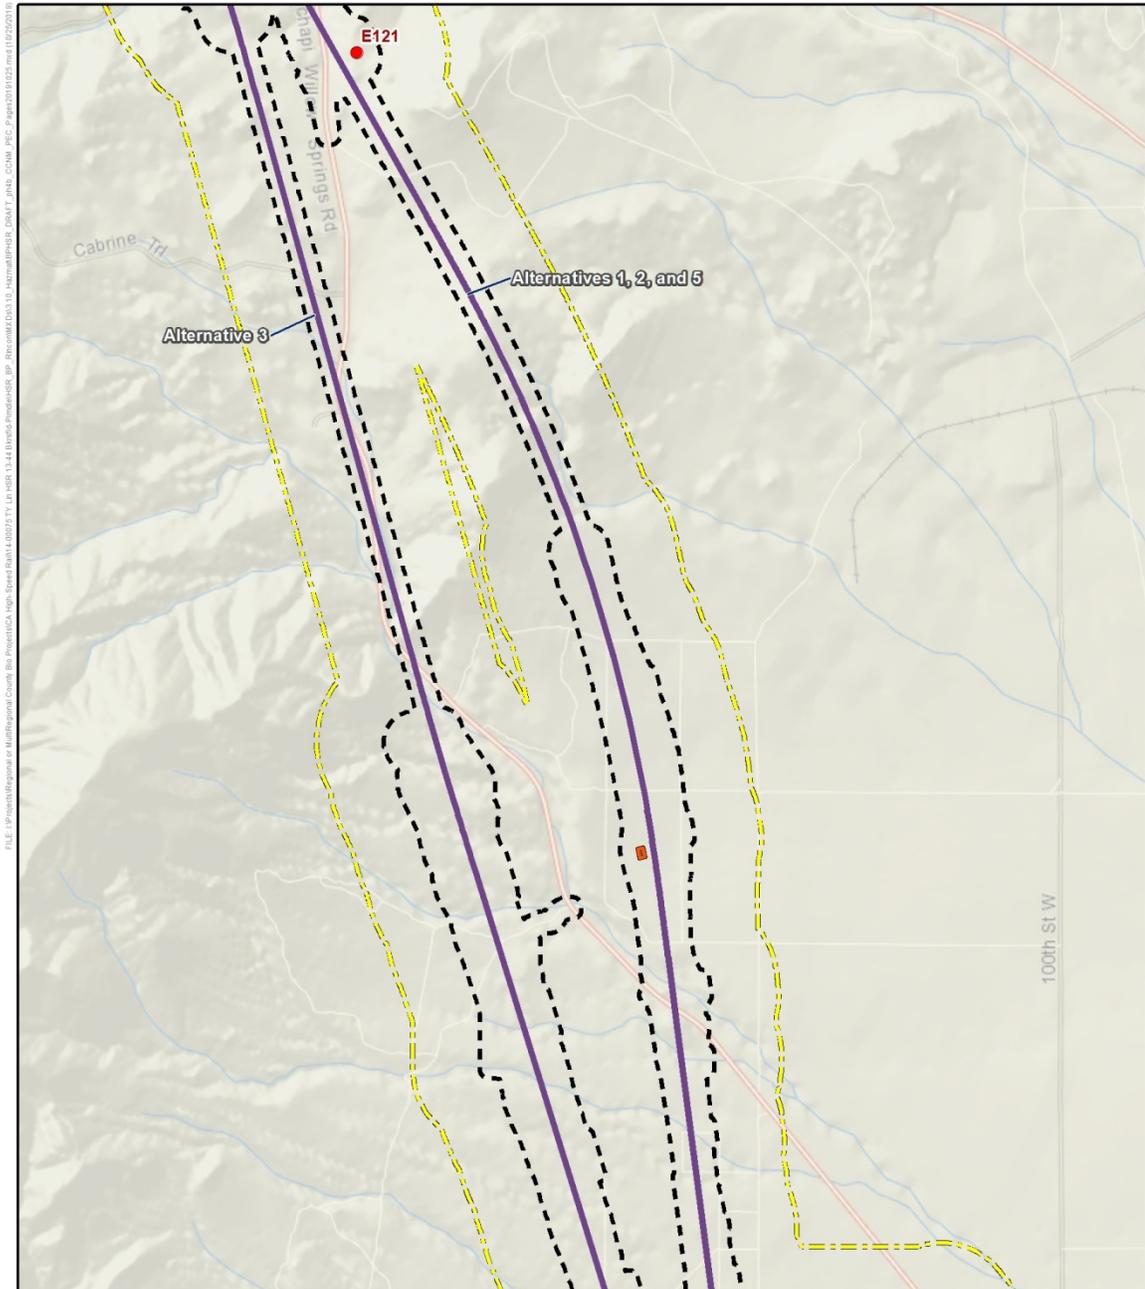
Figure 3.10-A-1 PEC Sites in the RSA (Sheet 12)

Sites labeled S# are from the Sanborn maps.
 Sites with E# are from the EDR database (Authority 2016: 6-14 to 6-47).
