Wetland Delineation

Teichert Boca Quarry

Wetlands and Other Waters

July 2012

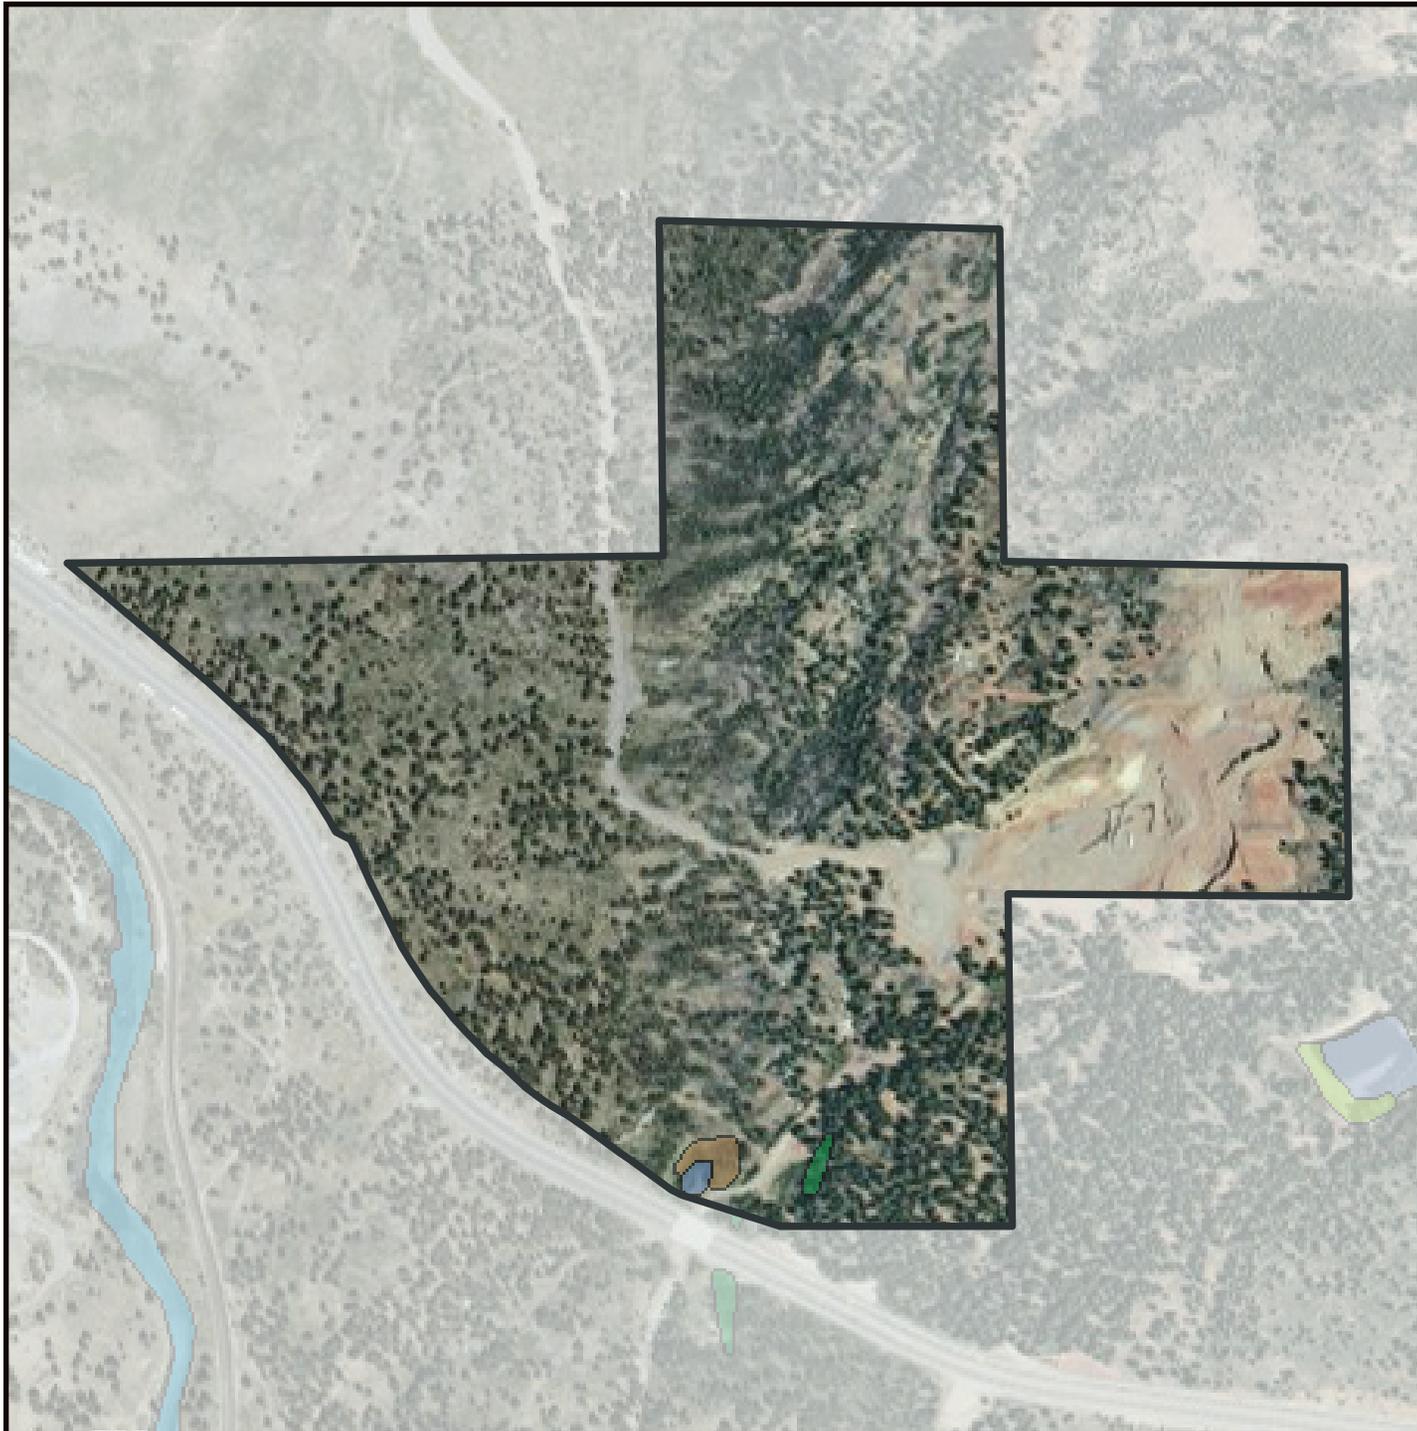
Figure 2. National Wetlands Inventory

The NWI mapping is provided in Figure 2. NRCS soil survey mapping is shown in Figure 3. The delineation mapping is provided in Figure 4. A list of plant species relevant to the determination of wetlands and other waters is provided in Table 1, and acreages of delineated features are provided in Table 2. Additional results are found in the appendices as follows:

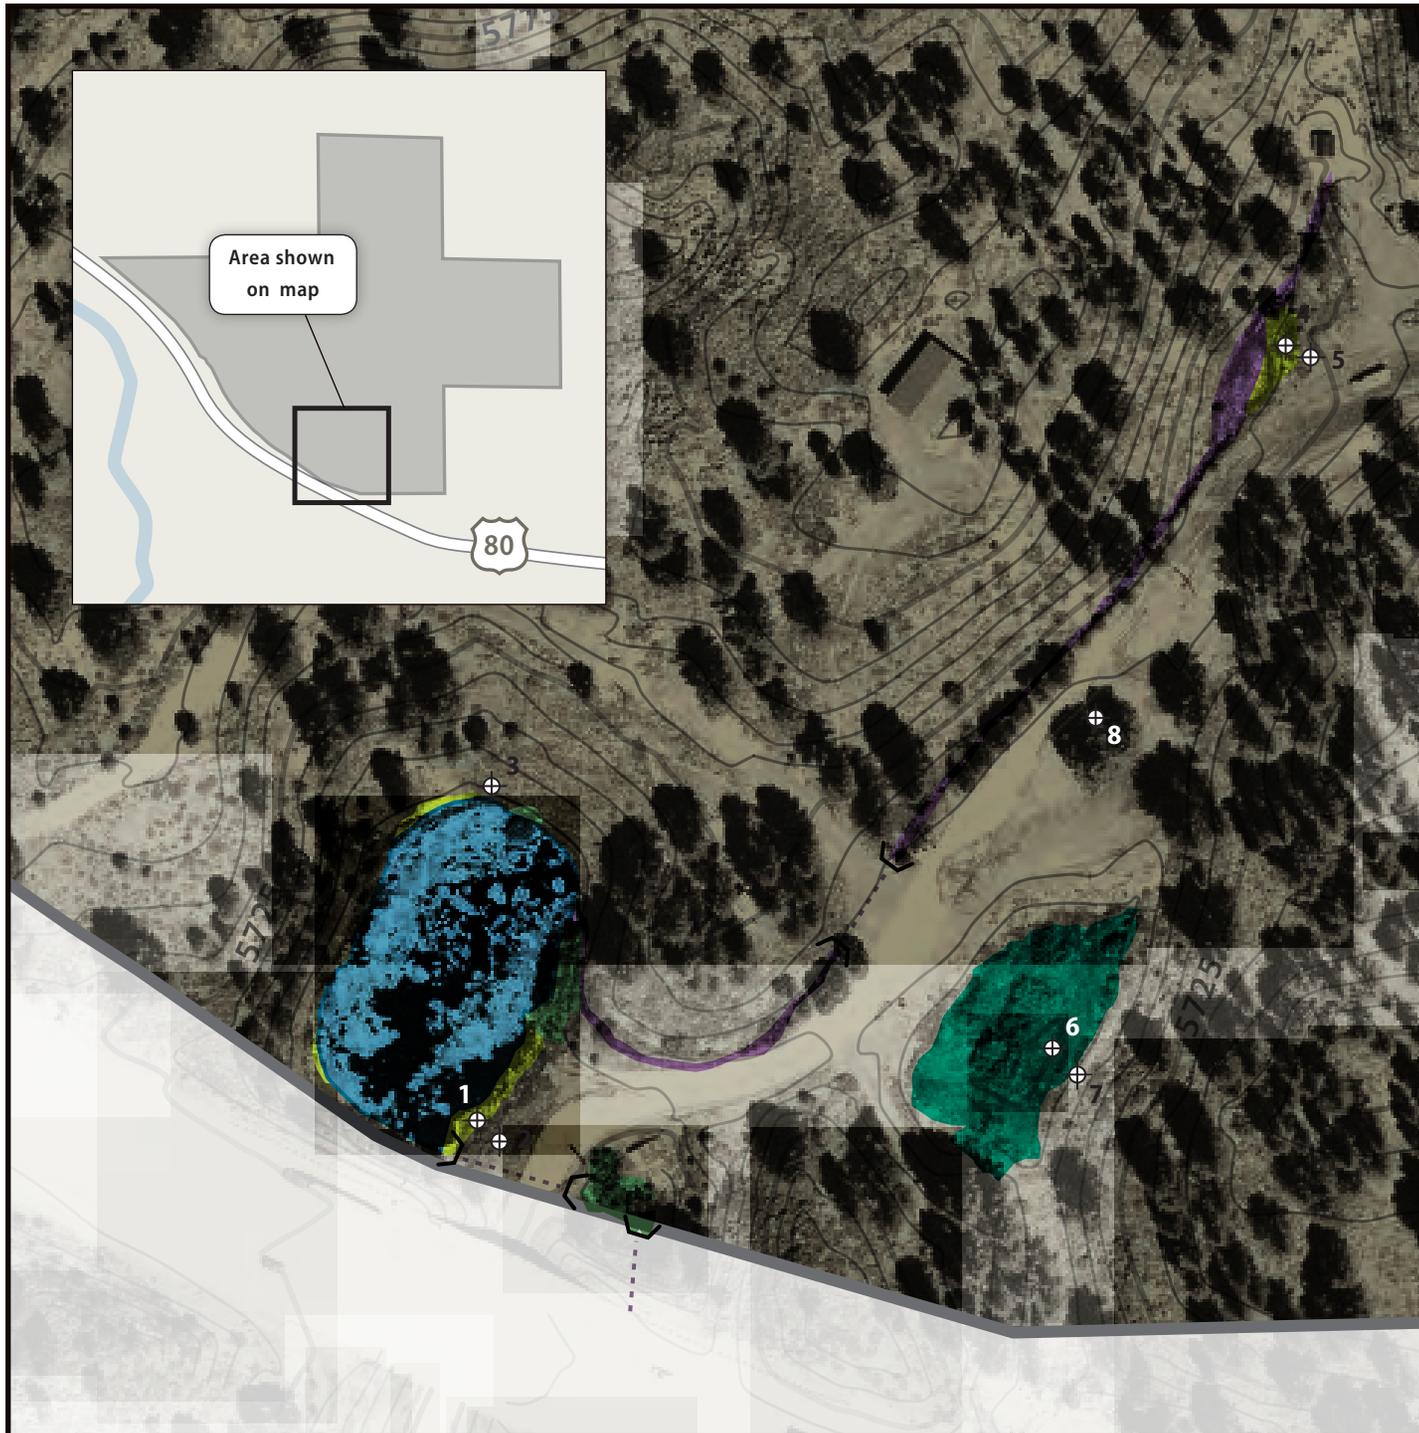
Wetlands and other waters shown on this map are waters of the State of California but not waters of the United States. See text for additional discussion.

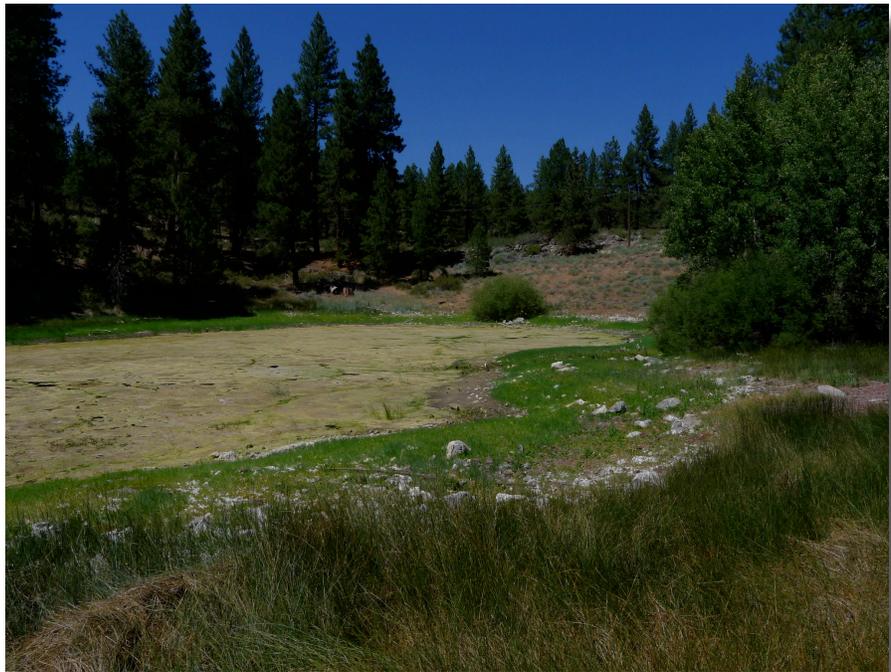
Photo 1. Perennial pond viewed from southwest. Pale algal mats represent OHWM when outflow culvert is blocked, presumably by ice. Bright green wetland vegetation is within OHWM. Some patches of Freshwater Emergent Wetland (Baltic/arctic rush) and clumps of Montane Riparian wetland scrub (Lemmon's willow, center of photo) but the pond outside the OHWM, and an area of Montane Riparian woodland (aspen grove) is at right side of photo, between pond and channel.

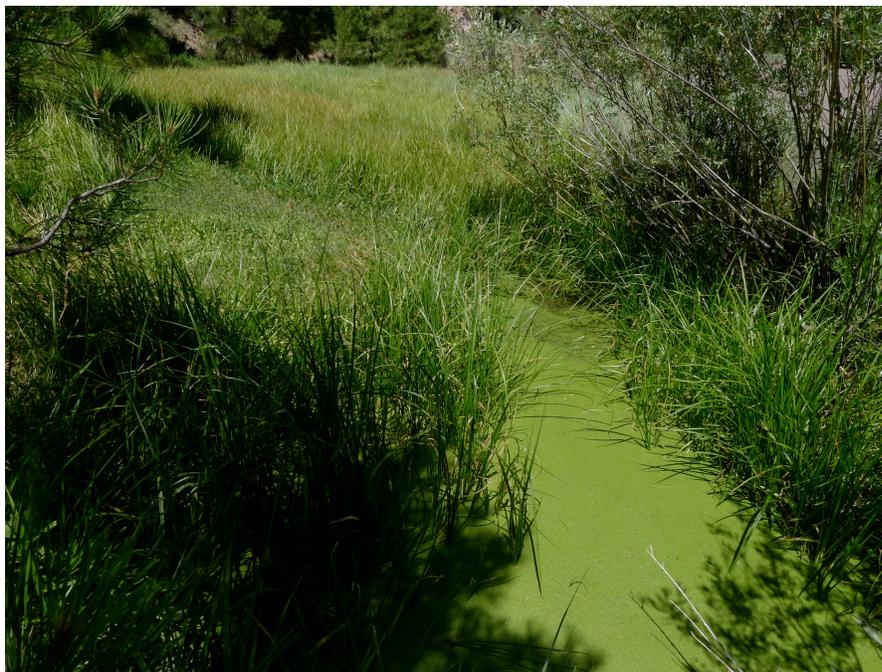
Photo 2. Perennial channel (outflow from spring) with emergent wetland above and below level of OHWM. Sedge wetland outside OHWM is perennially saturated with the seasonal water level varying from the soil surface down to (probably) about 4 inches below the surface in the late summer and autumn, when spring flows are reduced. Pale green non-persistent floating aquatic vegetation is duckmeat (*Spirodela polyrhiza*).

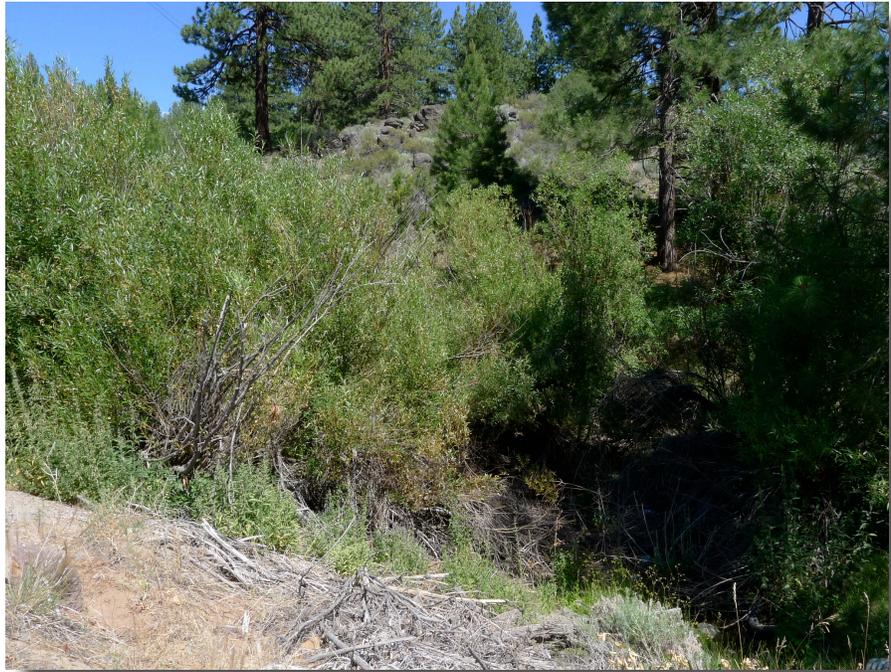
Photo 3. Montane Riparian vegetation (*Salix lasiandra*) in wetland supported by culverted outflow from Perennial Pond. A narrow area of long-seasonal flow, in shadow, occurs between the outfall of the pond culvert (barely visible at lower right corner) and the inlet of another culvert that drains under I-80 to an isolated off-site wetland (see report Figures 2 and 4).

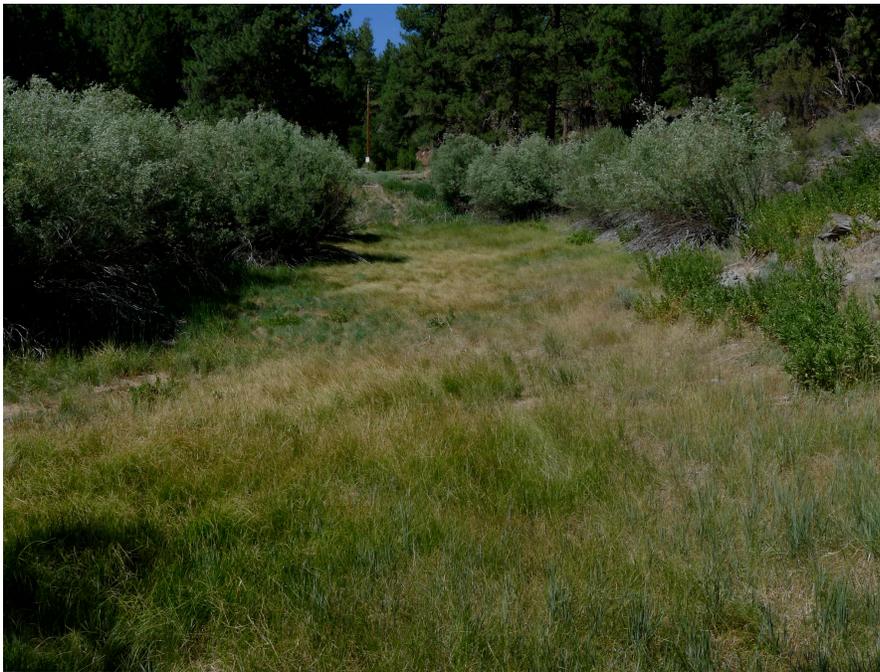
Photo 4. Mixed Montane Meadow and Montane Riparian scrub (*Salix geyeriana*) in isolated depression. Herbaceous vegetation is dominated in a mosaic by *Carex douglasii* and *Hordeum brachyantherum*, with much lesser proportions of *Juncus balticus (arcticus)*, *Poa pratensis*, and *Potentilla biennis*. The tall coarse herb is *Senecio serra* (FACU), of which a few plants occur within the wetland. Additional meadow occurs to the left of the willows on the left side of the photo.

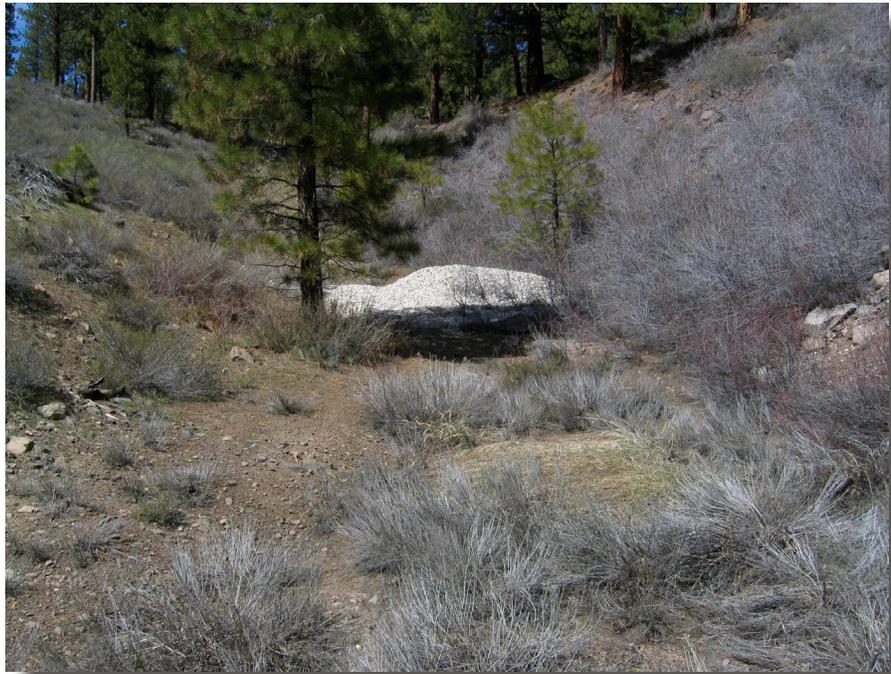
Photo 5. Topographic valley immediately (about 20 feet) upslope from the perennial spring, with no water-borne debris, sediment deposits, or scouring of the lowest part of the valley. This spot would have been expected to be the single most likely place for evidence of a seasonal or ephemeral tributary to be found, but no such evidence could be found anywhere in the valley. The white patch in the valley, taken in May, is a melting snowbank.

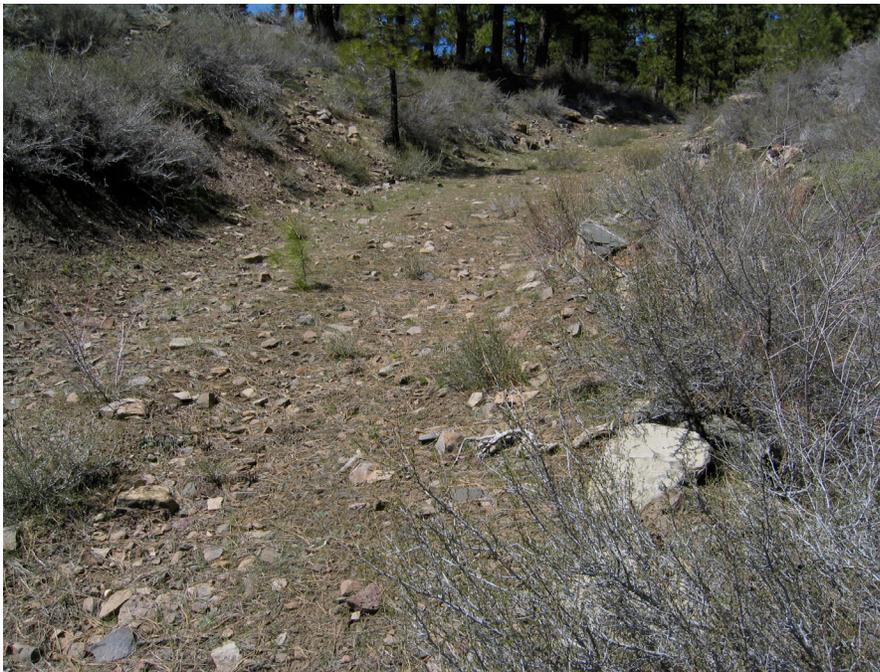
Photo 6. Same valley, a short distance up valley from Photo 5. Part of the bottom of this main valley may have been graded to make an access path or road at some point in the very distant past. Photo shows no flow in early May, lack of scouring of a definable channel (proportion of stones on surface is about the same at the lowest point and up the side slopes), persistence of fines and light debris, and growth of strictly upland plant species. All of these show that this feature is not a seasonal watercourse.

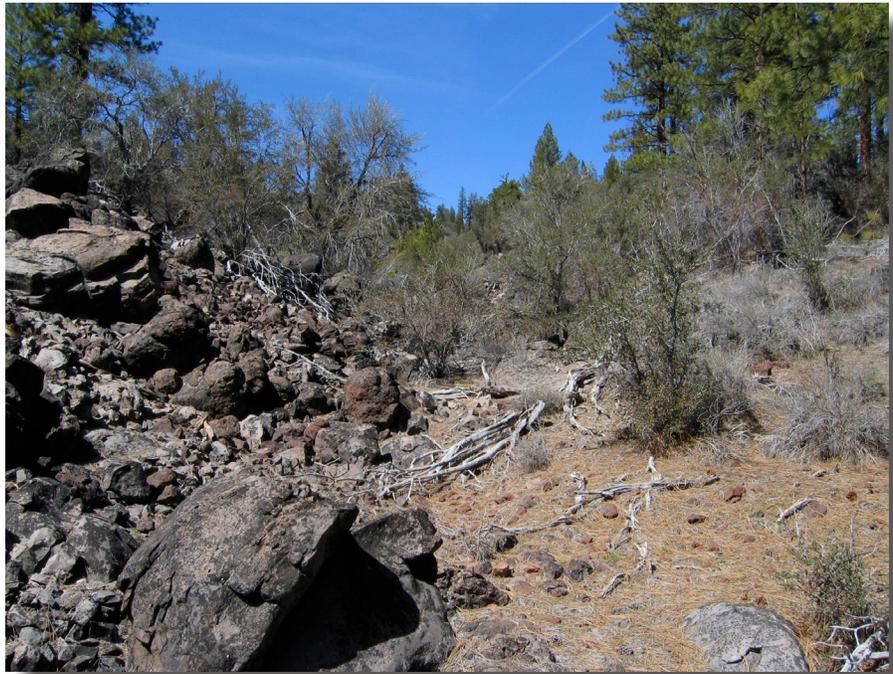
Photo 7.
Typical conditions in upper part of main topographic valley in center of site. Photograph was taken standing in the very bottom of the valley and shows extensive talus fields and highly permeable forest slopes that result in there being no surface flow through the valley.

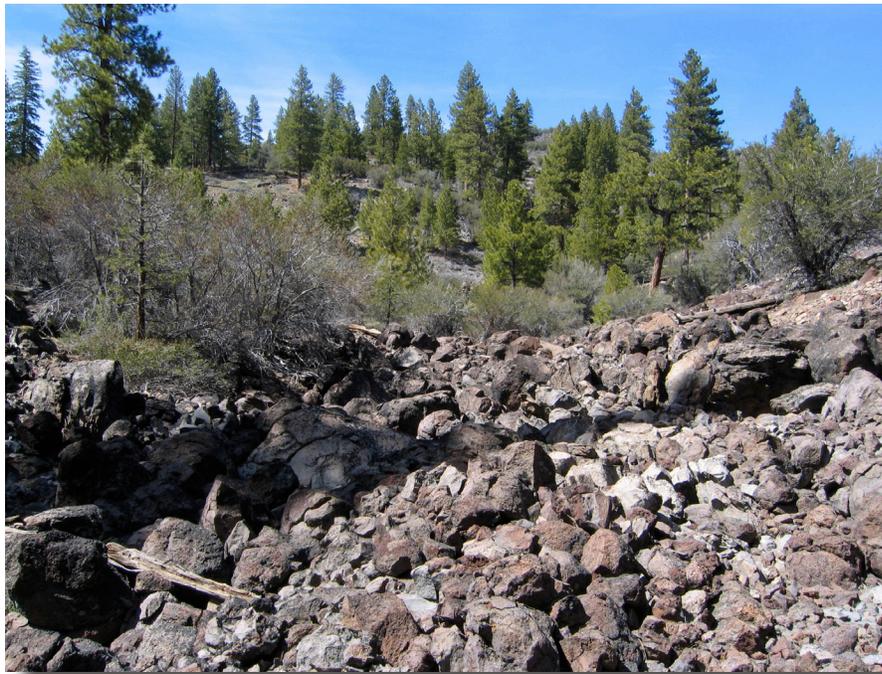
Photo 8.
Further up the same main valley, also taken from a point at the bottom of the valley.

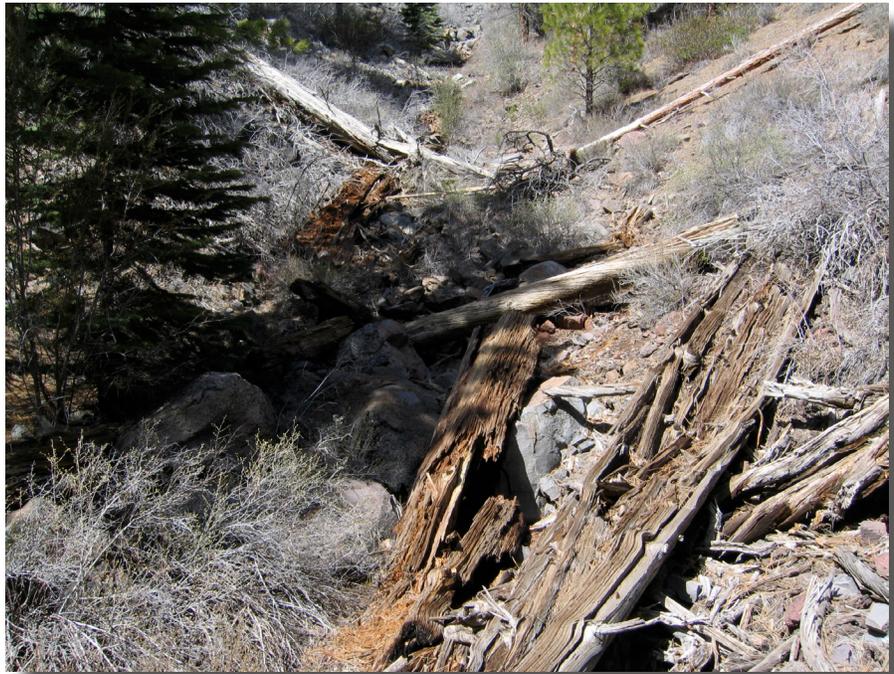
Photo 9.
Typical conditions in lower part of smaller valley to the west of the one shown in Photos 5-8. Soils are usually present albeit with many large and small rocks on the surface, none showing evidence of weathering by flowing water such as rounded edges or water staining. Fine debris and upland species such as bitterbrush, squirreltail grass, and Jeffrey pine are found at the very lowest point of the valley, where they would not be present if there were even occasional surface flow.

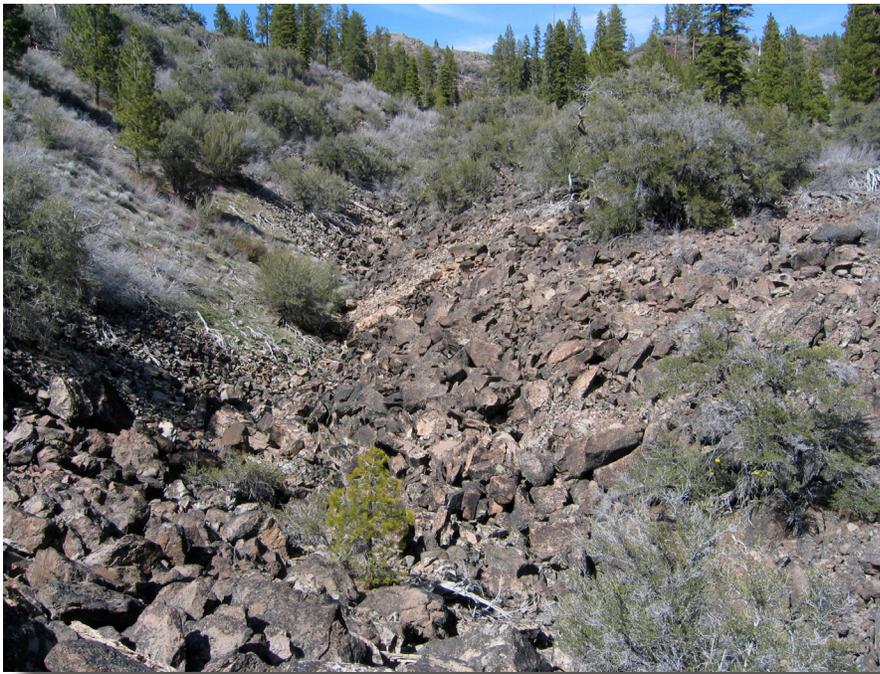
Photo 10.
Upper part of smaller valley; conditions are similar to those found in the largest valley of the site: extensive talus field filling the entire bottom of the valley. Material is much too porous to support surface flow.

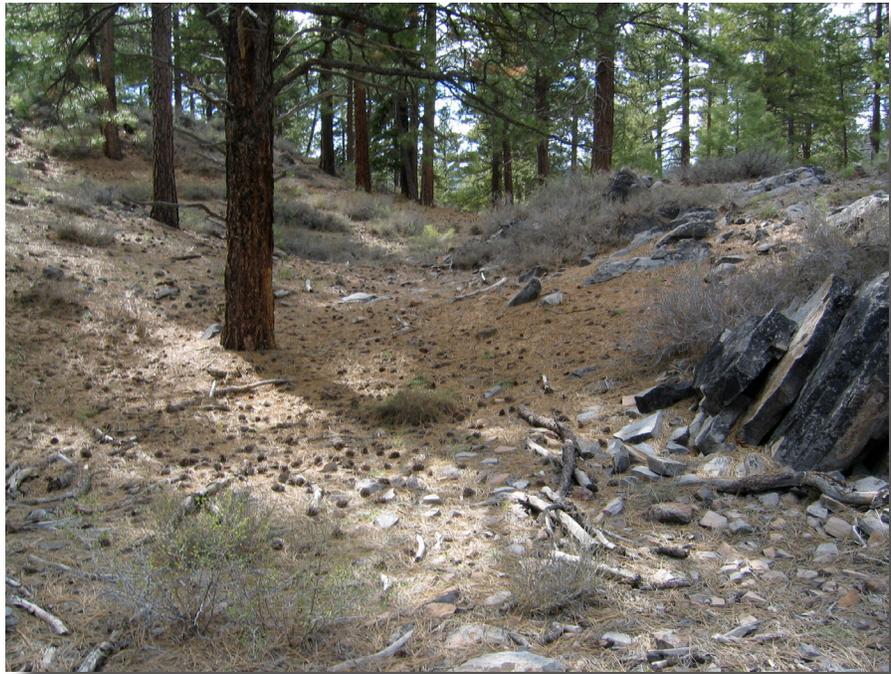
Photo 11.
Typical conditions in lower gradient valleys in Jeffrey pine/bitterbrush vegetation. Valley slopes and bottom are soil, not talus, but with no flowline evident: no scouring (removal of fines or vegetative debris), water staining, or incision of the soil surface.

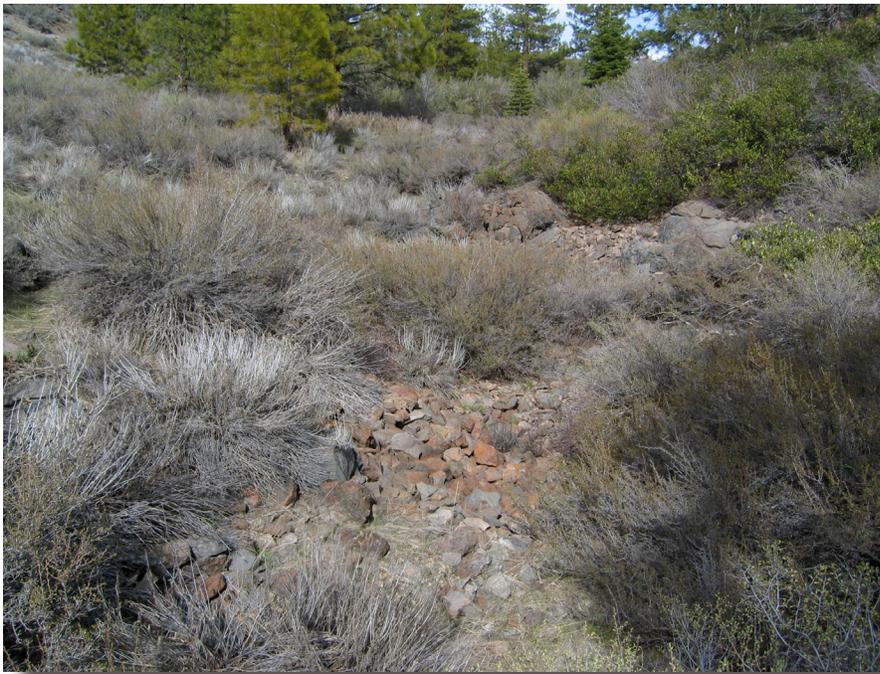
Photo 12.
Typical conditions in shrubland portions of smaller valleys in lower part of site: soil surface is much more rocky than in the woodland/savanna vegetation seen above. But there is still no evidence of surface flow occurring even occasionally.
